**APPENDIX 3.0-H  
Terrain Stability Field Assessment 4X4  
Access Road Avanti Kitsault Mines  
Kitsault BC**

Prepared by  
J.W. Schwab P.Geo., Eng.L.  
Geomorphologist

Prepared for  
Avanti Kitsault Mines Ltd.

August 15, 2011

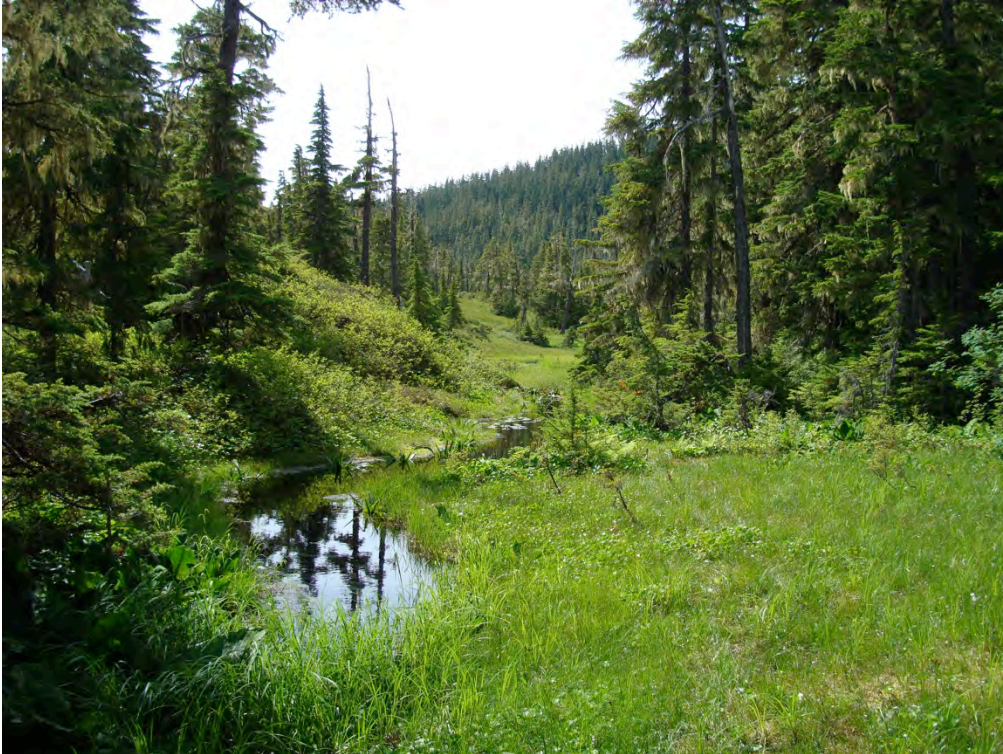
The deeper organics and hummocky terrain within the basin pose a construction challenge (Figure 2). Overland construction with the use of an engineering geotextile, covered with free draining material, will enable the floating of the road over many organic soils. No ditches are cut in the organics but cross drainage is provided at sites of surface water flow. However, overland construction is not fail safe—density and water content of the organics are critical inherent factors that must be considered. Sloping bogs are an additional problem—loading of the organics even with overland construction could result in movement of the organic mat (this comment also applies to the sloping organic bogs at road section 2+888 to 2+540 and revised section 0+546 to 0+700). Geotechnical Engineers specialized in overland construction should be consulted and possibly supervise the construction through the organic terrain, in particular, the deep wide wet bogs.

**Figure 2 Hummocky terrain with deep organics in the dips between bedrock ridges.**

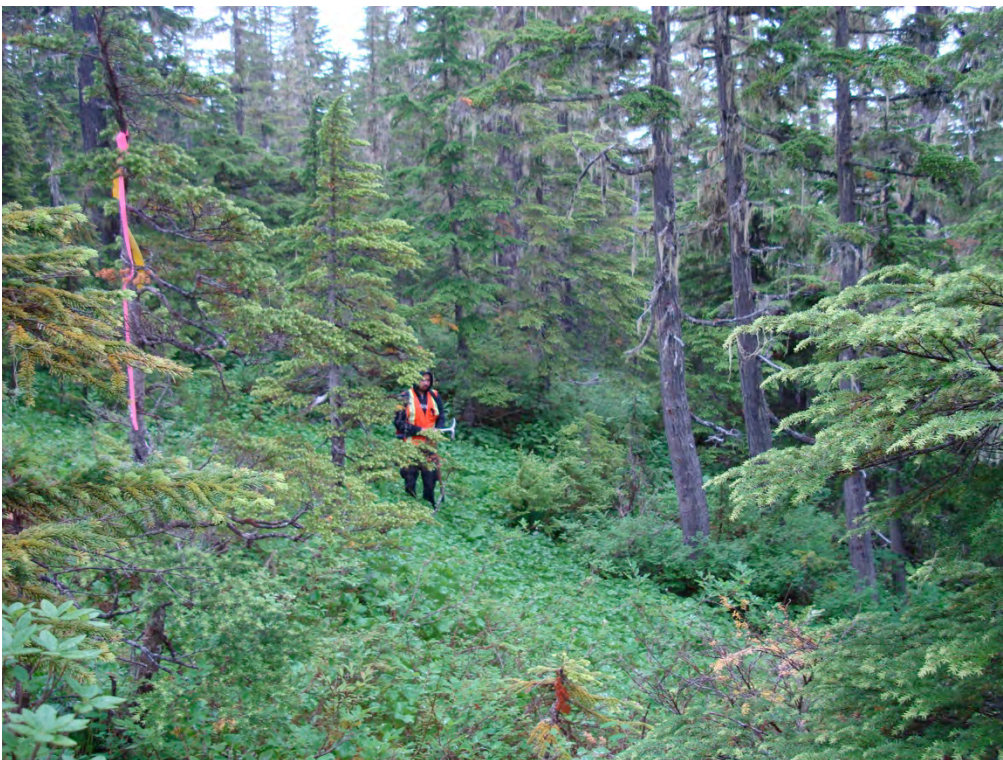
Scrub forests and bogs have developed on all the gently sloping relatively flat terrain within the lower basin and on the gentle upper slopes. These areas are poor to very poorly drained. Forest stands have developed only on the moderate to rapidly drained steeper slopes. Few defined streams drain the hillside and few deep gullies have been eroded into the bedrock or surficial materials. The lack of confined drainages has resulted in the development of the deep organic soils in the lower basin and at higher elevation. Pockets of deeper organics have also developed at slope breaks and along benches of the steeper slopes (Figure 3).

Folic soils and pockets of organic soils occur at many sites along this forested section of the road (Figures 3 and 6). These soils must be removed and not loaded with waste materials or by equipment during construction—they will fail under load or vibration. Only use excavators for construction on the steeper slopes (refer to the section on landslides in folic soils).

**Figure 3 Organic soils on a forested slope. Leaning trees (photo centre right) show slope movement into a depression that breaks off steeply downslope.**

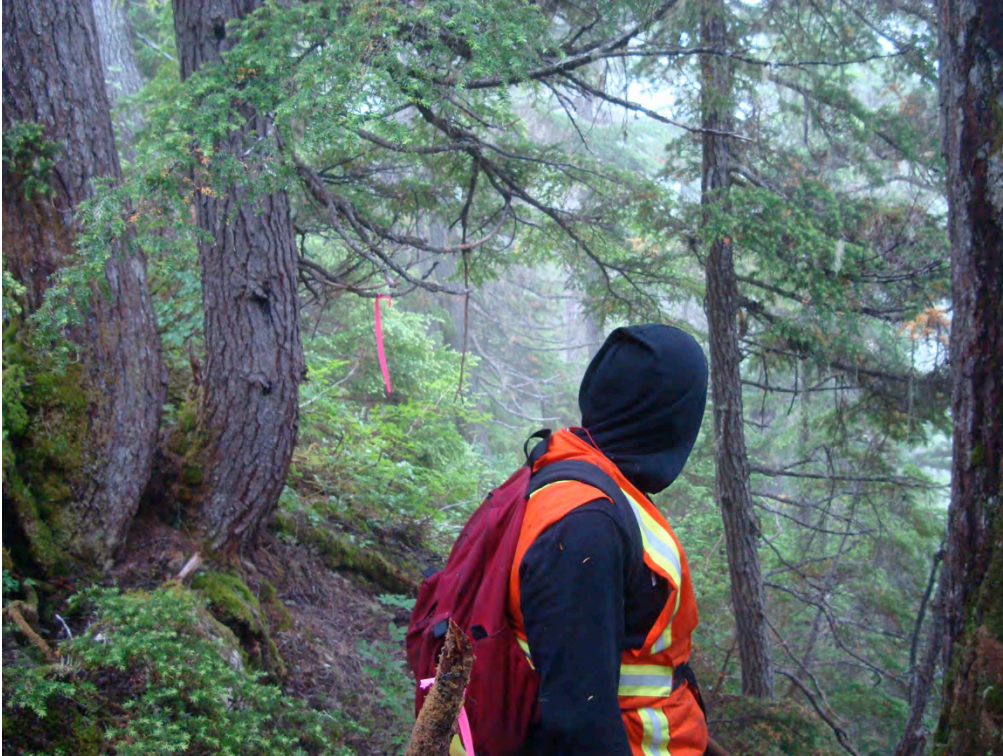
**Figure 4 Steep forested slope with a narrow bench located above headwalls.**

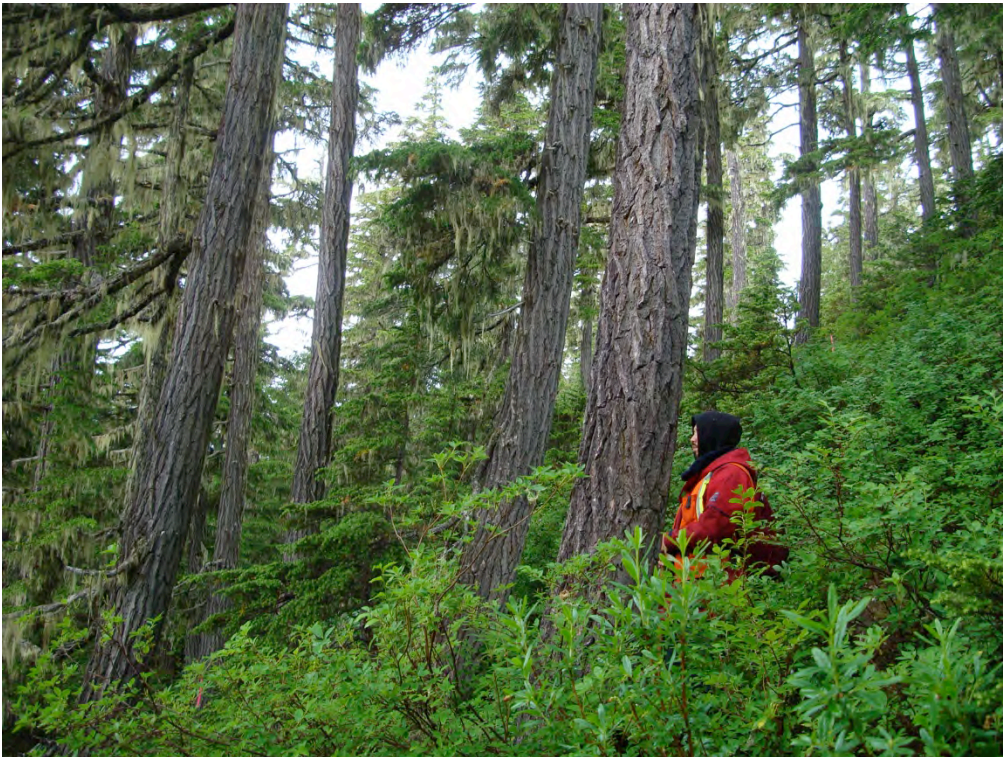
**Figure 5 Leaning trees show active slope movement.**

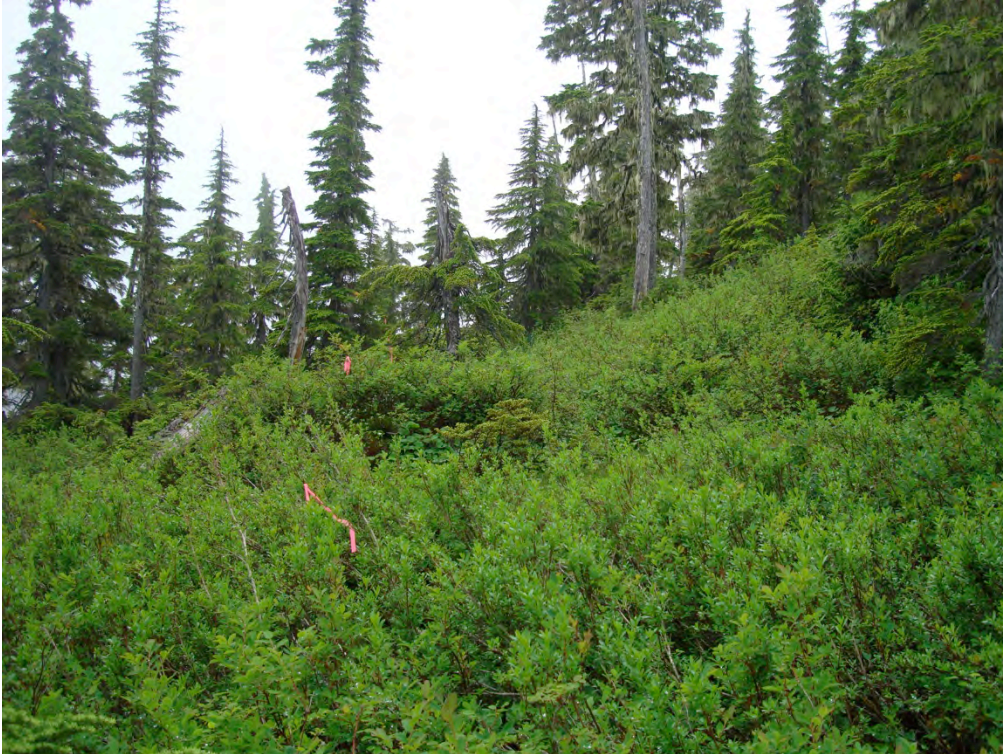
**Figure 6 Imperfect to well drained slope with open growing forest and folic soils.**

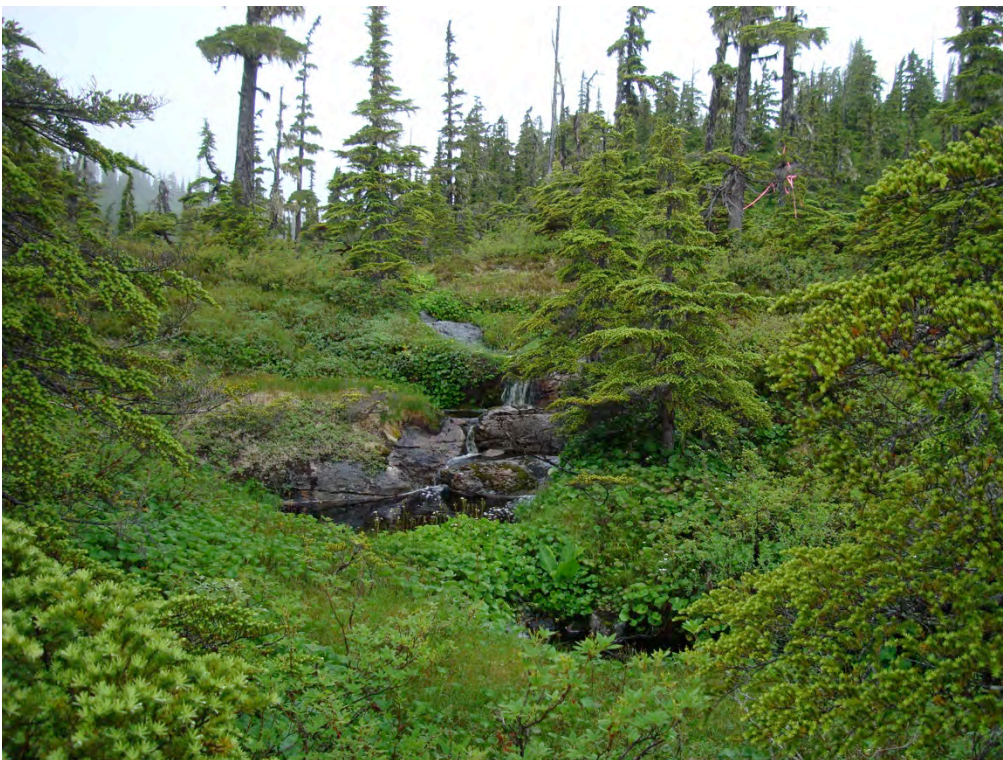
**Figure 7 Bedrock appears close to the surface over much of the higher elevation plateau.**
