January 13, 2013
File No.: ECON-12-7

**RE: TERRAIN STABILITY ASSESSMENT FOR CUTBLOCKS C3UX, C3H8 & C2XU,
MCNAB CREEK AREA, BCTS LICENSE A90229**

TSA ECON-12-7. Cutblocks C3UX, C3H8 & C2XU, McNab Creek. January 13, 2013.

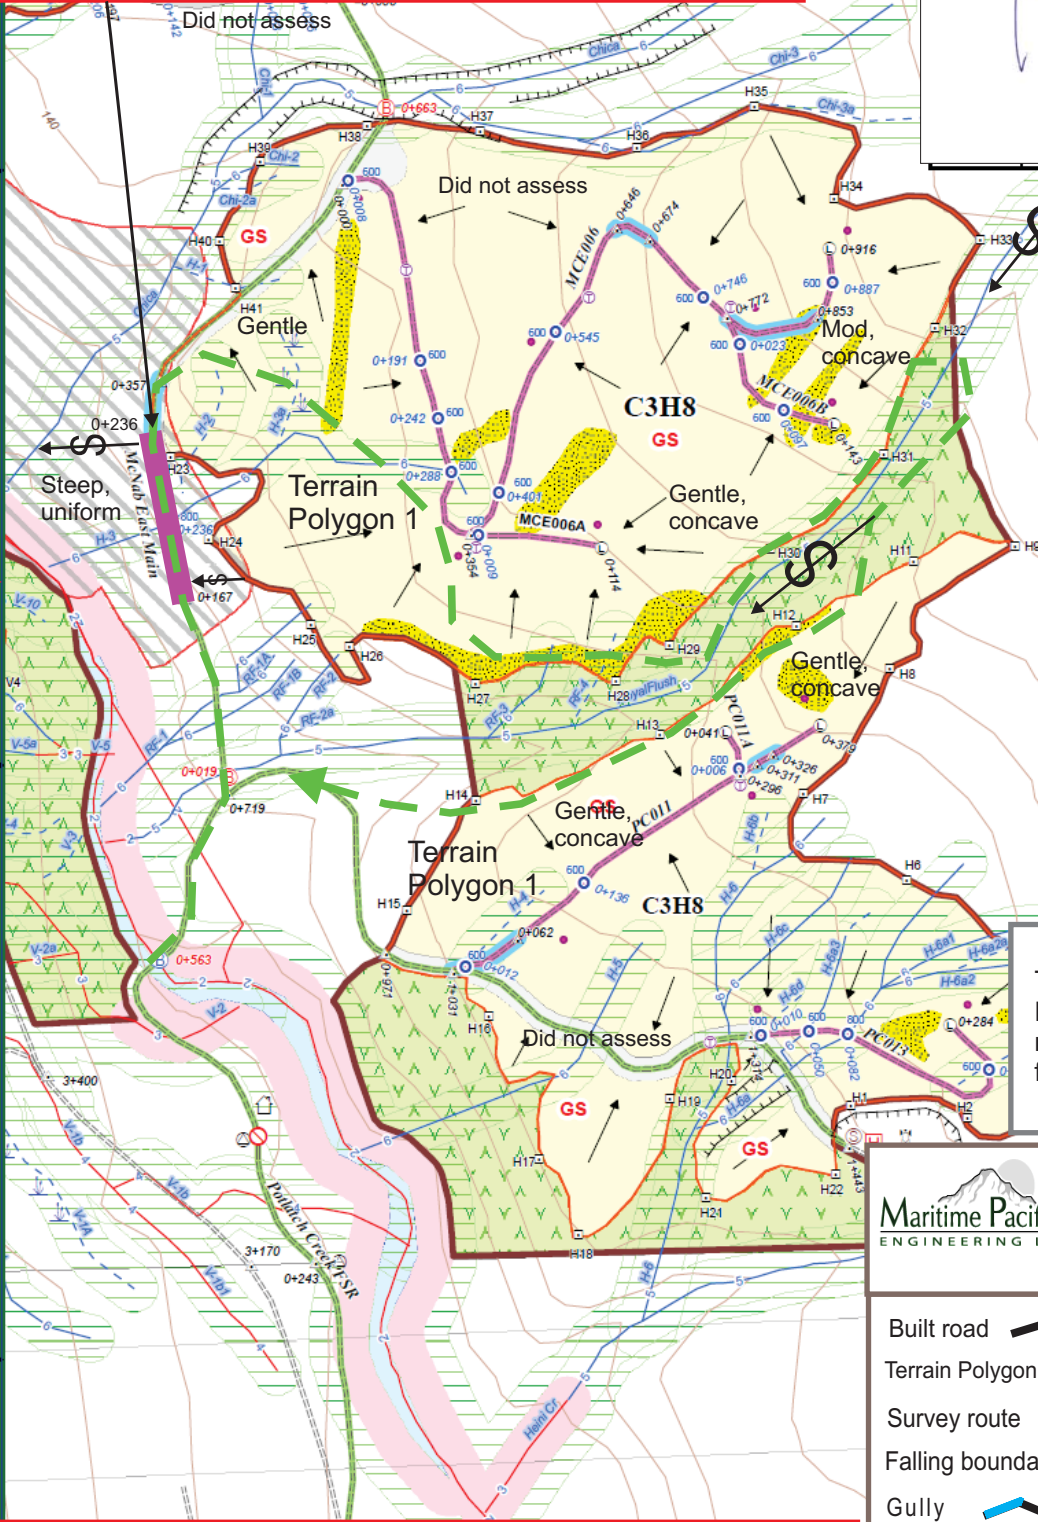
Maritime Pacific ENGINEERING LTD
 BCTS - ECON Consulting
 McNab Creek
 Cutblock C3H8 TSA

High terrain stability hazard 0+167-0+236:

Raveling overhanging cutbank ~0+167 - remove trees and scale.
 Utilize boulder buttress wall to contain rockfall.
 No sidecast - previous sidecast failure, move road into cutbank
P.Eng. monitoring recommended

Royal Flush Creek:

Hazard of severe stream avulsion and erosion - retain timber within stream draw

Caution: Avalanche hazard -

Identified streams exhibit avalanche activity which could be hazardous; avalanches are most active in winter months at times of heavy precipitation, especially rain-on-snow events
