# Terrain Stability Assessment

## Additional area added to Cutblock C34M

### McNab Creek

December 17, 2007

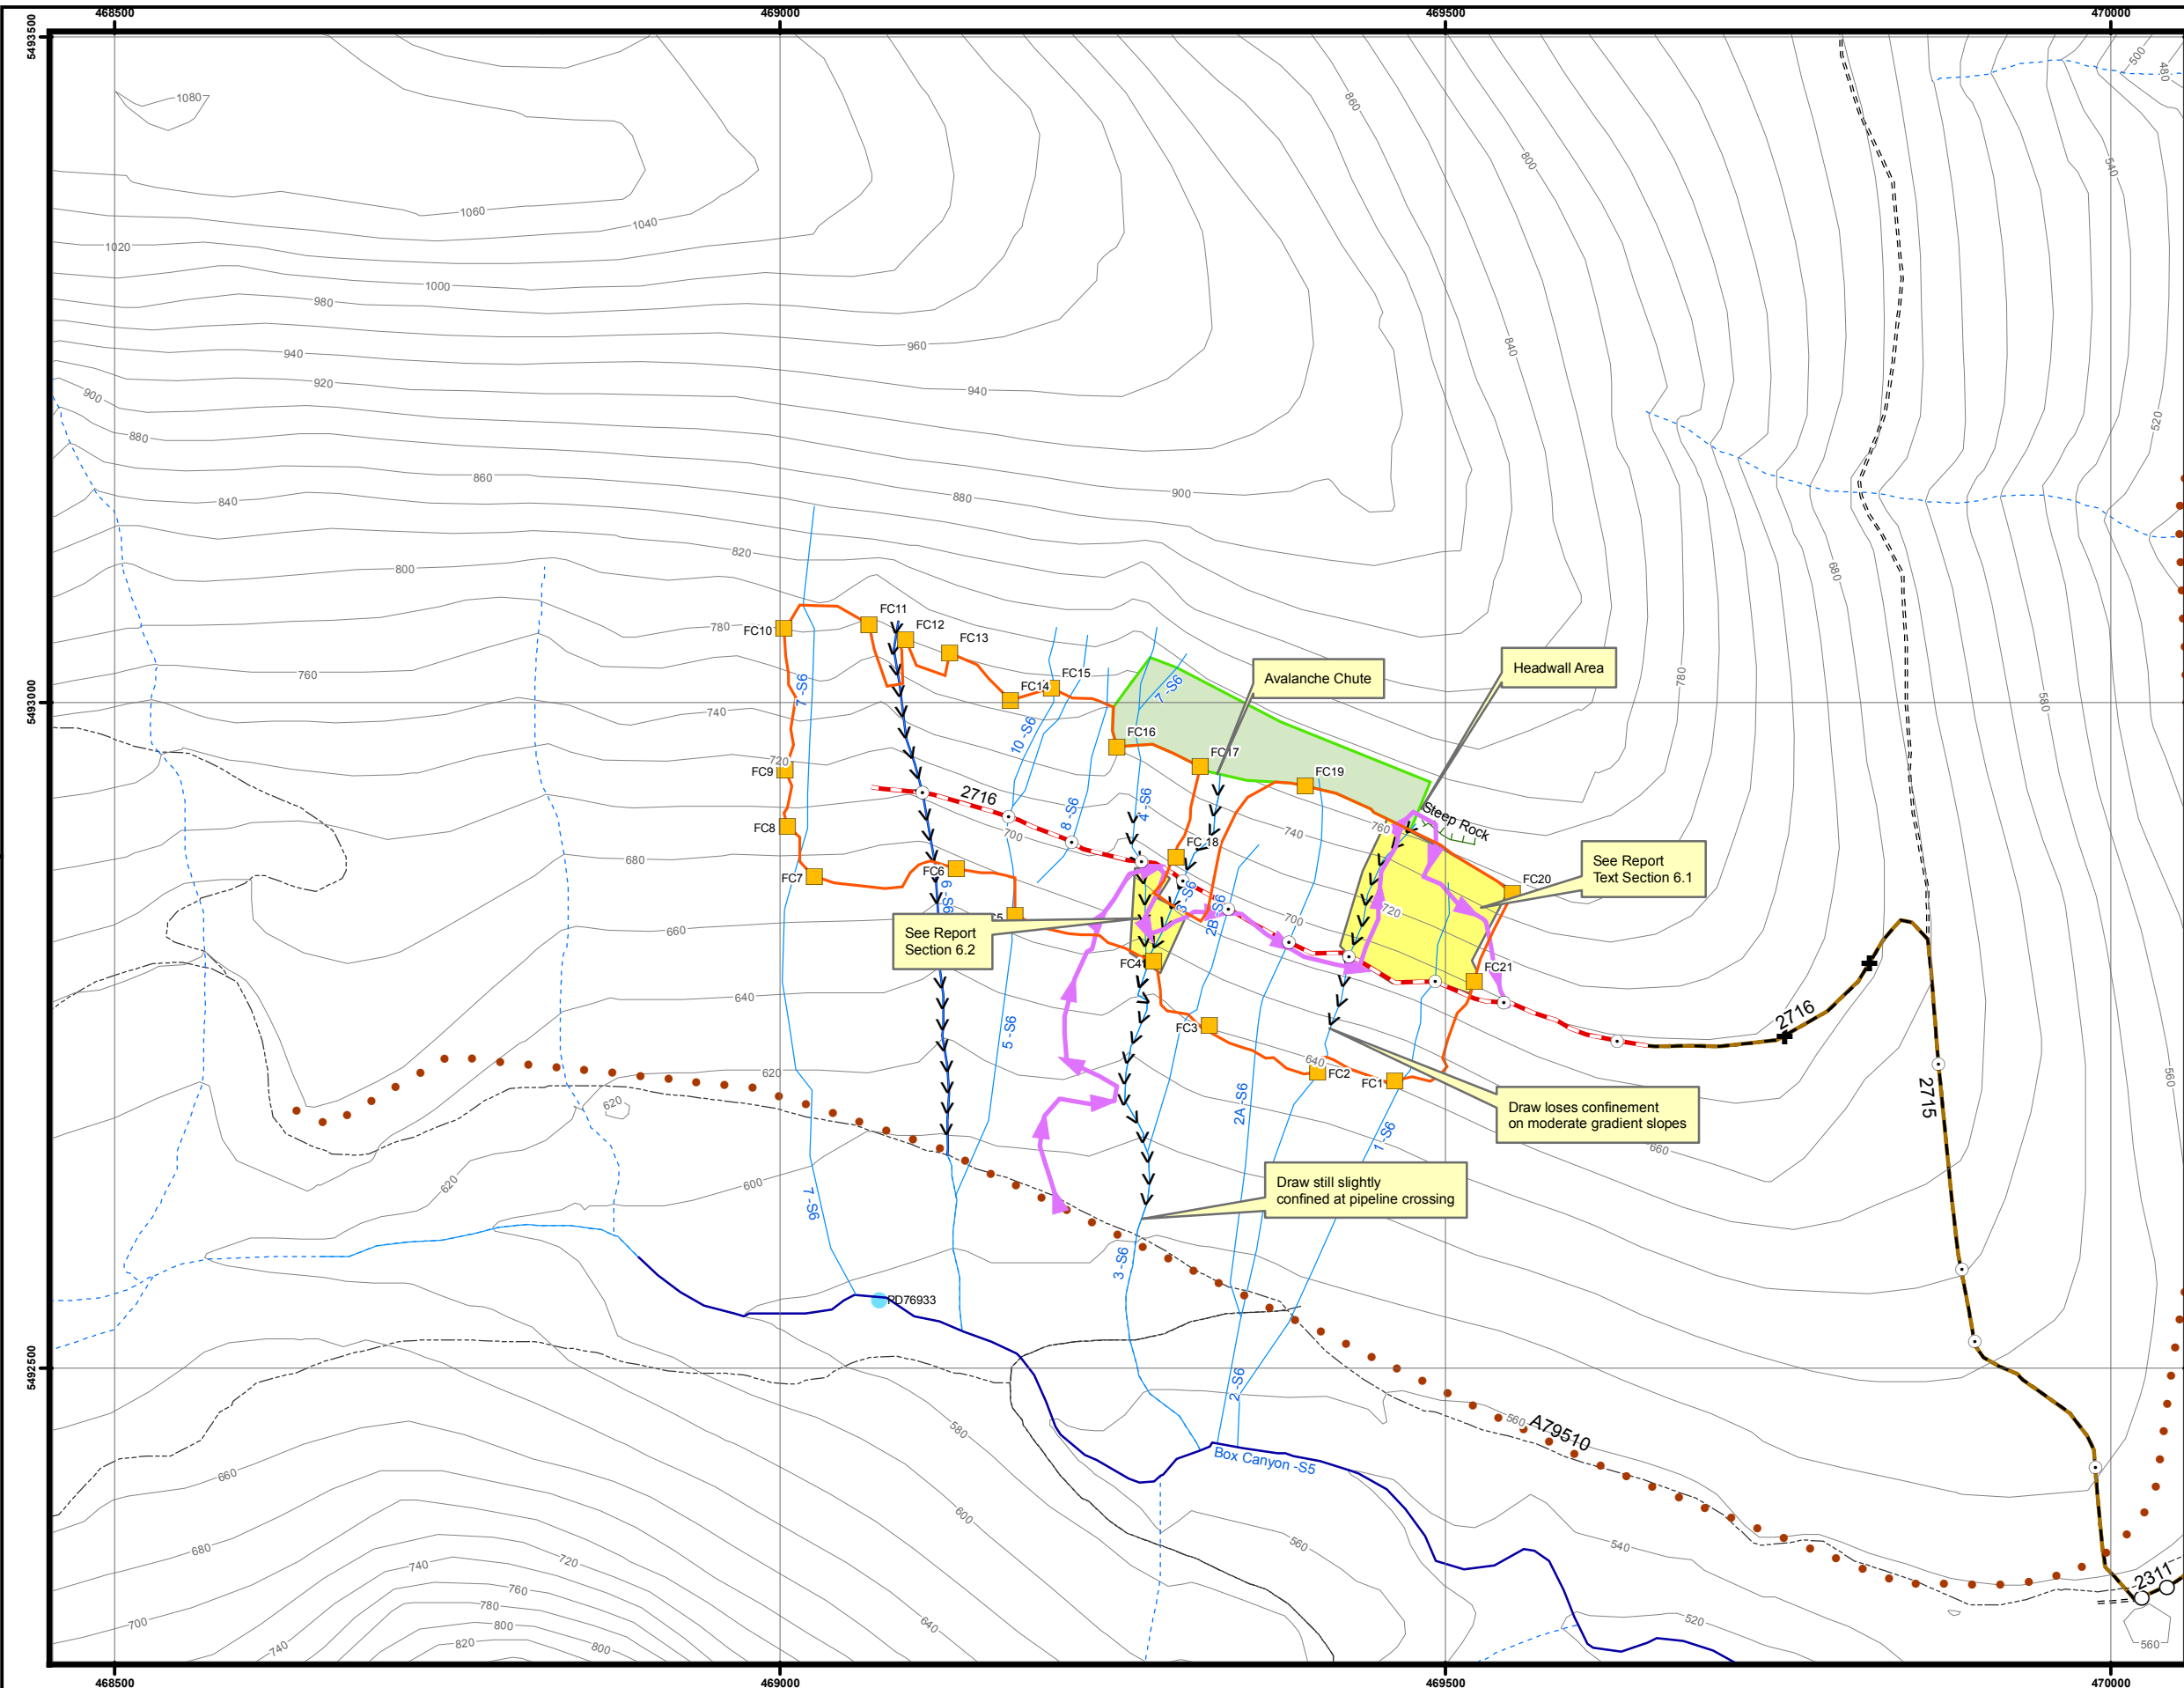
## TSL :A79510-G053C34M Figure 1. Terrain Assessment Map

A small 1 hectare addition was added to the eastern portion of this cutblock (see Figure 1) This area extended the proposed cutblock over to the edge of the harvested cutblock to the east. This portion of the cutblock is proposed for cable based harvesting.

Stream 2 initiates from a wet bowl and then curves below a steep headwall slope within a bedrock controlled gully-like draw (see Figure 1). The stream channel is primarily bedrock and angular rubble. The bedrock surface is rough. The sidewalls of the draw are steep (to 80%) and up to 25m long. The headwall area near the upper falling boundary is primarily rock with very thin intermittent organic soils. The bedrock surface is rough, with minor irregularities suggesting a recent disturbance on the headwall area. The draw downslope contains no mature trees indicating disturbance.

Results from this TSA conclude that **there is an estimated moderate<sup>7</sup> likelihood of post-harvest landslide occurrence on the steep slopes draped by the thin veneer of weathered soil present near the upper boundary and headwall area of the gully-like draw of stream 2.**

The original cutblock layout contained several reserve areas within the harvest area. These reserve areas were removed as part of the current amendments to this cutblock due to windthrow concerns. The area around the confluence of streams 3 and 4 was included in one of the reserves (see Figure 1).

Although the inclusion of this area into the harvest area removes the potential for windthrow on the gully sidewall slopes, the old slide scarp on the sidewall below the road and the unconsolidated surficial materials present on these slopes indicate that the surficial materials may be sensitive to scour during yarding. **Significant scour on the sidewalls of the draw during yarding operations would result in a moderate likelihood of sidewall failures in this area.**

- 1) Fall away yard away practices must be employed during harvesting in this area. Timber must be felled out of the gully-like draw of stream 4 and yarded away from the draw.**
- 2) Any residual stems that can not be felled out of the draw should be left standing.**
