DATE October 12, 2010**PROJECT No.** 09-1416-0004/3100**TO** Derek Holmes
BURNCO Rock Products**CC** Mark Johannes, Fred Shrimmer, Rowland Atkins**FROM** Richard C. Butler, P.Eng.**EMAIL** rbutler@golder.com**GEOTECHNICAL STABILITY ASSESSMENT
COMPENSATION GROUNDWATER CHANNEL
MCNAB VALLEY PROJECT**

This memorandum presents the results of geotechnical stability analyses of the existing slopes of the compensation groundwater channel located within the southerly portion of the overall McNab valley and an engineering assessment of the impact of these stability conditions on the safety and performance of the compensation channel.

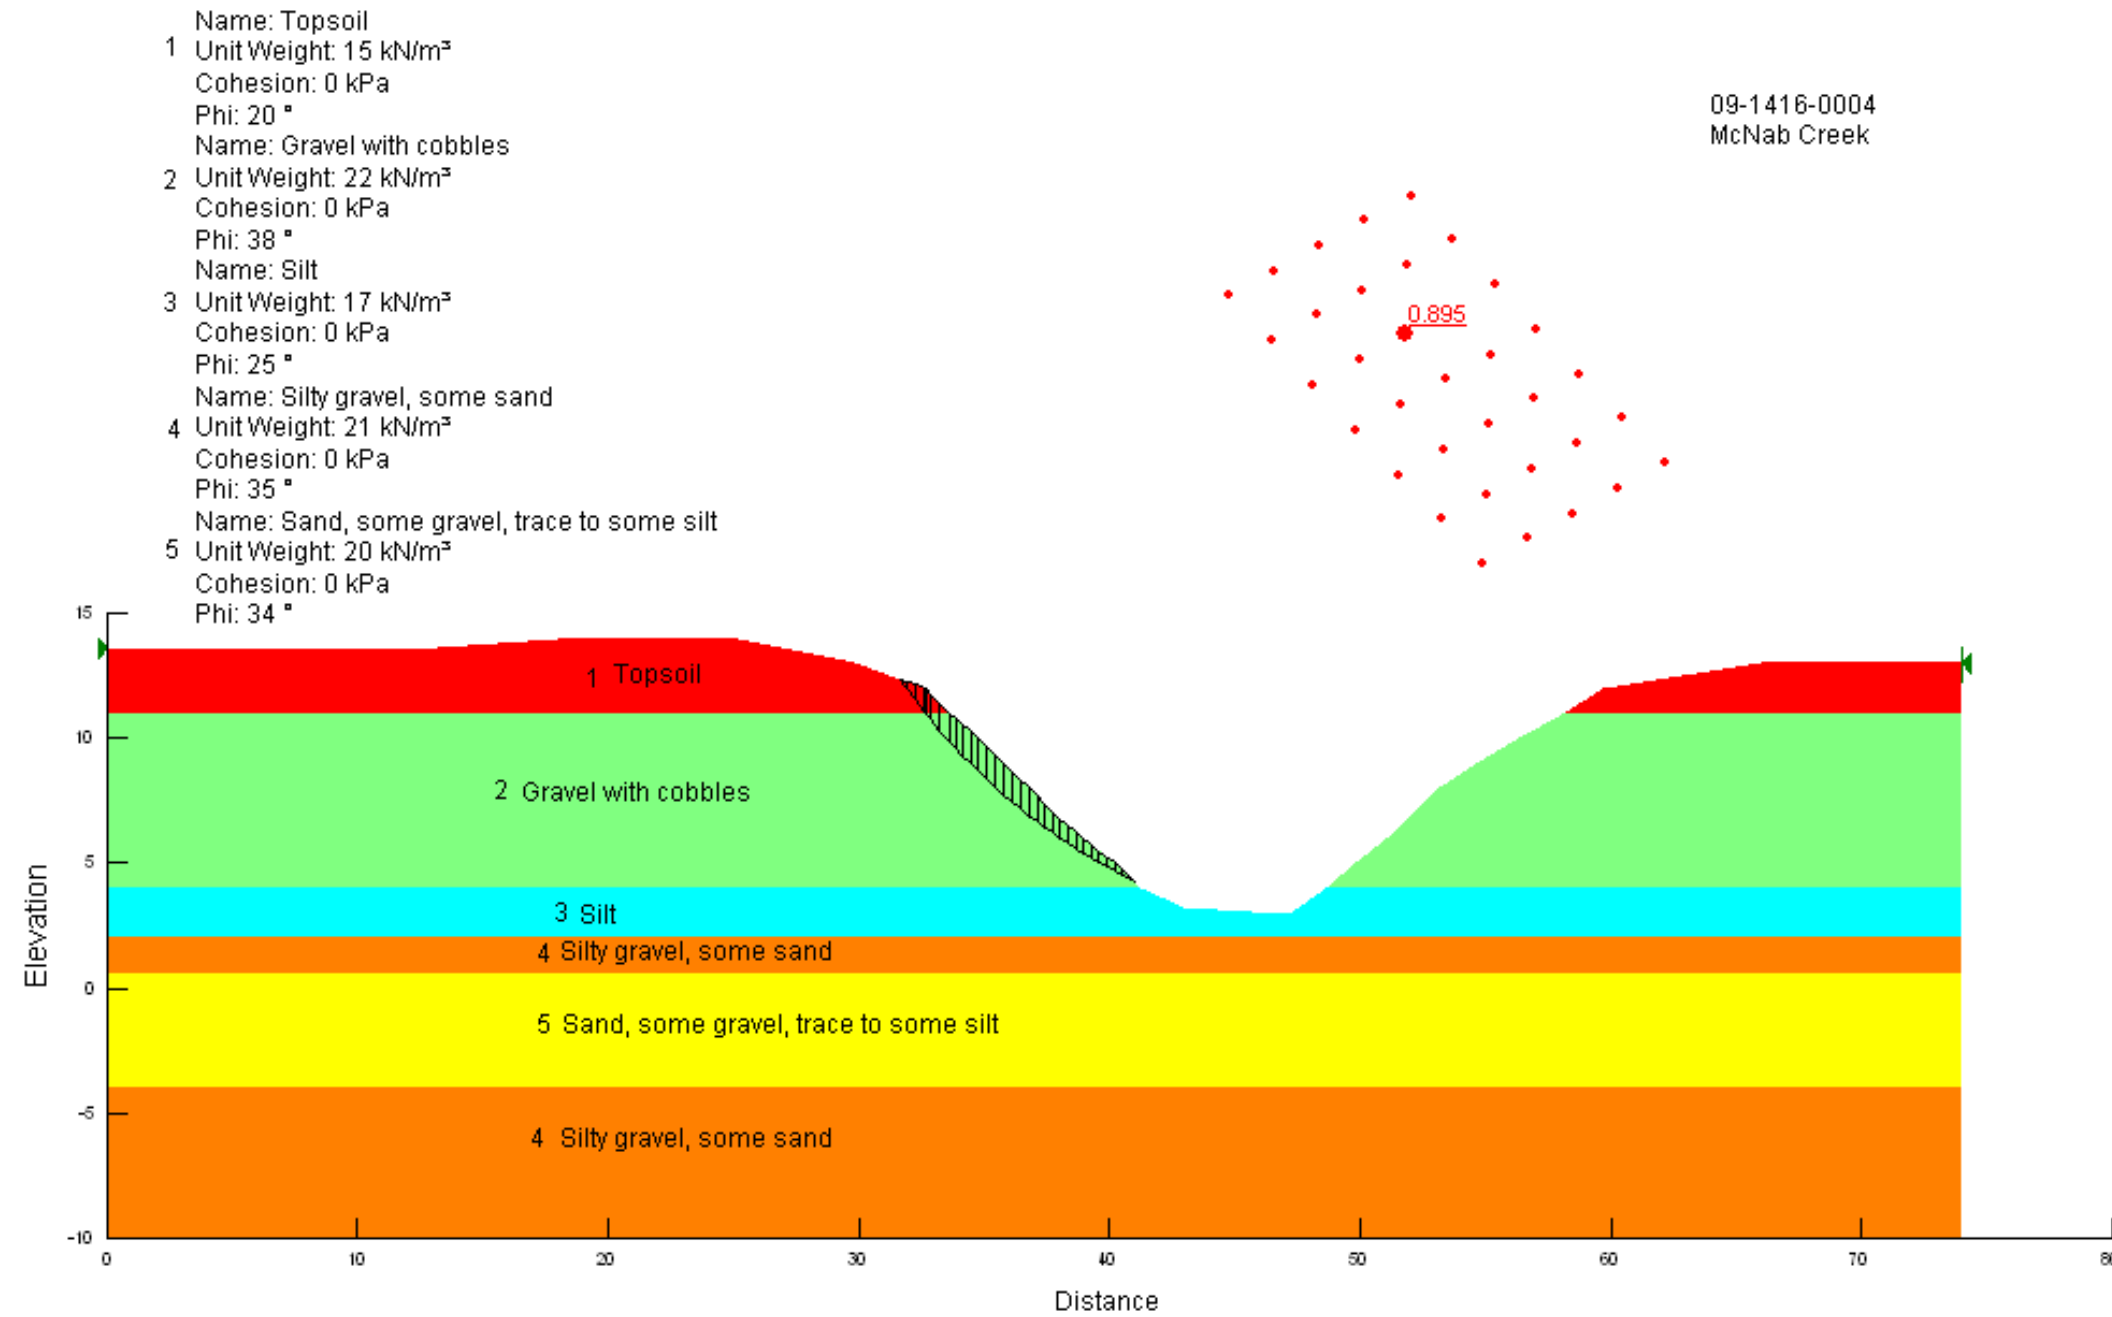
PROJECT		BURNCO	
		MCNAB VALLEY AGGREGATE PROJECT	
		HOWE SOUND, BC	
TITLE			
NORTH SECTION – SHALLOW FAILURE			
COMPLETELY DRY CONDITIONS			
PROJECT No. 09-1416-0004		PHASE No. 3100	
DESIGN	CHC	06OCT10	SCALE
CADD	CHC	06OCT10	REV.
CHECK	CHC	08OCT10	FIGURE 3
REVIEW	RCB	08OCT10

As described above, the existing slopes of the compensation channel have low Factors of Safety varying from about 0.9 to 1.2 for shallow failures and 1.1 to 1.4 considering deep seated failures for the most optimistic, but unrealistic, scenario in which the slopes are completely dry, with no groundwater level, seepage areas or surficial saturation layers within the channel slopes. Even under these most favourable conditions, these Factors of Safety indicate that both the North and South cross sections have a significant risk of shallow slope failures.

Even under completely dry conditions, the steeper North Section is at best marginally stable against deep seated failure while the flatter, and lesser height South Section has a Factor of Safety of more than 1.3, which is generally considered the minimum acceptable Factor of Safety for sites and uses which do not present a risk to human life or significant environmental damage. However, considering the more realistic but still favourable condition in which groundwater levels are limited to the lower portion of the gravelly soils forming much of the compensation channel slopes, the computed Factors of Safety against deep seated slope failures are less than 1.3 for both the North and South cross sections, with the steeper slopes at the North having a Factor of Safety of 0.8 representing significant risk of larger scale or deep seated instability and failure.

In addition, these analyses also indicate that the channel slopes are at high risk of shallow slope movements and failures and that such shallow instability has, in all probability, been ongoing since initial excavation and development of the compensation channel, which is consistent with the observations of sparse to non-existent vegetation cover on these slopes after a period of at least several years. Typically, it is recommended that permanent slopes within granular deposits be developed not steeper than 2 Horizontal to 1 Vertical to minimize the risk of shallow slope failures and permit revegetation.

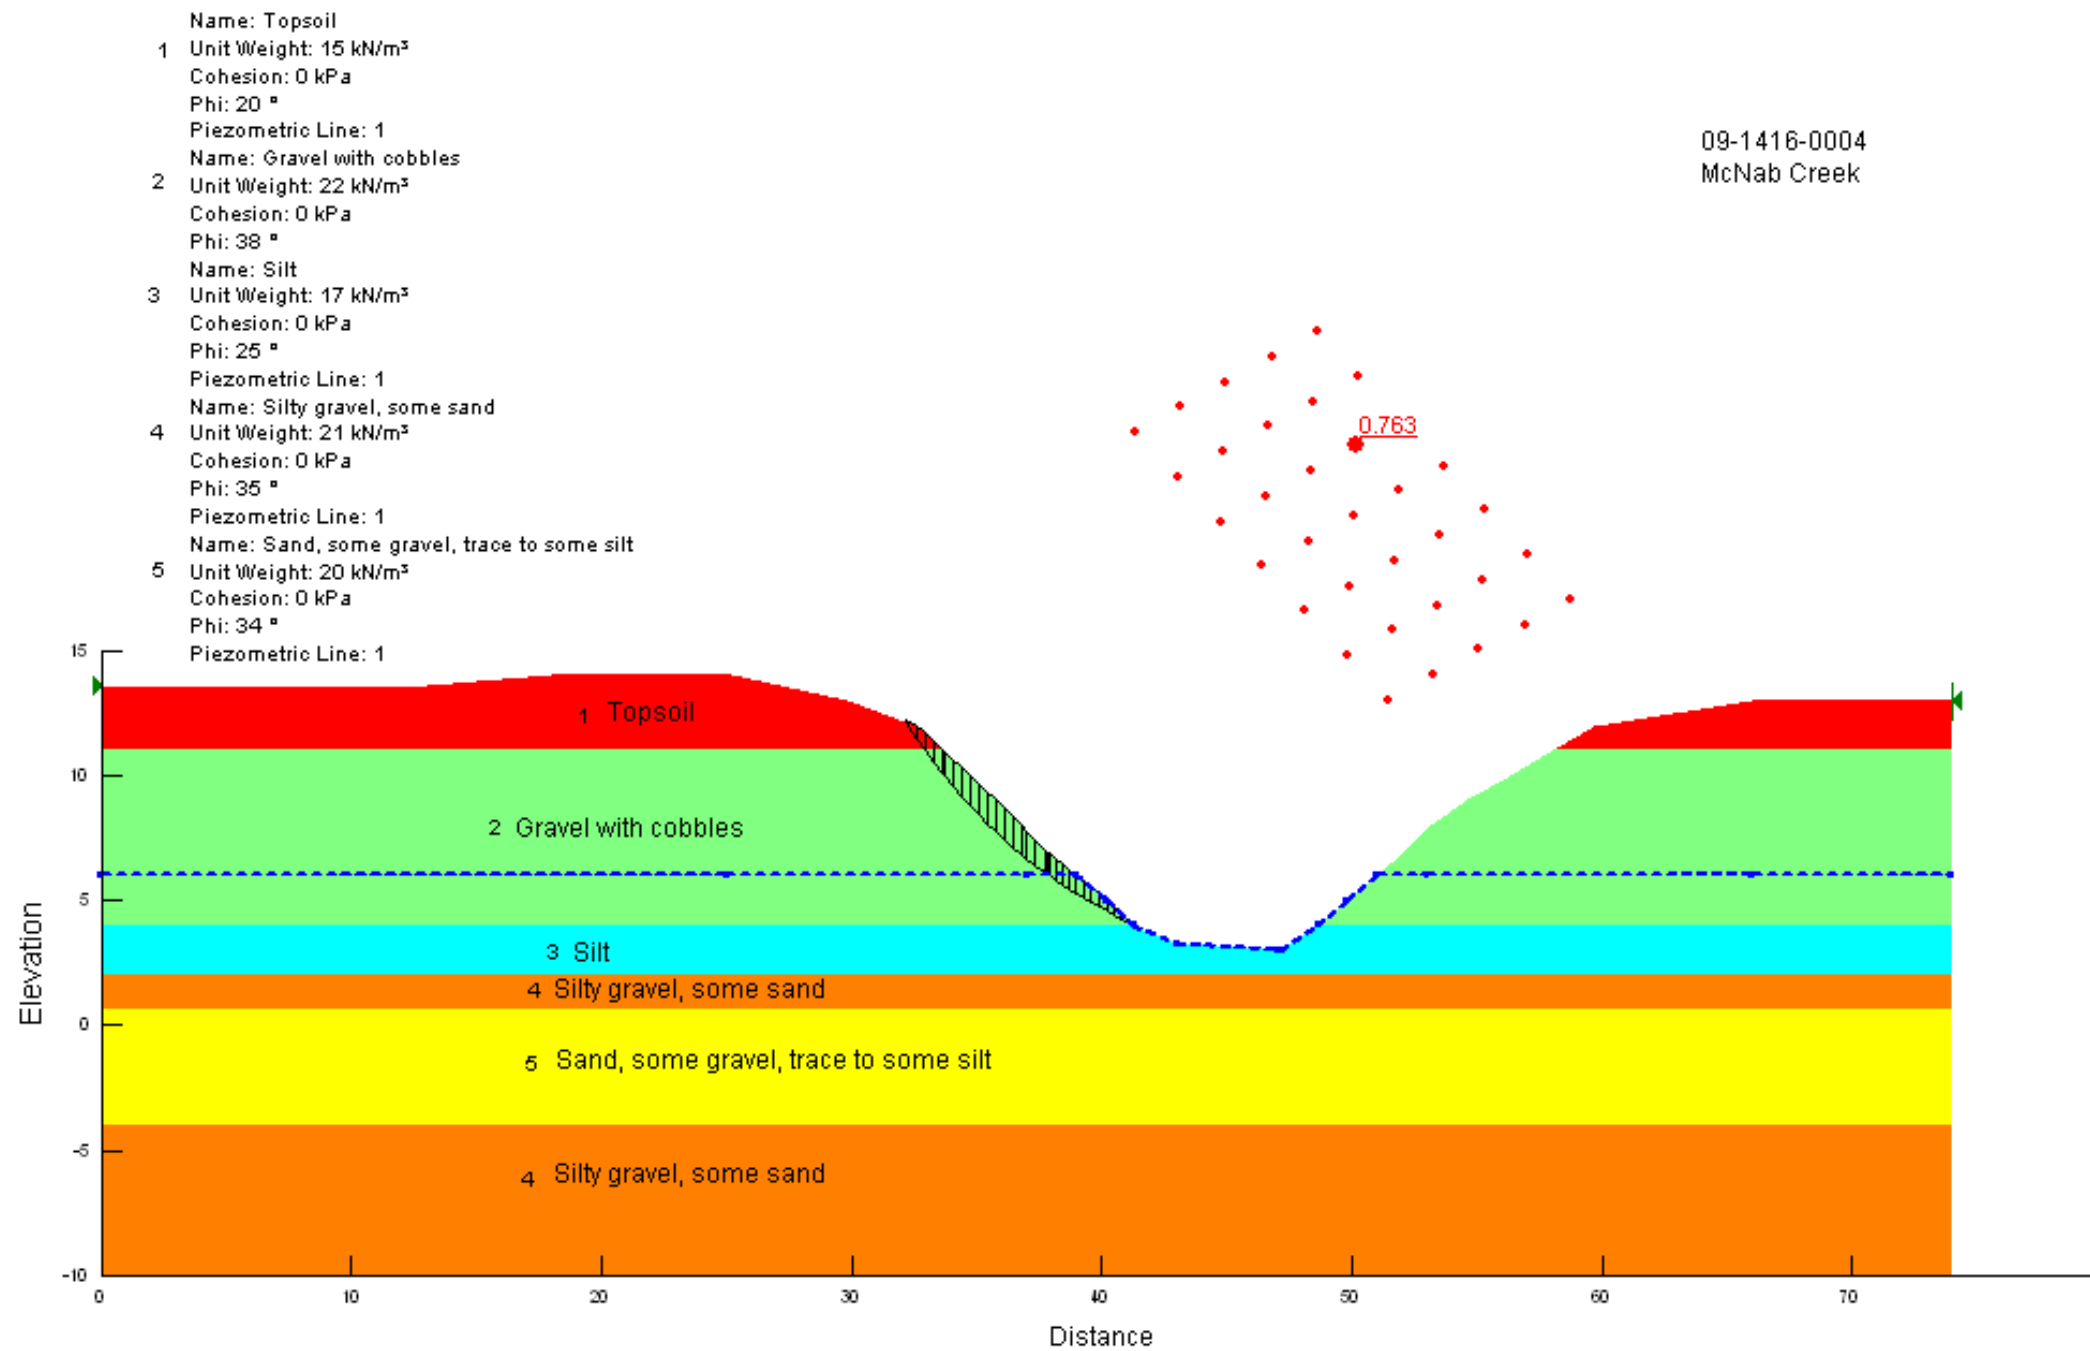
PROJECT		BURNCO	
		MCNAB VALLEY AGGREGATE PROJECT	
		HOWE SOUND, BC	
TITLE		NORTH SECTION – SHALLOW FAILURE	
		GROUNDWATER LEVEL WITHIN	
		LOWER PORTION OF SLOPE	
		PROJECT No. 09-1416-0004	PHASE No. 3100
DESIGN	CHC	06OCT10	SCALE
CADD	CHC	06OCT10	REV.
CHECK	CHC	08OCT10	FIGURE 4
REVIEW	RCB	08OCT10

For the scenario considering only the groundwater level within the lower portion of the overall slope, but dry conditions above that level, the Factors of Safety for shallow failures decrease to values of about 0.8 and 1.1, such that there is increased risk of and potential for slope movements and failure.

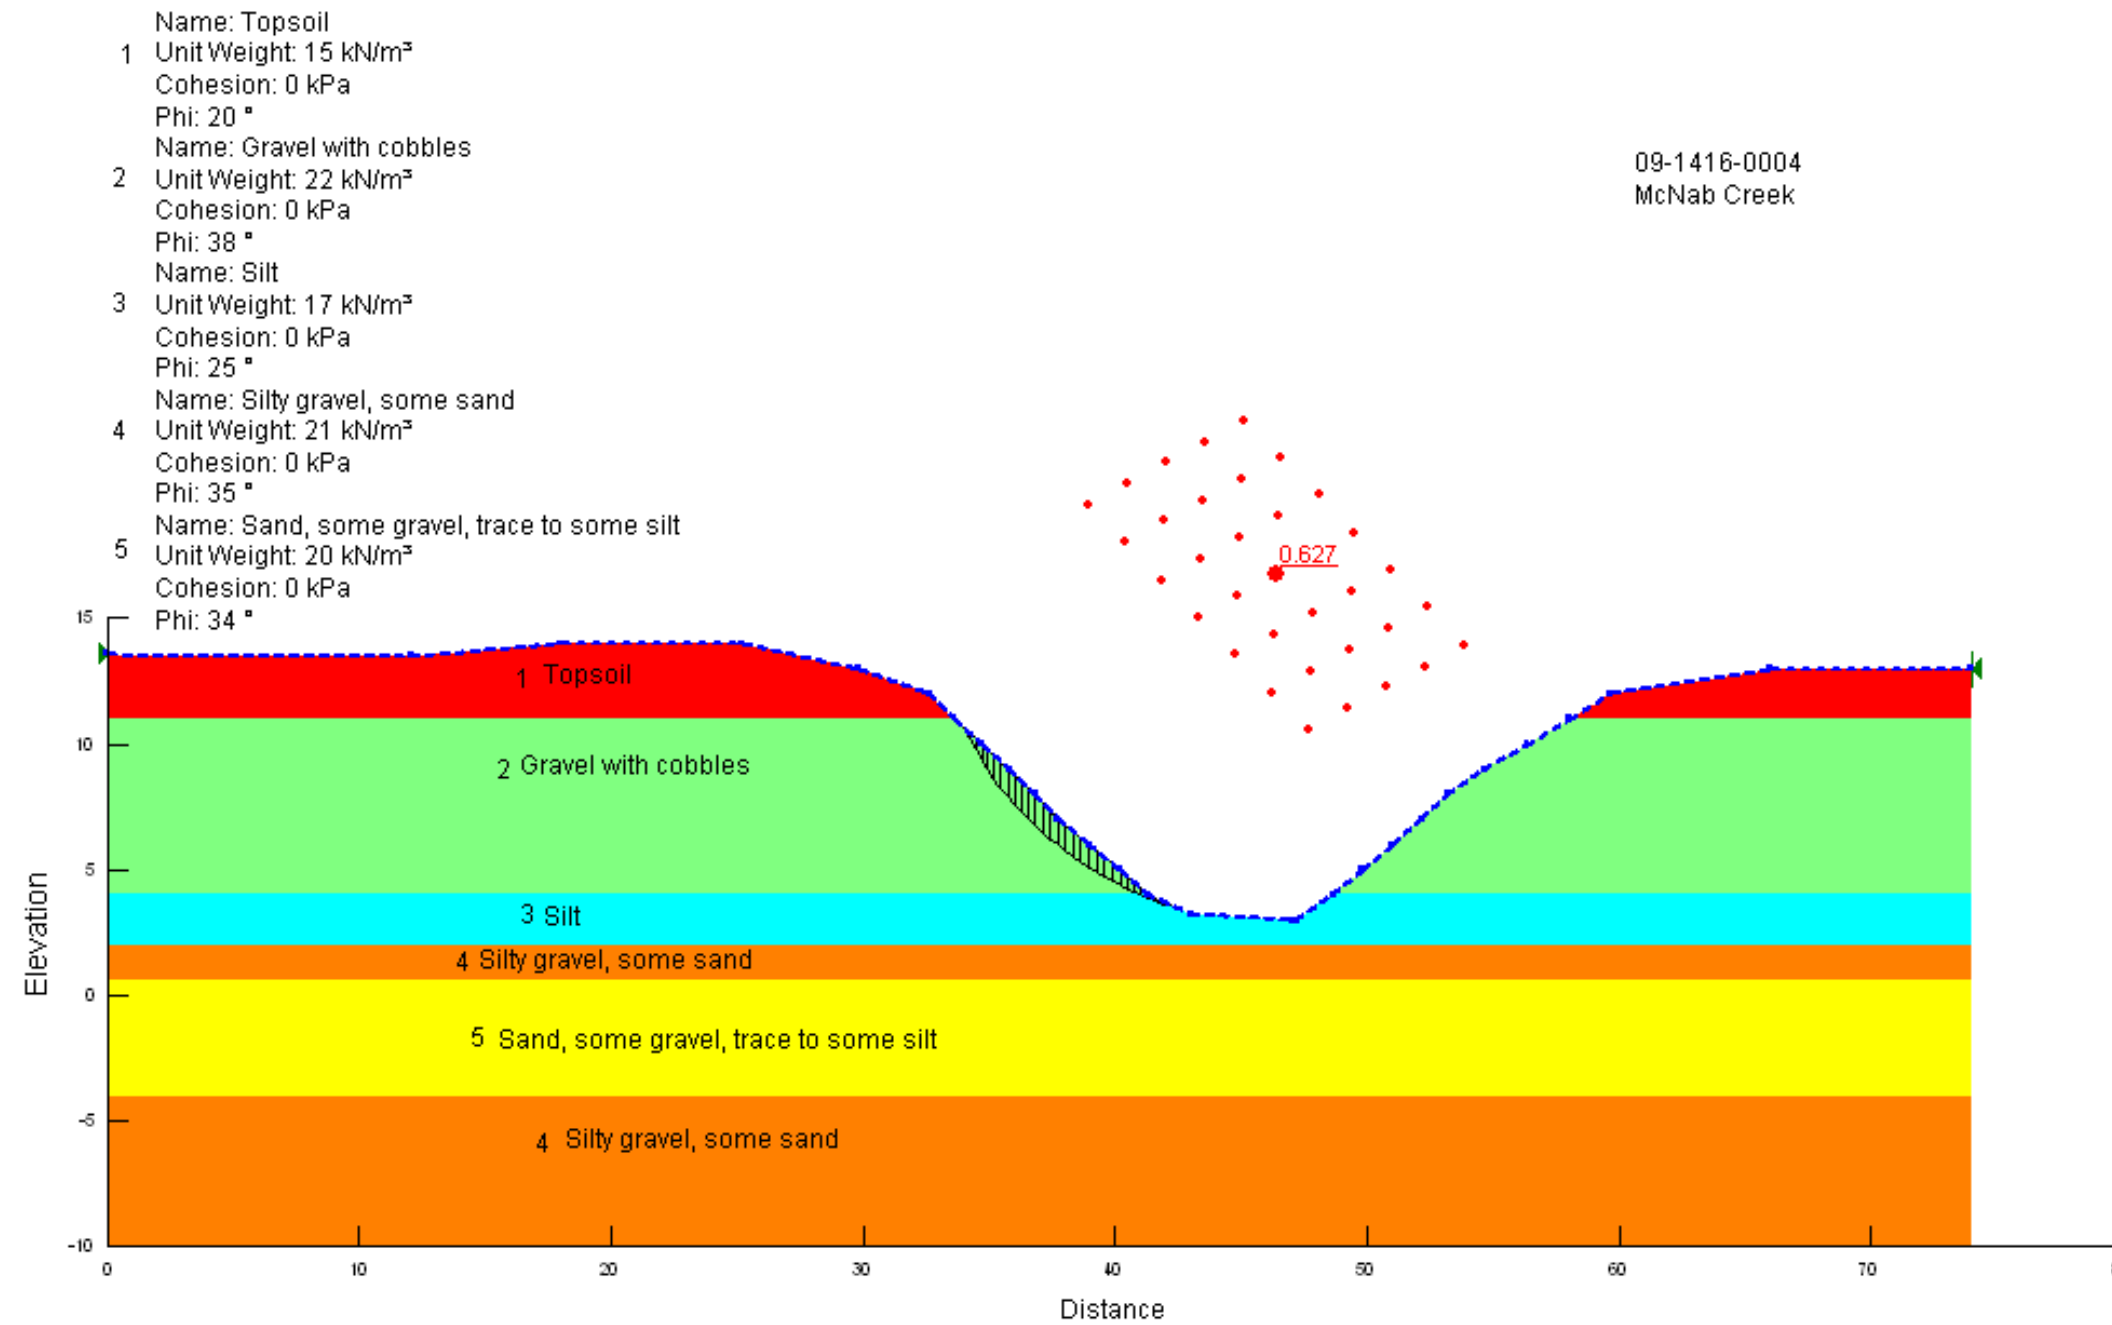
PROJECT		BURNCO	
		MCNAB VALLEY AGGREGATE PROJECT	
		HOWE SOUND, BC	
TITLE			
NORTH SECTION – SHALLOW FAILURE			
SATURATED SURFACE CONDITIONS			
PROJECT No. 09-1416-0004		PHASE No. 3100	
DESIGN	CHC	06OCT10	SCALE
CADD	CHC	06OCT10	REV.
CHECK	CHC	08OCT10	FIGURE 5
REVIEW	RCB	08OCT10

In the scenario where the upper 1 m of the otherwise completely dry soils forming the channel slopes become saturated, the Factors of Safety against shallow slope failure are less than 1.0 for both the North and South Sections, with the steeper North Section slopes having a Factor of Safety of about 0.6 and a high probability that such shallow failures occur frequently during periods of sustained wet weather, locations where surface runoff is directed onto the slope, and during or following periods of significant snow accumulation and melt.
