RE: 150L Dyed Diesel Fuel Spill - SAC Reference #2733-AHPQSH

newgoldTM Rainy River Project

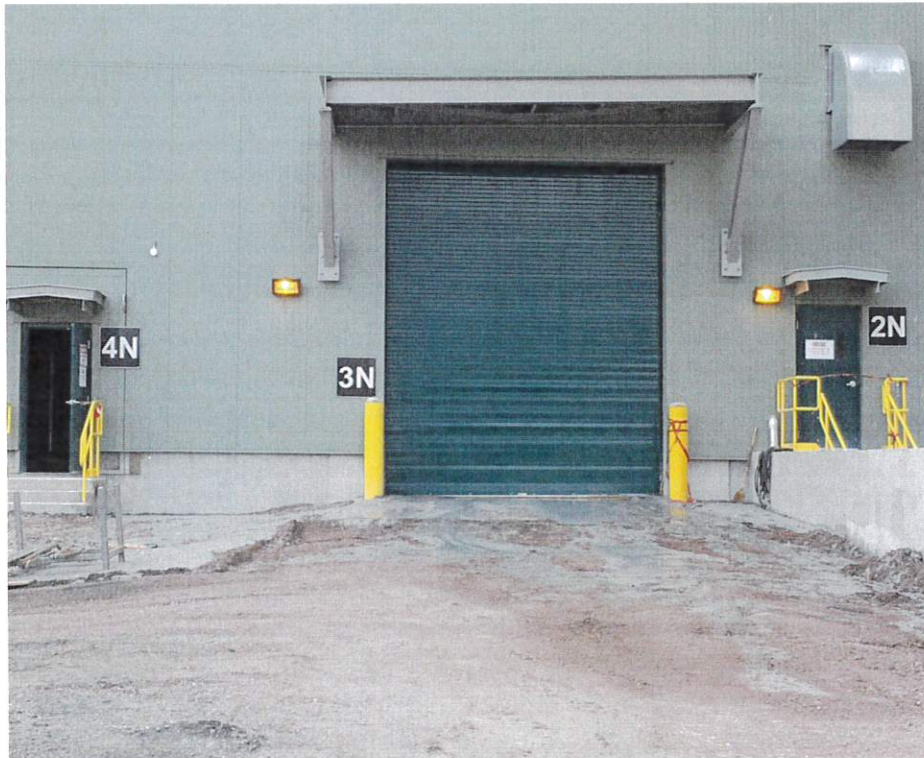
- During routine maintenance on the tailings slurry sampler on the second floor of the Mill, operators disconnected a hose and tailings slurry flowed out of the hose.
- The majority of the tailings slurry spilled out of the hose was contained in the Mill however some of the tailings slurry flowed to the ground floor of the Mill and out of the north outside door 3 (3N).

- Currently the Mill is being commissioned, and is in the commissioning phase. During the commissioning phase, process upsets occur regularly because the processes and procedures are being fine-tuned and refined.
- While during commissioning and normal operations, capacity to contain spills exists within the Mill, a process upset had already flooded the internal capacity.
- When the operators disconnected the hose from the sampler tailings slurry spilled out of the hose and instead of being contained in the Mill, flowed onto the ground outside of door 3N.

Figure 1: Door 3N Exterior Mill Spill

- There was no impact to any water body.
- The majority of the cyanide destruction tailings slurry spilled out of the process was contained within the Mill however 2m³ of cyanide destruction tailings slurry was spilled to the exterior of the Mill.
- The 3N door was closed to stop the spill out of the Mill and a berm was constructed to stop flow further from the door.
- The exterior spilled material was dug up and put back into the Mill process for disposal. The interior spilled material will be pumped and put back into the Mill process for disposal.

- Discuss with all crews about the importance of housekeeping (ensuring the Mill sumps are empty) and keeping containment capacity available for maintenance operations.
- Review maintenance procedure for the tailings slurry sampler and make changes as appropriate.
- Floor drainage is being reviewed and redesigned to ensure proper drainage to sumps.

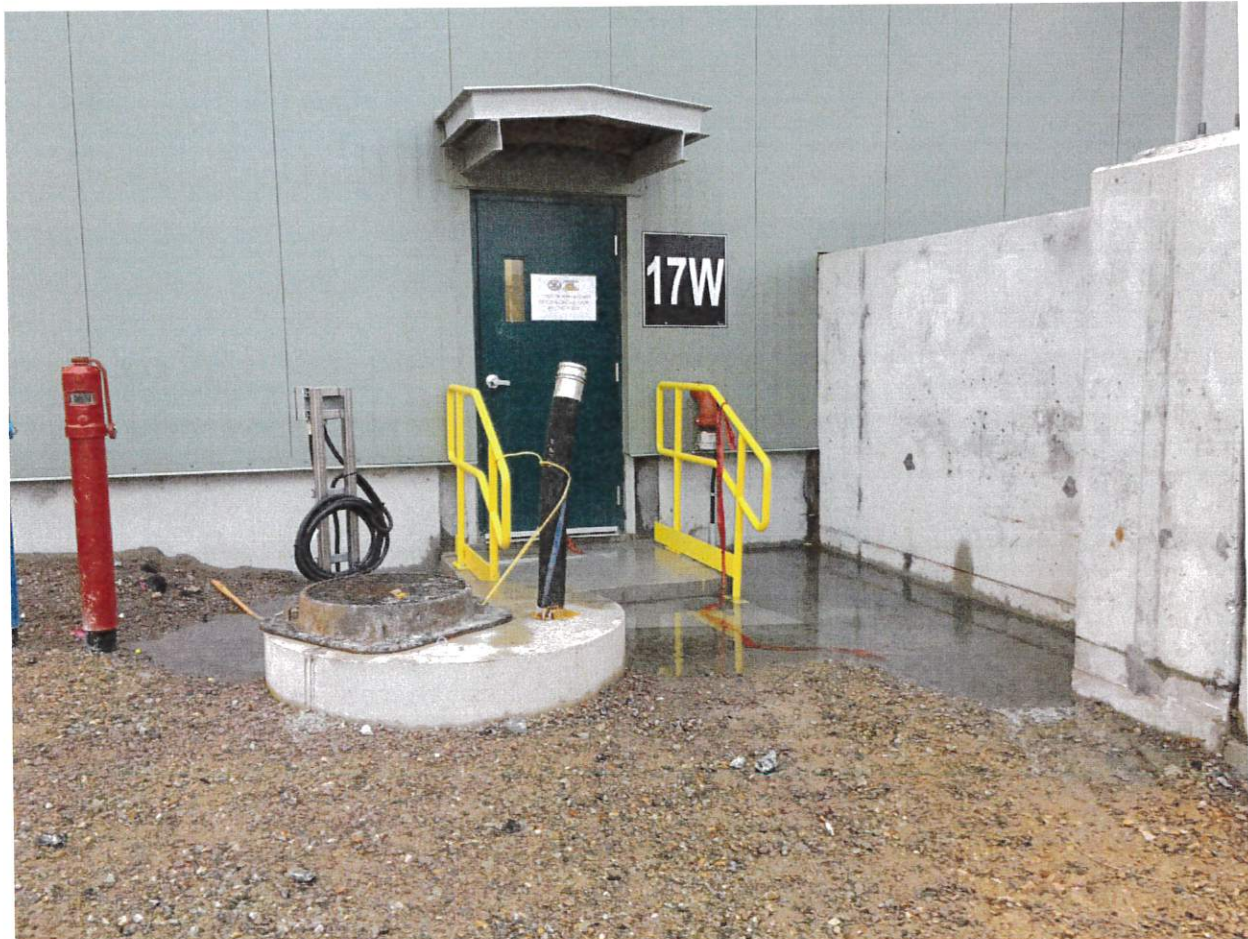
- As part of the regular commissioning phase, the Mill process was shut down.
- During the Mill shut down, an operator did not stop the flow from one of the water sources, resulting in a flow of water into an interior Mill sump.
- Due to a process upset previously, the interior sump already contained some process water. With the additional volume the interior sump overflowed.
- Process water filled the interior Mill capacity and overflowed outside the Mill building.

- Currently the Mill is being commissioned, and is in the commissioning phase. During the commissioning phase, process upsets occur regularly because the processes and procedures are being fine-tuned and refined.
- While during commissioning and normal operations, capacity to contain spills exists within the Mill, a process upset had already flooded the internal capacity.
- When the operator did not stop the flow, process water flowed onto the ground outside of door 17W of the Mill.

Figure 1: Door 17W Exterior Mill Spill

- There was no impact to any water body.
- The majority of the process water spilled out of the process was contained within the Mill however 2.85 m³ of process water was spilled to the exterior of the Mill.
- The exterior spilled material, as well as the interior spilled material, will be pumped and put back into the Mill process for disposal.

- Discuss with all crews about the importance of housekeeping (ensuring the Mill sumps are empty) and keeping containment capacity available for maintenance operations.
- Review procedure for the addition of water to the process and make changes as appropriate.
- Floor drainage is being reviewed and redesigned to ensure proper drainage to sumps.
