<b>Date:</b>	May 25,2022	<b>Owner/Client:</b>	New Gold Inc.
<b>Day:</b>	Wednesday	<b>OKC Project #:</b>	1003-19
<b>Prepared by:</b>	Keith Naumann	<b>Project Location:</b>	Rainy River - Ontario

<b>Date:</b>	May 26,2022	<b>Owner/Client:</b>	New Gold Inc.
<b>Day:</b>	Thursday	<b>OKC Project #:</b>	1003-19
<b>Prepared by:</b>	Keith Naumann	<b>Project Location:</b>	Rainy River - Ontario

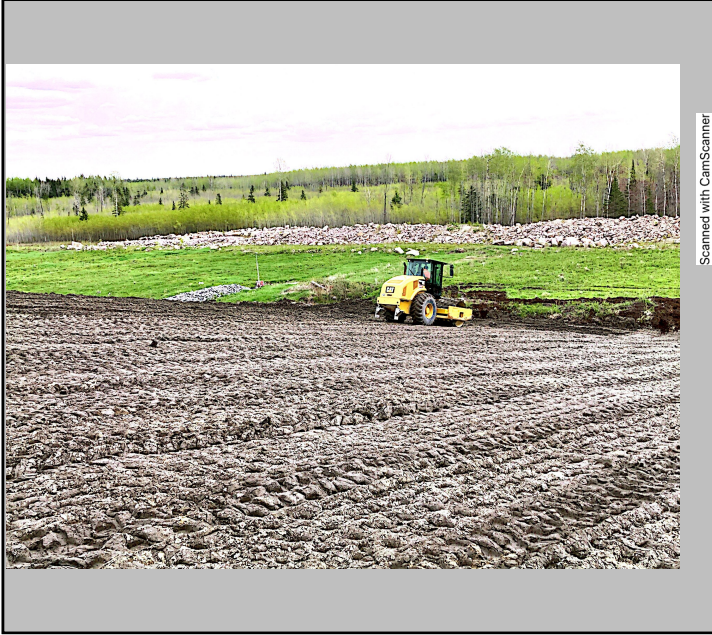
Photo #: 1

Cat CP56B compacting panel 30 Lift 1.

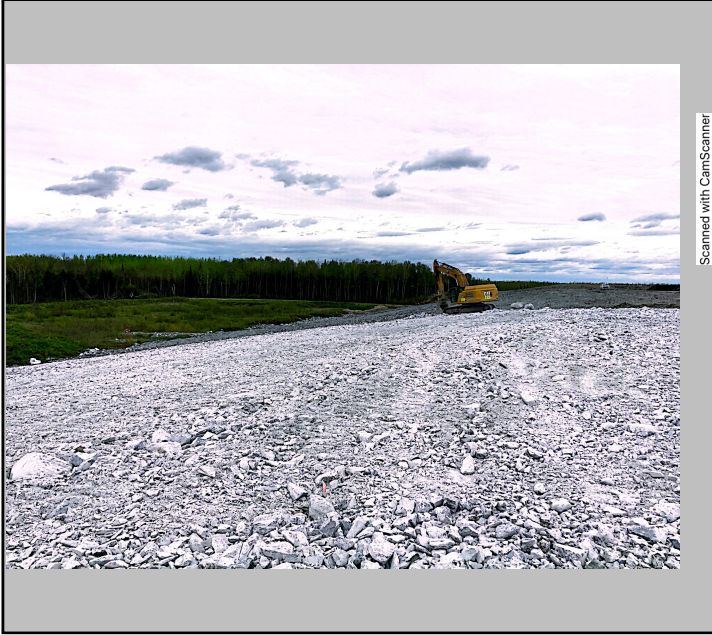
Photo #: 5

Panel 31 slope complete for reclamation.

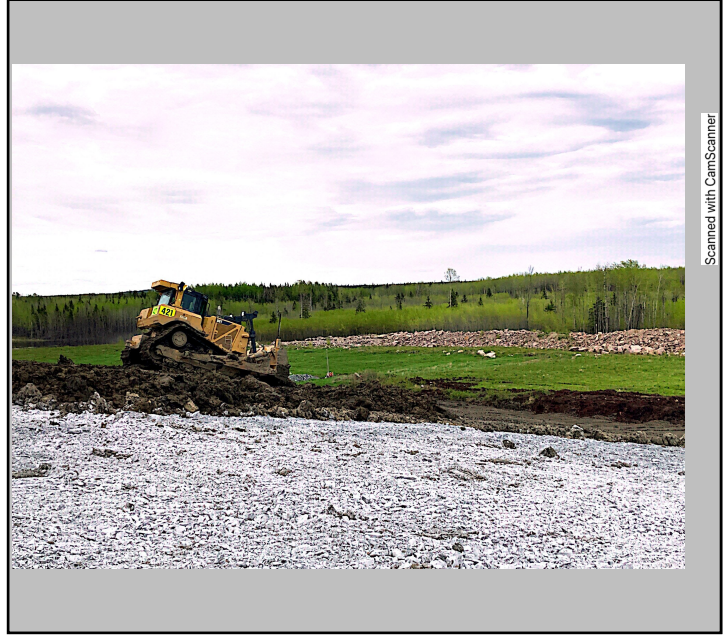
Photo #: 6

Dozer 421 starting CCL lift 2 on panel 30. At the south west corner.

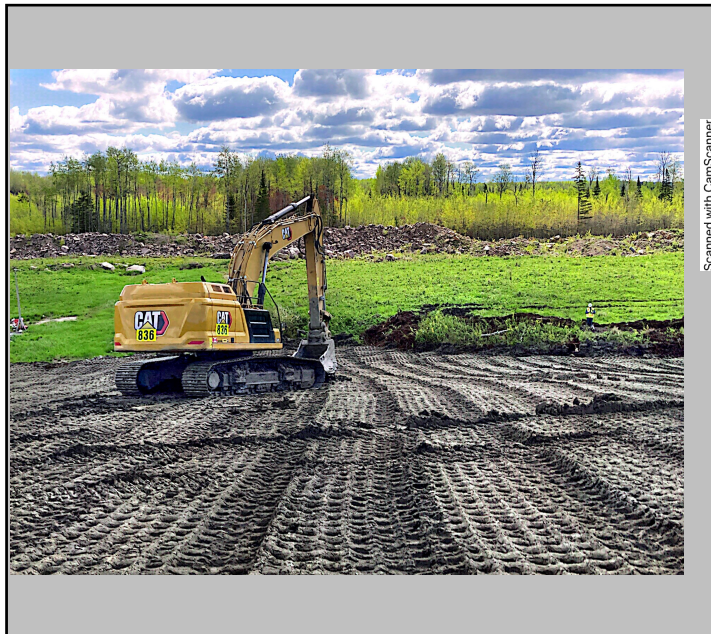
Photo #: 3

Excavator 836 Removing oversize rock.

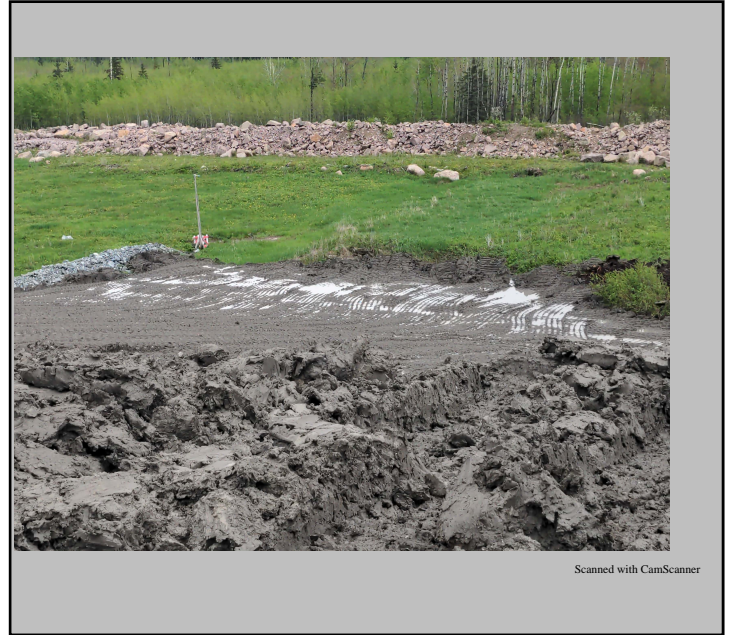
Photo #: 2

Okane advised the CCL Lift 2 is over saturated to place NCL Lift 3 after the lightning stand down was cleared. Tulloch spoke with New Gold Supervisor and relayed the message from Okane. With more rain in the forecast expected over night New Gold ceased the EMRS operation to allow the lifts to dry.

Water pooling after rain storm on Panel 30 CCL Lift 2.

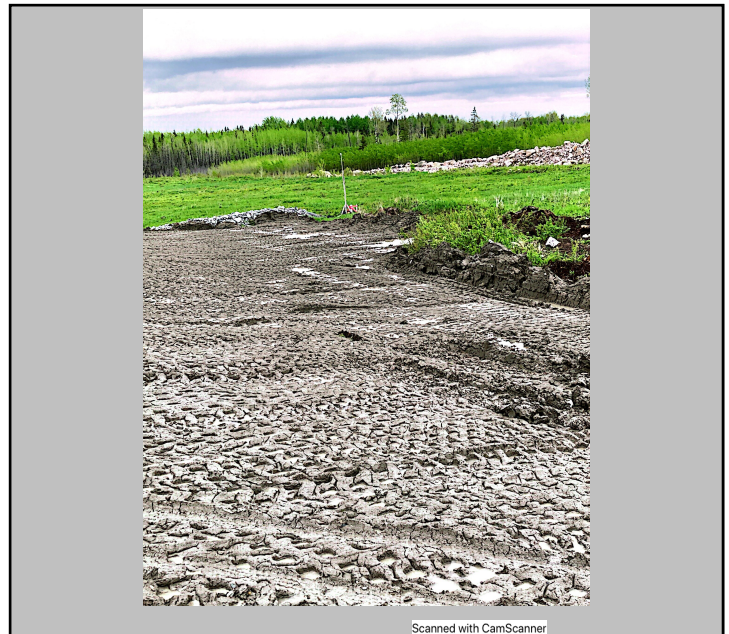
Photo #: 4

Water pooling after rain storm on Panel 30 CCL Lift 2.

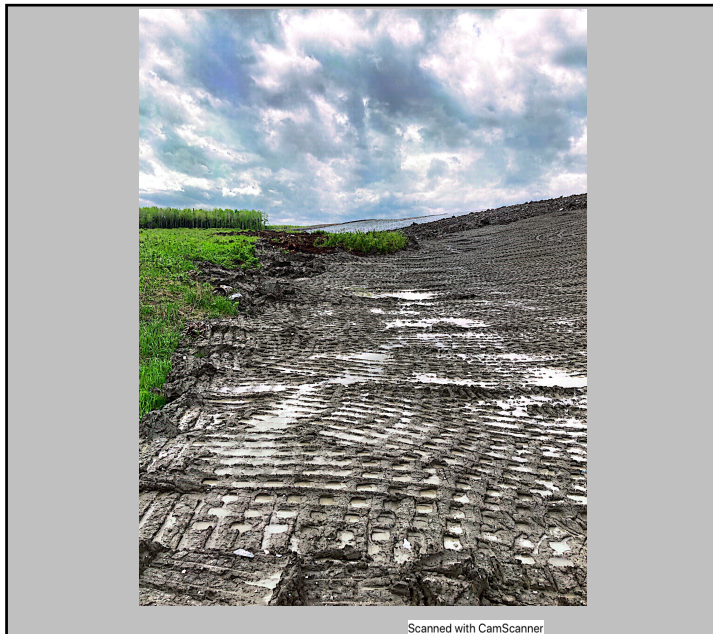
Photo #: 3

Water pooling on the Panel 30 CCL Lift 2.

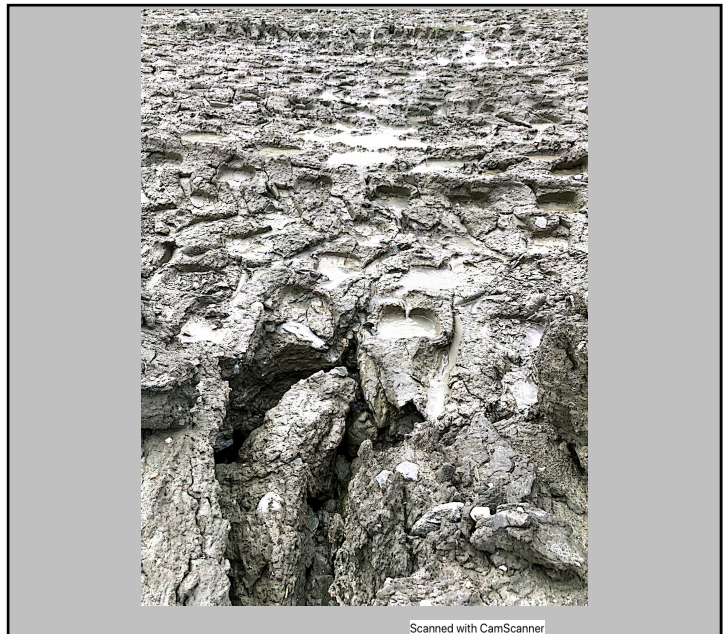
Photo #: 4

Heavy saturated clay after rain.
