<b>Date:</b>	July 26, 2022	<b>Owner/Client:</b>	New Gold Inc.
<b>Day:</b>	Tuesday	<b>Okane Project #:</b>	1003-223
<b>Prepared by:</b>	Blake Weinrauch	<b>Project Location:</b>	Ontario

## 2022 Rainy River EMRS CQA

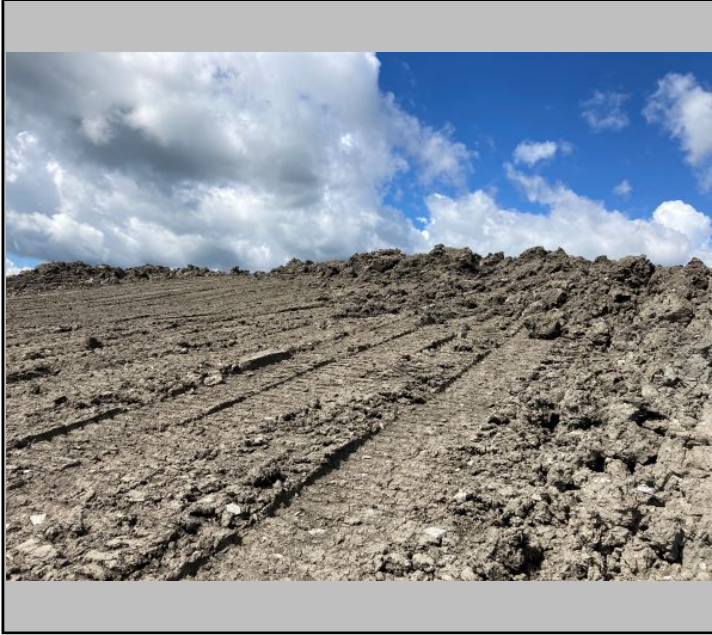
Photo #: 1

P32, L4 placement prior to rainfall

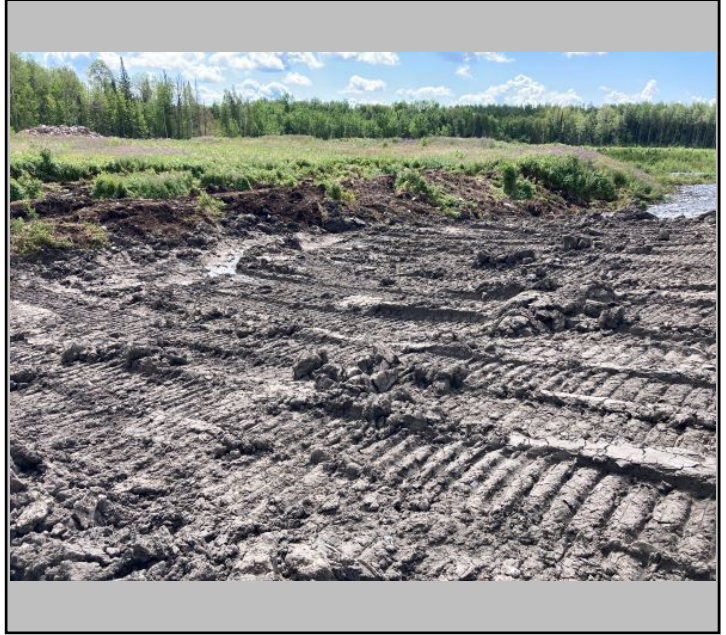
Photo #: 2

P33, L2 prior to rainfall

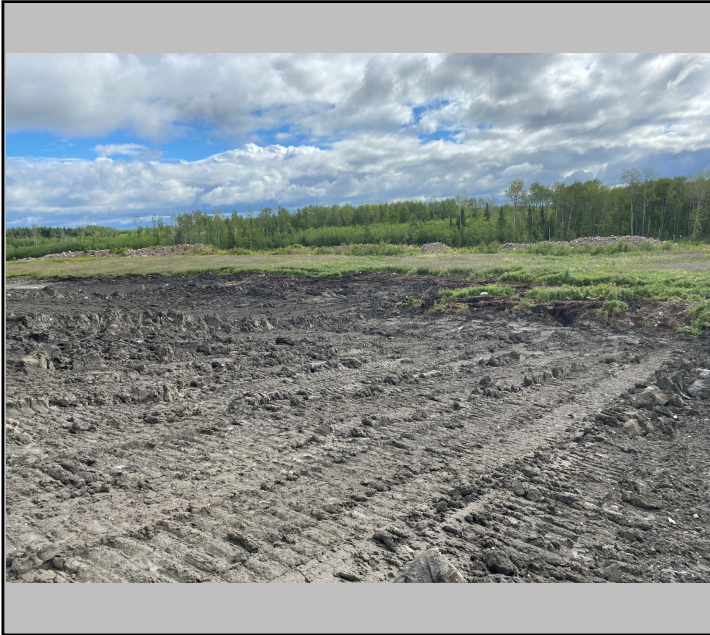
Photo #: 1

- Standing water present in track marks upon morning inspection.
- Warm temperatures and moderate winds aiding in the drying of saturated areas.

P33, L2 morning conditions

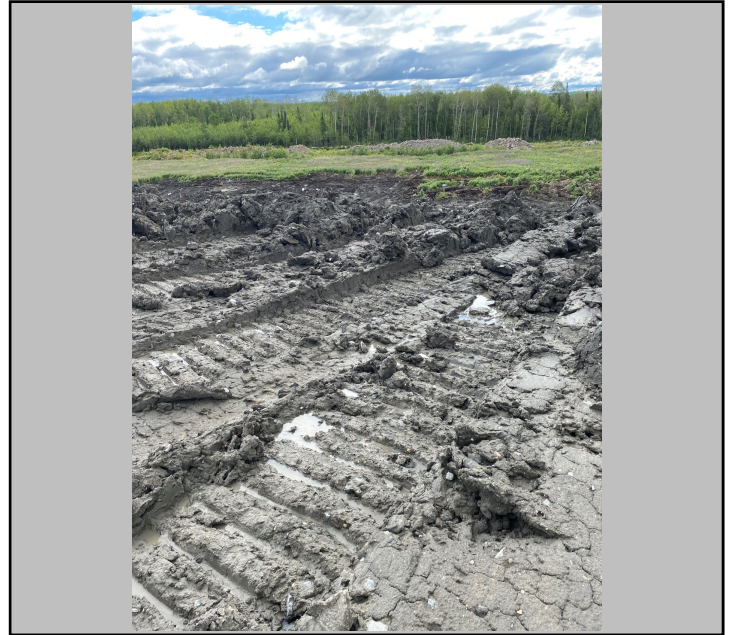
Photo #: 2

- Standing water present in track marks upon morning inspection.
- Warm temperatures and moderate winds aiding in the drying of saturated areas.

P32, L3/L4 morning conditions

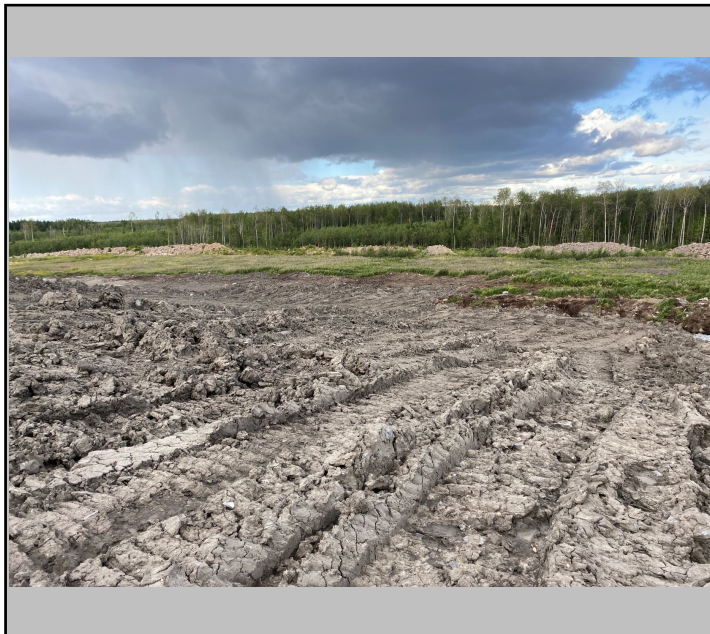
Photo #: 3

P33, L2 end of day conditions

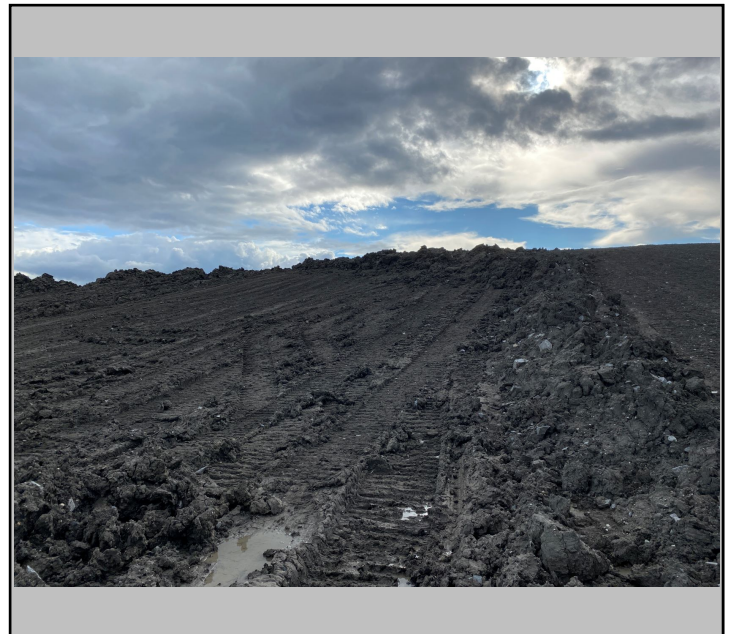
Photo #: 4

P32, L3/L4 end of day conditions

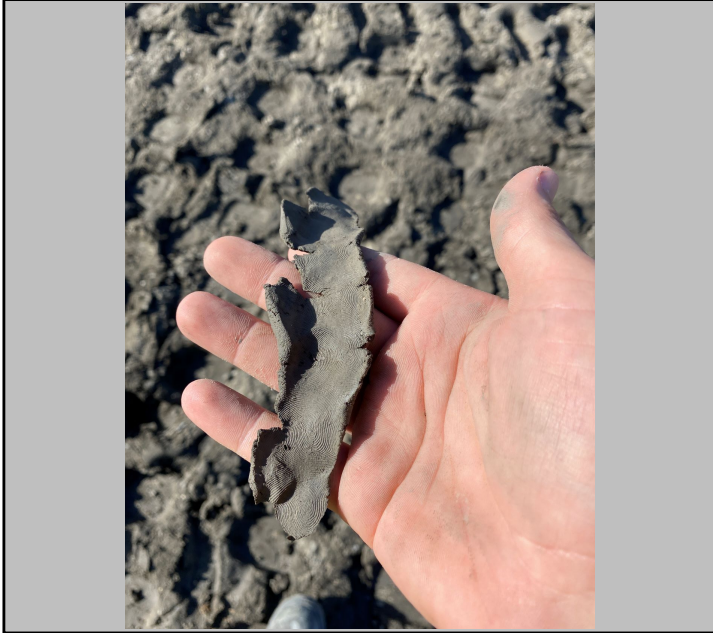
Photo #: 5

- Varied results obtained during testing of the bench. D520 yielded a moisture content of 32%, but following in-situ inspection the material appeared moist and pliable. Lab moisture content results to be used for corrected results. Results became more consistent as testing progressed on the slope producing satisfactory results.

D520 material

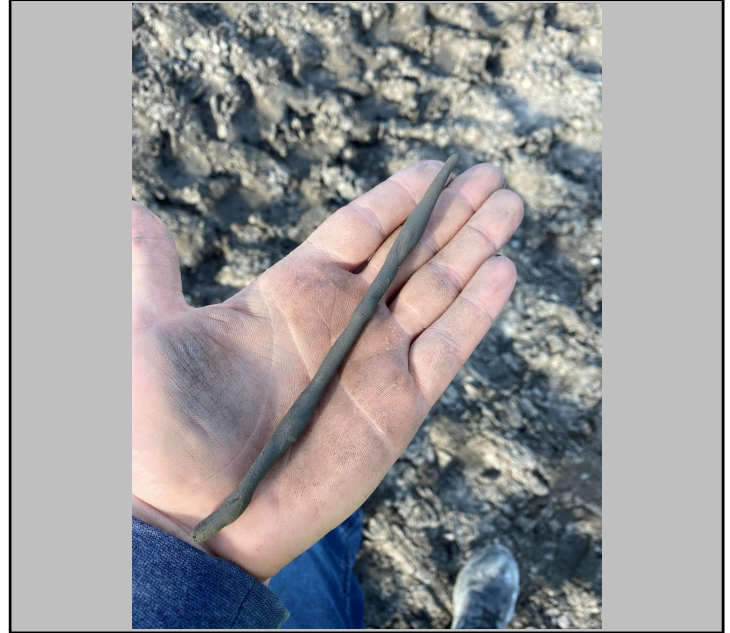
Photo #: 6

D522 material

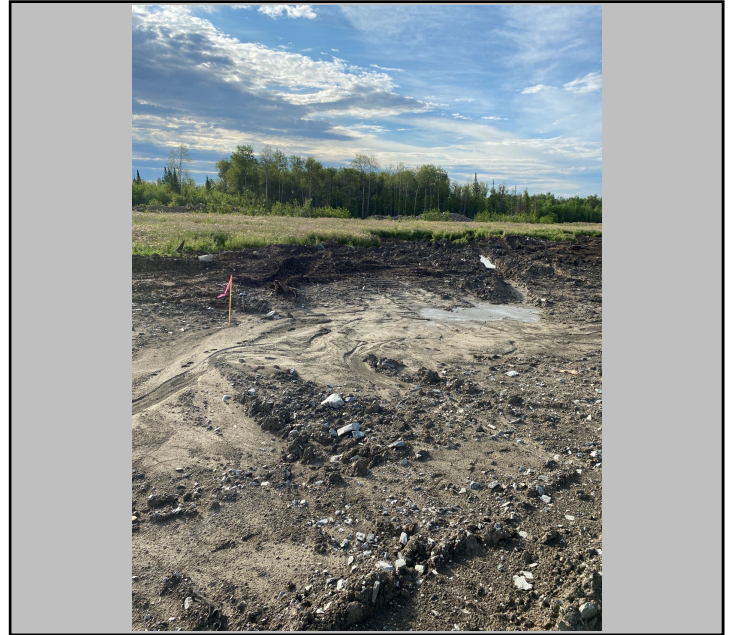
Photo #: 5

Area of P30 toe where pooling occurs. Ditch made by excavator in order to limit pooling.

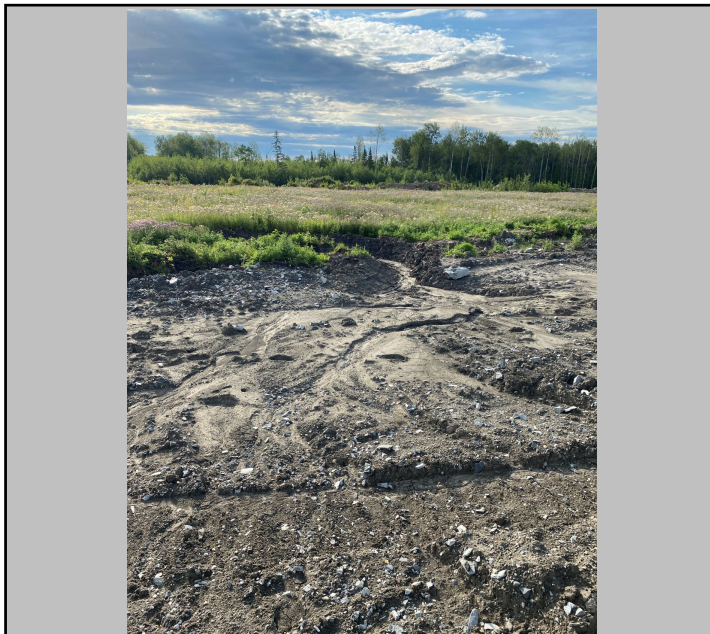
Photo #: 7

Second area of P30 toe where pooling occurs. Ditch made by excavator in order to limit pooling.

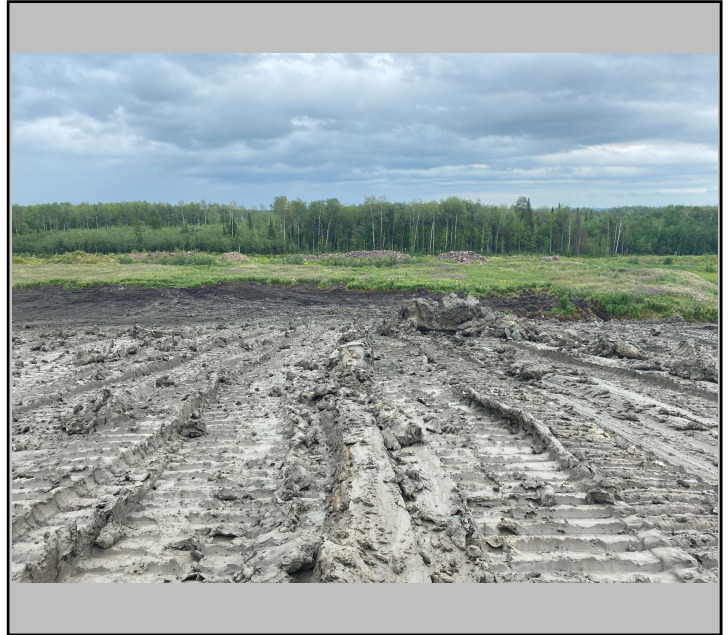
Photo #: 2

P33, L4 conditions after morning showers

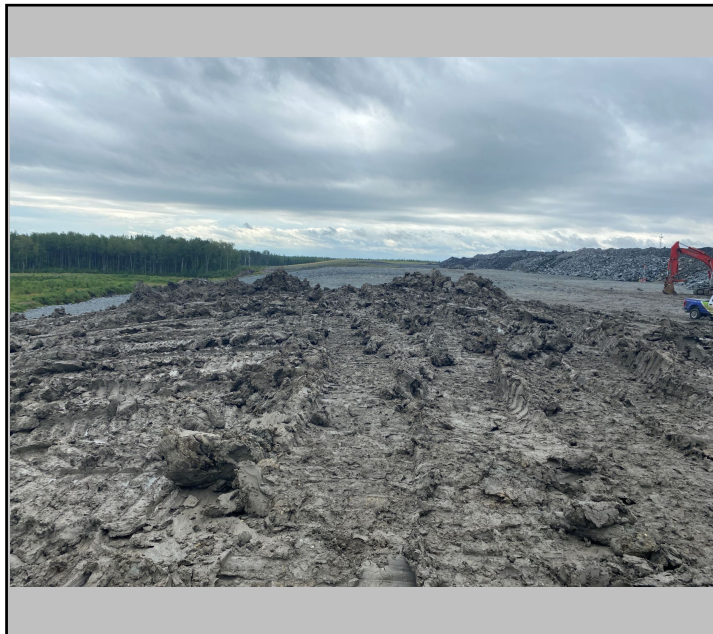
Photo #: 3

P33, L4 conditions after morning showers

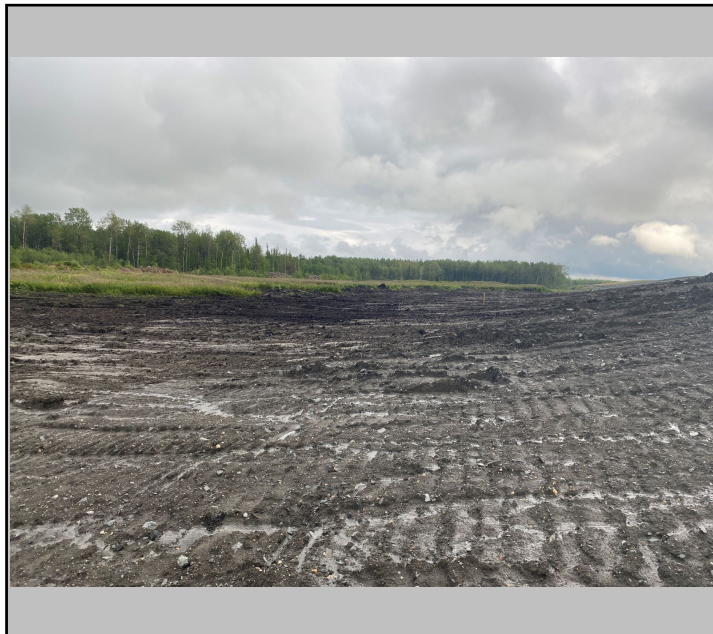
Photo #: 7

P30 toe following rework

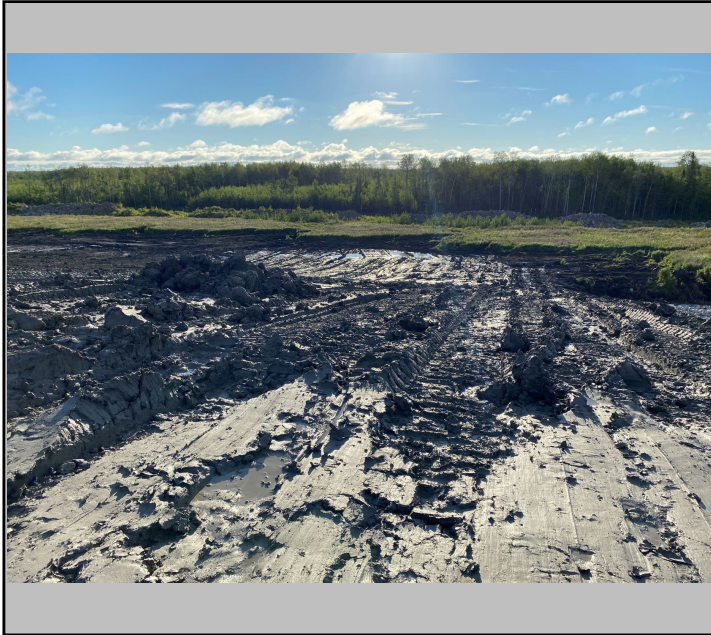
Photo #: 1

- Wet material and standing water in track marks present throughout L4 during morning inspection.
- L4 material given the majority of the day to dry before being track packed and mixed around 16:00 by the dozer. L4 was unable to be finished to grade due to material still being too wet in areas at the bottom of the slope and toe.
- L4 in progress.

P33, L4 morning conditions

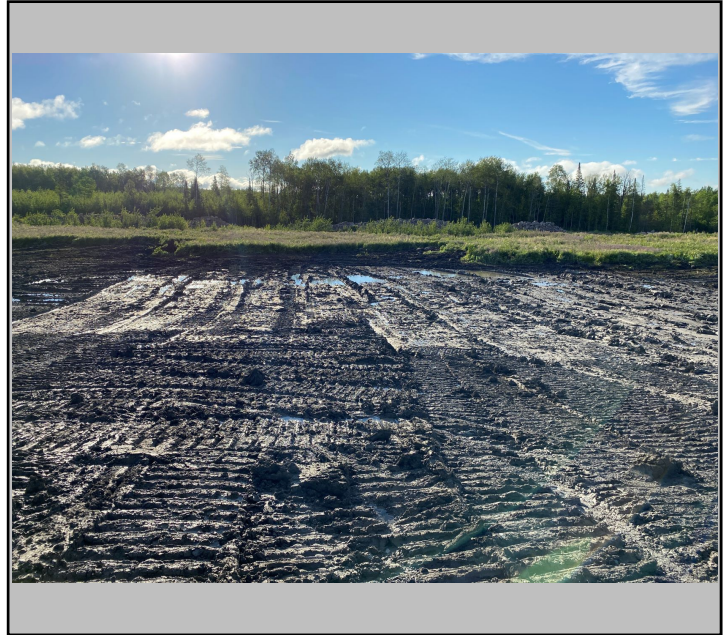
Photo #: 2

P33, L4 morning conditions

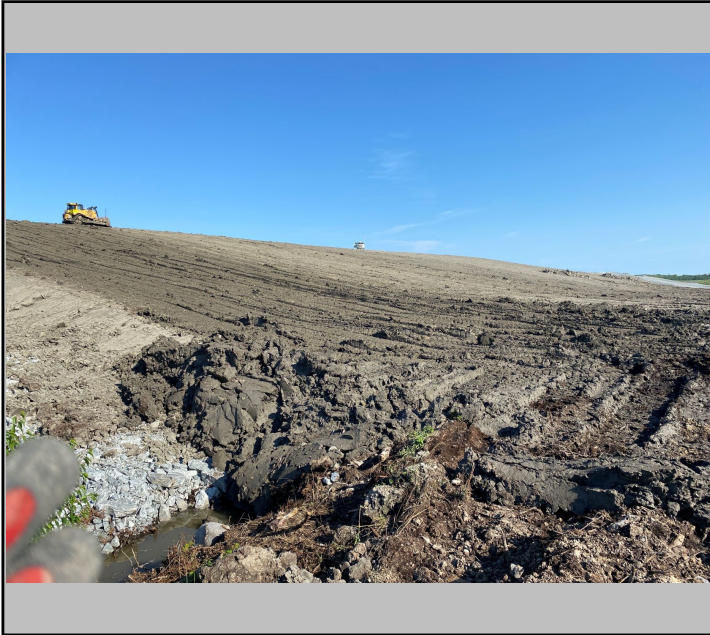
Photo #: 1

P33, L4 morning conditions
