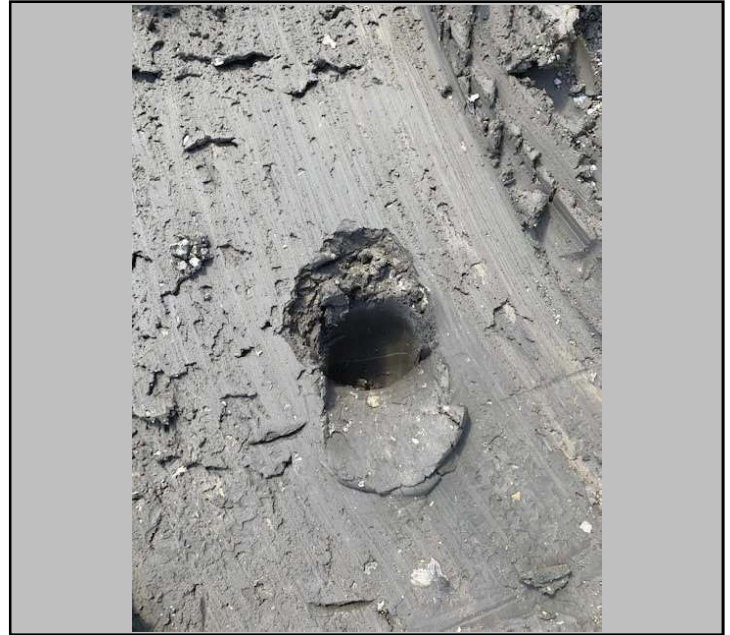
Photo #: 1

Compaction Test being completed on CCL Lift 2
Panel 2

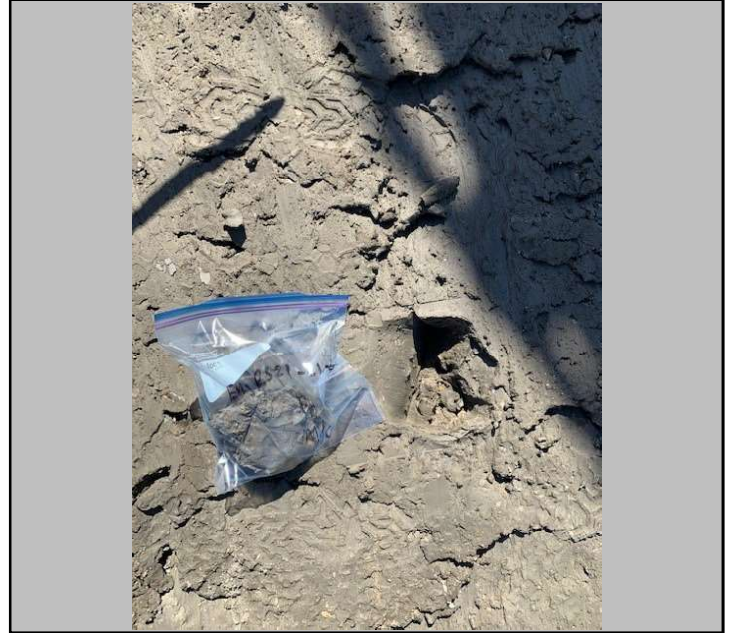
Photo #: 5

In field density tests were giving low compaction results but CQC and CQA felt like this had to do with the material having a higher moisture content.

Wet spot on top of CCL material on Panel 4.

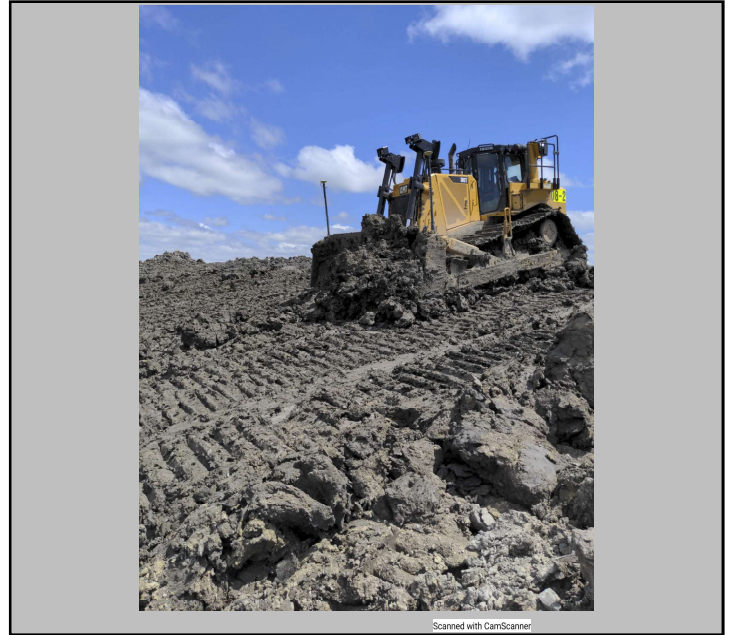
Photo #: 1

Panel 6 CCL Lift 1, Visually wet.

NG graded and packed Panel 6 CCL Lift 1. After packing the first half of the panel density testing resulted in high moisture content >33% and Ice was found when sampling. Re-testing will be completed tomorrow.

CCL material was dark grey with dark and light brown spots mixed in. Material was pliable and could be rolled out to form a ribbon in your hands. Oversize boulders were removed from the lift. Density testing was not approved due to high moisture content. When sampling ice was discovered in the lift.

Panel 6 CCL Lift 1 Nuclear Gauge testing results varying from 24% to 32% for Moisture content. Tulloch informed New Gold supervisors and discussed with Okane. The lift was re-worked with the Dozer tracks then re-graded with D8-2. After completing one density test that passed the lift was re-packed and testing and sampling completed.

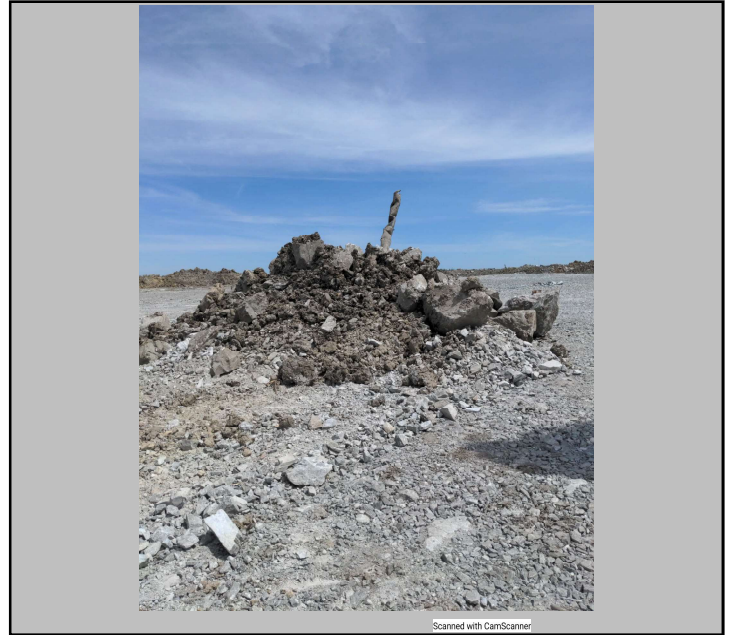
Photo #: 5

Test pit for Sample 206.
