PHOTOGRAPHS

Date:	June 19, 2021	Owner/Client:	New Gold Inc.
Day:	Saturday	OKC Project #:	1003-19
Prepared by:	Martin Moore	Project Location:	Rainy River - Ontario

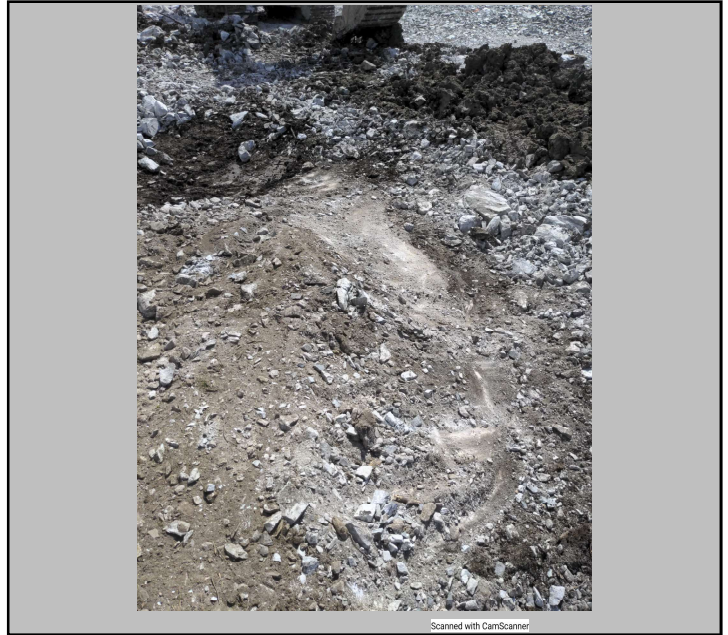
Photo #: 1

Panel 8 CCL Lift 1.

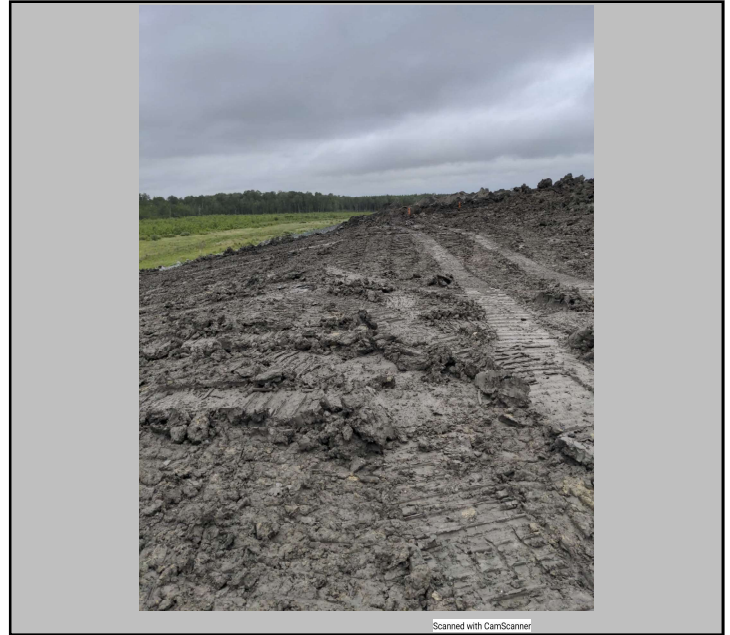
Photo #: 1

Rain in the morning delayed packing as Panel 8 CCL Lift 2 was visually too wet. NG supervisor on site to review the lift. After rain stopped NG re-attempted to pack the lift but continued to get pickup.

CT 349 removing oversize boulders from Panel 8 CCL Lift 2 that were not removed during placement prior to packing. Rain at EMRS caused Panel 8 CCL Lift 2 too wet to begin packing.

Panel 8 CCL Lift 2 slope after rain.

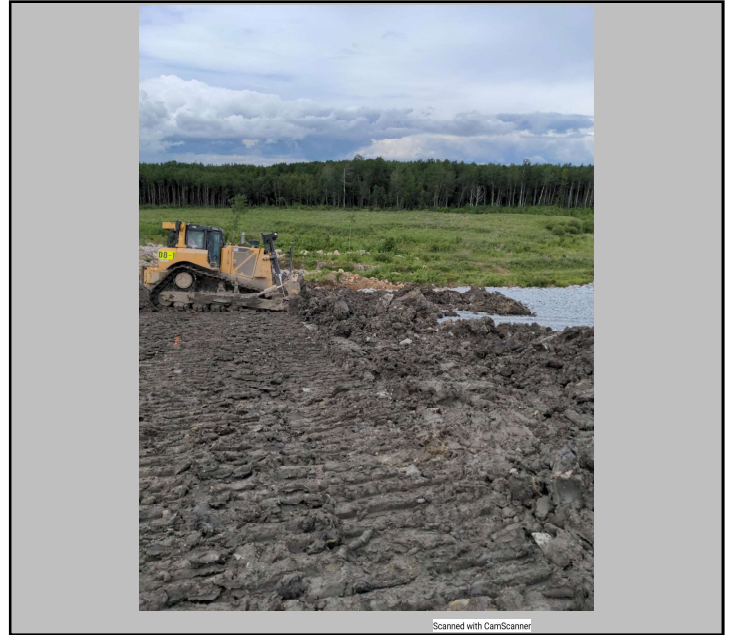
Photo #: 9

Panel 8 CCL Lift 2 roller pickup.

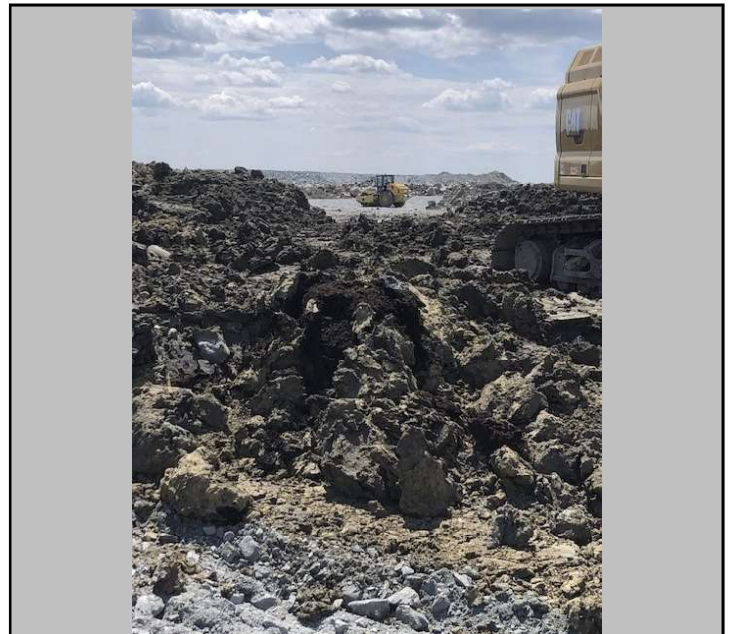
Photo #: 3

Removed organic and silty material CCL L1 P9

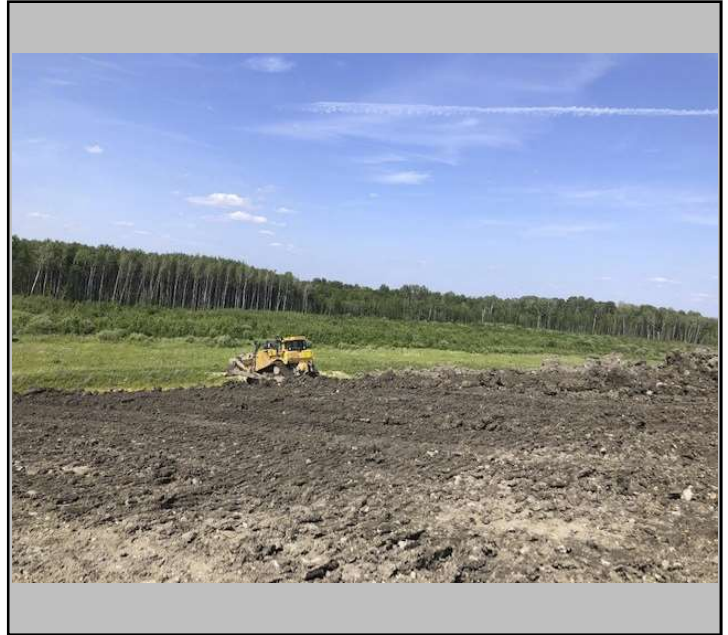
Photo #: 1

NCL Panel 12 Lift 3 after night shift placement
(not to grade)

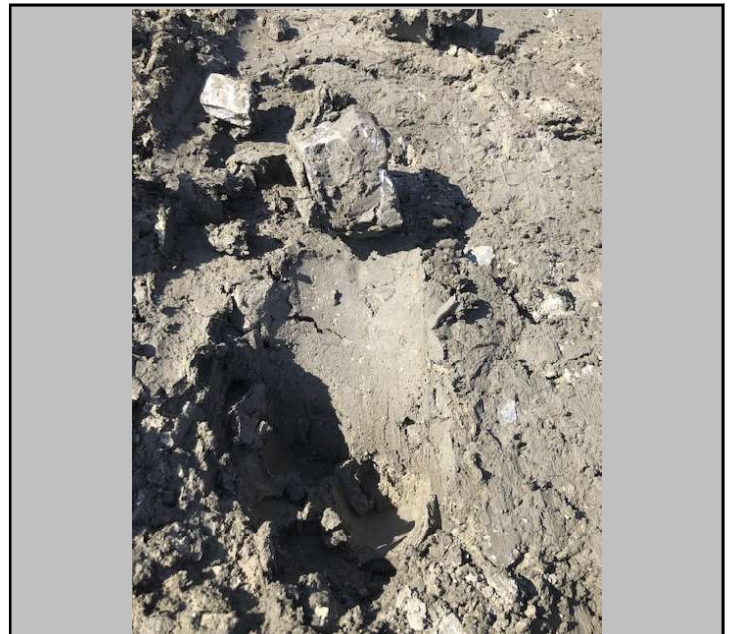
Photo #: 7

D186 Rock under probe

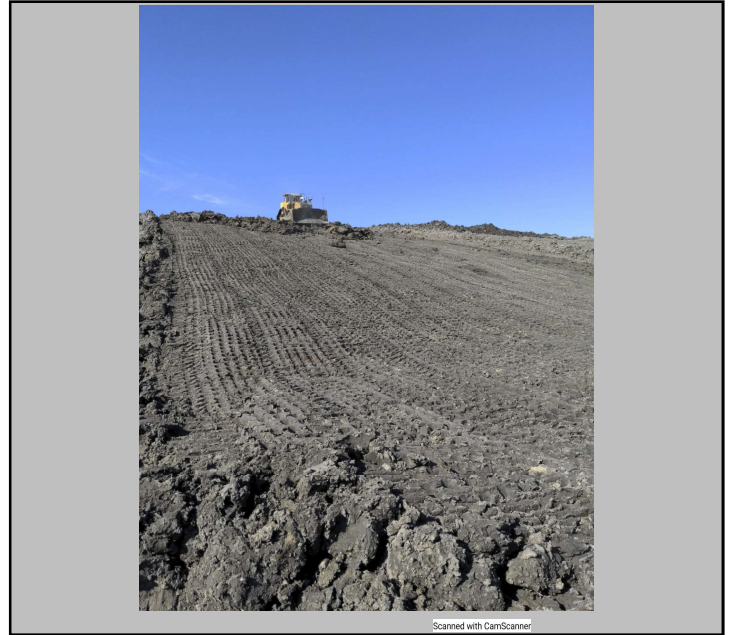
Photo #: 1

Key Trench built to 2+357 filled with water over night.

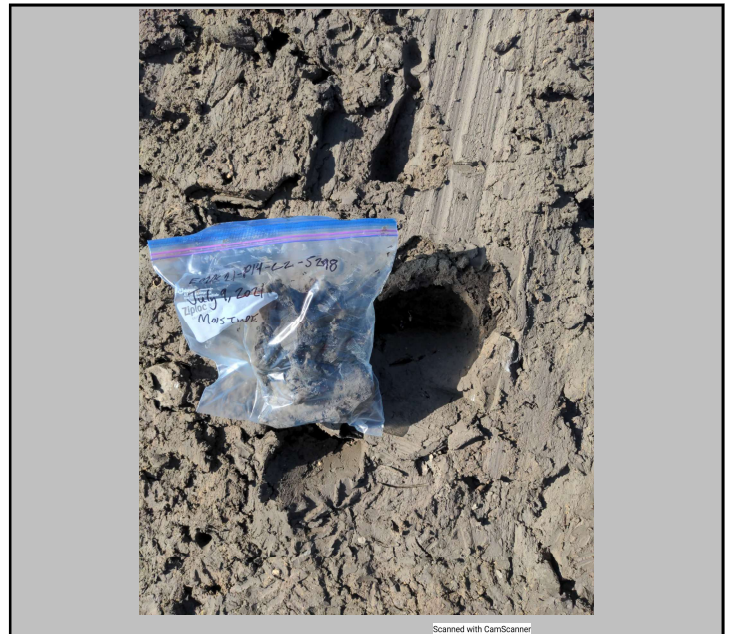
Photo #: 3

Test D212 Rock in probe hole.
