Date:	July 16, 2021	Owner/Client:	New Gold Inc.
Day:	Friday	OKC Project #:	1003-19
Prepared by:	Martin Moore	Project Location:	Rainy River - Ontario

Date:	July 17, 2021	Owner/Client:	New Gold Inc.
Day:	Saturday	OKC Project #:	1003-19
Prepared by:	Martin Moore	Project Location:	Rainy River - Ontario

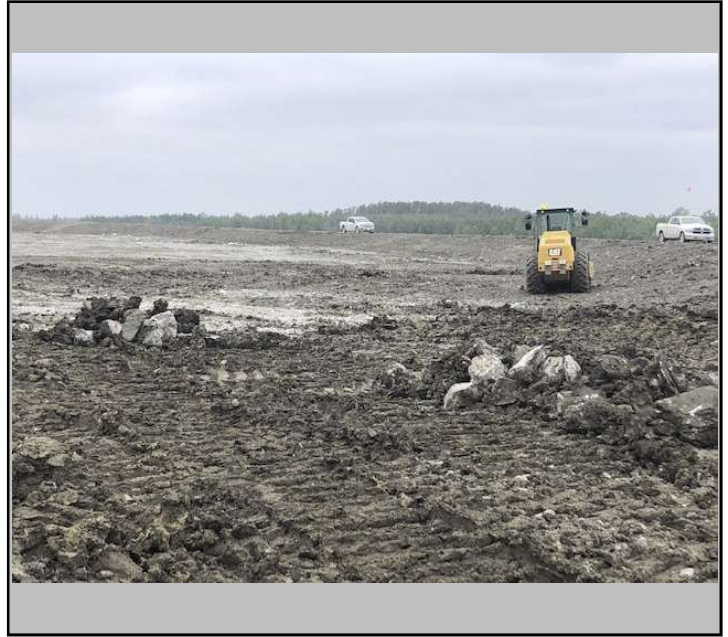
Photo #: 1

CCL material appeared dark grey/brown. The material appeared moist and pliable which could be rolled into strings without crumbling. Substantial amounts of large rocks found in stockpiled material Excavator 349 removing rocks from lift.

Excavator 349 removing rocks from Panel 18 L1

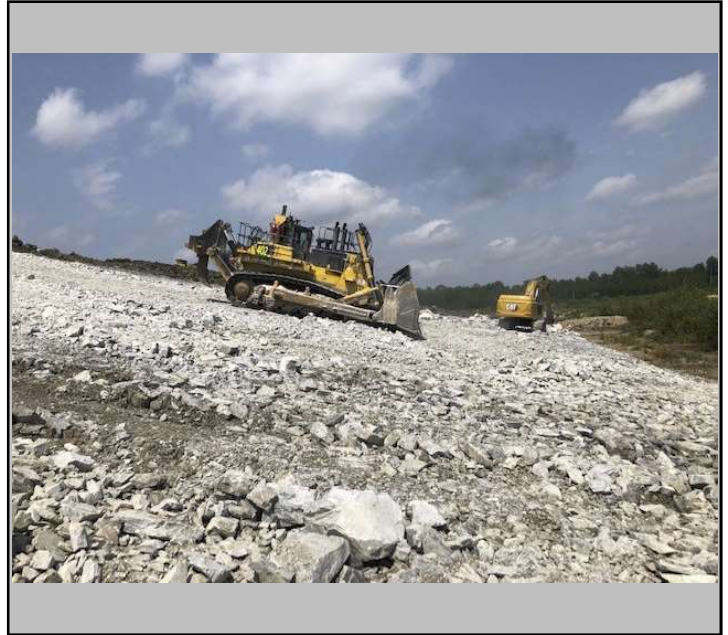
Photo #: 1

Kamatsu dozer filling low spot on base slope

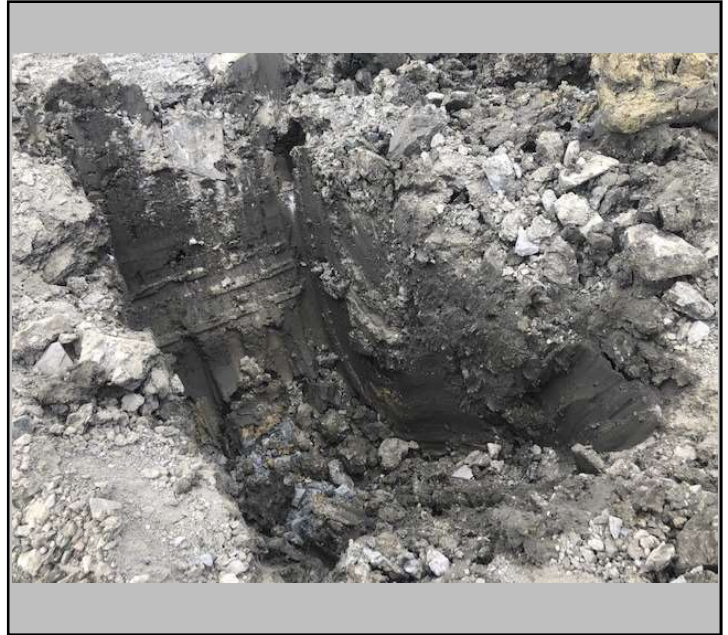
Photo #: 6

1.5m Thickness confirmed at Heat map red spots

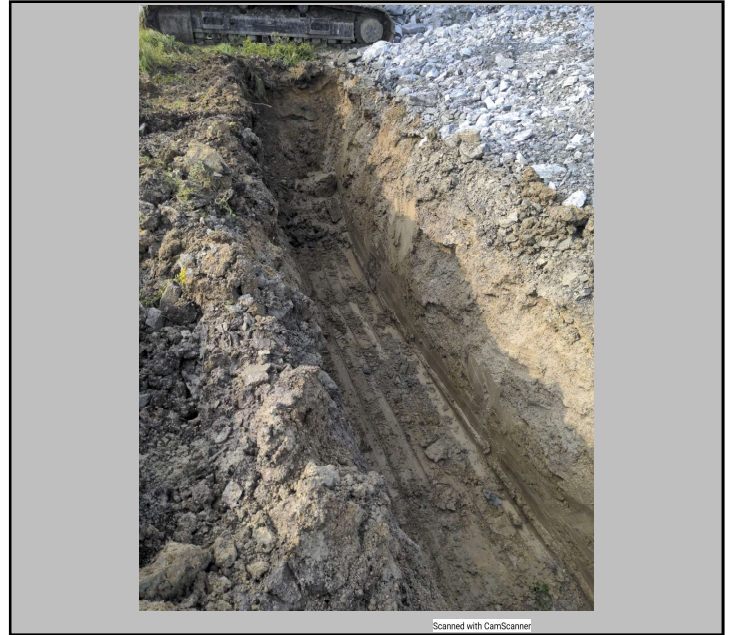
Photo #: 1

Panel 23 Key Trench ~2.5m deep.

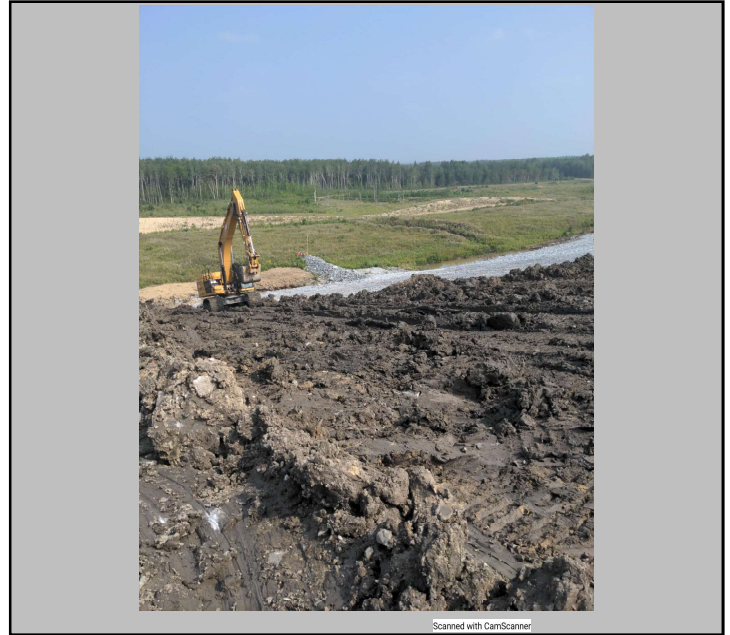
Photo #: 5

Panel 23 CCL Lift 1 placement.
