<b>Date:</b>	August 14, 2021	<b>Owner/Client:</b>	New Gold Inc.
<b>Day:</b>	Saturday	<b>OKC Project #:</b>	1003-19
<b>Prepared by:</b>	Martin Moore	<b>Project Location:</b>	Rainy River - Ontario

<b>Date:</b>	August 15, 2021	<b>Owner/Client:</b>	New Gold Inc.
<b>Day:</b>	Sunday	<b>OKC Project #:</b>	1003-19
<b>Prepared by:</b>	Martin Moore	<b>Project Location:</b>	Rainy River - Ontario

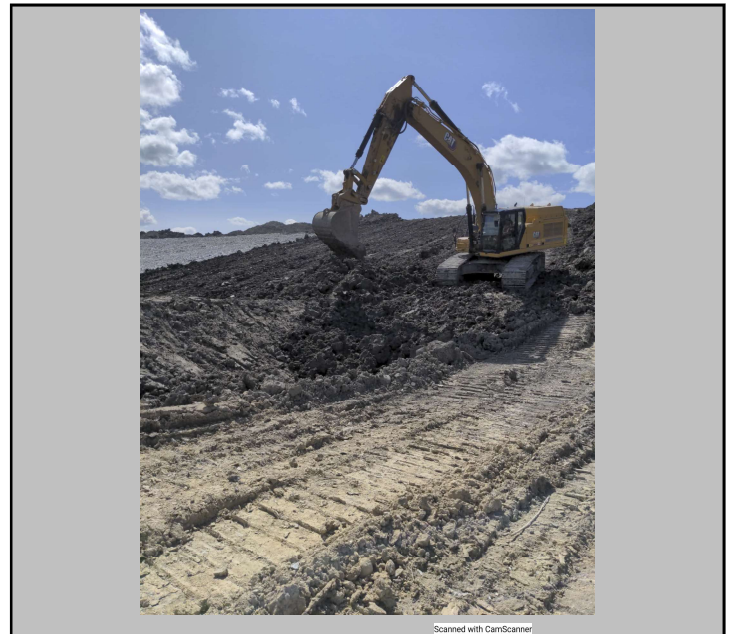
Photo #: 3

Panel 24 Lift 4 placement.

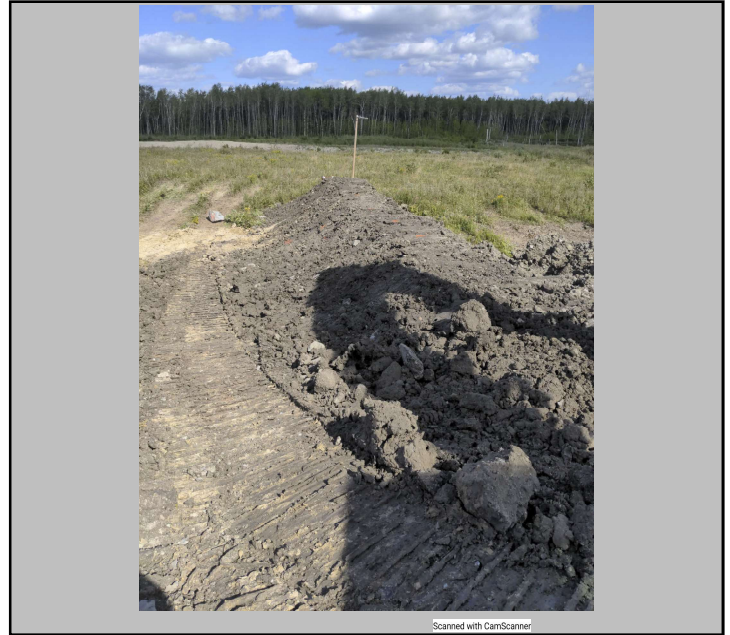
Photo #: 5

VWP Instrument behind the burrito.

- Tulloch completed Lift 3 and burrito survey. Back side of burrito has instrument very close and no slack wiring to move the instrument box. back side of burrito has NCL material covering lift 2 but unable to add additional material due to the proximity of the instrument.
- D8-1 initiated Lift 4 placement.

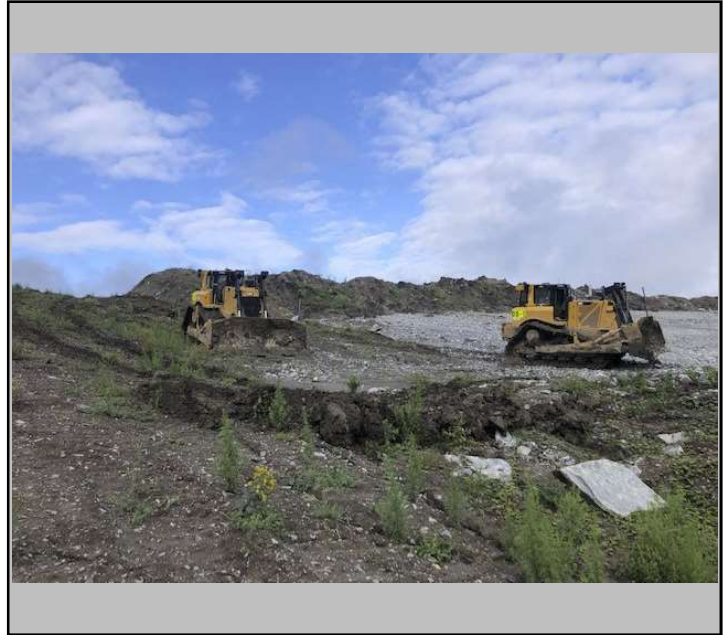
Photo #: 1

Bedrock at toe of Panel 27 and removal of organic material and oversize

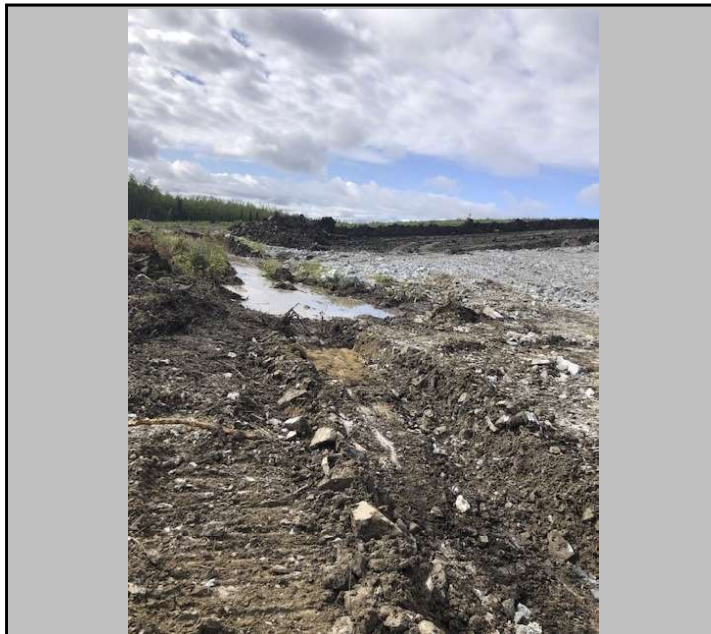
Photo #: 2

Panel 27: Station 0+114 to 0+175  
 - Dozers removed frost trials from last year and trimmed clay to tie in with CCL  
 - Dozers filled identified low spots with extra NAG near the toe of slope the newly fixed base slope was picked up by Tulloch survey  
 - Excavator 349 dug key trench which consisted on mostly bedrock from station 0+114 to 0+175, pictures can be viewed below  
 - After removing overburden in stockpiles they appeared ideal for CCL material  
 - Dozers and Excavator initiated placing CCL Lift 1 with stockpiled material  
 - Bench and crest area provided GPS surface is inaccurate once stockpile material was placed. Excavator exposed sections to to allow CQC to survey to provide an accurate surface.

Before trimming organics and frost trial from last year

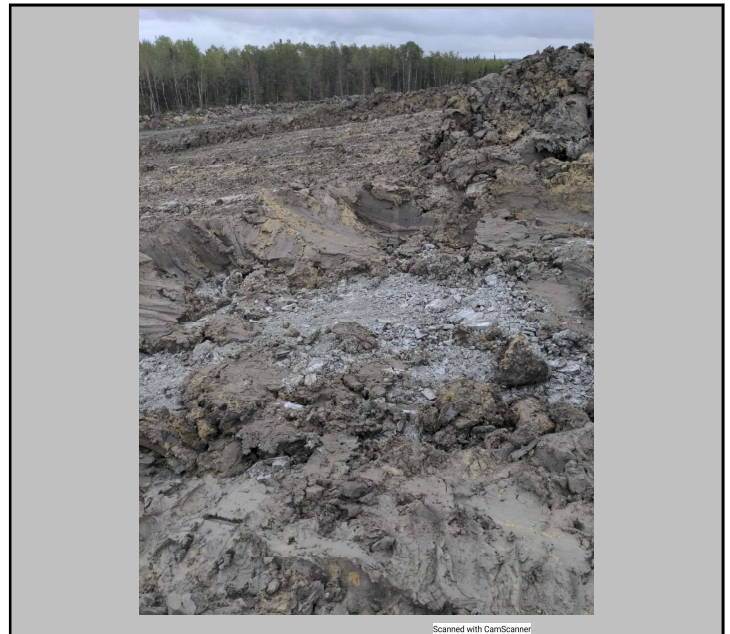
Photo #: 3

0.5m hump of rock.

Additional locations with humps of rock showing through Lift 1 being removed when found.

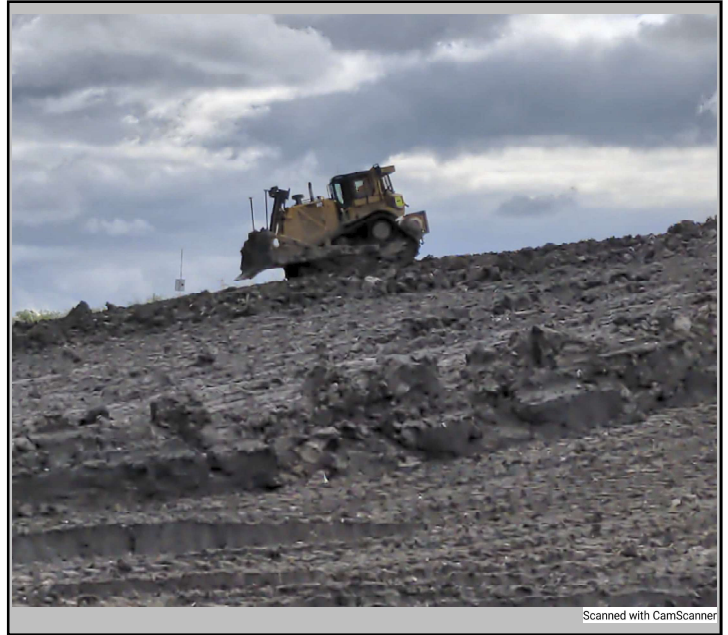
Photo #: 1

CCL material appeared to be dark brown and grey with spots of light brown. Abundance of oversize rocks being removed from Lift 1. Sections with an abundance of smaller rocks removed and replaced with suitable material with no rocks.

Oversize rock removal.

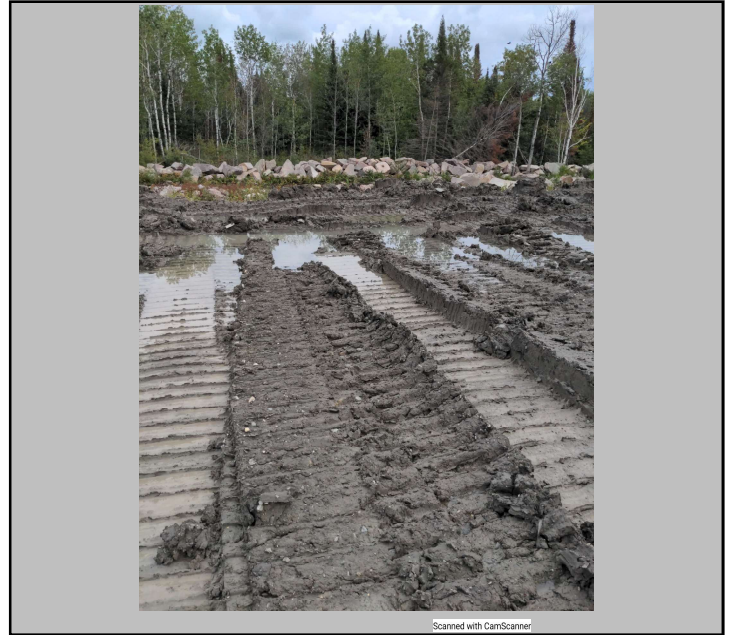
Photo #: 5

Panel 28 Lift 2 standing water.

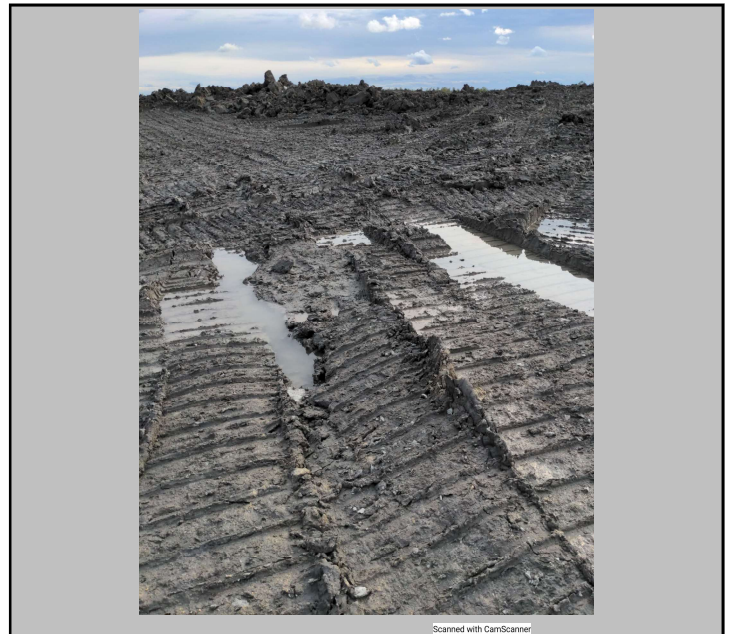
Photo #: 7

Panel 27 standing water at toe.

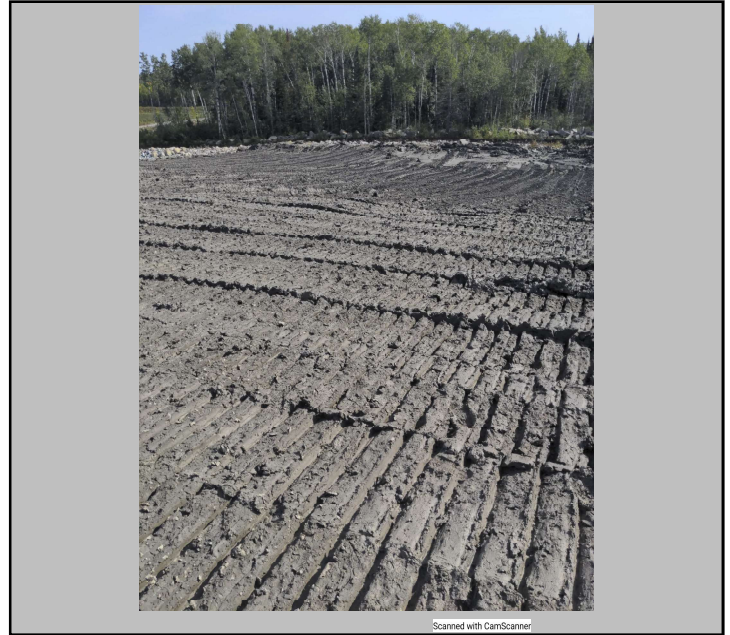
Photo #: 1

Removal of pooled water at toe.

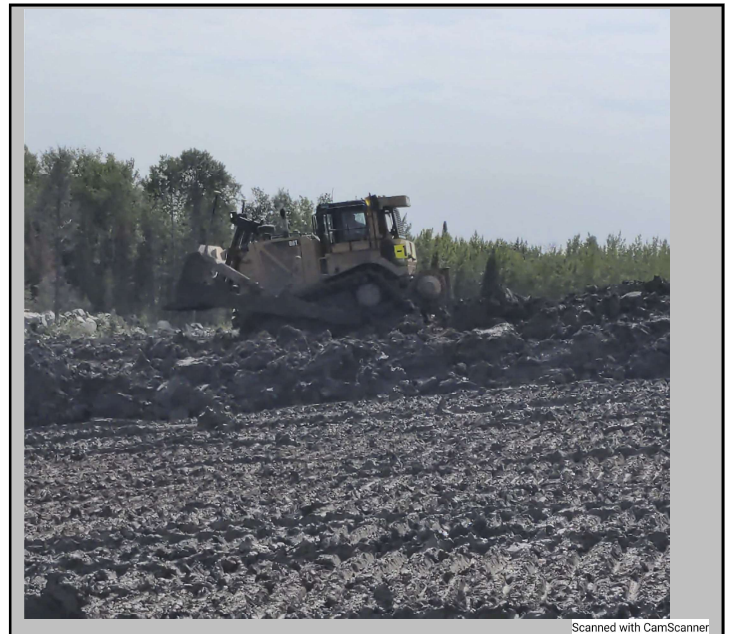
Photo #: 3

Track packing CCL Lift 2 again to remove standing water.

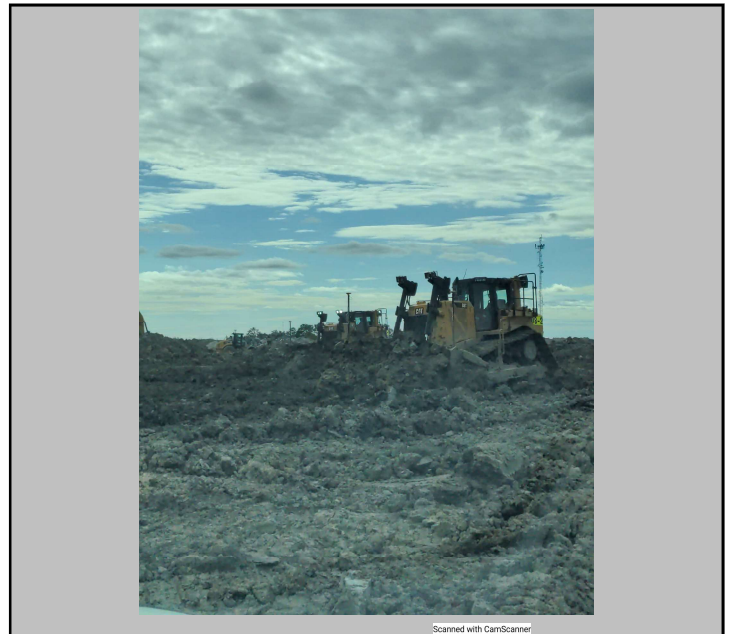
Photo #: 7

Fill in borehole on Panel 23.
