**PHOTOGRAPHS**

<b>Date:</b>	August 25, 2021	<b>Owner/Client:</b>	New Gold Inc.
<b>Day:</b>	Wednesday	<b>Okane Project #:</b>	1003-027
<b>Prepared by:</b>	Blake Weinrauch	<b>Project Location:</b>	Ontario

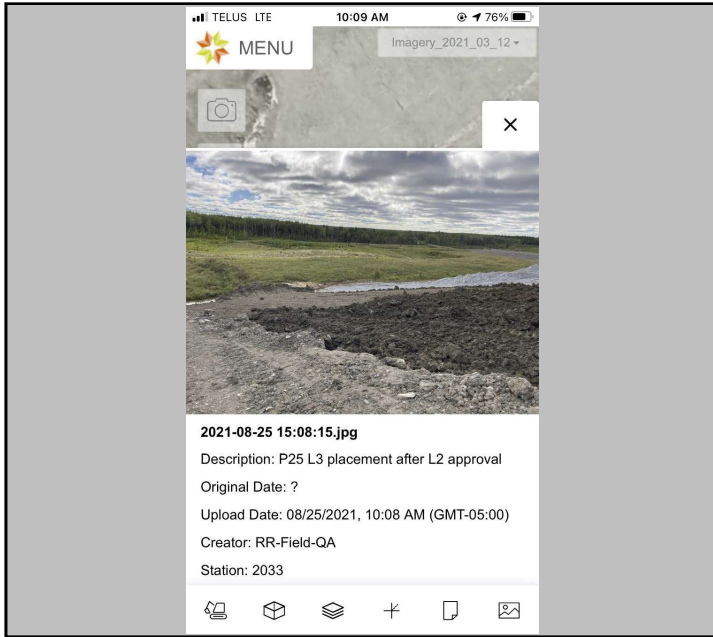
Photo #: 1

P25 L3 placement after L2 approval

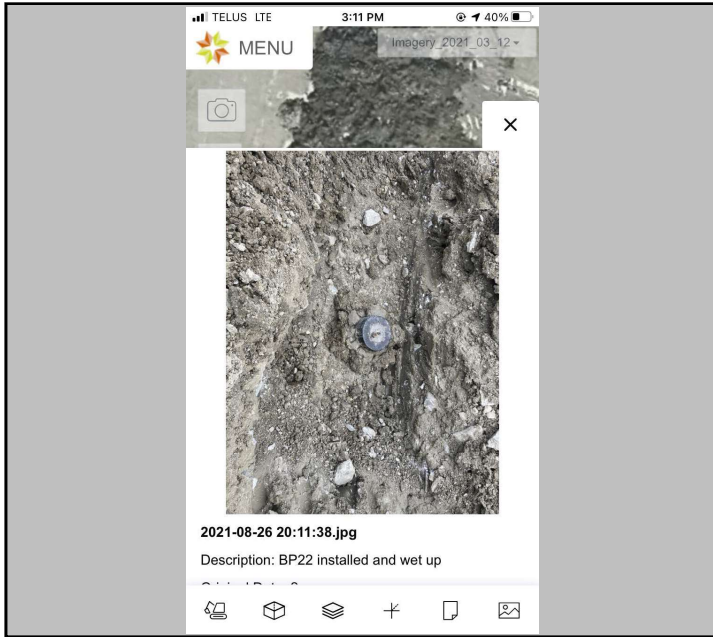
Photo #: 1

BP 22 installed and wet up

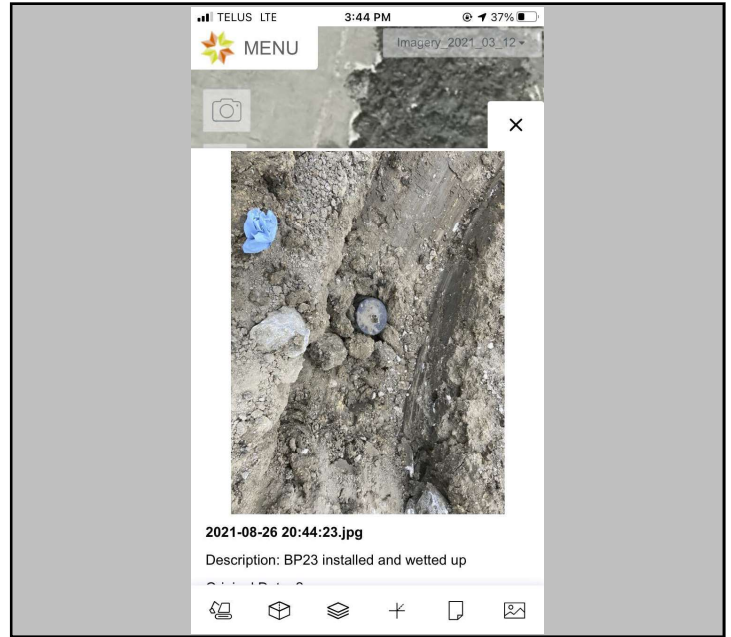
Photo #: 2

BP 23 installed and wet up

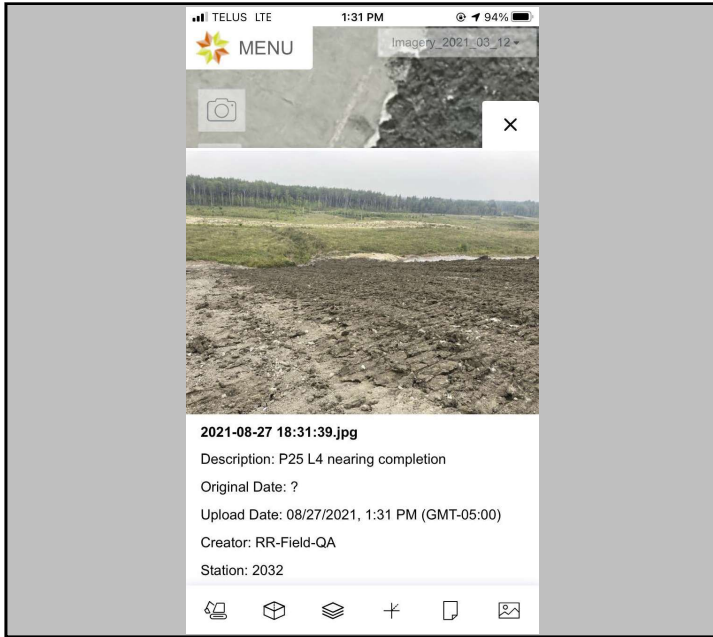
Photo #: 1

Finishing up P25 L4

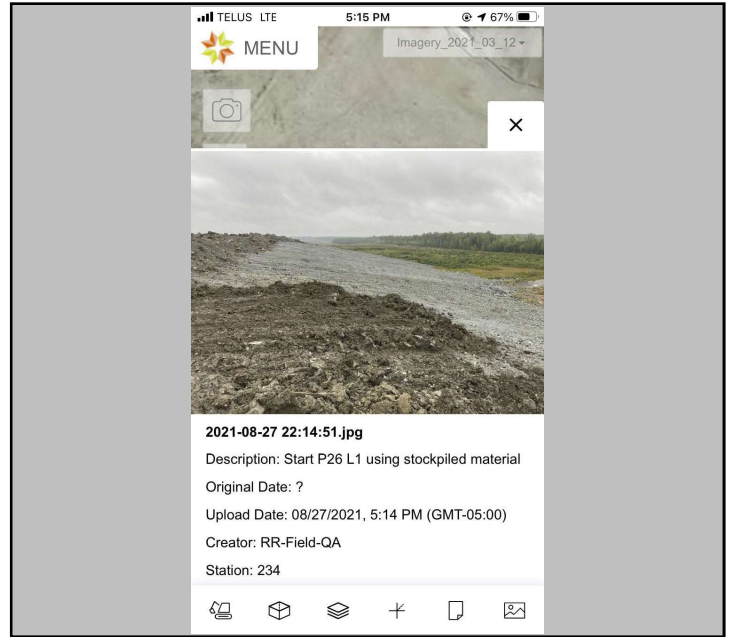
Photo #: 2

-Heavy afternoon rainfall made material very moist; the material at the bottom of the stockpiles appears to be very dark brown, moist, and plastic with some lighter brown Brenna material mixed in.

P26 L1 material being placed using stockpiled material

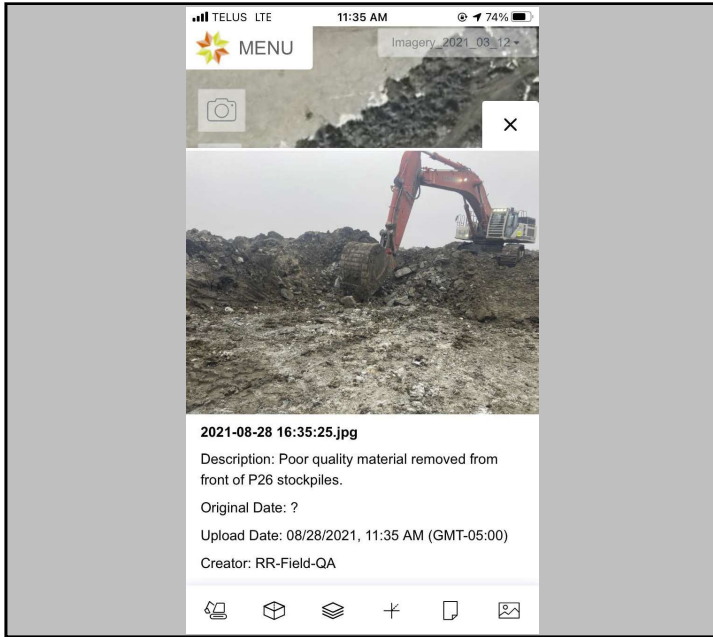
Photo #: 1

P26, L1:  
 -Due to very poor stockpile quality, rocky material is actively being sorted through and hauled away from the crest of the slope.  
 -Afternoon rainfall made material very moist; the material at the bottom of the stockpiles appears to be dark brown, moist, and plastic with lighter brown Brenna material mixed in, and contains a moderate amount of rock.

Poor quality material removed from front of P26 stockpiles

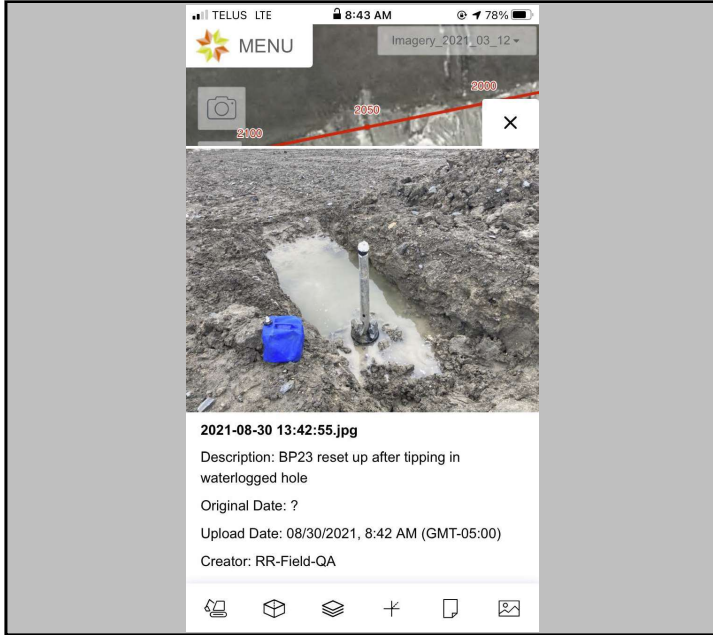
Photo #: 1

BP23 reset after tipping in hole

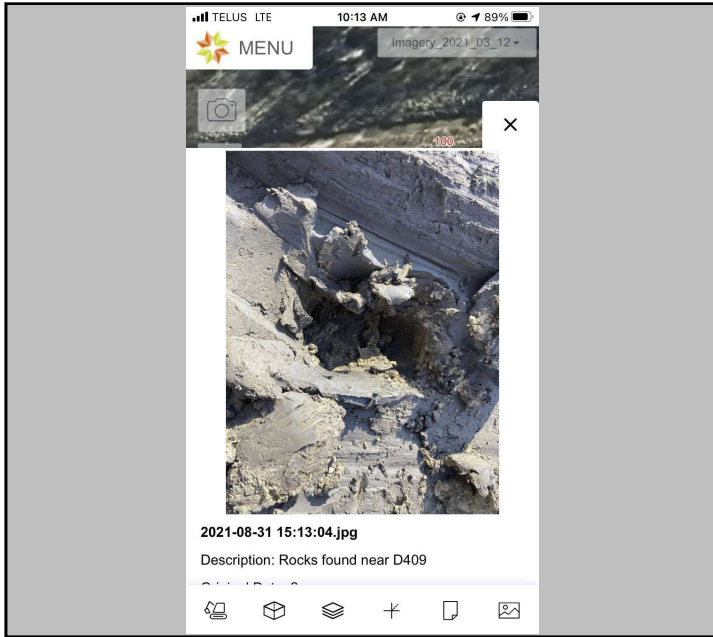
Photo #: 1

P27, L2:  
 -Continued placement with material from stockpiles which appeared visually very moist, dark brown, and free from small rock, with some larger rock present. There was small patches of lighter brown Brenna material that were removed for use in L3 and L4.  
 -Began compacting with the sheepsfoot roller and testing near the end of the day, however the panel was too wet to successfully compact; only one nuclear densometer test was collected.  
 -Operators track compacted the lift to assist with drying of the material; compaction will continue in the morning.

Some rocky material found near D409

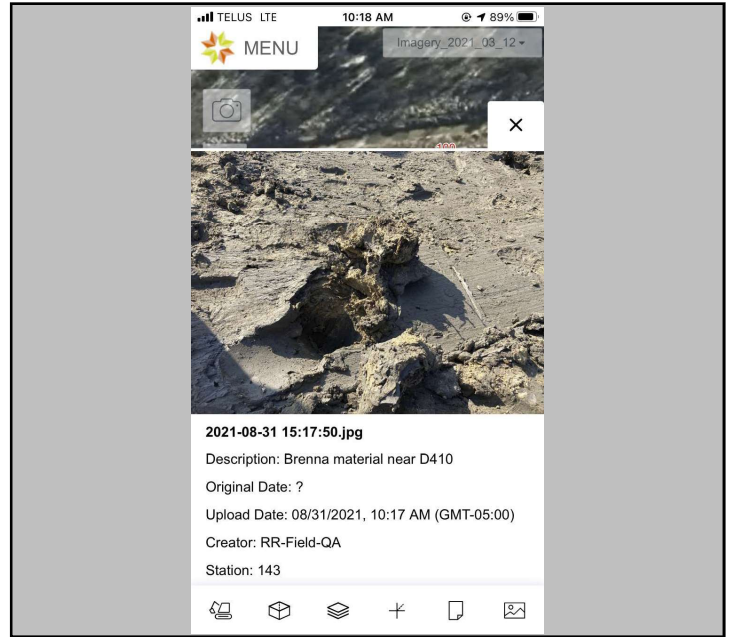
Photo #: 2

Brenna patch near D410

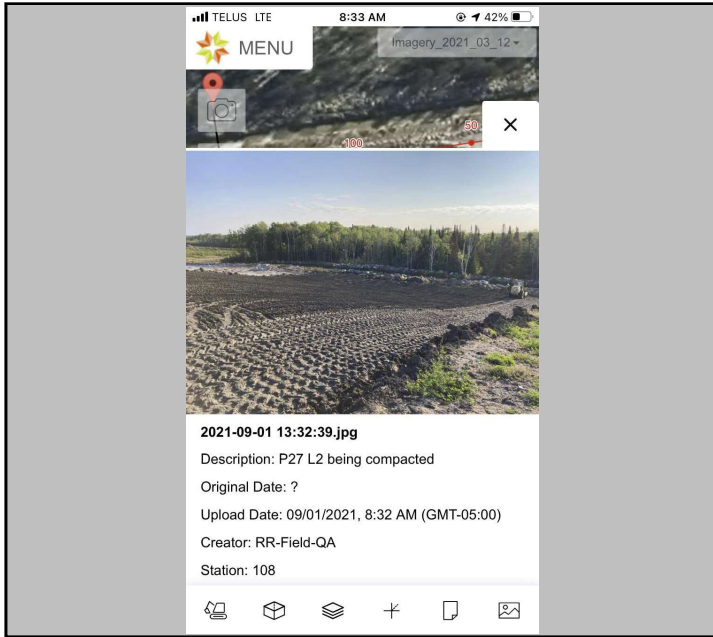
Photo #: 1

P27 being compacted

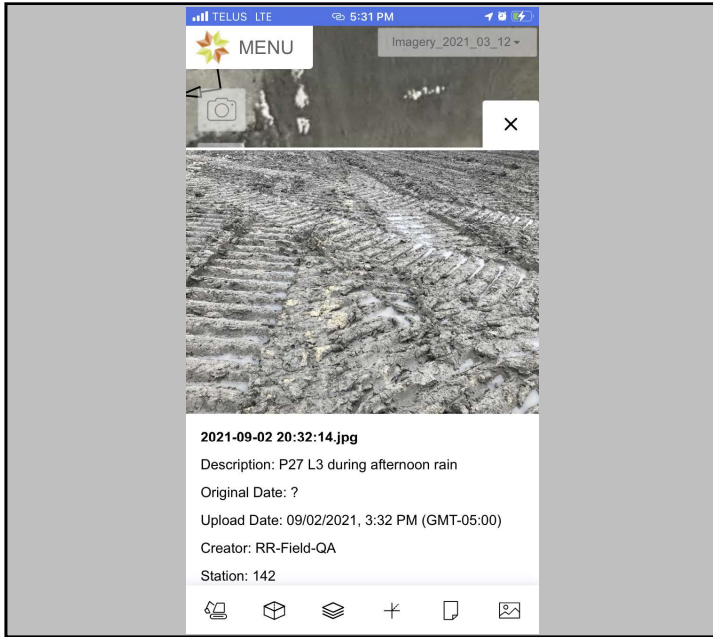
Photo #: 1

- Wet conditions on completed P27, L3 during afternoon rain

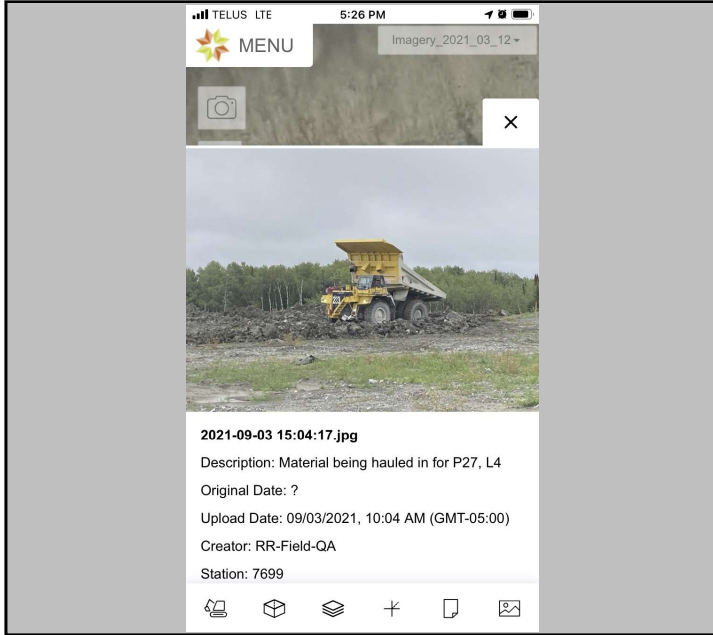
Photo #: 1

Material being hauled for use in P27, L4

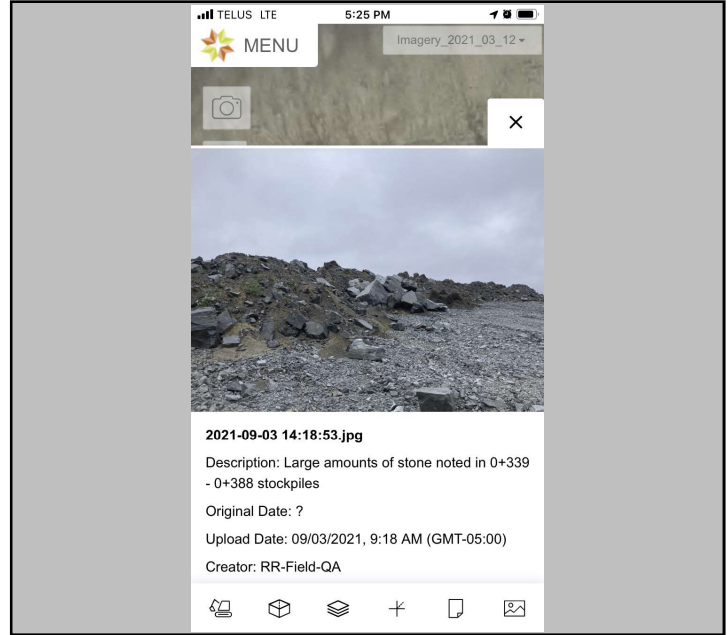
Photo #: 2

General:  
 - Stockpiles further up chainage (0+388-0339) where future panel construction is to take place were inspected. Upon inspection a large amount of both oversize and small stone were noted throughout the area.  
 - The exposed CCL from boreholes (EMRS21\_BP\_P23\_L2\_B22\_210826 & EMRS21\_BP\_P24\_L2\_B23\_210826) was inspected for desiccation and is ready to be filled in when conditions allow and equipment is available.

Large amount of stone noted in (0+339-0+388) stockpiles

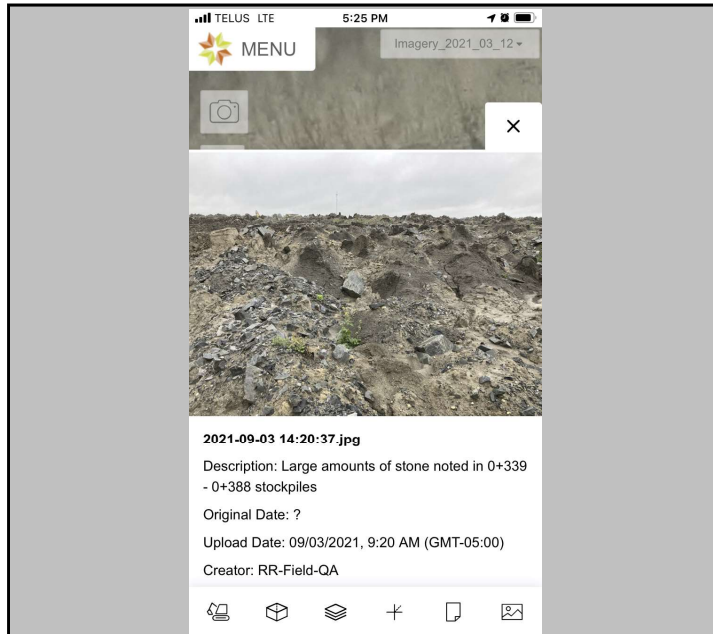
Photo #: 3

Large amount of stone noted in (0+339-0+388) stockpiles

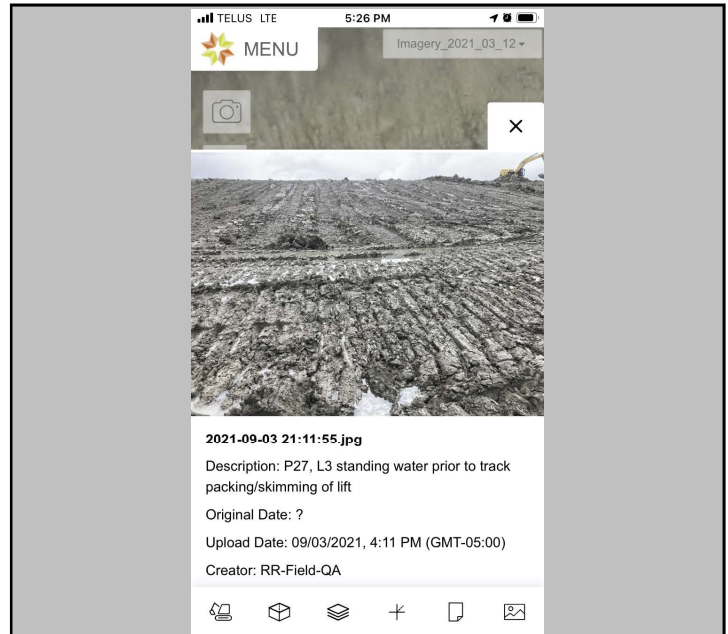
Photo #: 4

P27, L3 standing water prior to being track packed and skimmed

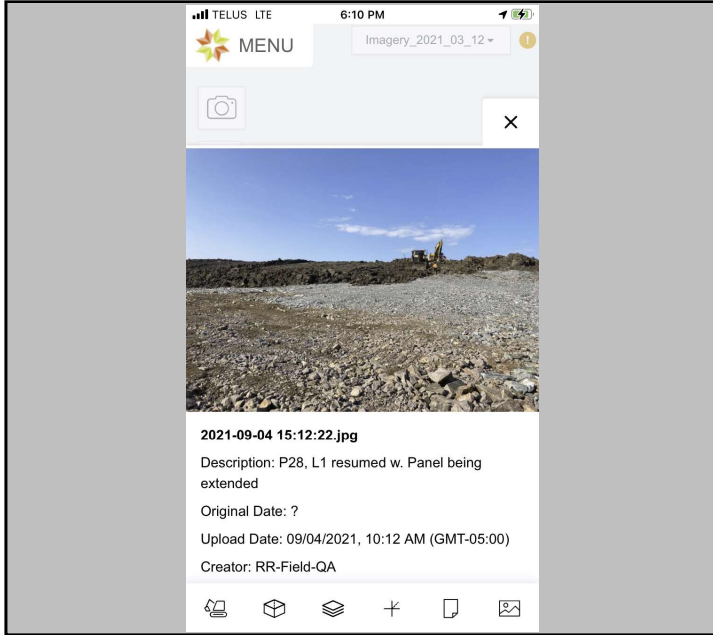
Photo #: 1

- P28, L1 resumed and width extended

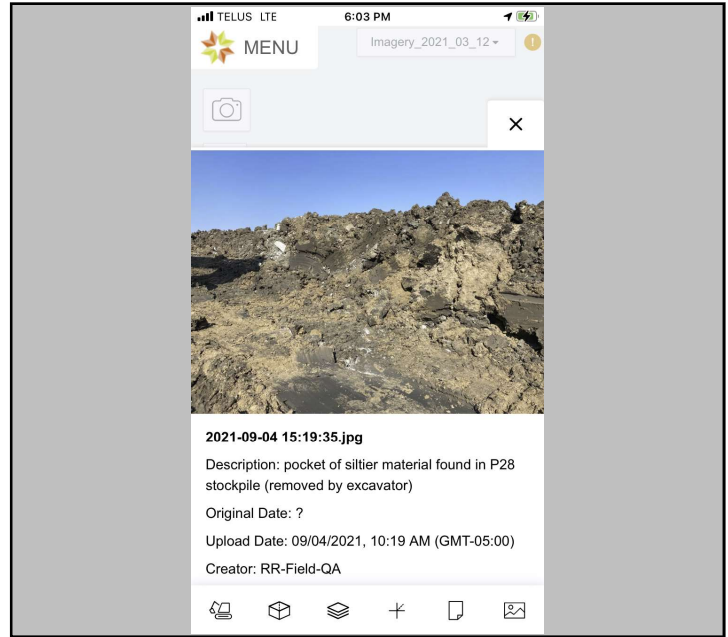
Photo #: 6

Pocket of silty material found in P28 stockpile.

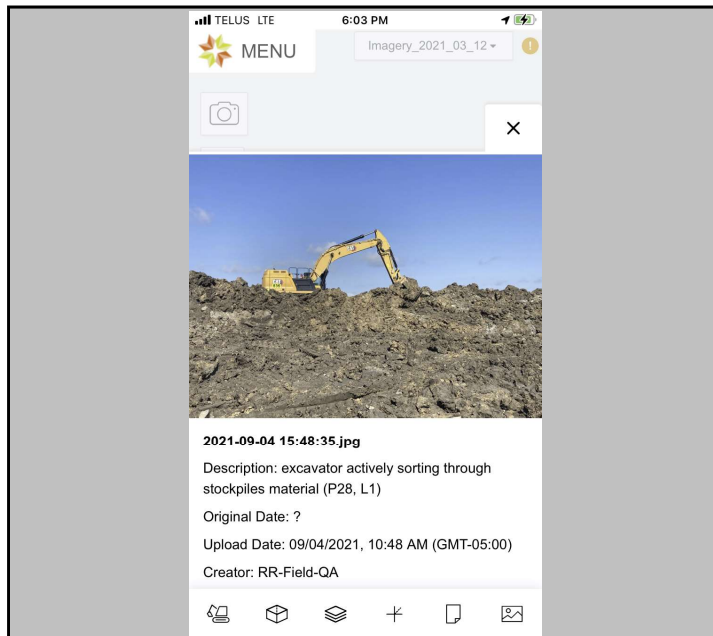
Photo #: 7

- Material appeared brownish grey with streaks of lighter silt scattered throughout, moist, and contained a moderate amount of stone.
- Excavator and dozer were able to remove groupings of stone and undesirable material during the placement process.

- Excavator actively sorting through stockpiled material

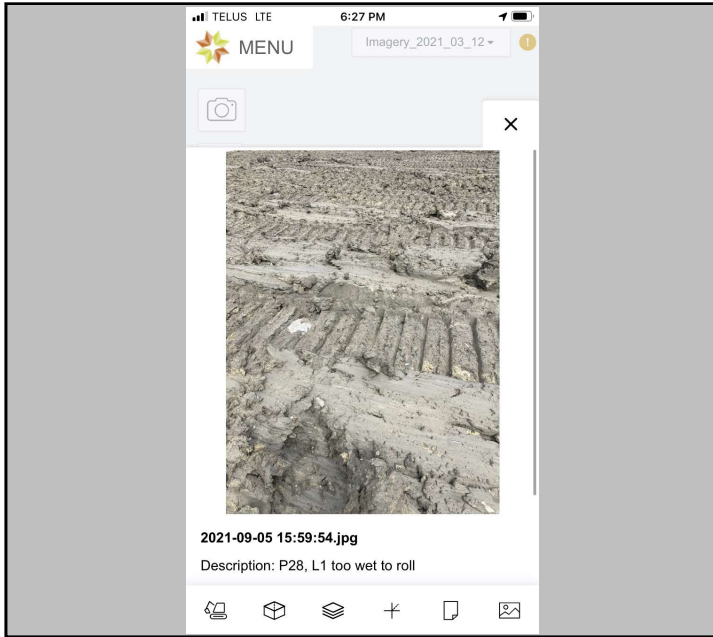
Photo #: 1

- Final grading of P28, L1 completed. Previously identified area of stone was still present after being completed to grade. The roughly 20'x20' section of L1 was removed and replaced with suitable material by the excavator during the process of removing oversize stone.  
- Due to evening and early morning showers L1 was deemed too wet for compaction after placement. The lift was given time to dry before being track packed again by the dozer. After being track packed the roller was able to begin compaction.  
- Material appeared brownish grey with streaks of lighter silt scattered throughout, moist, and contained a moderate amount of stone.  
- Compaction and testing to be completed tomorrow.

P28, L1 material once completed to grade

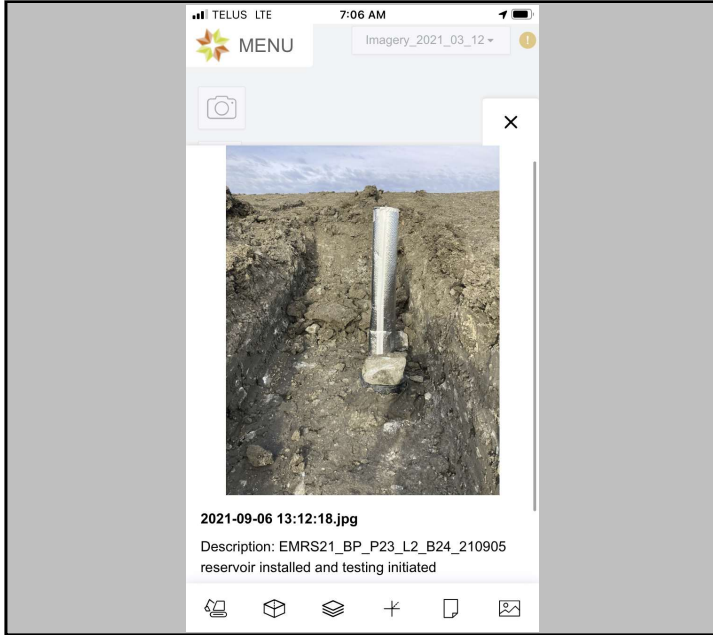
Photo #: 1

EMRS21\_BP\_P23\_L2\_B24\_210905 reservoir installed and testing initiated

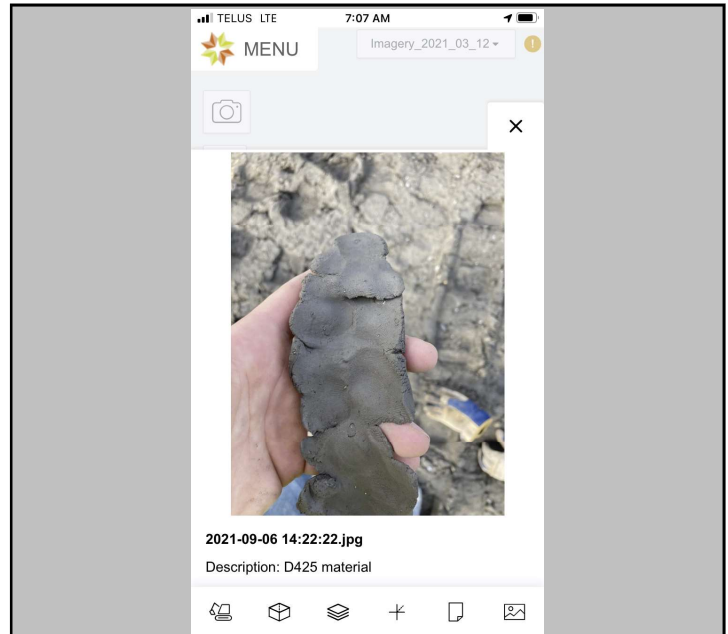
Photo #: 4

P28, L1:  
- Field proctor switched to EMRS21\_PR\_ST\_S302\_210710.  
- Moisture contents over thirty percent obtained obtained during testing in two areas which resulted in failed compaction results. Upon inspection the material appeared grey, moist, and pliable. The surface of the lift was not visibly wet and equipment had no issues working on the material. The area of D425/426 has been flagged for hydraulic conductivity testing.  
- Compaction and testing of lift complete. Surveyed by Tulloch and proper thickness confirmed.  
- P28, L1 approved pending borehole permeameter testing.

D425 material (31.1% field moisture content)

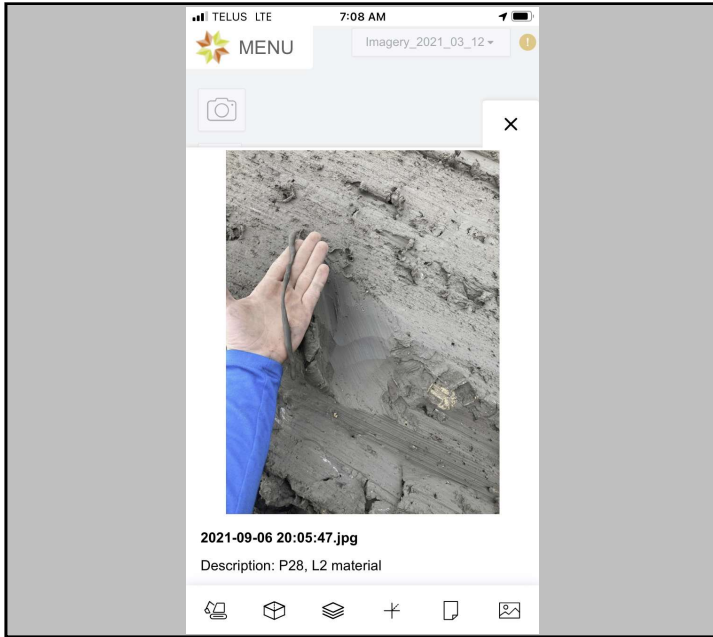
Photo #: 5

P28, L2:  
- Material visually consistent with L1 and appeared brownish grey, moist, pliable, with a moderate amount of stone.  
- L2 was placed to cover the entirety of L1 with rain forecasted in the evening.

- P28, L2 material

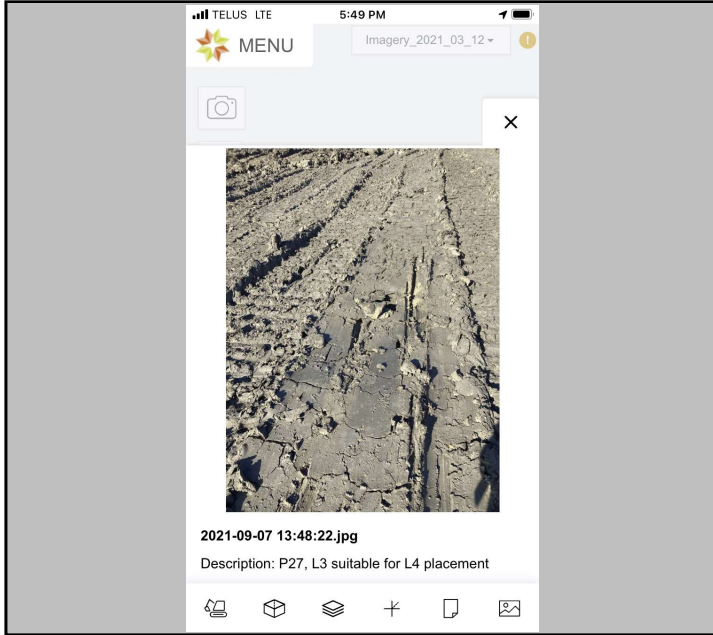
Photo #: 1

P27, L3 suitbale for NCL placement after previous evening showers

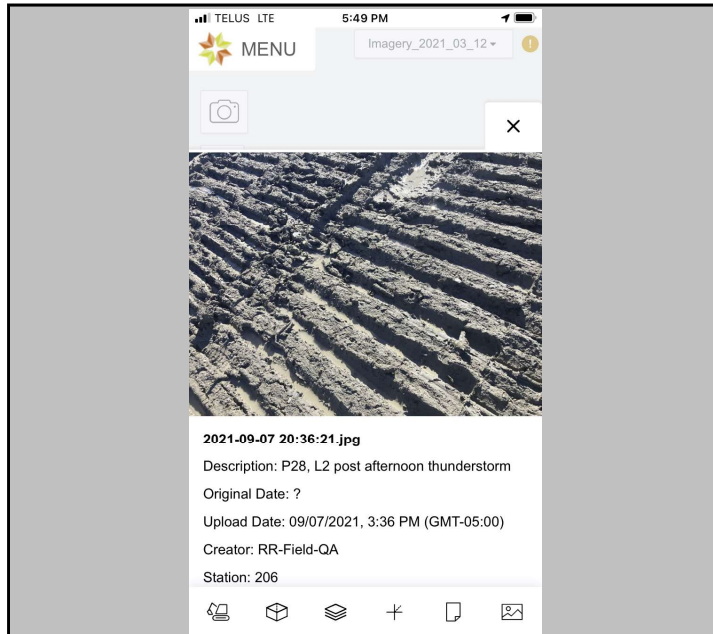
Photo #: 3

Wet conditions on P28, L2 after evening thunderstorm

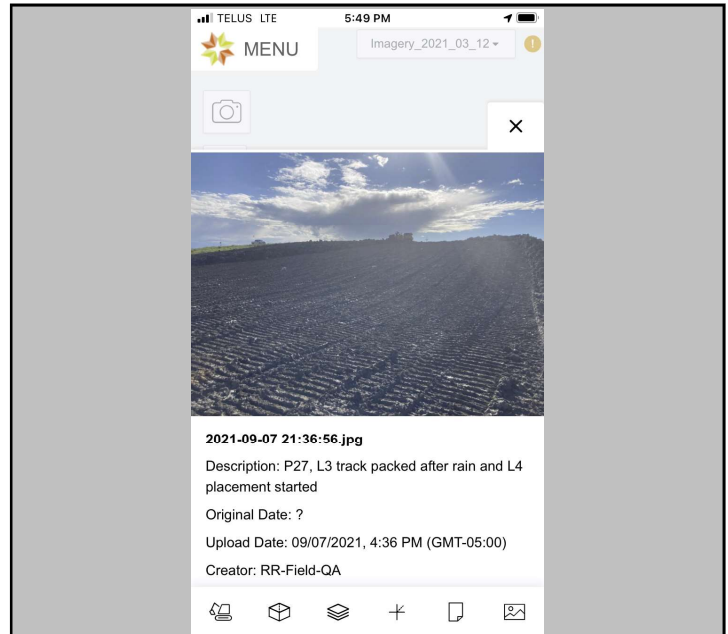
Photo #: 4

P27, L3 track packed after thunderstorm and P27, L4 placement resumed

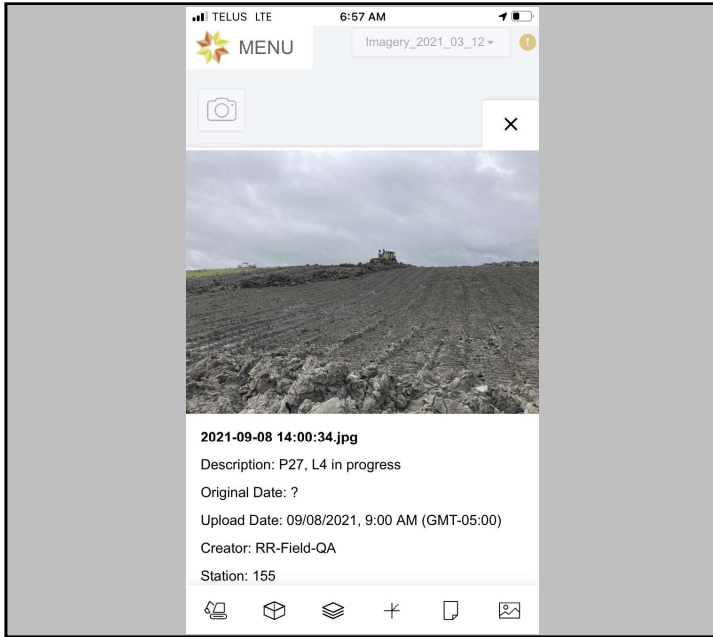
Photo #: 1

- Lift placement continued in the morning until rain resulted in wet conditions and pooling water on the exposed areas of L3. At this time CQA made the recommendation that construction be halted due to the material being too wet to place or cover without L3 being track packed or scraped. Due to the conditions the dozer operator began pushing material to the bench for placement when construction resumes until being moved to another job.

- P27, L4 placement in progress

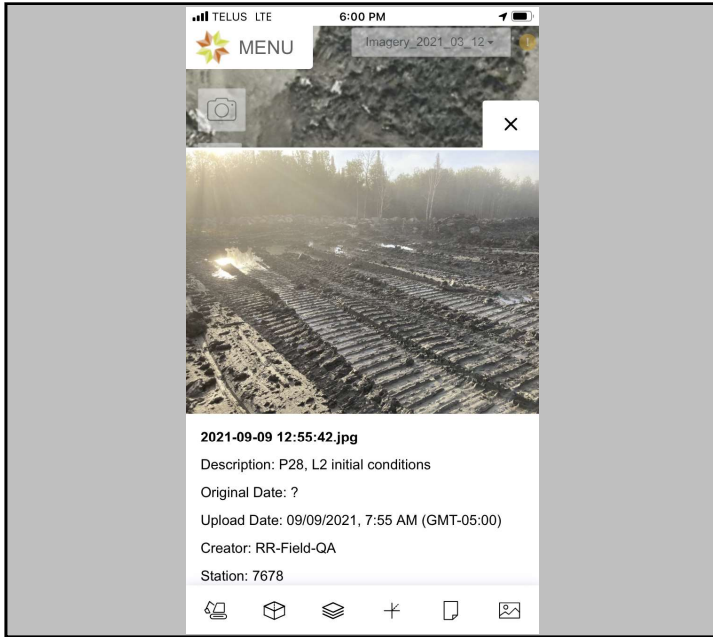
Photo #: 1

P27 & P28:  
- Previous days rain resulted in wet conditions and pooled water on both panels. The material was given time to dry while the dozer pushed material to the benches of both panels for later NCL use.

- P28, L2 morning conditions

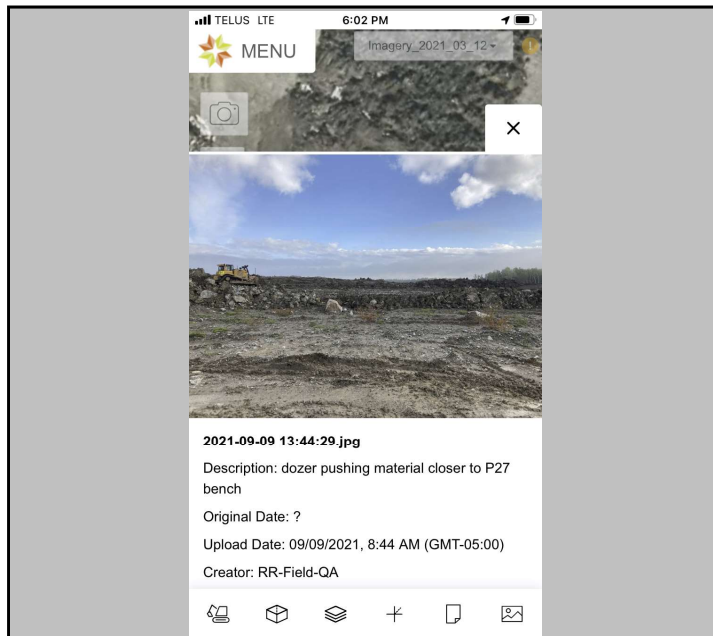
Photo #: 3

- Dozer pushing material to P27 bench

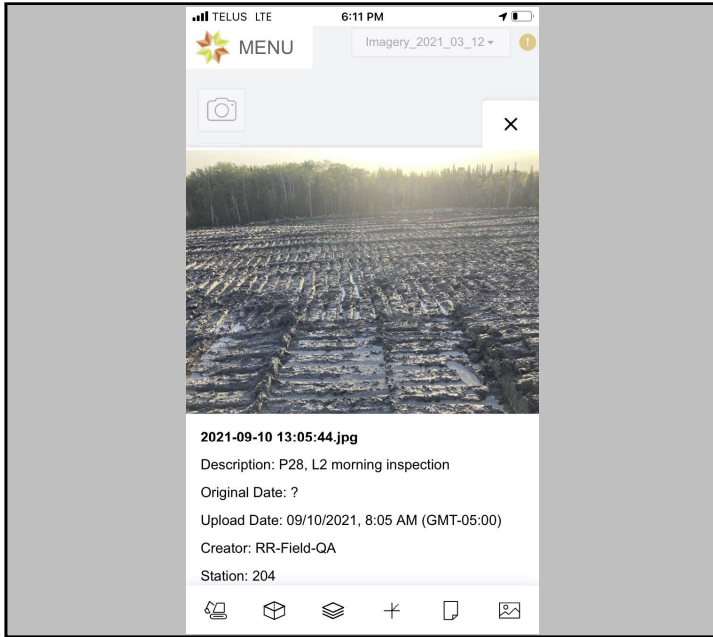
Photo #: 1

- P28, L2 morning conditions

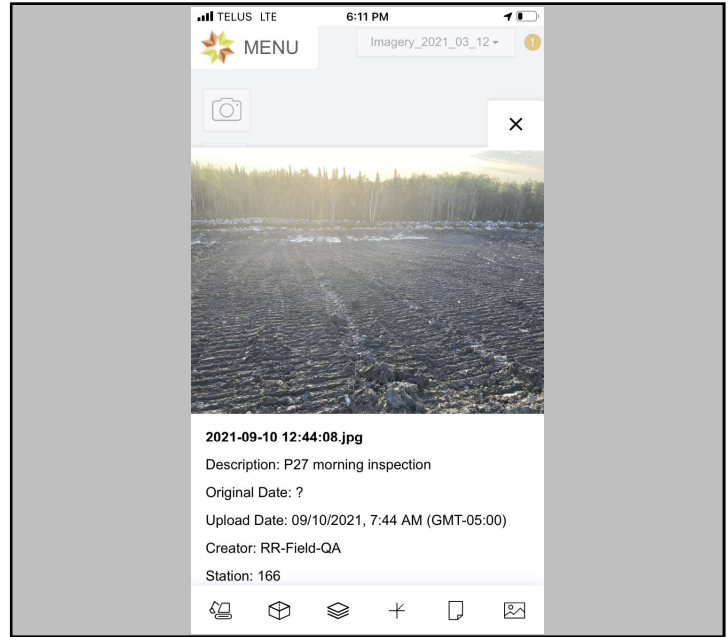
Photo #: 2

- P27, L3 morning conditions

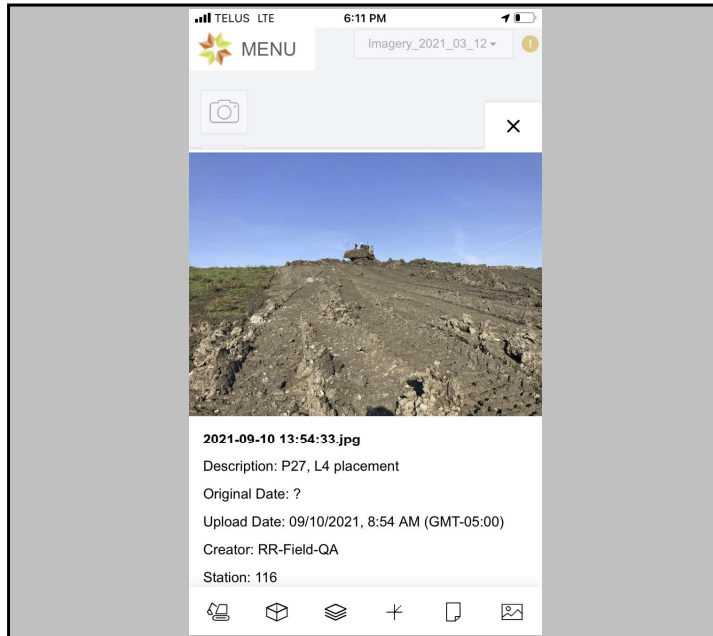
Photo #: 3

- P27, L4 placement

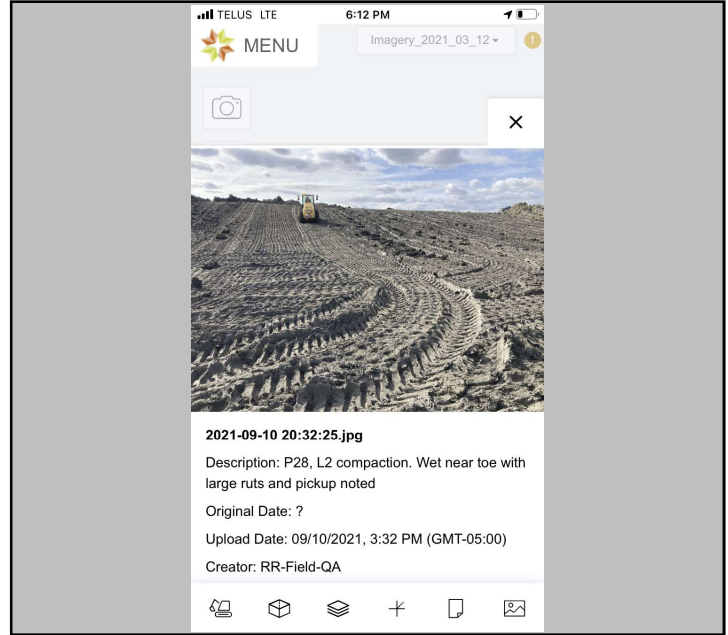
Photo #: 6

- P28, L2 comaction. Wet conditions near the toe with large ruts

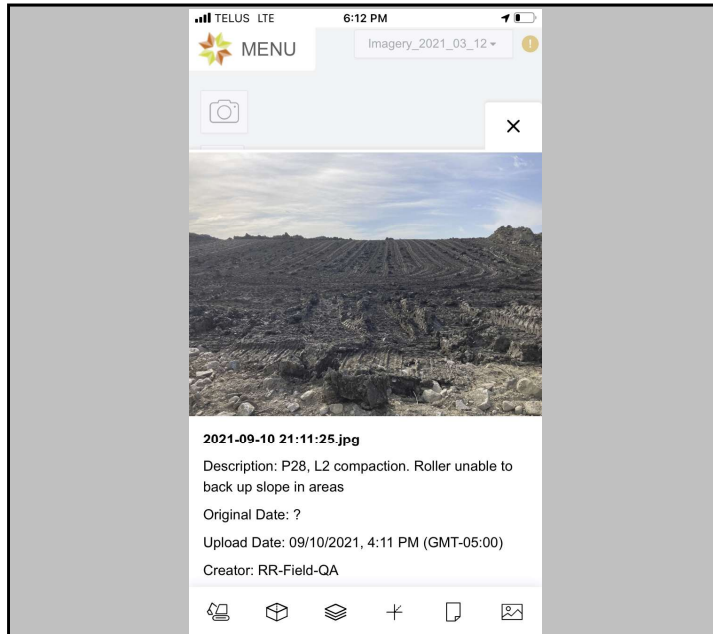
Photo #: 7

- P28, L2 compaction. Roller unable to back up the slope in areas

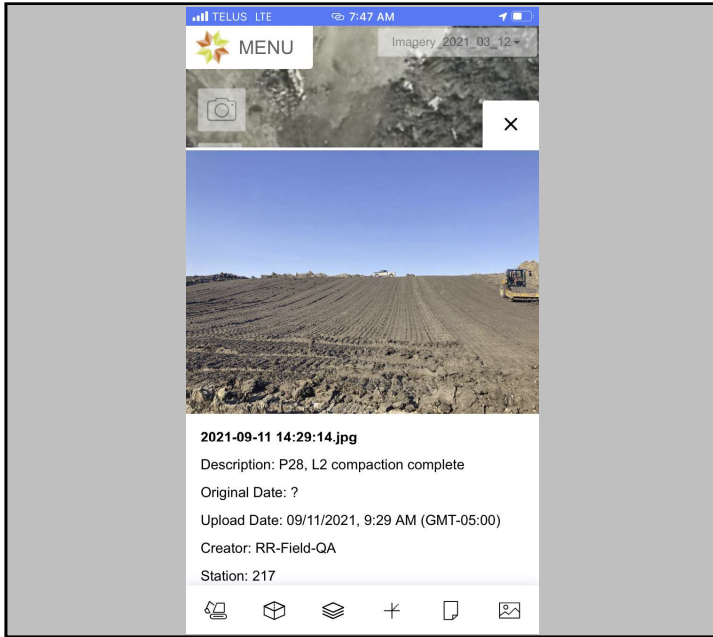
Photo #: 1

- P28, L2 compaction complete

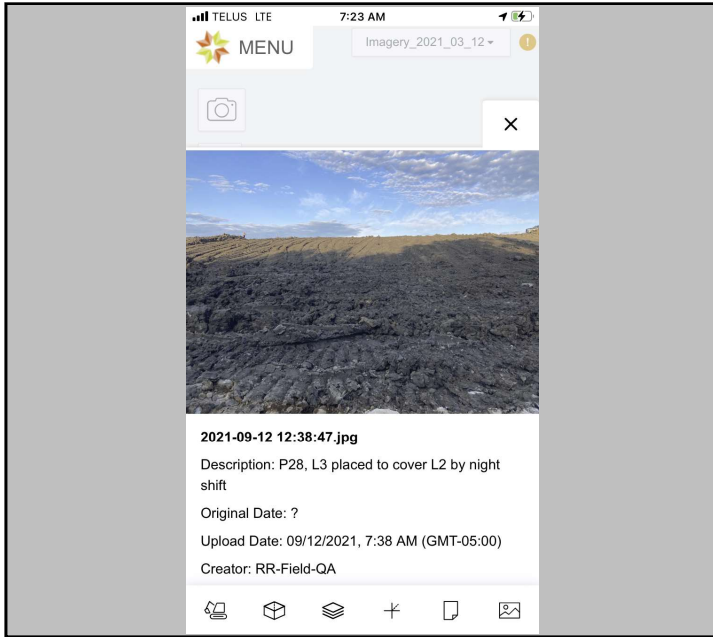
Photo #: 1

- P28, L3 thin layer completed by night shift to avoid desiccation

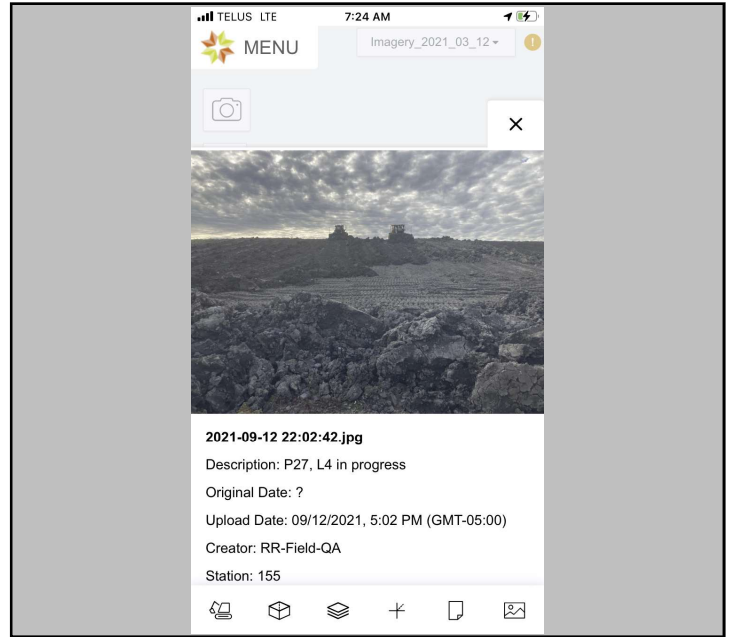
Photo #: 6

- P27, L4 in progress

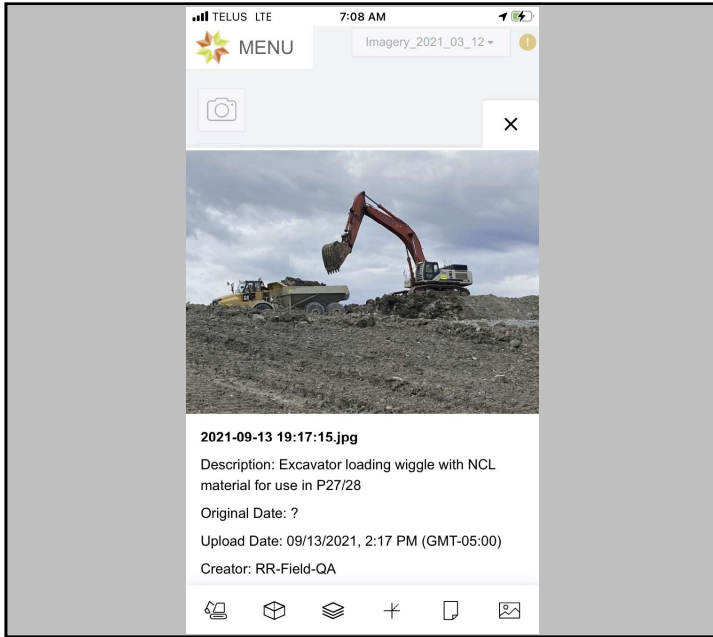
Photo #: 1

- Excavator loading trucks with NCL material for panels 27 &28

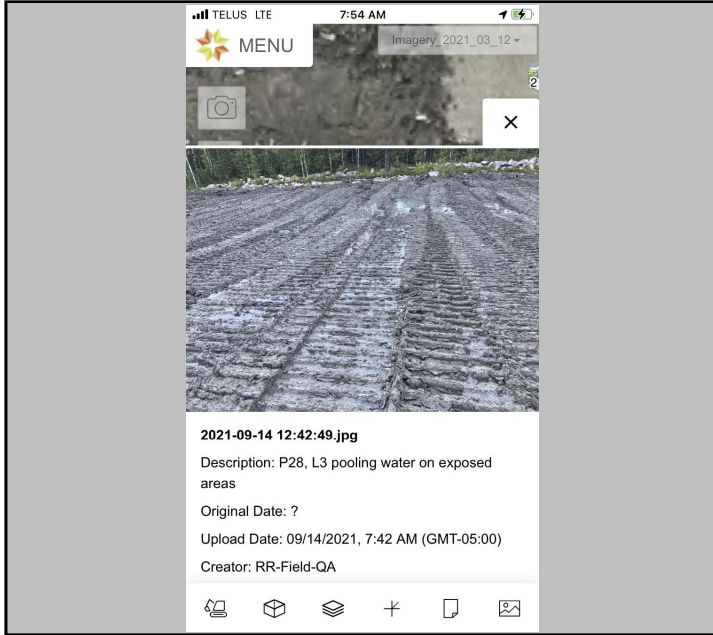
Photo #: 1

- P28, L3 morning conditions

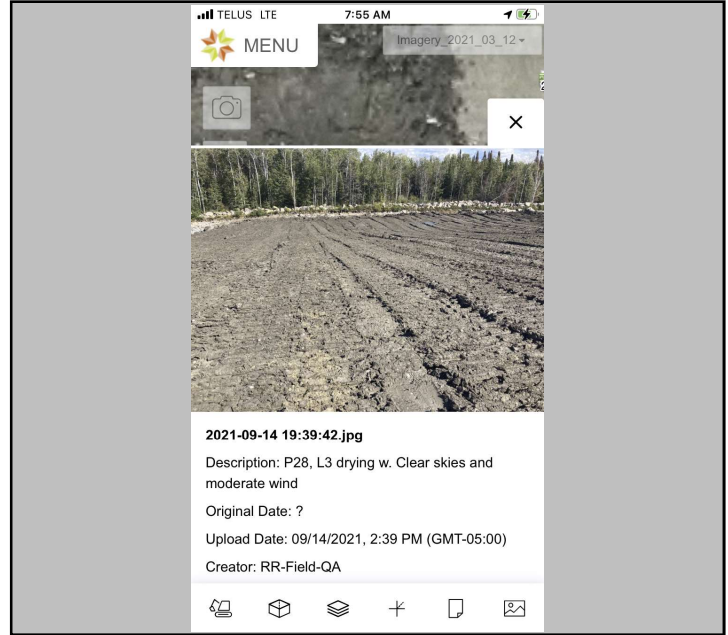
Photo #: 2

- P28, L3 drying with clear skies and moderate wind

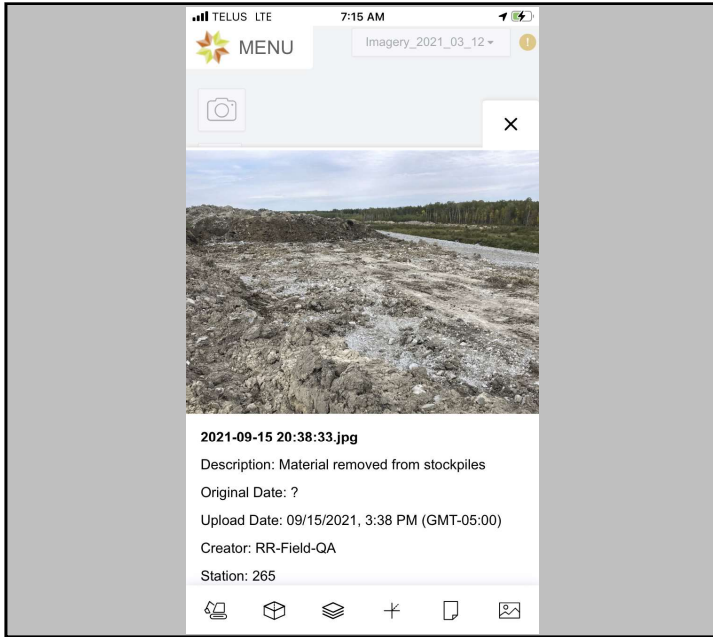
Photo #: 1

- Material removed from stockpiles

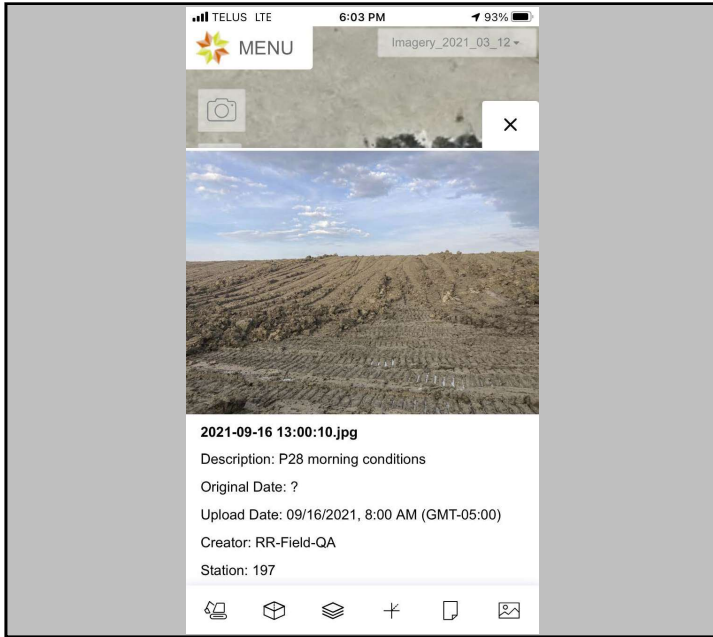
Photo #: 1

P28 L4 in the morning

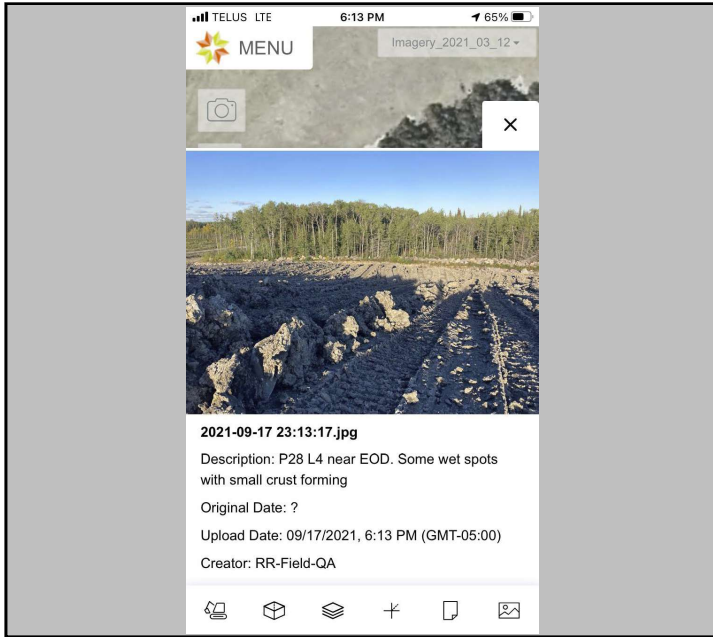
Photo #: 1

P28 L4 near EOD. Pooling in low spots with thin crust forming on surface

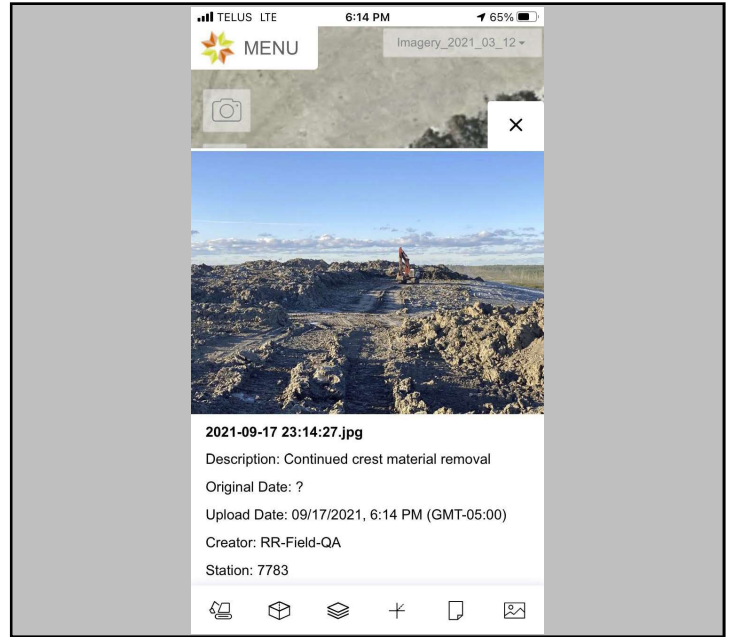
Photo #: 2

Continued removal of crest material

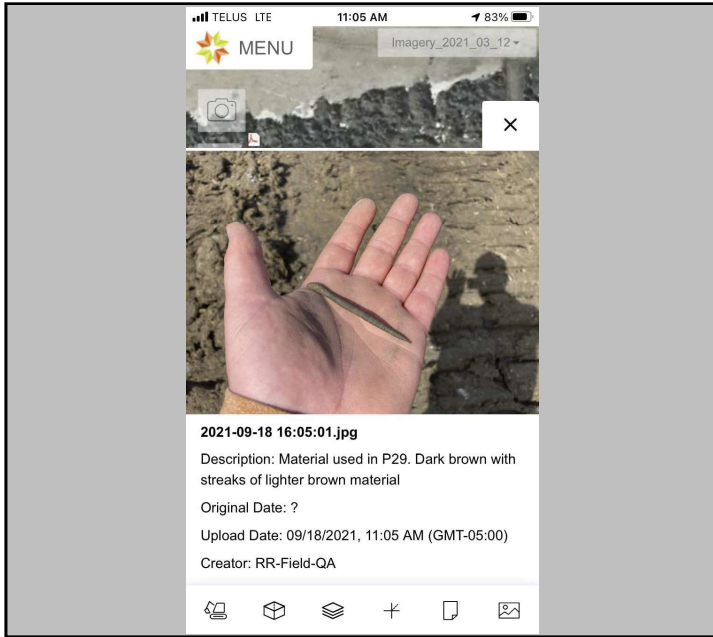
Photo #: 1

P29 L1 material was dark brown with streaks of lighter brown material in it

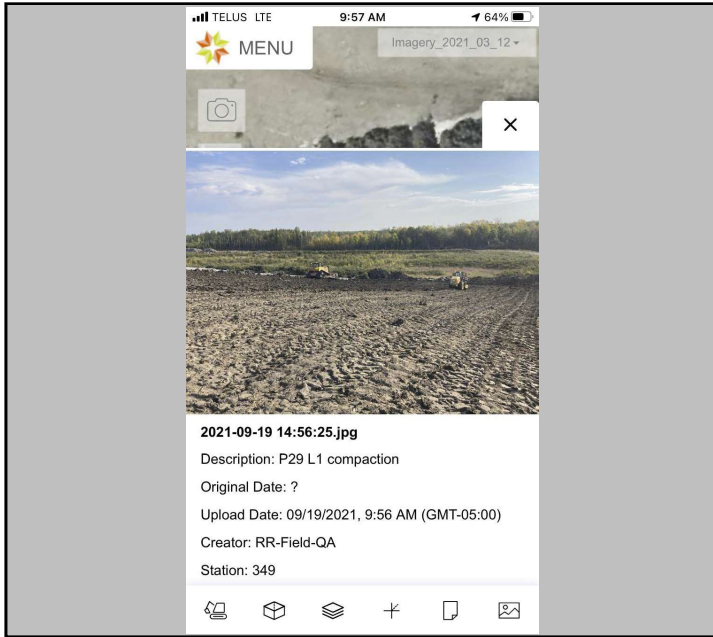
Photo #: 1

P29 L1 compaction

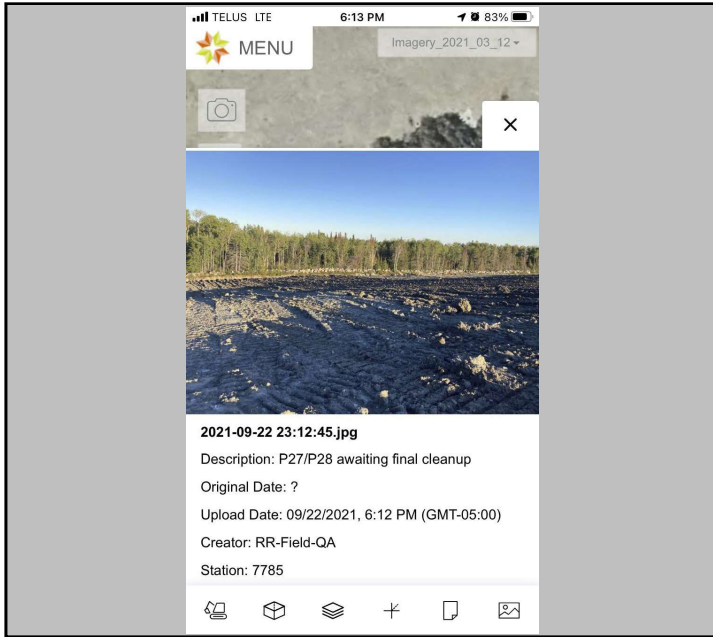
Photo #: 1

P27/P28 awaiting final cleanup. Placement complete
