**PHOTOGRAPHS**

<b>Date:</b>	August 25, 2021	<b>Owner/Client:</b>	New Gold Inc.
<b>Day:</b>	Wednesday	<b>Okane Project #:</b>	1003-027
<b>Prepared by:</b>	Blake Weinrauch	<b>Project Location:</b>	Ontario

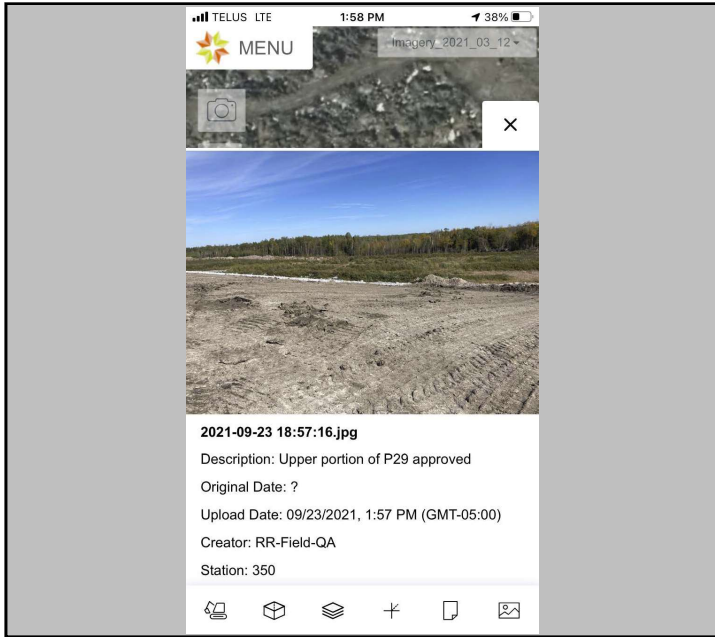
Photo #: 1

Upper portion of P29 L2 approved

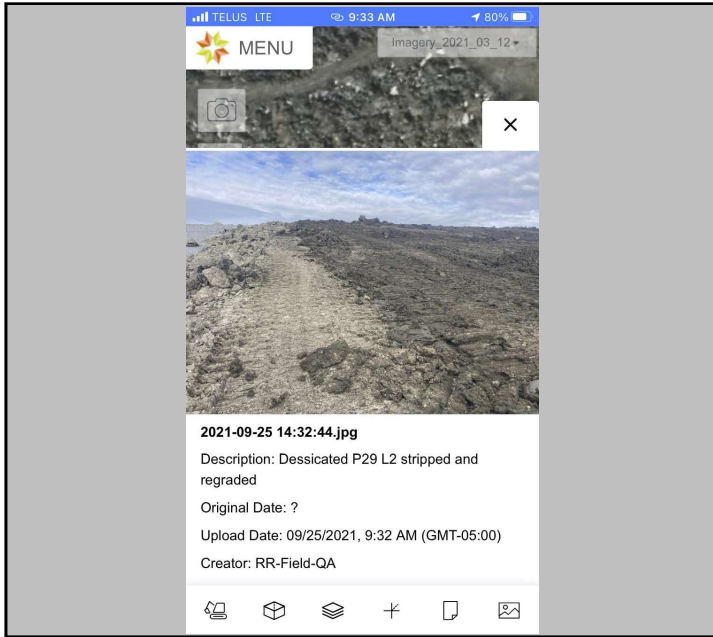
Photo #: 1

Dessicated P29 L2 stripped and regraded

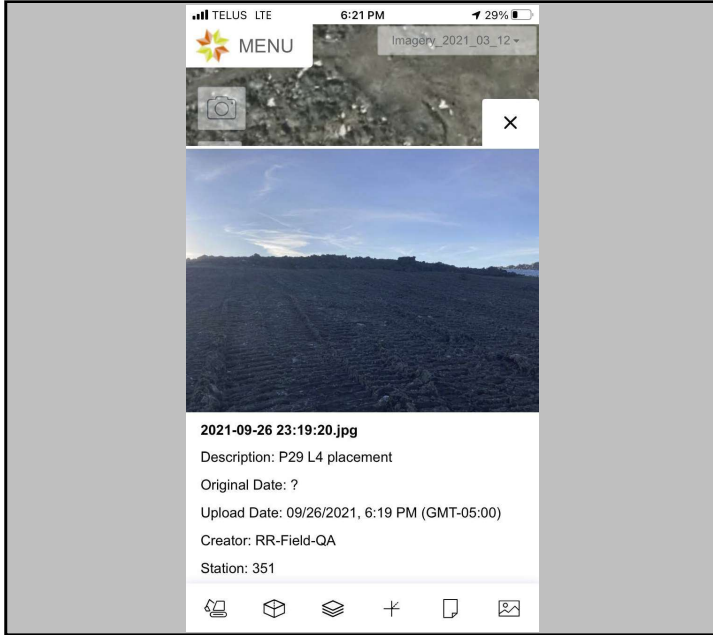
Photo #: 1

Dessicated P29 L4 placement

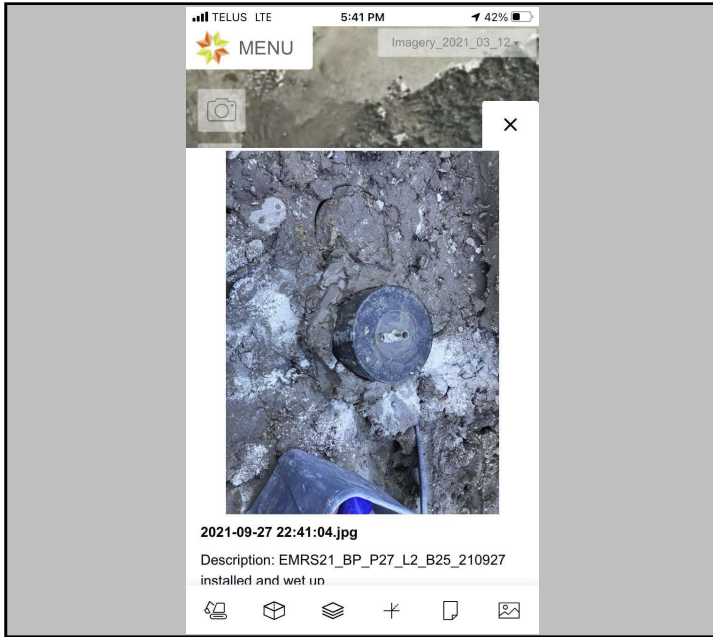
Photo #: 1

Borehole permeameter B25 installed and wet up

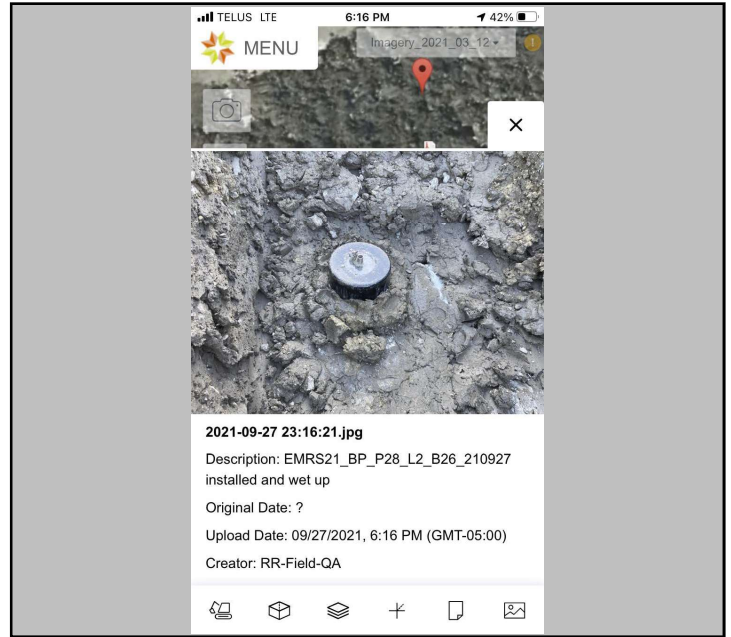
Photo #: 2

Borehole permeameter B26 installed and wet up

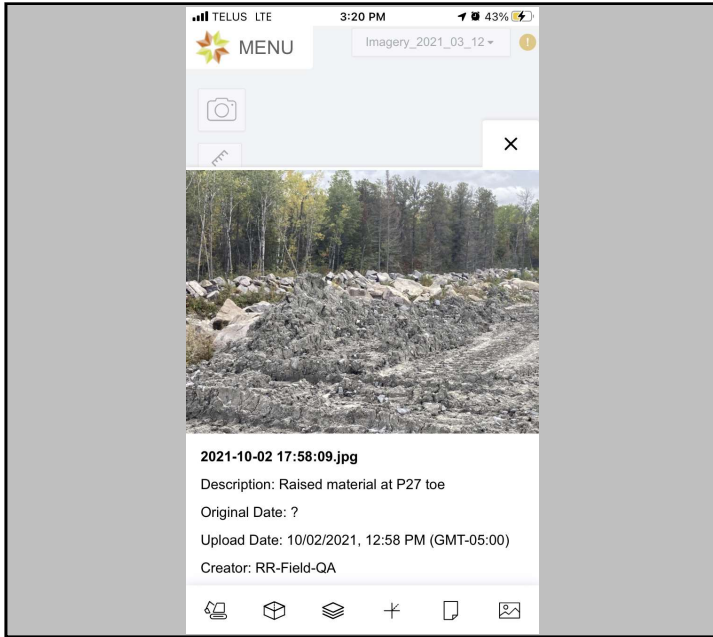
Photo #: 1

Raised material at P27 toe

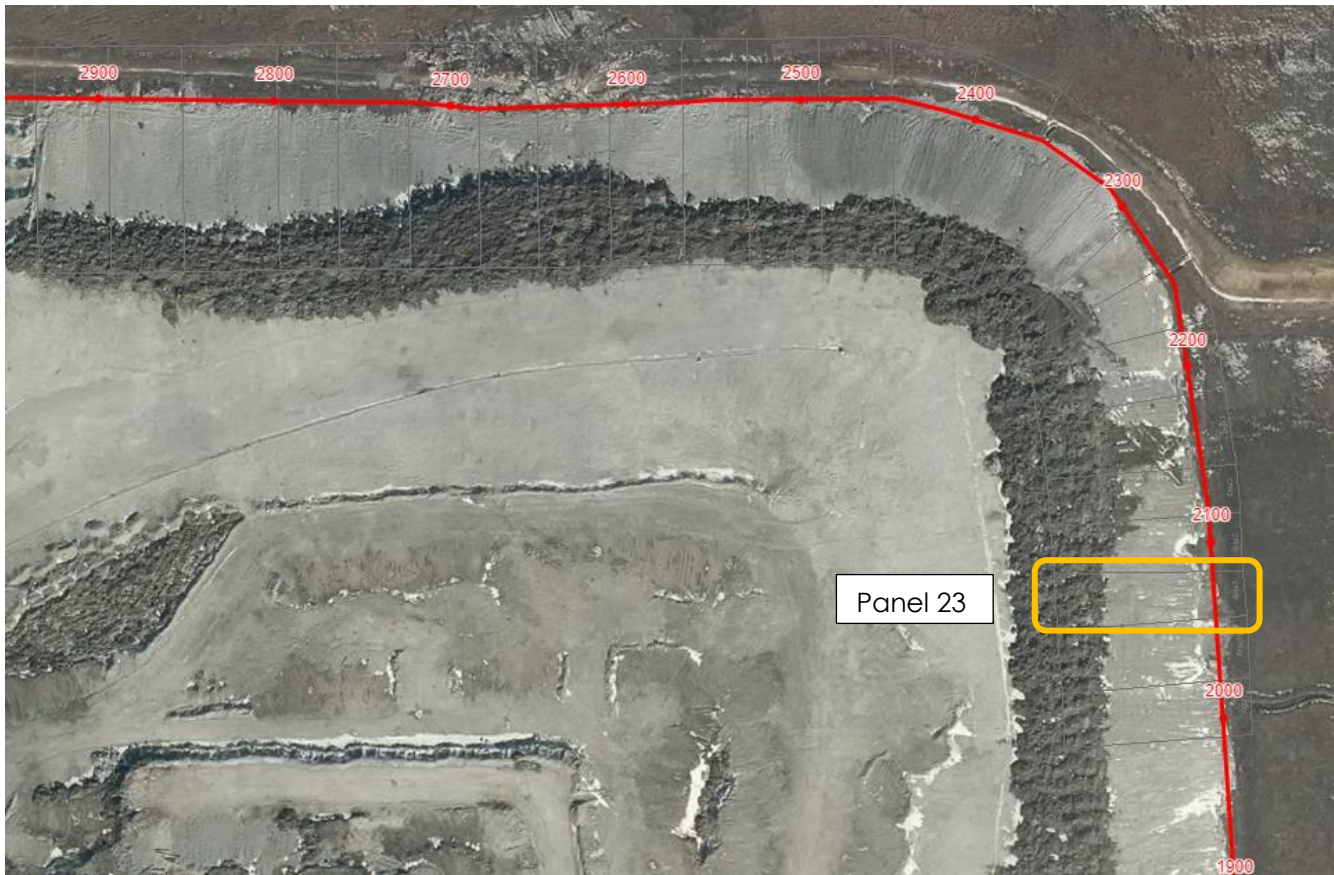
**Figure 2: EMRS Panel 23 plan view.**

The Northeast corner of the EMRS, Panel 23 (2+085 – 2+055) was flagged for hydraulic conductivity testing due to the material being sourced from multiple locations, concerns over the quality of the material in areas of the second stockpile location, and low moisture contents obtained during field testing of the second lift of the CCL (L2). Figure 2 illustrates the location of Panel 23. During the construction of Panel 23 (P23), L2 material was sourced from a new location within the stockpiled borrow source (Station: 1+404.4, O/S: -794.7) west of EMRS21-PR-ST-S404-210805. The material from this new location appeared drier with an increased amount of rock. Construction was halted while CQA, CQC, and New Gold met to inspect the new borrow area after concerns over the quality of the material were brought up by both Okane and Tulloch. After a brief meeting the decision was made by New Gold to return to

the previous borrow location (used for P23, L1) to utilize the remaining material. Approximately one third of the lift was constructed with material from the new location.
