McNab Creek Project:
Blocks G063C3UW, G053C39P–A, B, C
and Associated Access Roads
Terrain Stability Assessment Report

McNab Creek Area
(Sunshine Coast Forest District)

January 15th, 2013

Type of Assessment: Terrain Stability, Hazard and Partial Risk Assessment

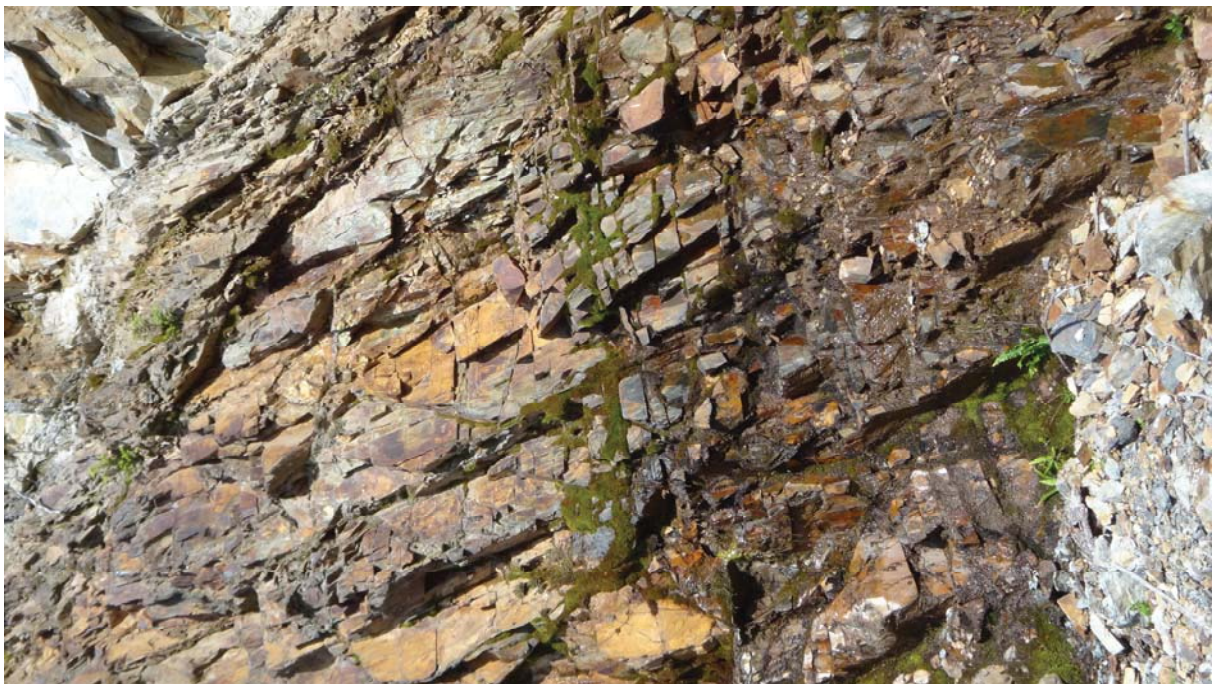
Rock types within the study area are quartz diorite intrusives belonging to the Middle Cretaceous Coast Plutonic Complex and marine sediments and volcanic rocks of the Lower Cretaceous Gambier Group. The rock types observed in the northern area of G063C3UW are weakly to moderately fractured quartz diorites. The rocks in the southern area of G063C3UW and in the operations area of G053C39P-B and C were fractured siltstones, slates and meta-argillites intercalated with volcanic rocks.

Photo 1: Rock below Block G053C39P-B in the FC B9 vicinity along existing road 2311-047.

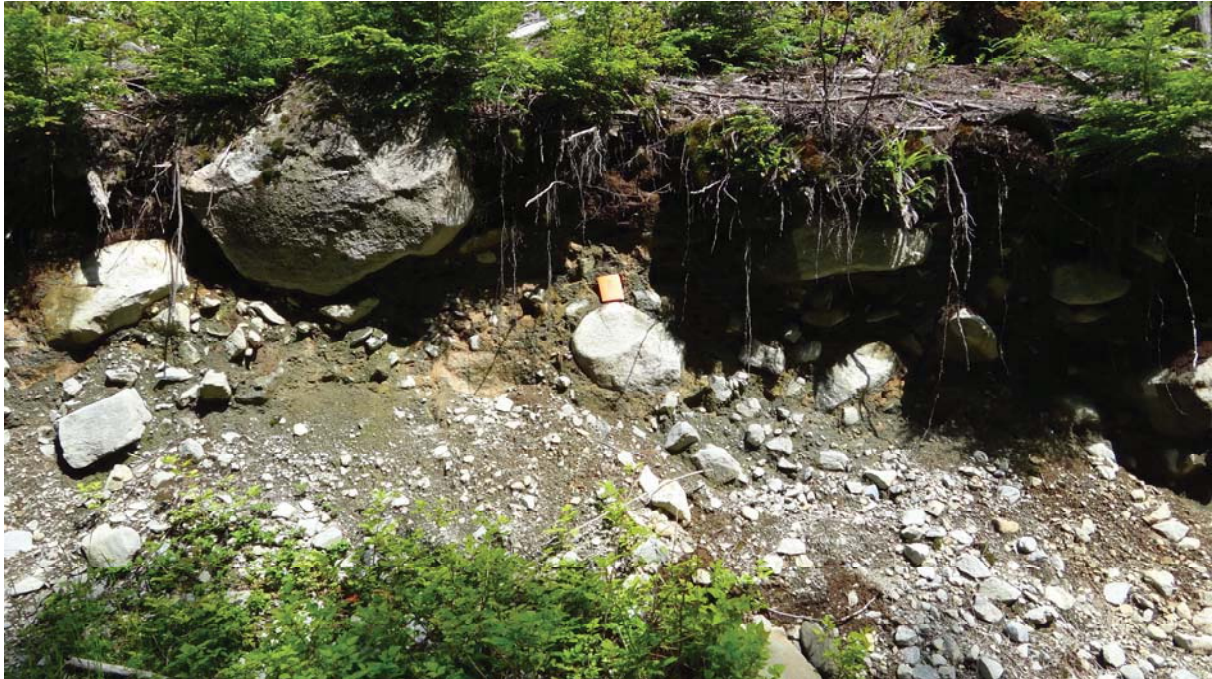
Photo 2: G063C3UW area, 2620 cutbank soils: variable thick till and colluvium.

The till is exposed intermittently in the local road cuts. The till tends to be of blanket thickness of up to 3m in the lowermost study area elevations. This unit thins upslope to veneer thickness and at the uppermost elevations, is absent. The till is composed of approximately 5% to 10% cobble to rubble material, 10% gravel, 25% to 30% sand, 30% to 45% silt and 10% clay (visually estimated). This unit is moderately dense (semi-compact, basal till) and was observed to hold up moderately well in existing cutbanks.

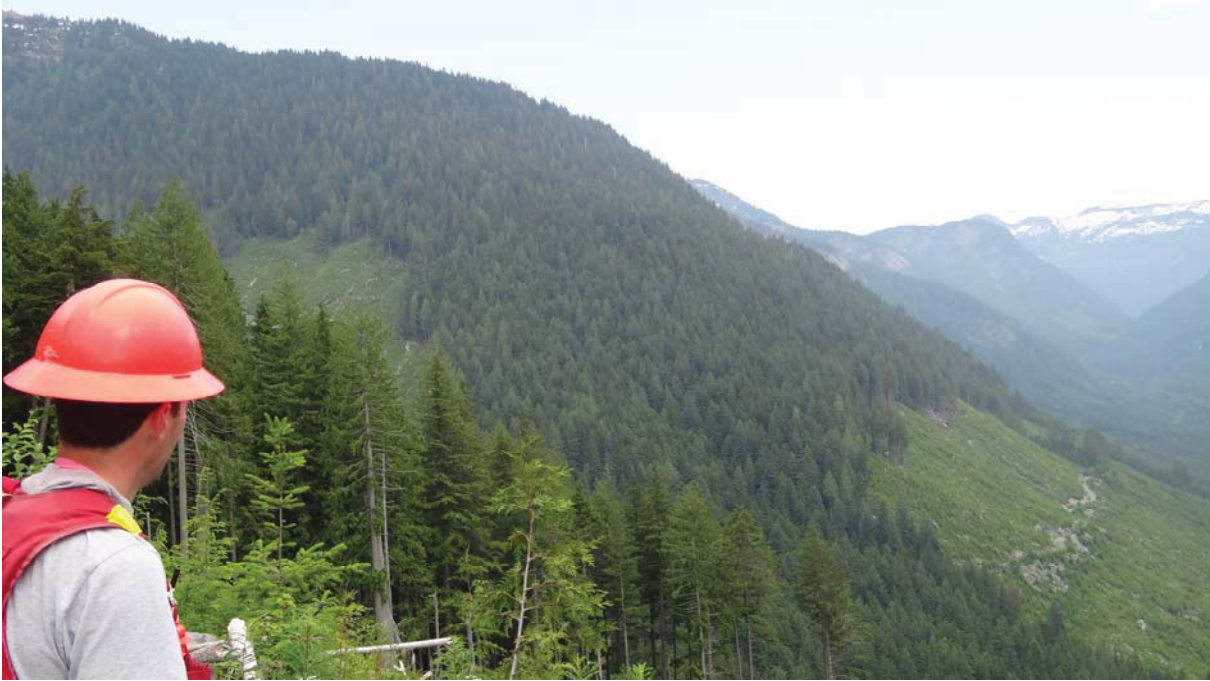
Photo 3: View from 2311-047 looking at slopes within proposed block G063C3UW.
