DATE March 27, 2013**REFERENCE No.** 1114220046-516-TM-Rev0**TO** Derek Holmes, Operations Manager
BURNCO Rock Products Ltd.**CC** Mark Johannes, Fred Shrimmer**FROM** Neil Goeller, Rowland Atkins**EMAIL** ngoeller@golder.com
ratkins@golder.com**ASSESSMENT OF AVULSION RISK ON MCNAB CREEK, BC**

This technical memorandum summarizes the findings of an assessment of the potential avulsion risk in the lower reaches of McNab Creek.

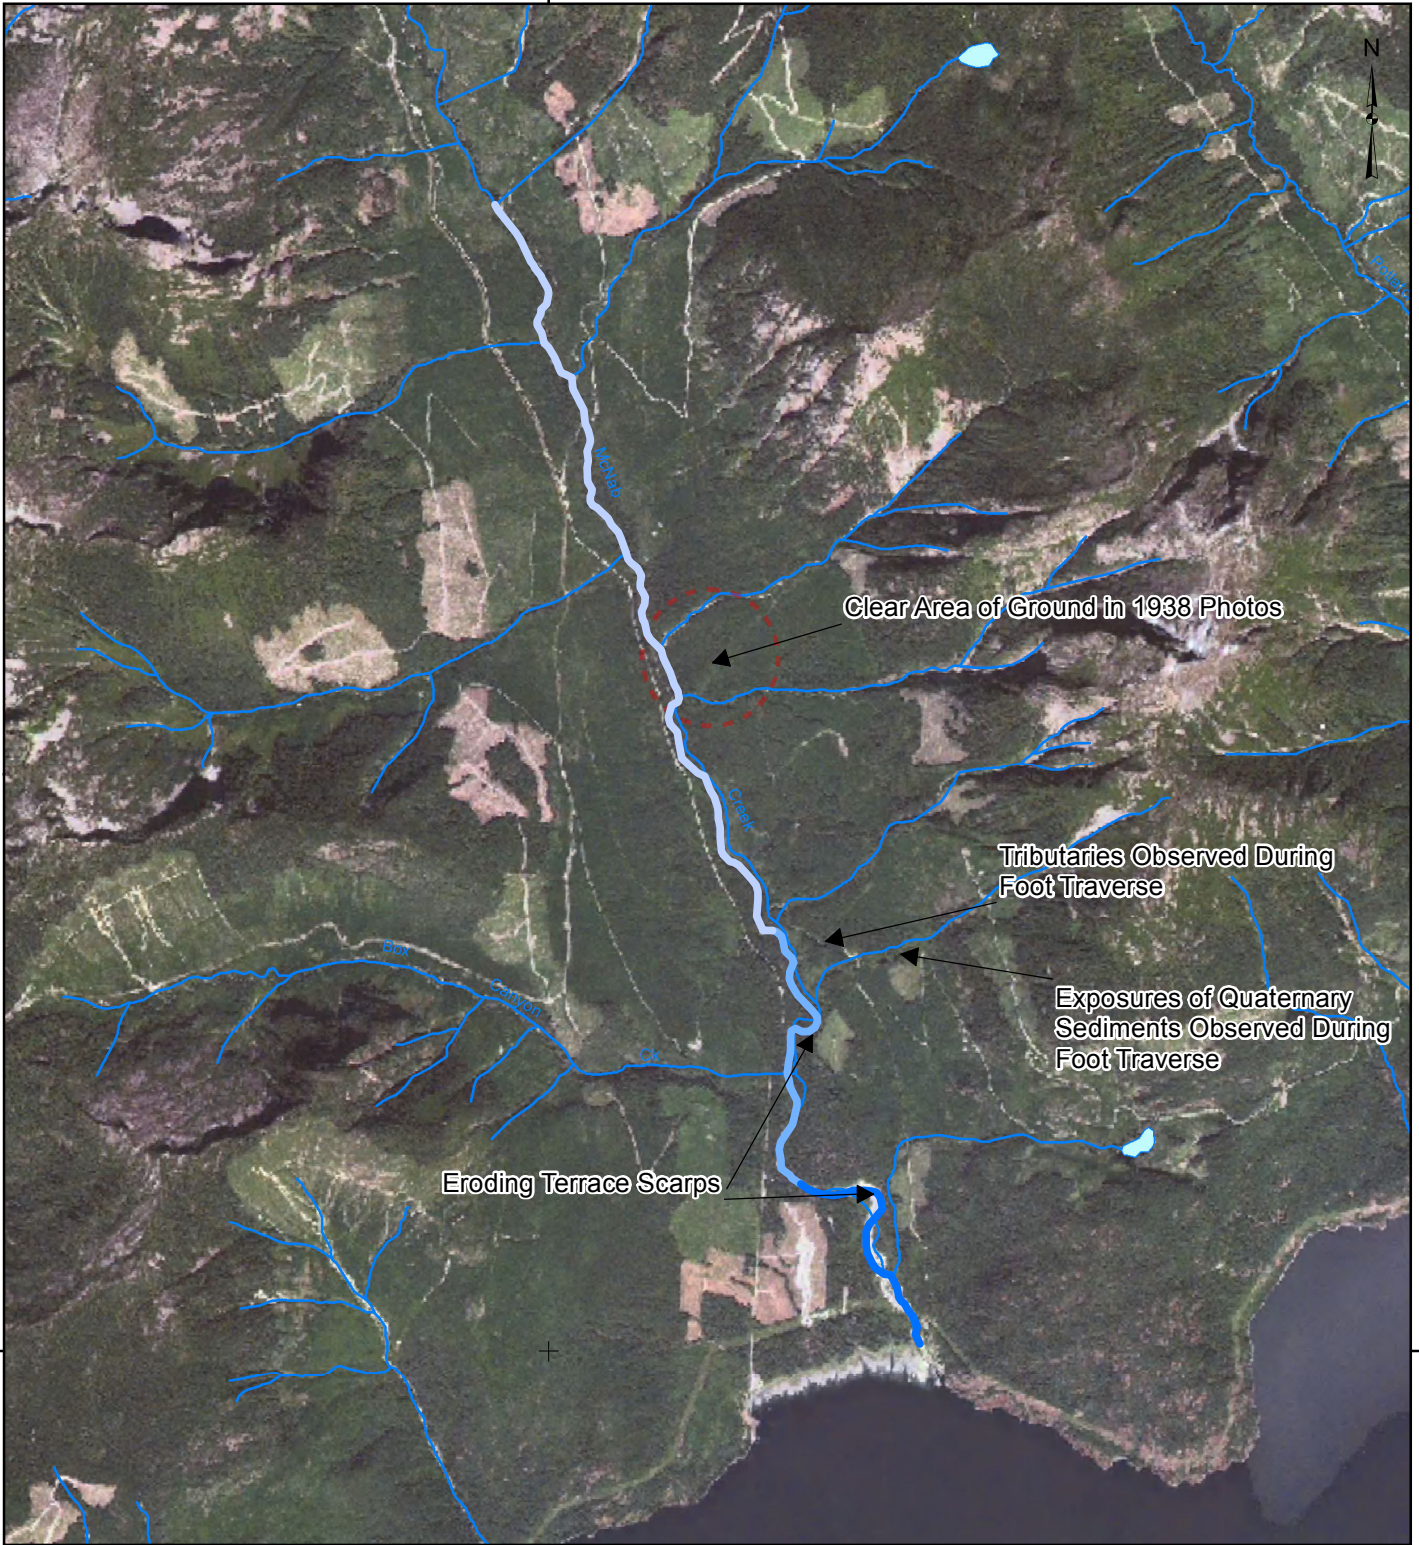
PROJECT No. 09-1416-0004			PHASE No. 3100	
DESIGN	NG	08OCT10	SCALE AS SHOWN	REV. 0
GIS	KG	08OCT10	FIGURE 2	
CHECK	NG	27MAR13		
REVIEW	RA	27MAR13

A clear patch of ground is visible in the 1938 air photos in Reach 1 (Figure 2). This clear patch of ground is estimated to be about 25 acres in area and is located downslope of several steep gullies; the fan-like shape is reminiscent of landslide deposit(s). A linear feature on the west side of the valley is interpreted to be a road. This feature appears to link to the clear patch of ground and suggests the area may be a harvested area. The colour and texture of the terrain in this area in the 1953 photos suggests that the interpretation of the area being a clearcut is more likely to be correct.

The helicopter reconnaissance of the McNab Creek valley covered McNab Creek to approximately 10 km north of the mouth, Box Canyon Creek, a tributary to the north of Box Canyon Creek and three tributaries on the east side of the valley (Figure 2).

A number of small landslides were observed during the helicopter flight. These landslides originated on the steeper upper valley walls in the McNab Creek valley and in Box Canyon valley. The landslides were observed to terminate on the lower, shallower slopes, terraces and valley floor without reaching the main channel. The flatter lower slopes appear to cause the landslide sediment to lose momentum and be deposited before reaching the main channel.

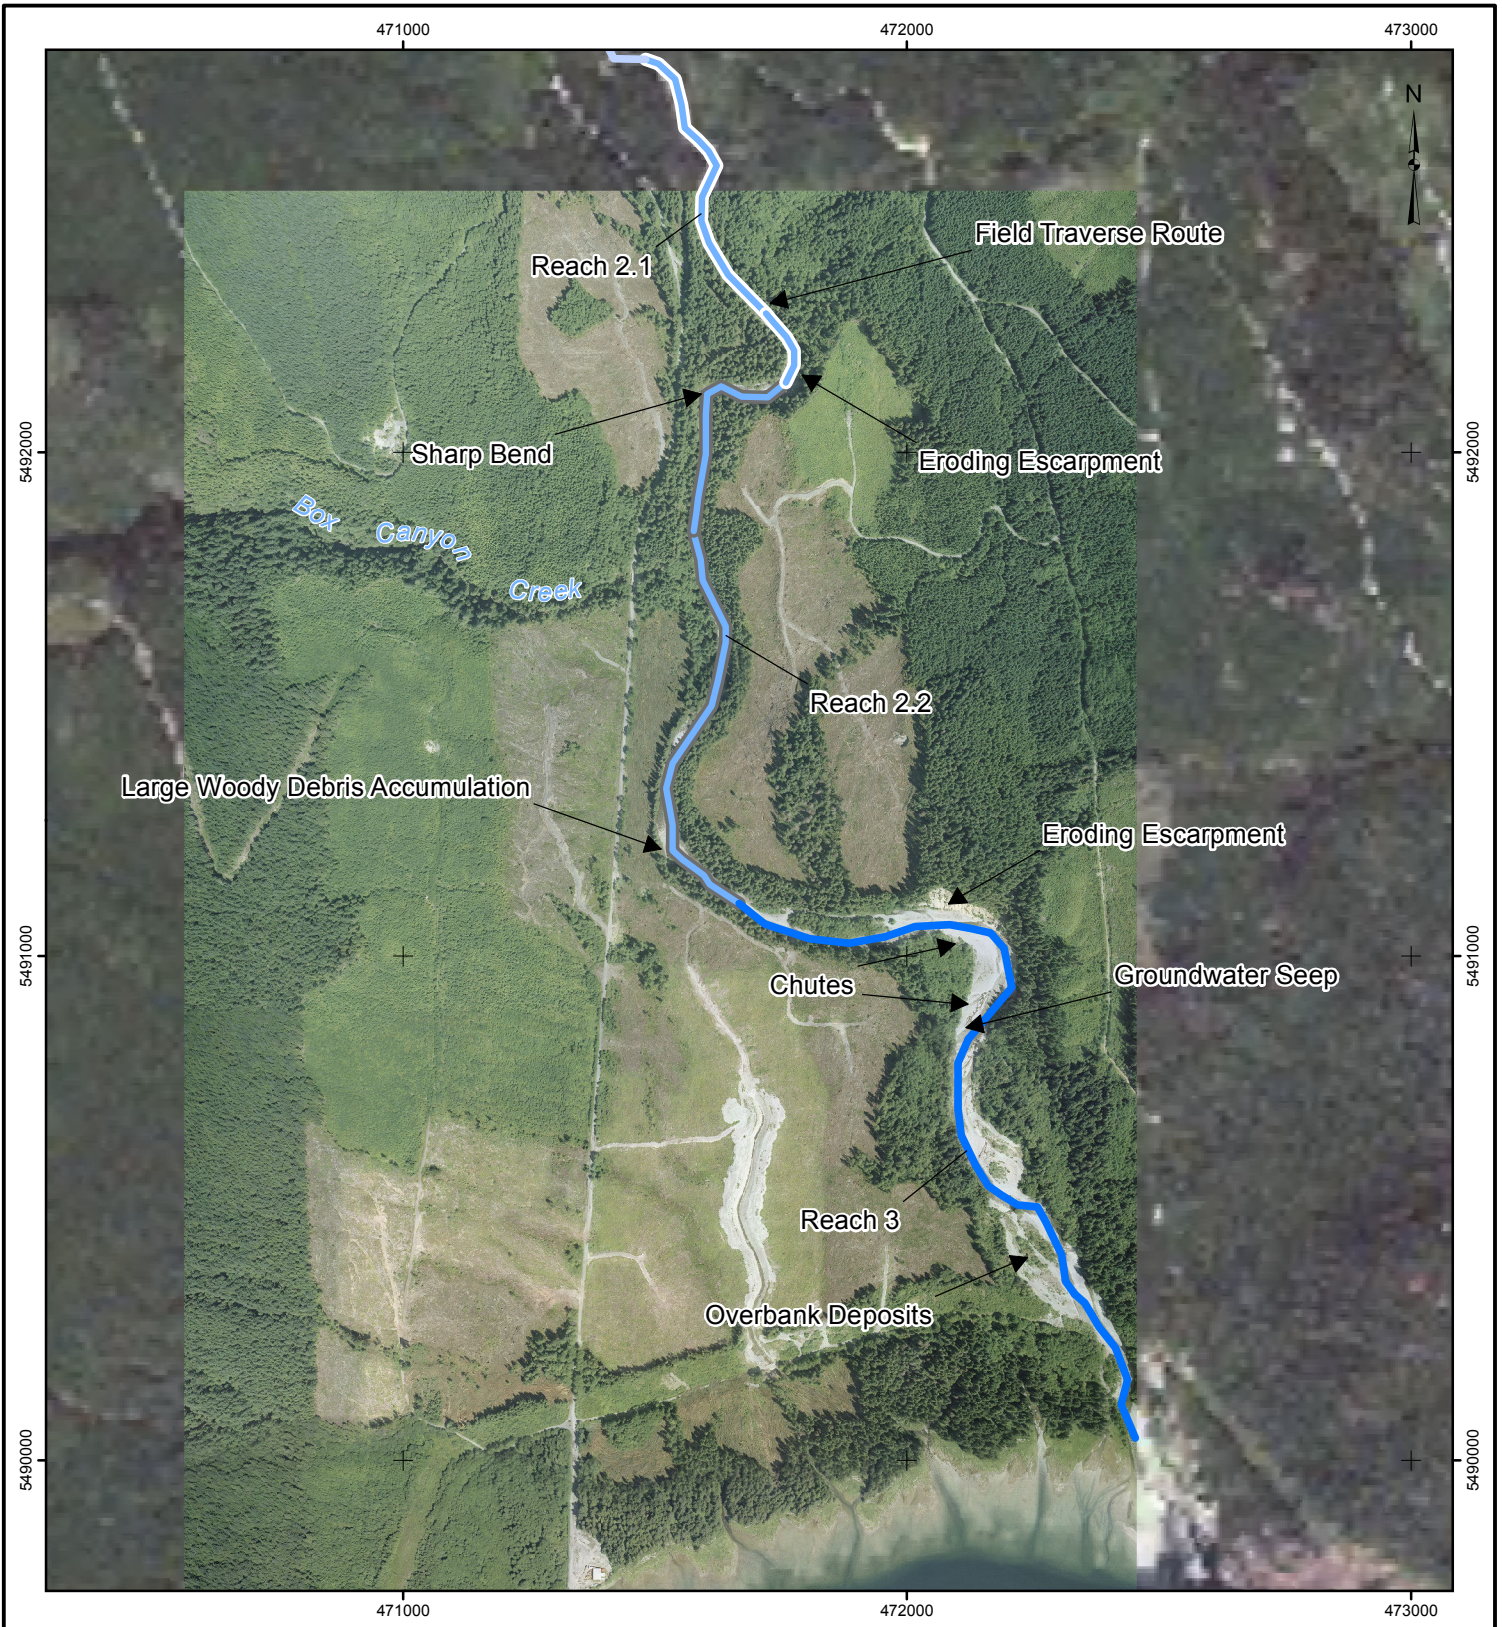
PROJECT No. 09-1416-0004			PHASE No. 3100	
DESIGN	NG	08OCT10	SCALE AS SHOWN	REV. 0
GIS	KG	12OCT10	FIGURE 3	
CHECK	NG	27MAR13		
REVIEW	RA	27MAR13

In Reach 1, more than approximately 3.5 km upstream of the mouth, the stream tends to be deeply incised into the valley floor sediments (Figure 3). Channel migration is constrained by the narrower valley. Downstream, McNab Creek flows across an increasingly broad, terraced valley floor (Figure 3, Reach 2) before flowing across the relatively flat McNab Creek fan-delta. The fan-delta appears to encompass the lower 1.6 km of McNab Creek (Figure 3, Reach 3).

In Sub-Reach 2.2, the channel is moderately incised into valley fill sediments flanked by terraces with stream banks ranging in height from 2 to 4 m (Figure 3). The composition of the bed material at the upper end of Sub-Reach 2.2 is similarly coarse to the bed material observed in Sub-Reach 2.1; however, near the lower part of Sub-Reach 2.2, the typical boulder sizes have decreased to less than 0.5 m, with occasional larger (up to 1 m) boulders. In places the erosion of the stream bank material has resulted in an armouring effect by removal of the finer sediment where the coarser boulders and cobbles are left behind. This coarse material remains against the stream bank, producing a natural armouring effect, likely reducing the erosive effect of higher flows on the stream banks (Photo 3). The formation of longitudinal bars is more pronounced through this sub-reach than in Sub-Reach 2.1. A bar-like feature was observed to support some vegetation with an elevated bar surface approximately 1 to 1.5 m above the channel floor (Photo4). This bar may also be an erosional remnant of the valley-fill floodplain that is presently being reworked by the stream channel.

Outcrops of bedrock were observed intermittently along this sub-reach in the channel banks and floor. A relatively sharp corner in the channel was observed towards the upper end of this sub-reach (Figure 3). The channel is constrained by the bedrock outcrop which has forced the channel to turn sharply south. The snout of an accumulation of coarse sediment was observed just upstream of the corner (Photo 5). This sediment has likely stalled here before being carried around the corner under high flows; during waning flow, it is likely that the velocity of water just before the corner is not sufficient to move this material.

Further downstream the confluence of McNab Creek and Box Canyon Creek was observed (Figure 3). The sediments discharged by Box Canyon Creek appear to be finer than those of McNab Creek. Box Canyon Creek

In Reach 3 the channel is mildly incised into fan-delta sediments, with banks generally less than 1 m high (Figure 3). The size of the bed material is smaller, ranging from coarse gravel (~ 0.05 m) to small boulders (~ 0.4 m) with sand and gravel deposits observed on the bars. Several longitudinal bars were observed with established vegetation (Photo 7).

Downstream of the confluence with Box Canyon Creek an accumulation of LWD is present on the right hand bank of McNab Creek in conjunction with a small side channel (Photo 6, Figure 3). This LWD jam is located at approximately the upstream end of Sub-Reach 3.1 (Figure 4). The sediments in the side channel were mainly sand with some cobbles and gravel. Flow was observed in the side channel during the field visit. The presence of fine grained sediments (sand) in this side channel suggests that flow velocities are lower behind the accumulated LWD, resulting in the deposition of finer sediments under moderate flow. This sediment is likely eroded under higher flow and replaced during waning flow.

On the outside of the large right-handed bend in Sub-Reach 3.2 (Figure 4), the stream channel was observed to impinge on the toe of an escarpment (Figure 3). The stream was not observed to be in contact with the escarpment during the field visit. On the inside of the bend, several chutes were observed (Figures 3 and 4). Just downstream of the bend, a groundwater seep was observed emerging on the west side of the channel (Figure 3).

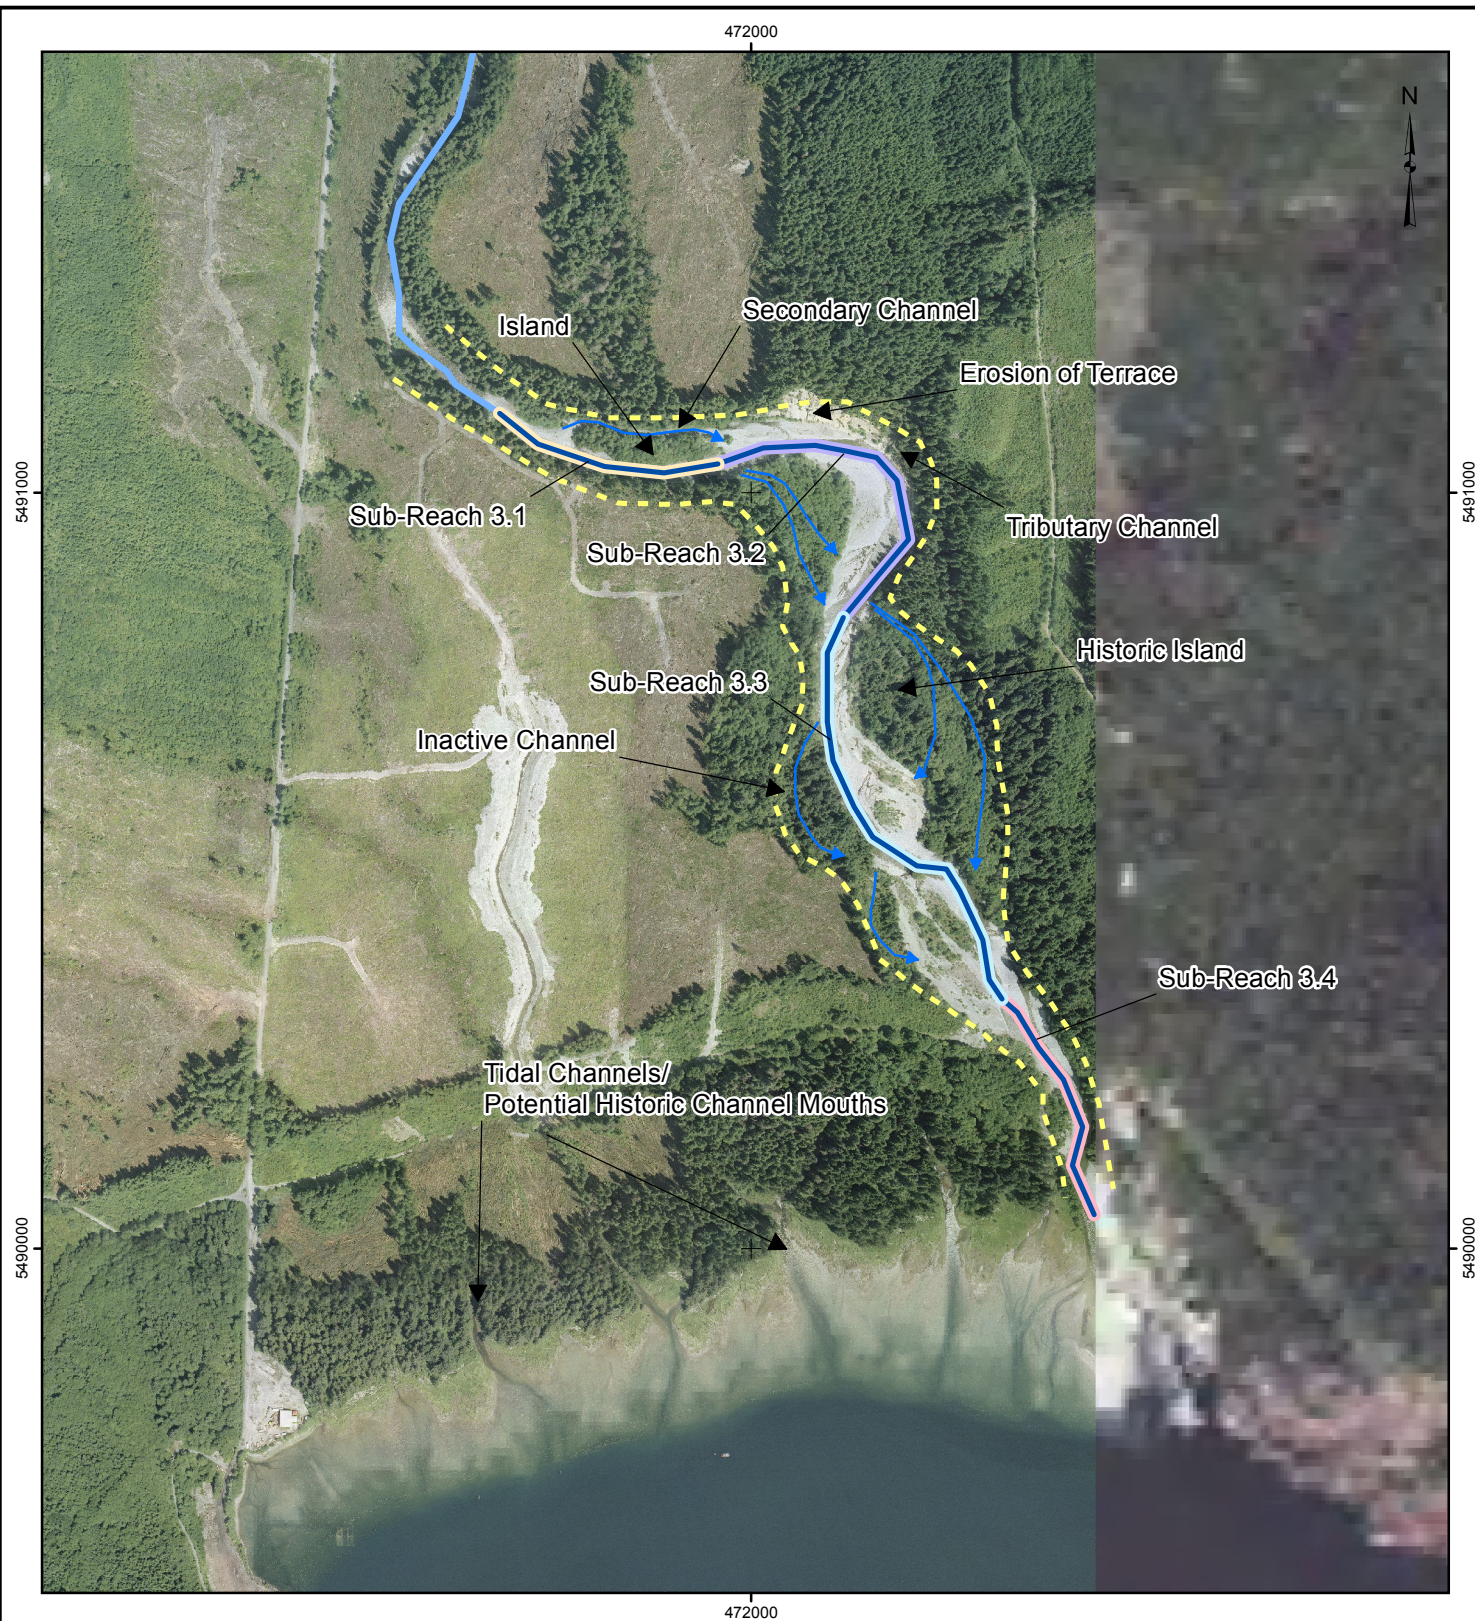
PROJECT	BURNCO ROCK PRODUCTS LTD. MCNAB VALLEY AGGREGATE PROJECT HOWE SOUND, B.C.		
TITLE	LOWER MCNAB CREEK		
	PROJECT No. 09-1416-0004	PHASE No. 3100	
	DESIGN NG 08OCT10	SCALE AS SHOWN	REV. 0
	GIS KG 12OCT10	FIGURE 4	
	CHECK NG 27MAR13		
	REVIEW RA 27MAR13

The lower 1.6 km of McNab Creek was divided into four sub-reaches. The four sub-reaches are described below (Figure 4). The approximate maximum extents of the channel margins observed in the air photo record for the lower 1.6 km are indicated in Figure 4.

In 1953, McNab Creek appears to occupy a single channel through Sub-Reach 3.1 including the large left-hand bend in the stream (Figure 4). By 1985 a secondary channel appears to have established to the north of the main channel, resulting in the formation of a vegetated island between the main channel and the north channel. The north channel is still present at the time of writing, based on foot traverse observations. The pair of channels appear to vary between 40 m and 60 m in width.

In Sub-Reach 3.2, the bend of McNab Creek appears to be eroding the toe of an escarpment as the creek migrates laterally to the northeast (Figure 4). This sub-reach includes the large right-hand bend in the stream. The active portion of the channel does not appear to be in contact with the escarpment at low flows, and erosion is likely limited to periods of higher flows.

A tributary is visible on the left bank in this reach (Figure 4). The tributary appears to have cut down through the terrace and be depositing material in the McNab Creek channel.

The field traverse of McNab Creek covered approximately the lower 3.5 km of the channel alignment (Figure 4, Reaches 2 and 3). The channel varied from a narrow, deeply incised cobble and boulder bed stream with bedrock outcrops to a broader, mildly incised, cobble bed stream. A general scarcity of fine grained sediment

As the channel broadens towards the mouth through Sub-Reaches 3.3 and 3.4, sediment was observed to have been deposited over the banks of the channel (Figures 3 and 4). These over-bank deposits were composed mostly of sand and coarse gravel, and some shrub vegetation has established on these deposits (Photo 8). Sparse LWD was observed to be deposited along these sub-reaches and near the mouth (Photo 8).

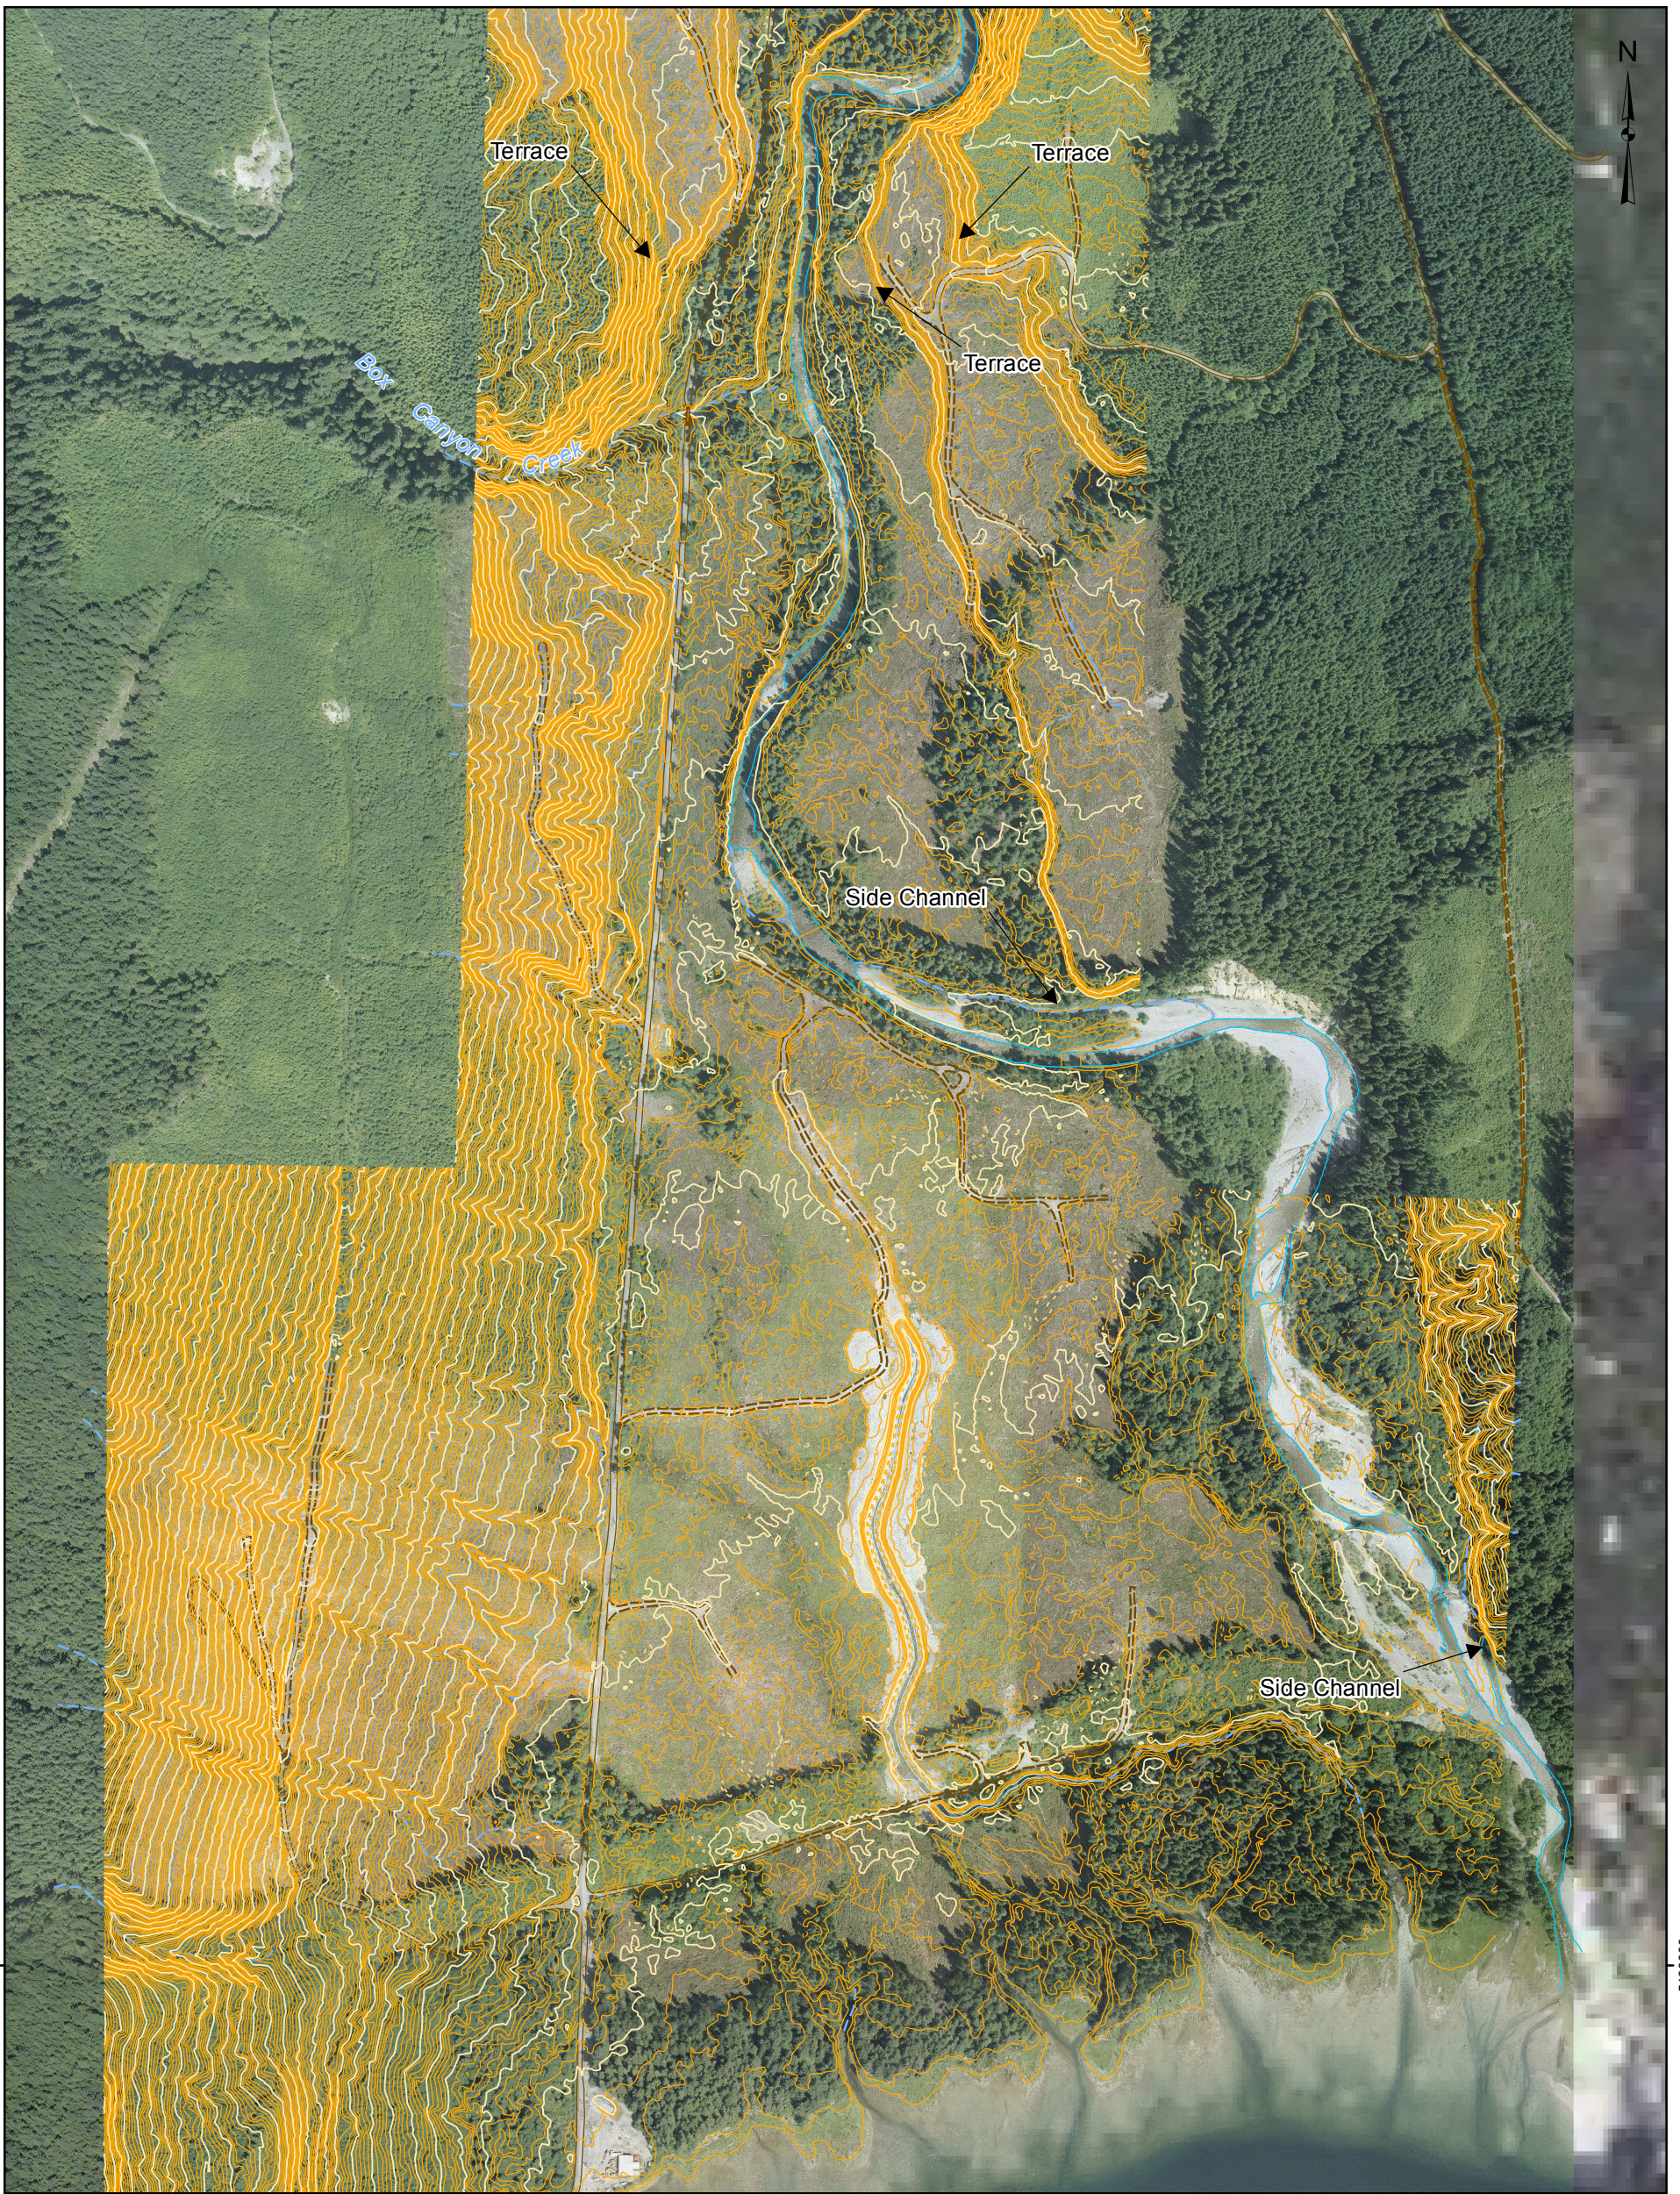
PROJECT		BURNCO ROCK PRODUCTS LTD. MCNAB VALLEY AGGREGATE PROJECT HOWE SOUND, B.C.	
TITLE		MCNAB VALLEY LIDAR SURVEY	
PROJECT No. 09-1416-0004		PHASE No. 6100	
DESIGN	NG	08OCT10	SCALE AS SHOWN
GIS	KG	11OCT10	REV. 0
CHECK	NG	27MAR13	FIGURE 5
REVIEW	RA	27MAR13

Between its mouth and a point approximately 1.6 km upstream (Reach 3), McNab Creek flows across a relatively low gradient fan-delta. Throughout this reach a number of side channels are visible adjacent to the existing channel (Figure 5). The side channels may be active during episodes of higher flow, but were mostly dry at the time of the field visit. Isolated shallow pools of standing water were observed in some of the side channels. No visible indications of historic main channels (e.g., oxbow lakes, abandoned chutes, channel-like depressions) were observed in the central and western parts of the fan-delta. The LiDAR dataset does not record terraced evidence of lateral migration in this reach. However, it is reasonable to assume that lateral migration of the channel in Reach 2 would have resulted in lateral migration of the channel in Reach 3 in order to maintain continuity of flow between reaches.
