## HERITAGE IMPACT ASSESSMENT

## Hammond Reef Gold Project 23 km Northeast of the Town of Atikokan Thunder Bay Mining District Northwest Ontario

Submitted to: Canadian Malartic Corporation 145 King Street East, Toronto, ON

Report Number: 1408383\_DOC005\_Rev 1 Distribution:

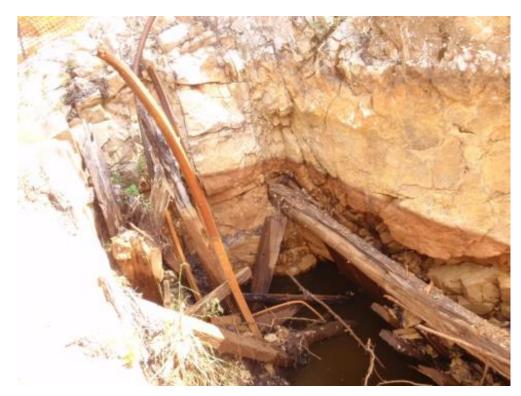
Figure 13: Main Shaft of Sawbill Mine (View North)

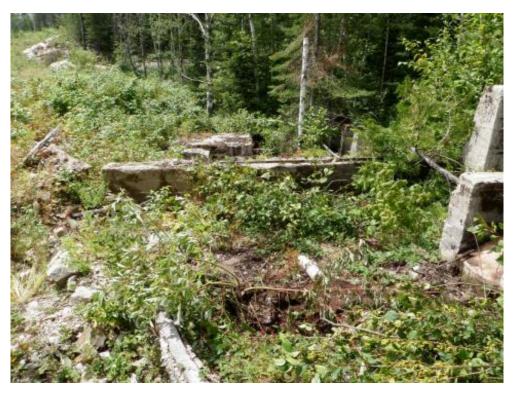
A concrete foundation approximately 20m by 30m with a 5m by 15m addition on the west side of the structure was located 20m to the east of the main mine shaft (Figures 14-15). The structure contains four concrete platforms stepped one below the other on the downslope from the main shaft. Several concrete pedestals and low walls with rebar projecting from the top were scattered throughout the structure (Figures 16-17). The concrete pedestals indicate that the building housed large mechanical equipment which required significant structural reinforcement to operate. One large rectangular pit was located in the northeast portion of the structure (Figure 18).

Figure 14: Northwest Corner of the Stamp Mill Foundation Looking along the South Wall of the Structure (View West)

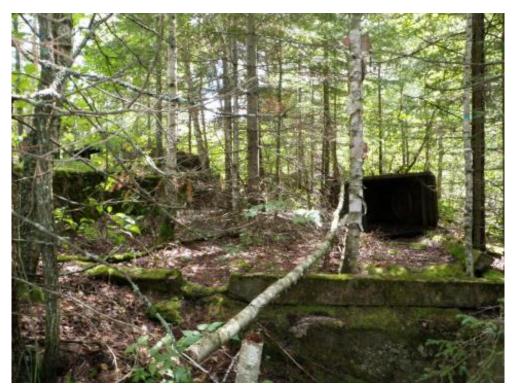
Figure 15: View of the Interior of the Structure from the Northwest Corner of the Stamp Mill Foundation (View South)

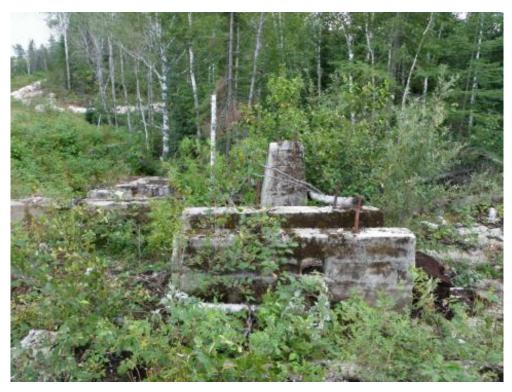
Figure 16: View of Southeast Corner of the Stamp Mill (View West)

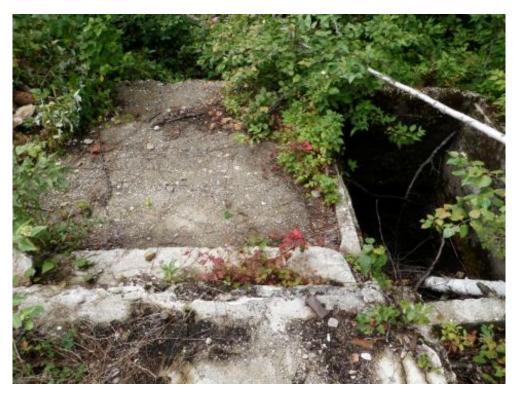
Figure 18: Concrete Tank to Right of the Concrete Slab in Northeast Portion of Stamp Mill Foundation (View East)

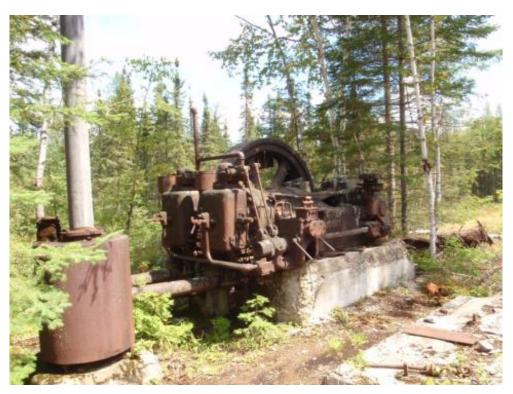
A large two-cylinder gasoline (or diesel) engine was located approximately 10m east of the main shaft (Figure 19). The engine was still located on its original concrete bed. The engine appears to be in relatively good condition and most of its components are still in place (Figures 20-21). A builder's plate identified it as "Imperial Keighley." This company manufactured oil and gas engines in the early 20<sup>th</sup> century in Keighley, England. The placement of the engine adjacent to the main shaft indicates that it was likely the hoist engine. When in operation, the engine would have been enclosed in a hoist house. No evidence of the structure remained at the time of the site visit. The engine is assumed to have been installed in the 1930s.

Figure 19: Engine Orientated North-South (View Northwest)

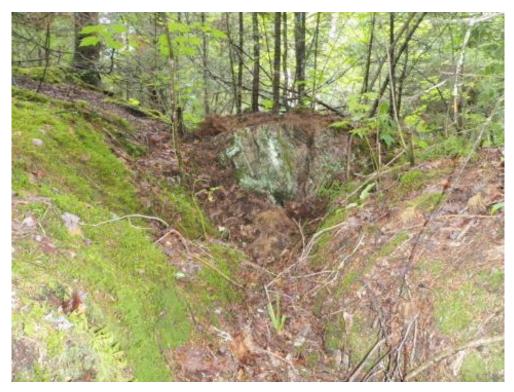
The geological map of the area, seen in Figure 9, identifies numerous trenches which were observed in the field work. The greatest concentration was observed along the crest of the hill (Figures 27-28). The trenches are now primarily overgrown.

Figure 27: Surface Trench along the William Vein (View Northeast)

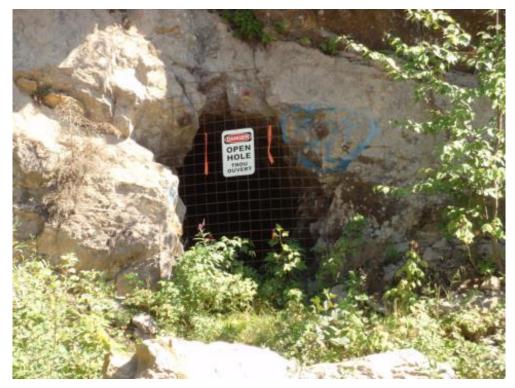
Two adits were noted during the field visit (Figure 29). These mine entrances had no visible historic infrastructure in place around them. One adit had several piece of machinery nearby which was part of a large engine (Figure 30). The areas around the entrances were particularly disturbed having the main road for the new mine infrastructure running directly in front of both.

Figure 29: Adit for the Original Hammond Reef Mine (View North)

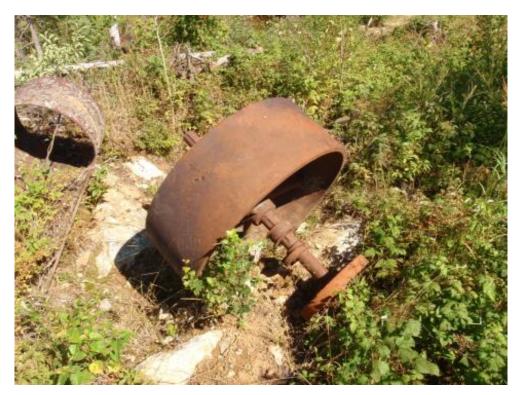
Figure 30: Drive Wheel for Engine Found in Front of Hammond Reef Adit (View Northwest)

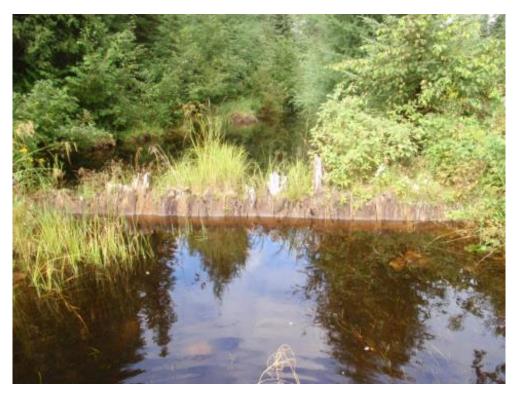
Figure 31: Timber Crib Dam Structure along Secondary Channel in Stream Valley (View West)

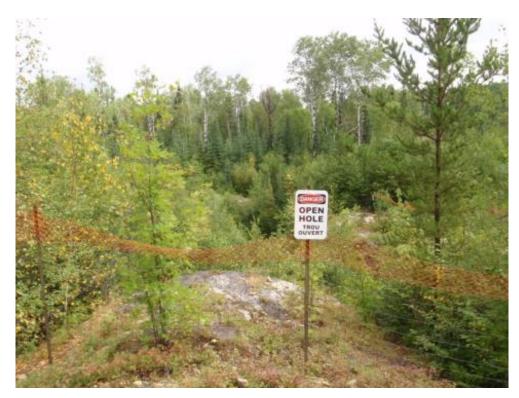
The only area of open cut which was identified was found along the edge of a rock hill and was fenced off due to a shaft located in the area (Figure 36). This trench area is labelled with the sample number WM-70 on the geology map of the mine (Figure 11).

Figure 36: Large Open Pit Associated with the Original Hammond Reef Mine (View Northeast)

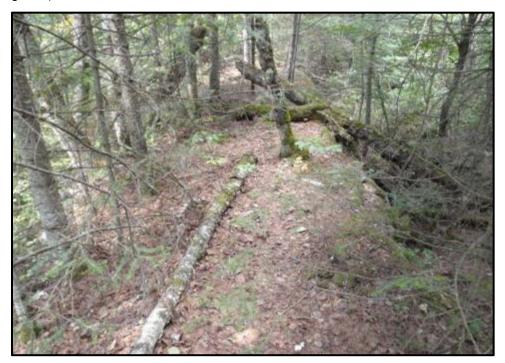
*Figure 1: Tramway roadbed on an earth embankment in valley near the Sawbill Mine, October 2011. Source Golder* Stage 1 Baseline Study and Stage 2 Archaeological Assessment *2013.*

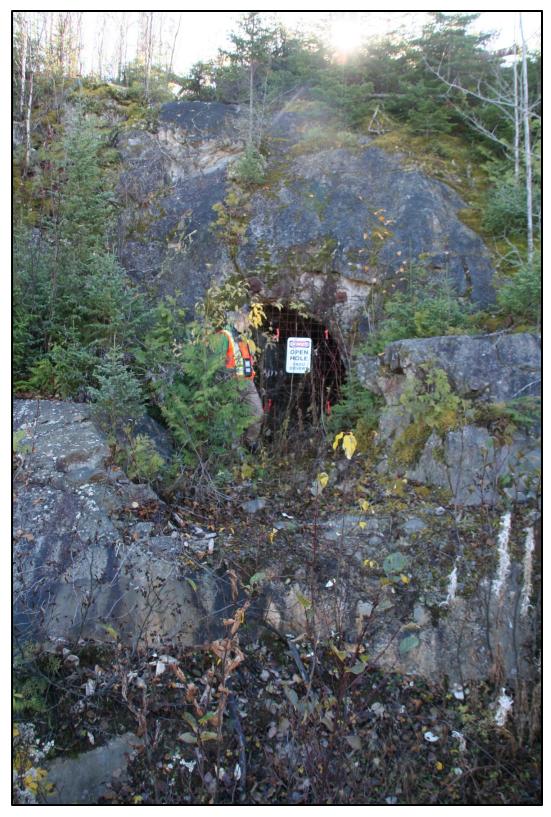
Plate H-1: Adit 1, Entrance

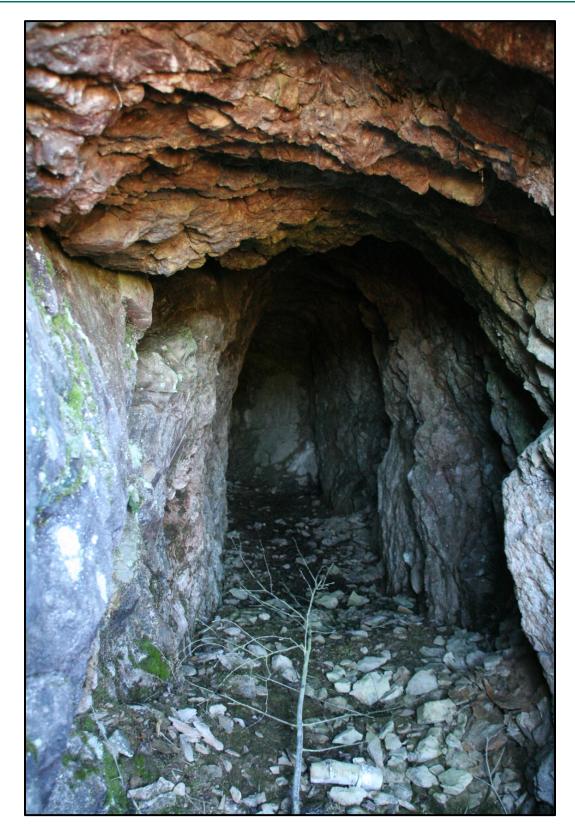
Plate H-2: Adit 1 looking from entrance with end of tunnel in rear

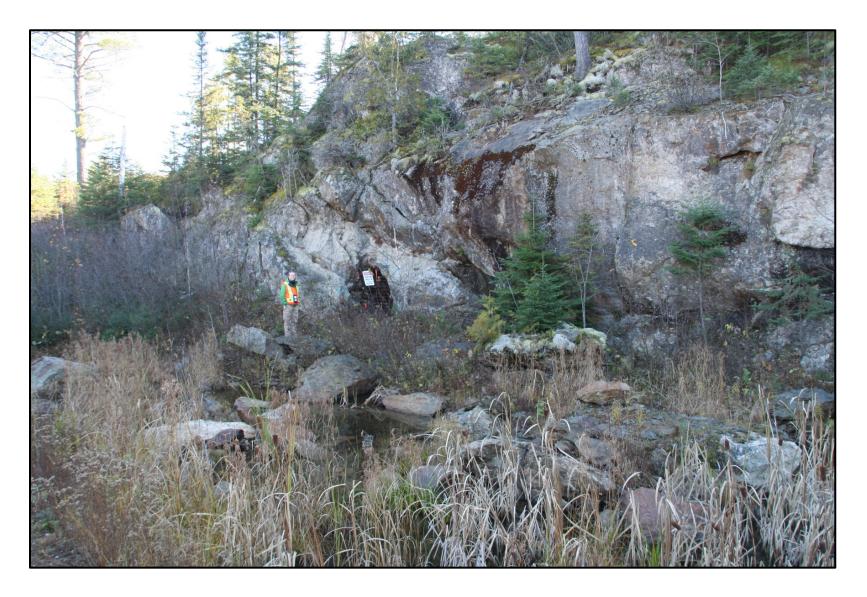
Plate H-3: Adit 2, Entrance

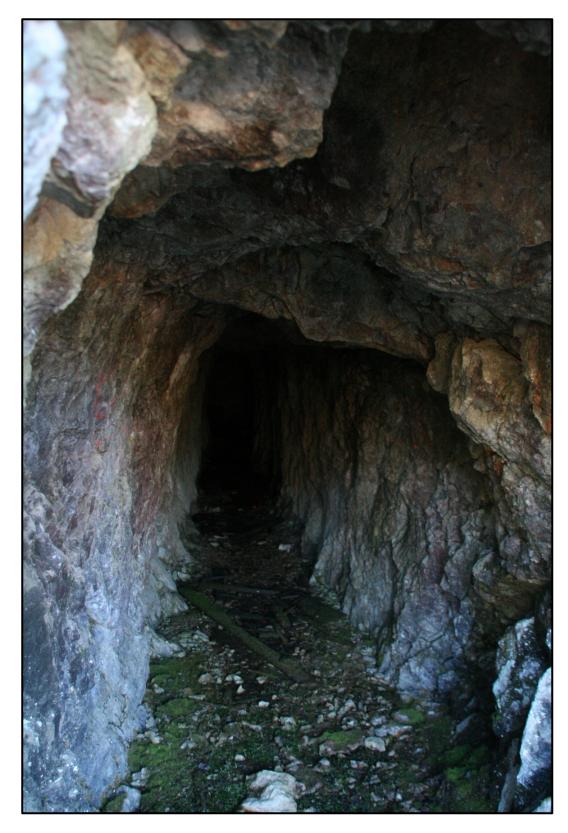
Plate H-4: Adit 2 looking from entrance; the end of tunnel in not visible

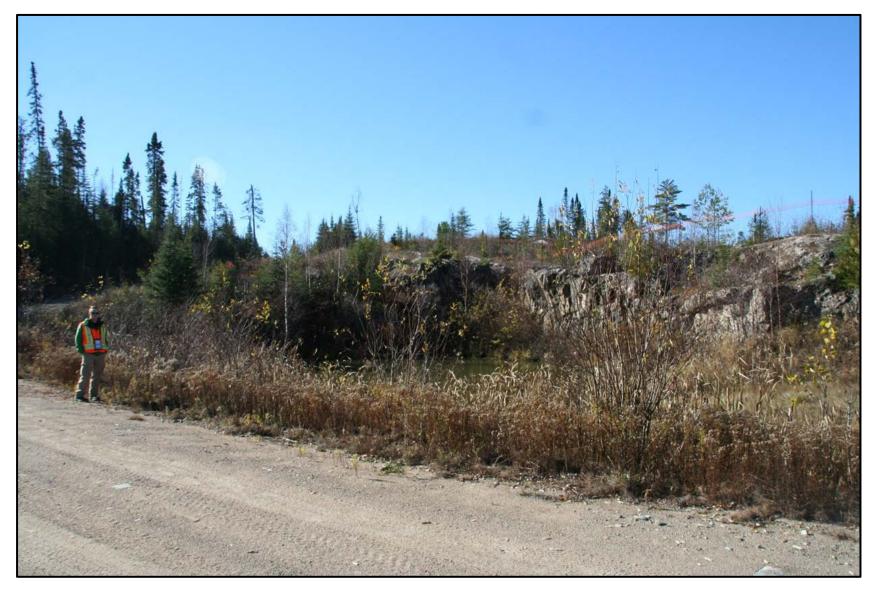
Plate H-5: Overview of Rock Cut with pond in foreground

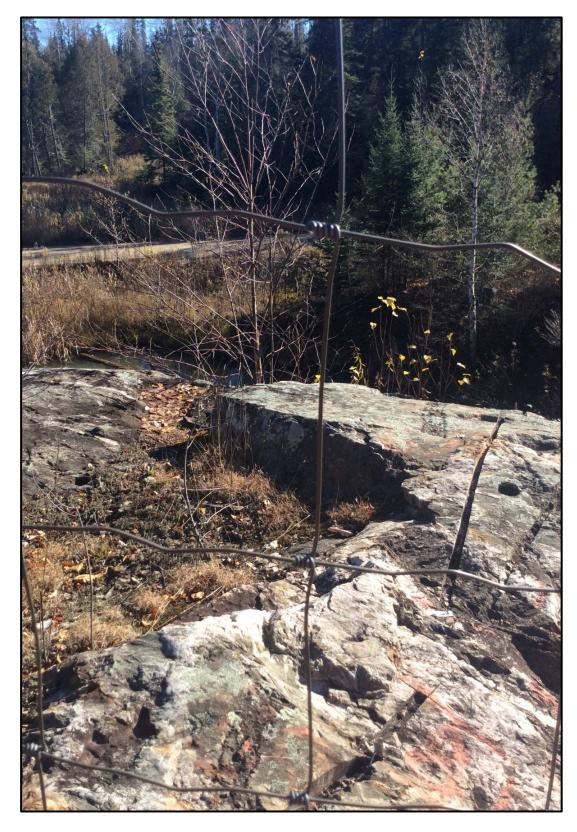
Plate H-6: Looking Over Quarry Face with Drill Hole

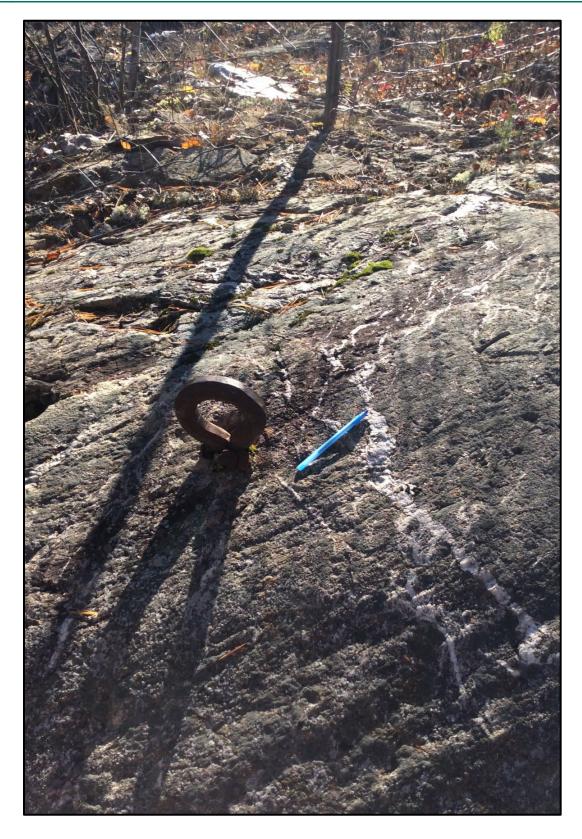
Plate H-7: Looking Over Quarry Face with Iron Ring

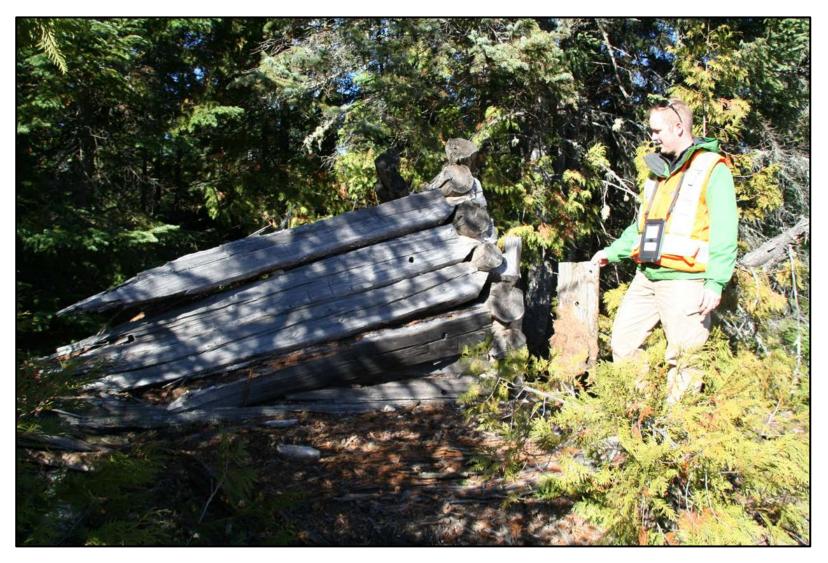
Plate H-8: Mine cabin, corner joints

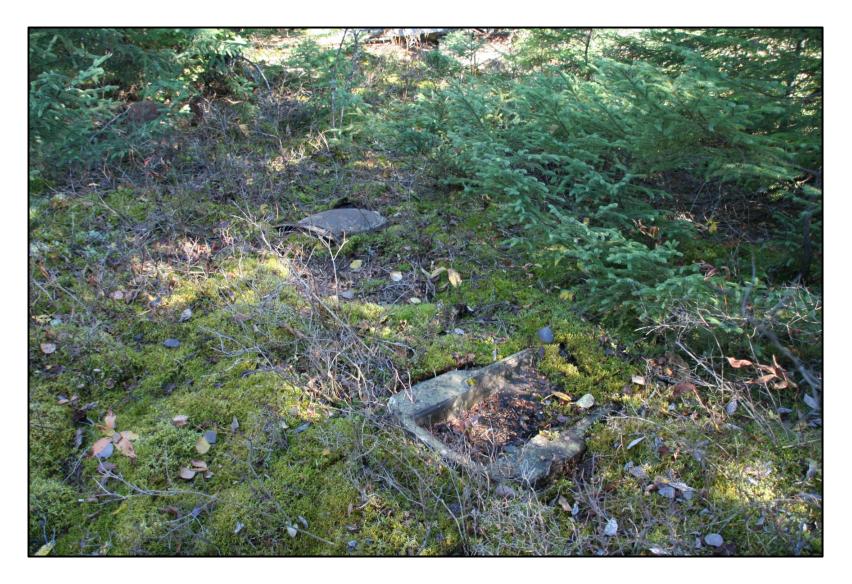
The only identifiable component were the cast iron plates from a wood stove with the casting "HAZELWOOD" on one of the plates (Plate H-9, H-10). The HAZELWOOD brand of stoves was manufactures by the Gurney Foundry in Hamilton at least during the 1890s. An identical casting was found at the Sawbill Mine during the 2011 Golder archaeological fieldwork.

Plate H-9: Mine cabin, stove parts

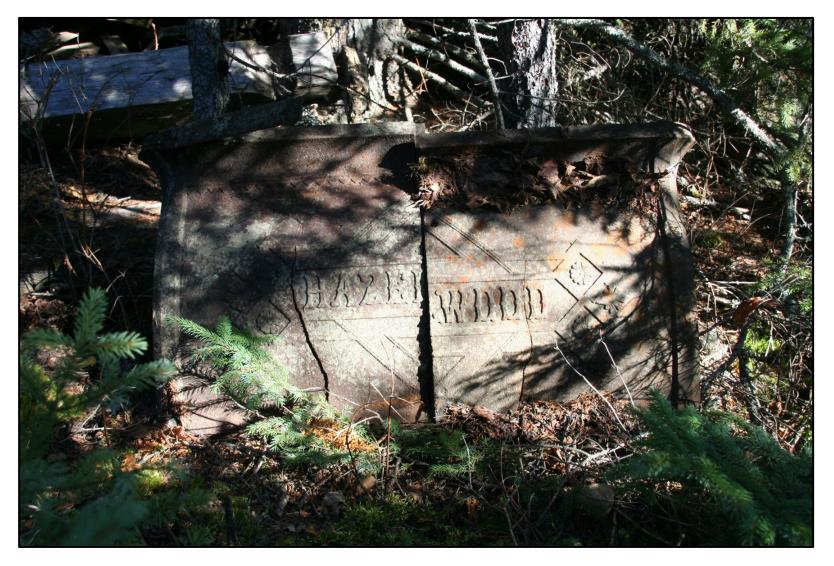
Plate H-10: Mine cabin, side casting of wood stove

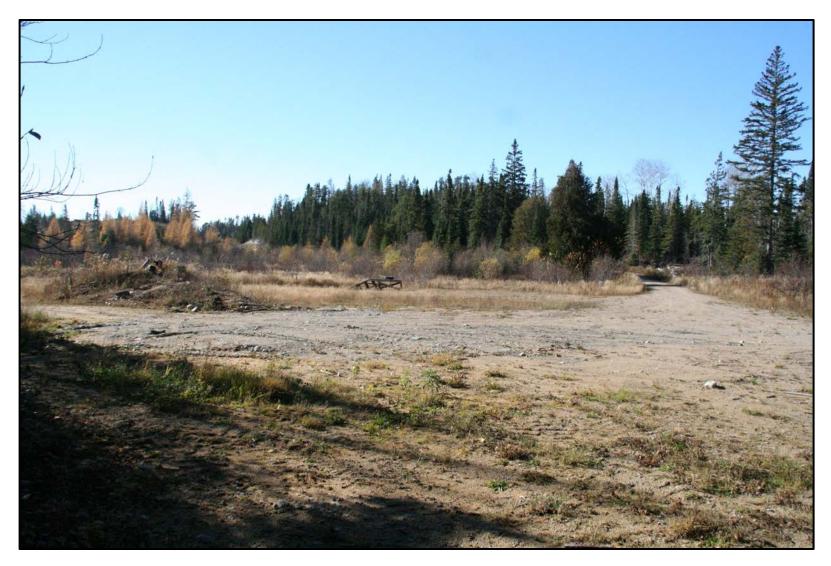
Plate H-11: Overview of mill site showing modern grading

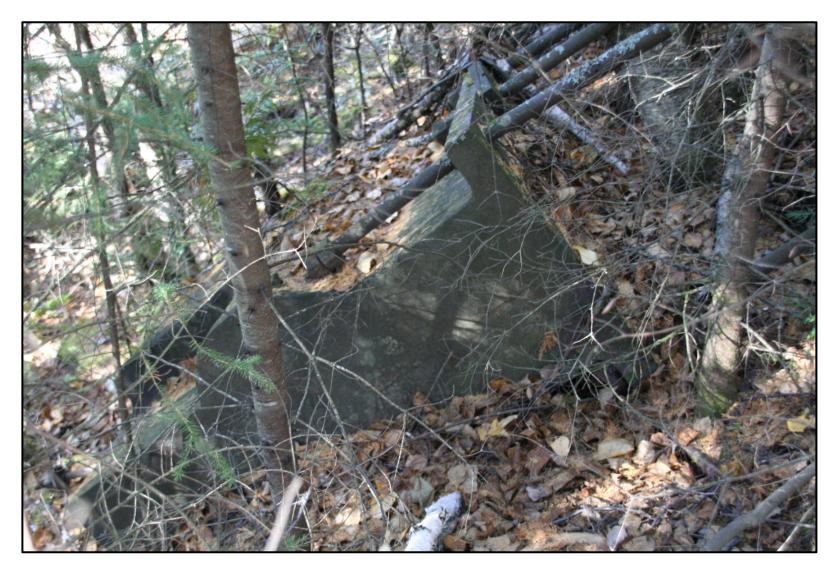
Plate H-12: Stamp mill box

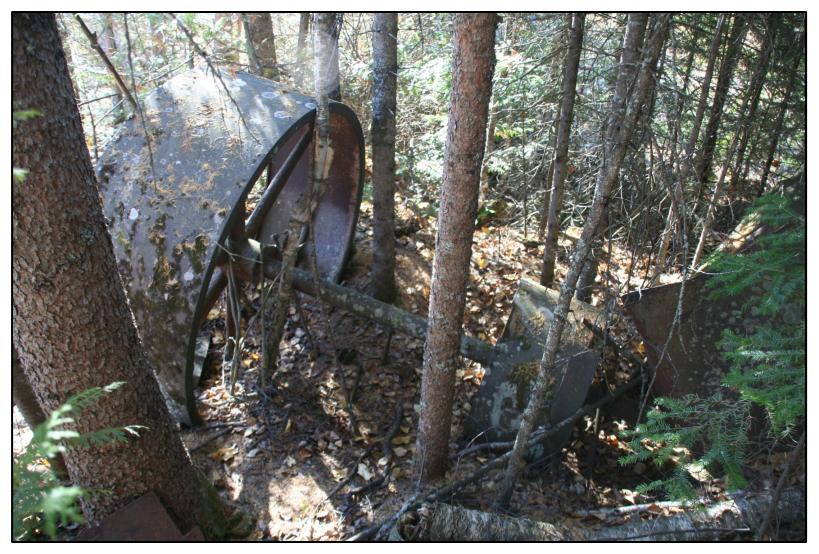
Plate H-13: Two pulleys on axle with the equipment dump

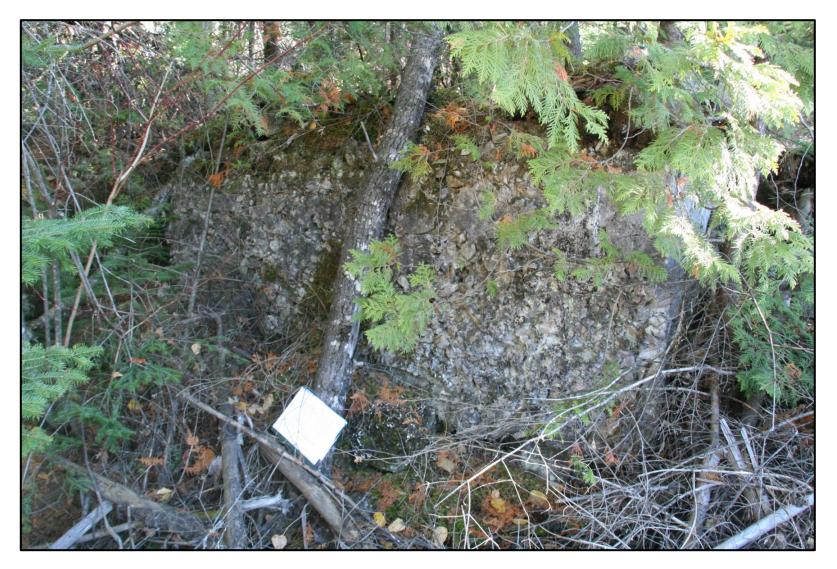
Plate H-14: Concrete machinery base with notebook for scale

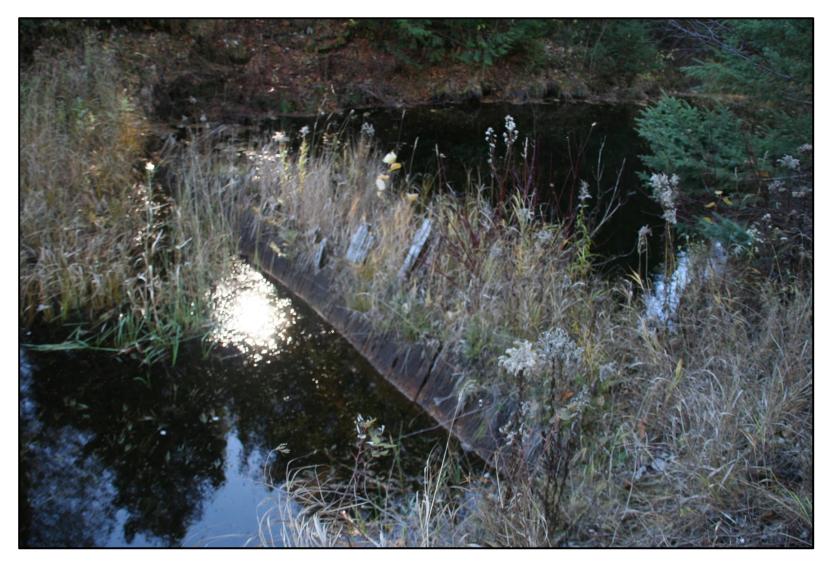
Plate H-15: Overview of dam showing timber framing on upstream side

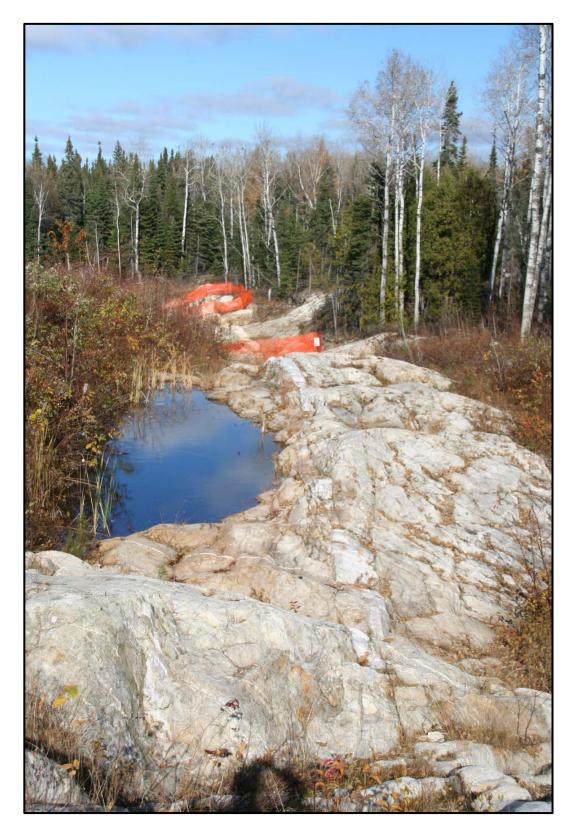
Plate S-1: Looking north from Shaft Three towards Shaft Two in middle and Shaft One in rear

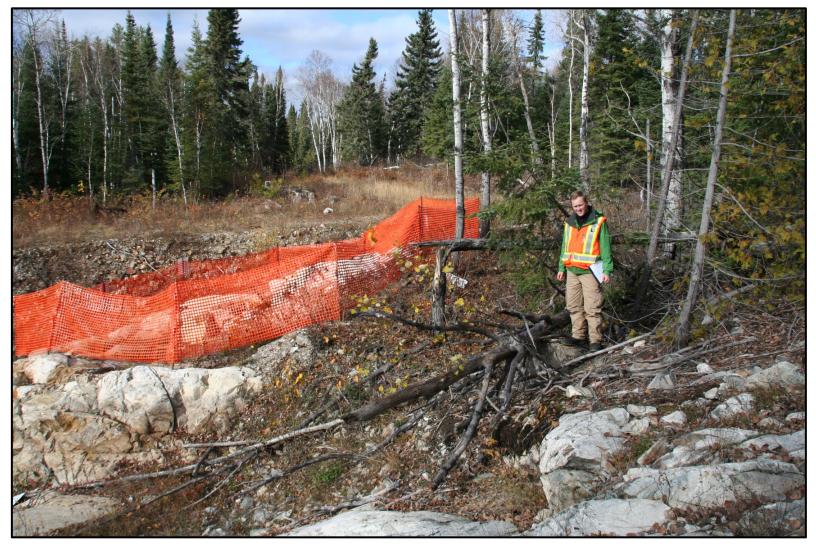
Plate S-2: Shaft One, looking west towards concrete ruins of mill building

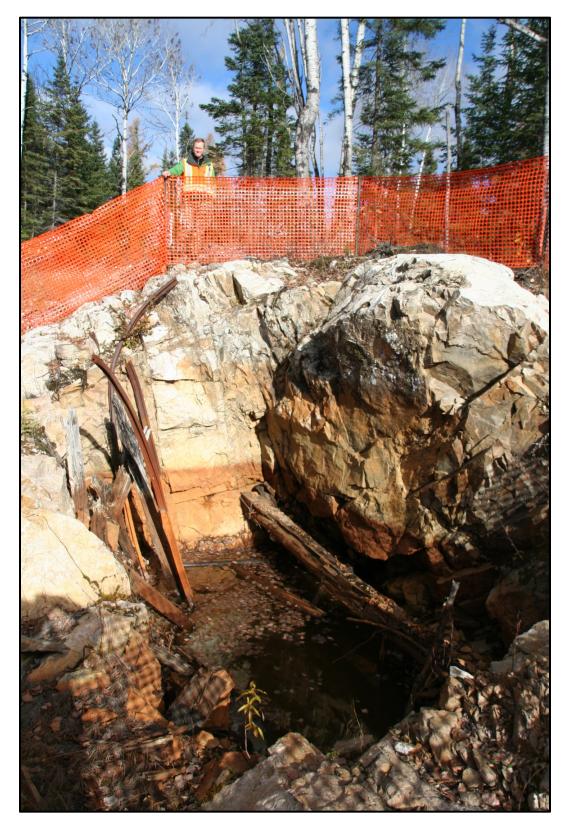
Plate S-3: Shaft One showing water in shaft, mine timber (right) and tramway rails (left)

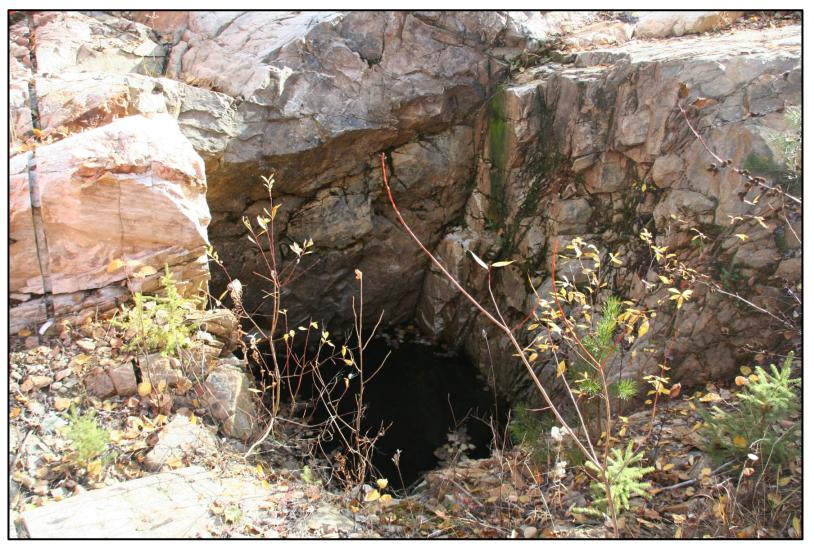
Plate S-4: Shaft Two

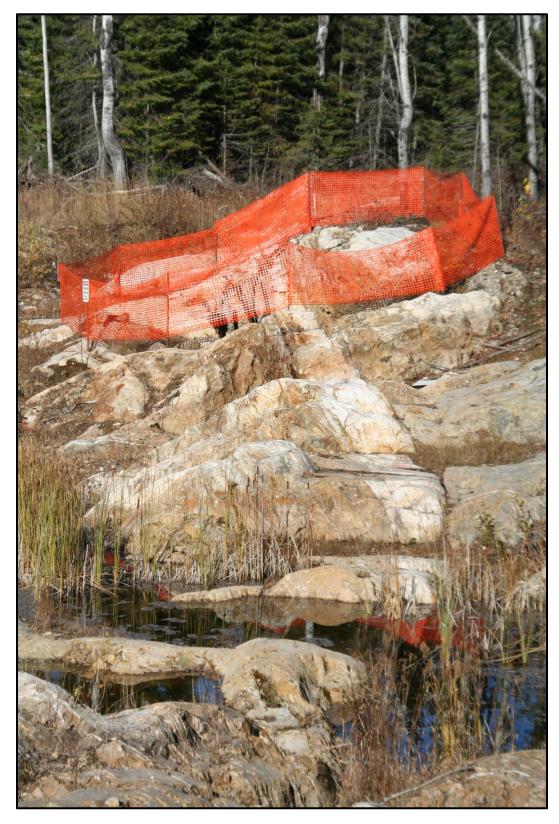
Plate S-5: Shaft Three looking south and up slope to the shaft

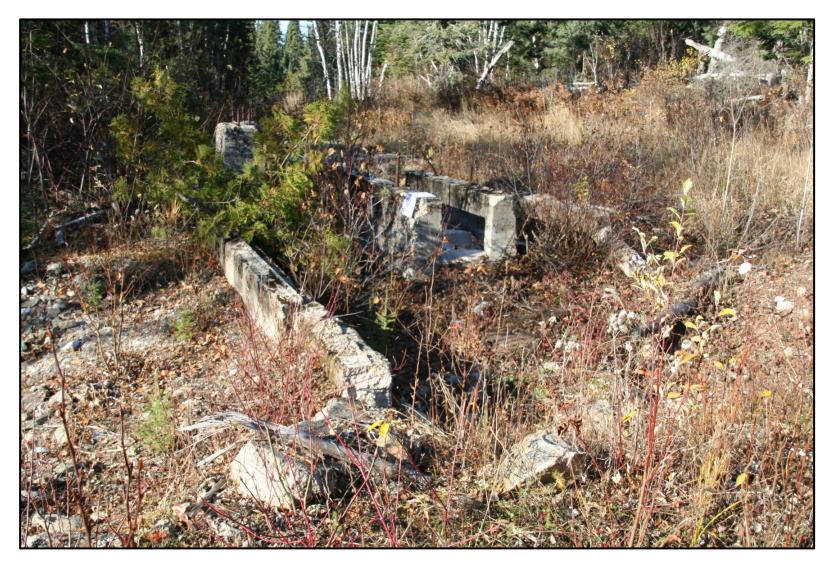
Plate S-6: Mill foundation overview looking from Shaft One

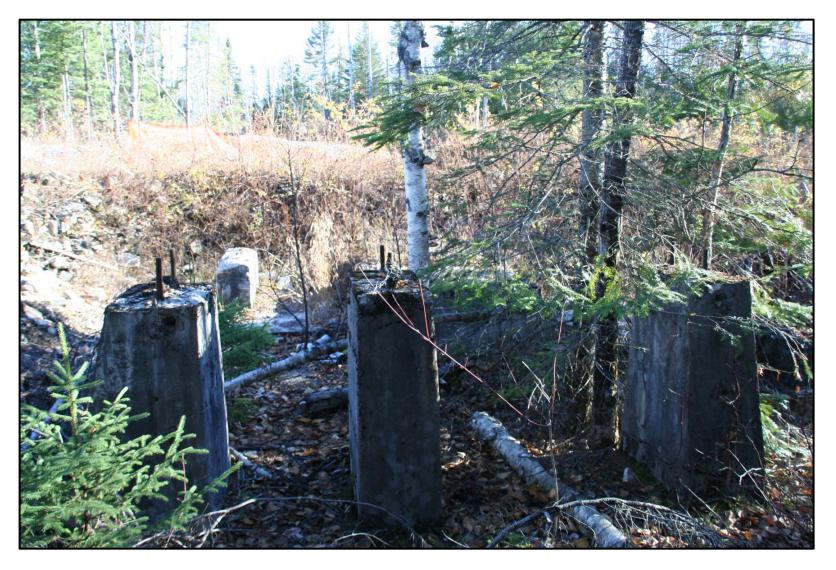
Plate S-7: Concrete footings for pillow blocks, looking towards Shaft One

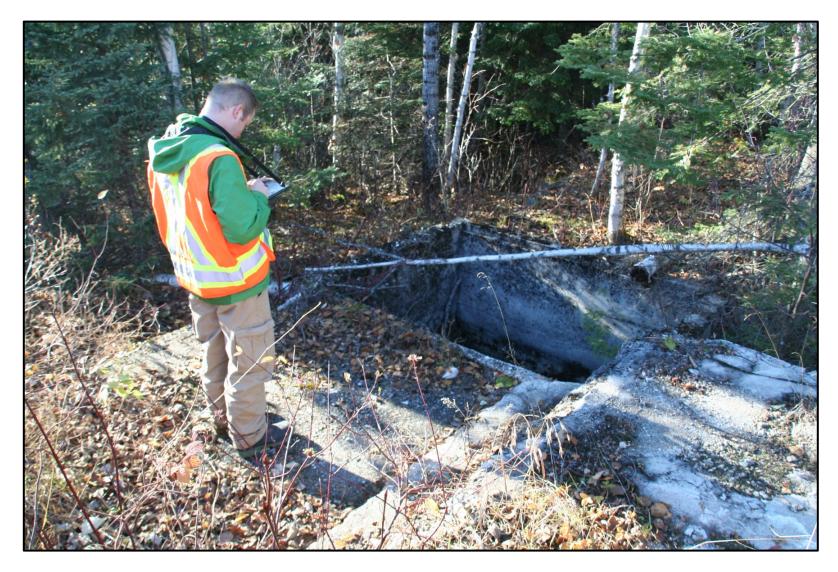
Plate S-8: Two concrete tanks on lowest level of mill foundation

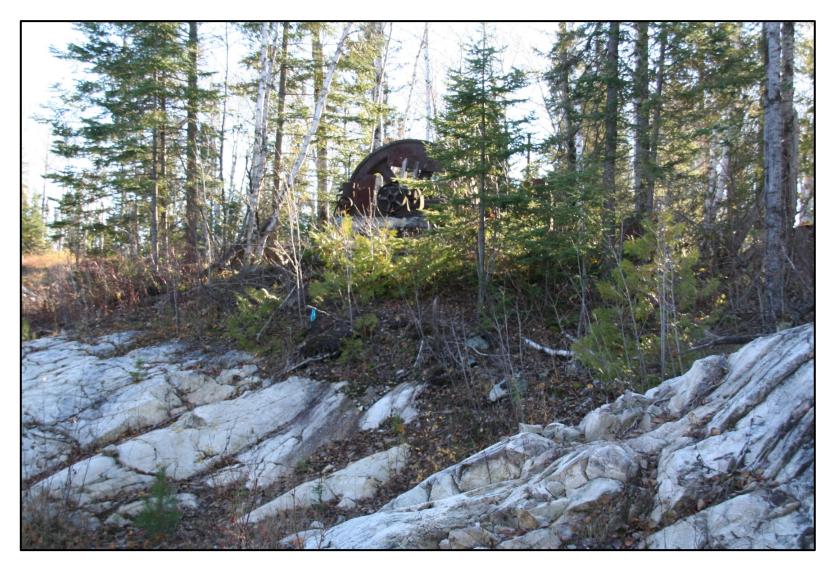
Plate S-9: Keighley Engine, north side

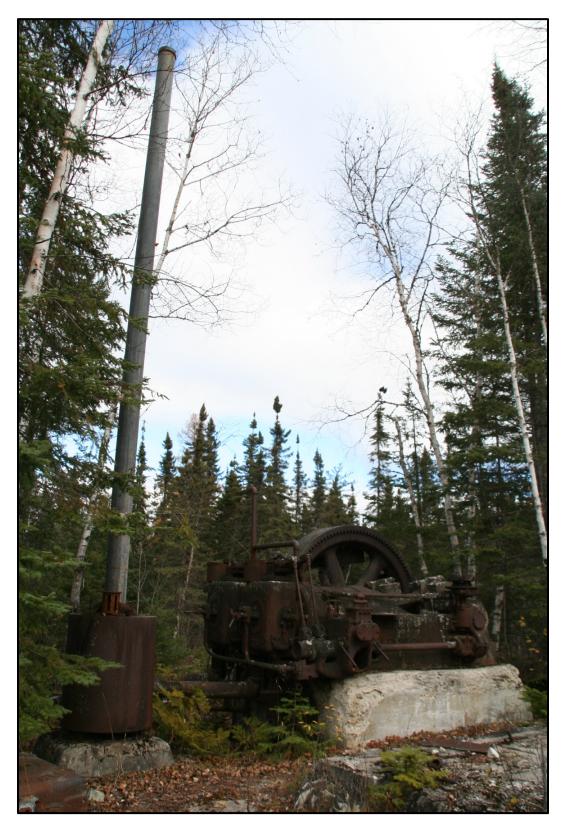
Plate S-10: Keighley Engine, south side

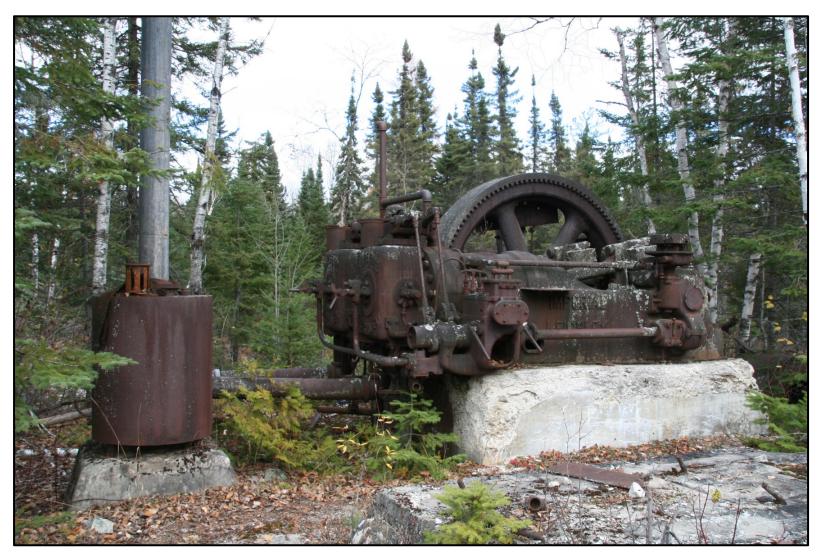
Plate S-11: Keighley Engine, south side

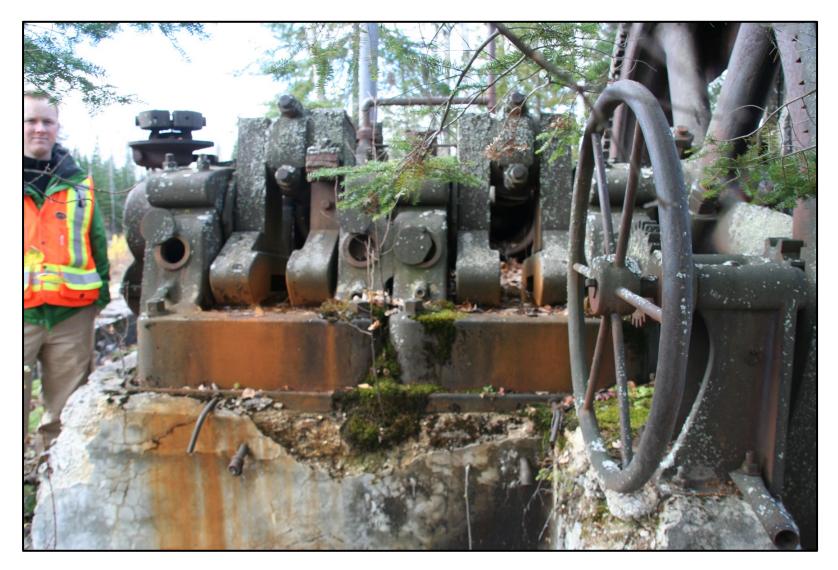
Plate S-12: Keighley Engine, east side

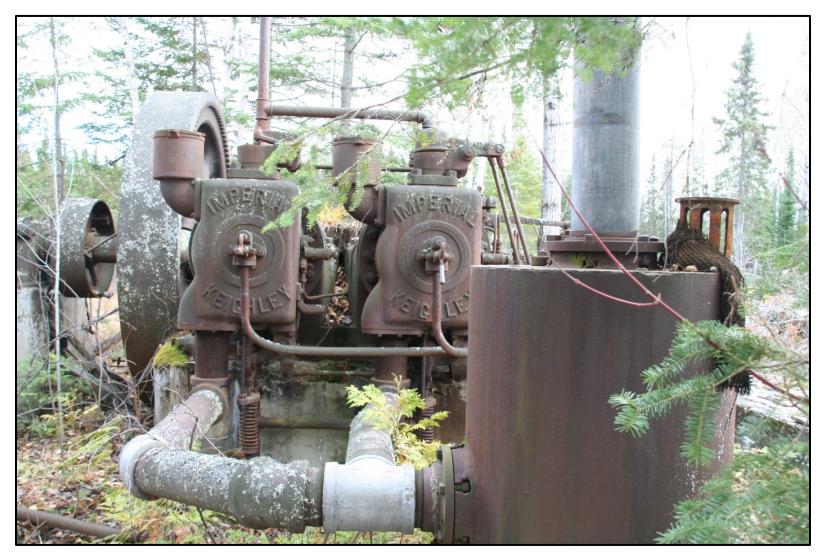
Plate S-13: Keighley Engine, west side

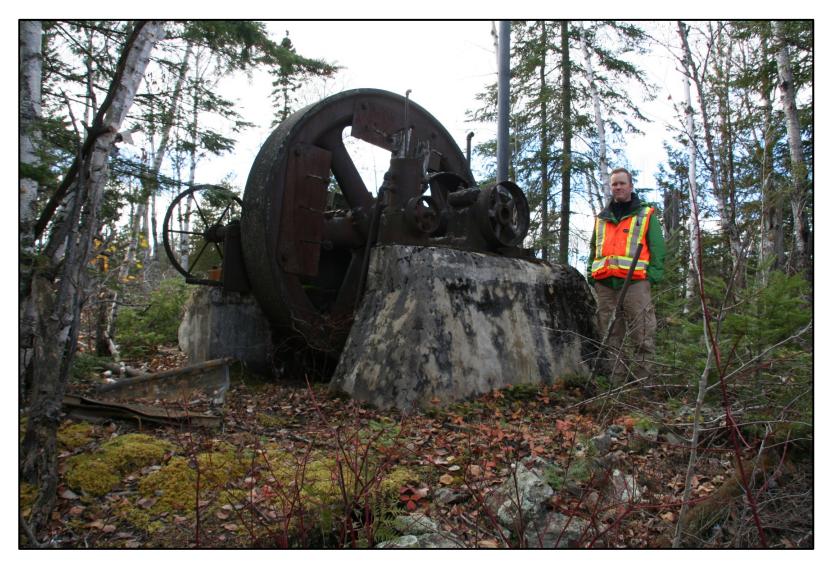
Plate S-14: Keighley Engine, east side

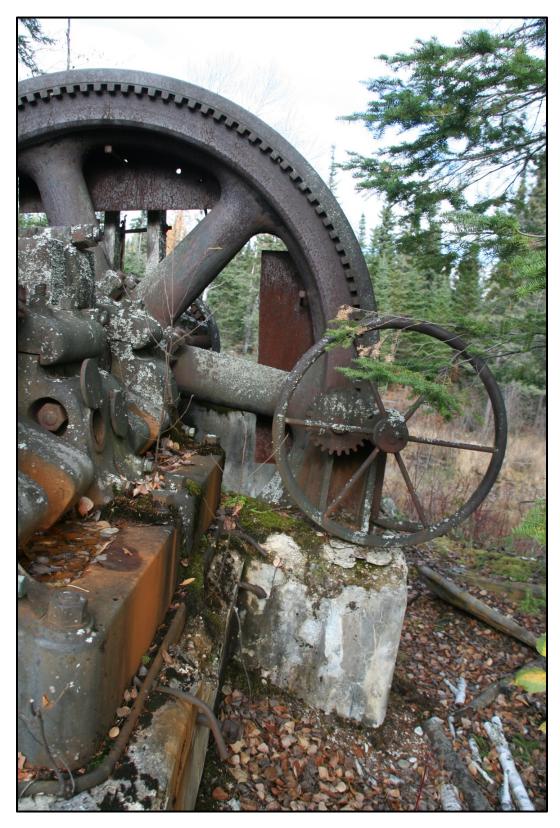
Plate S-15: Keighley Engine, flywheel

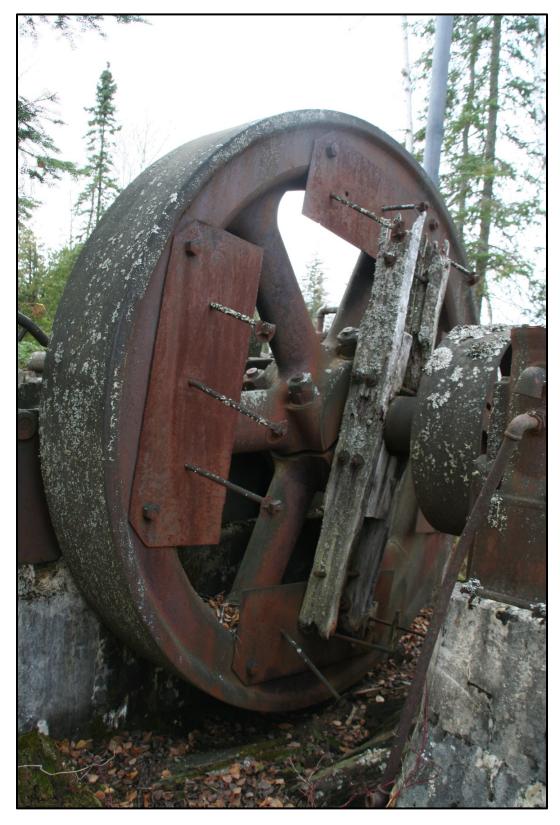
Plate S-16: Keighley Engine, flywheel/belt drive

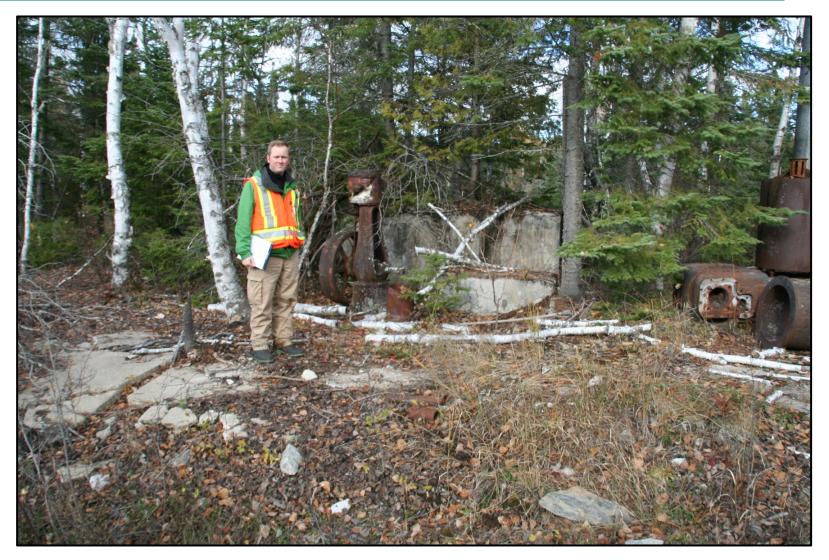
Plate S-17: Keighley Engine, east side; small steam engine

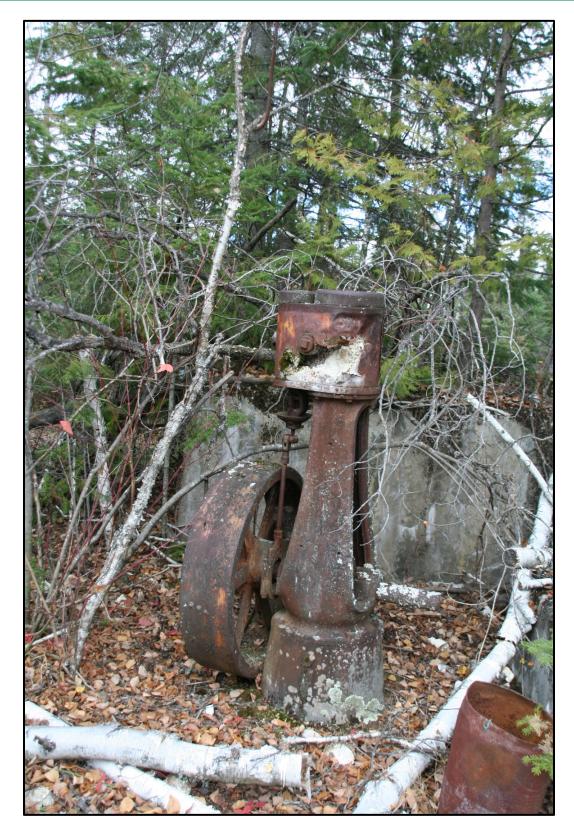
Plate S-18: Small steam engine west of Keighley Engine

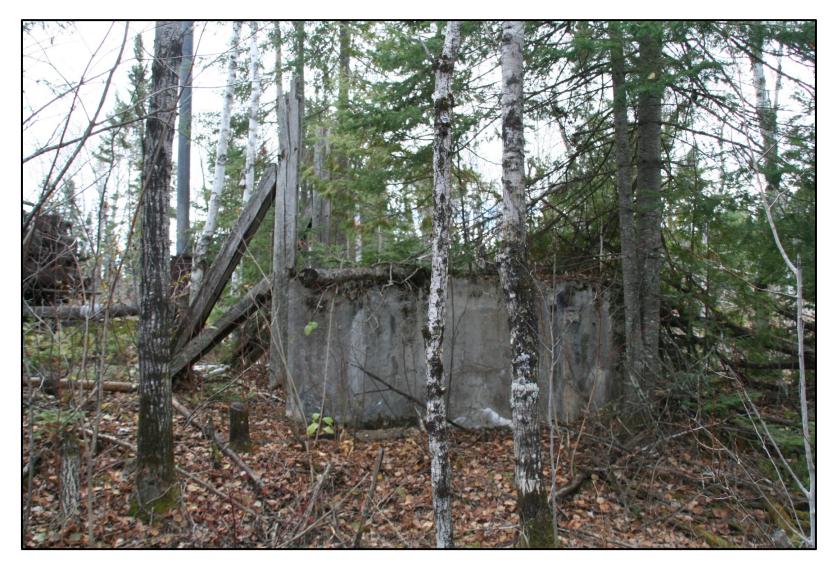
Plate S-19: Pulley block west of Keighley Engine

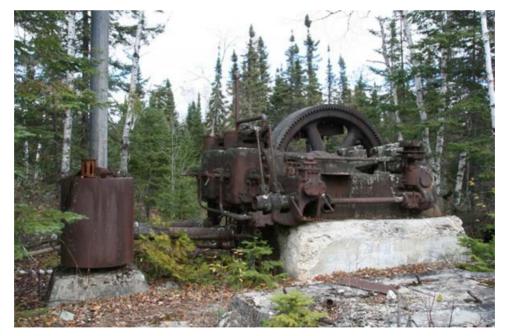
The Keighley engine is located immediately north of the proposed waste-rock stockpile of the future mine operation. The planned access road to the mine will be adjacent to the engine. Once mining begins, relocation of the engine may be required to facilitate rock waste disposal or road construction.

Figure 1: Keighley Engine with exhaust manifold/pipe on left at Sawbill Mine (October 21, 2014)

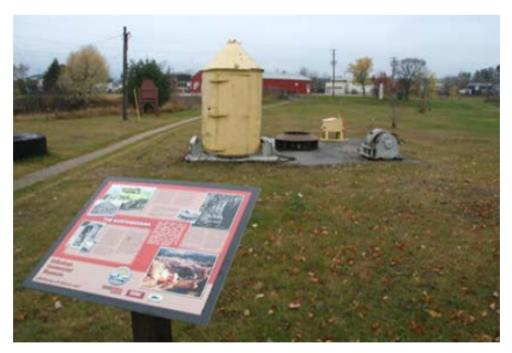
Figure 3: Historical Park showing displays and Centennial Museum in rear (Oct 22, 2014)

The landscaping and the condition of the artifacts have not been maintained over the last 30 years. The paths have become overgrown and the displayed equipment needs painting and other maintenance. If the Keighley
