**RE: Deceased Chestnut-sided Warbler**

# newgold<sup>TM</sup> Rainy River Project

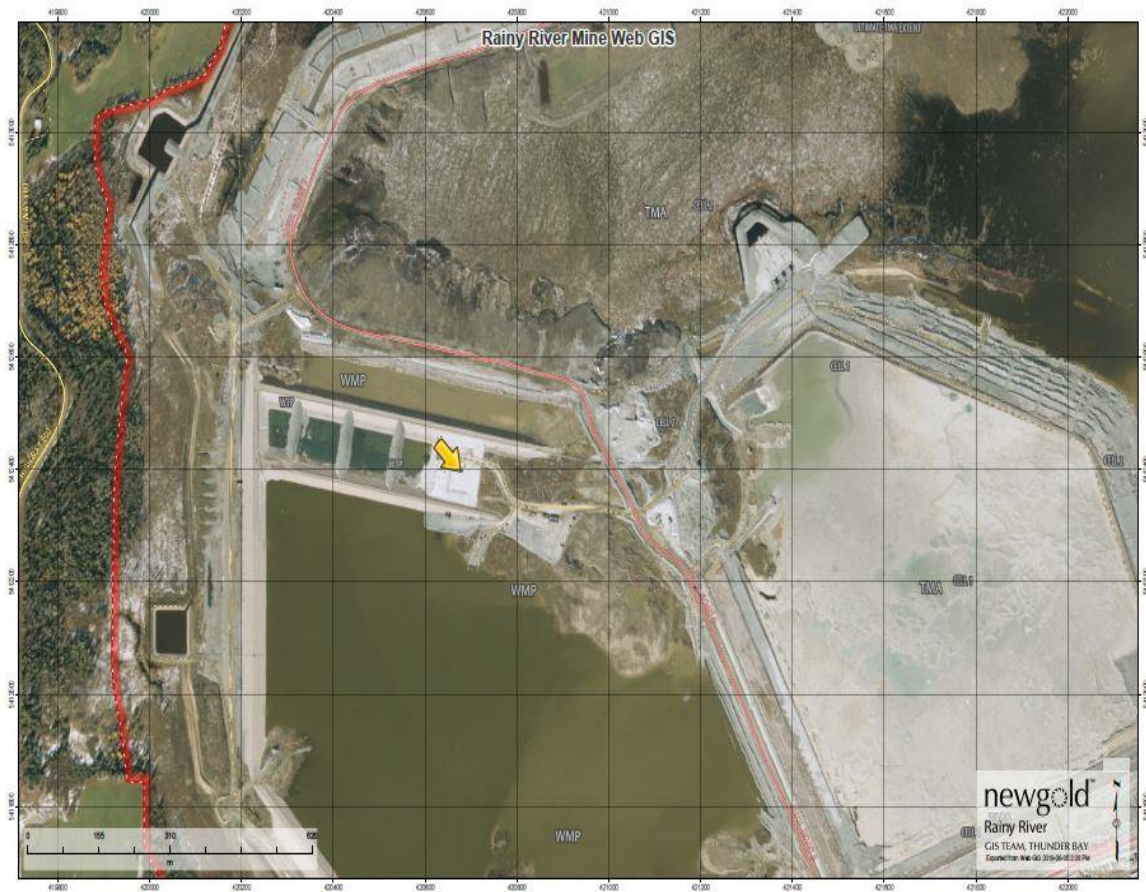
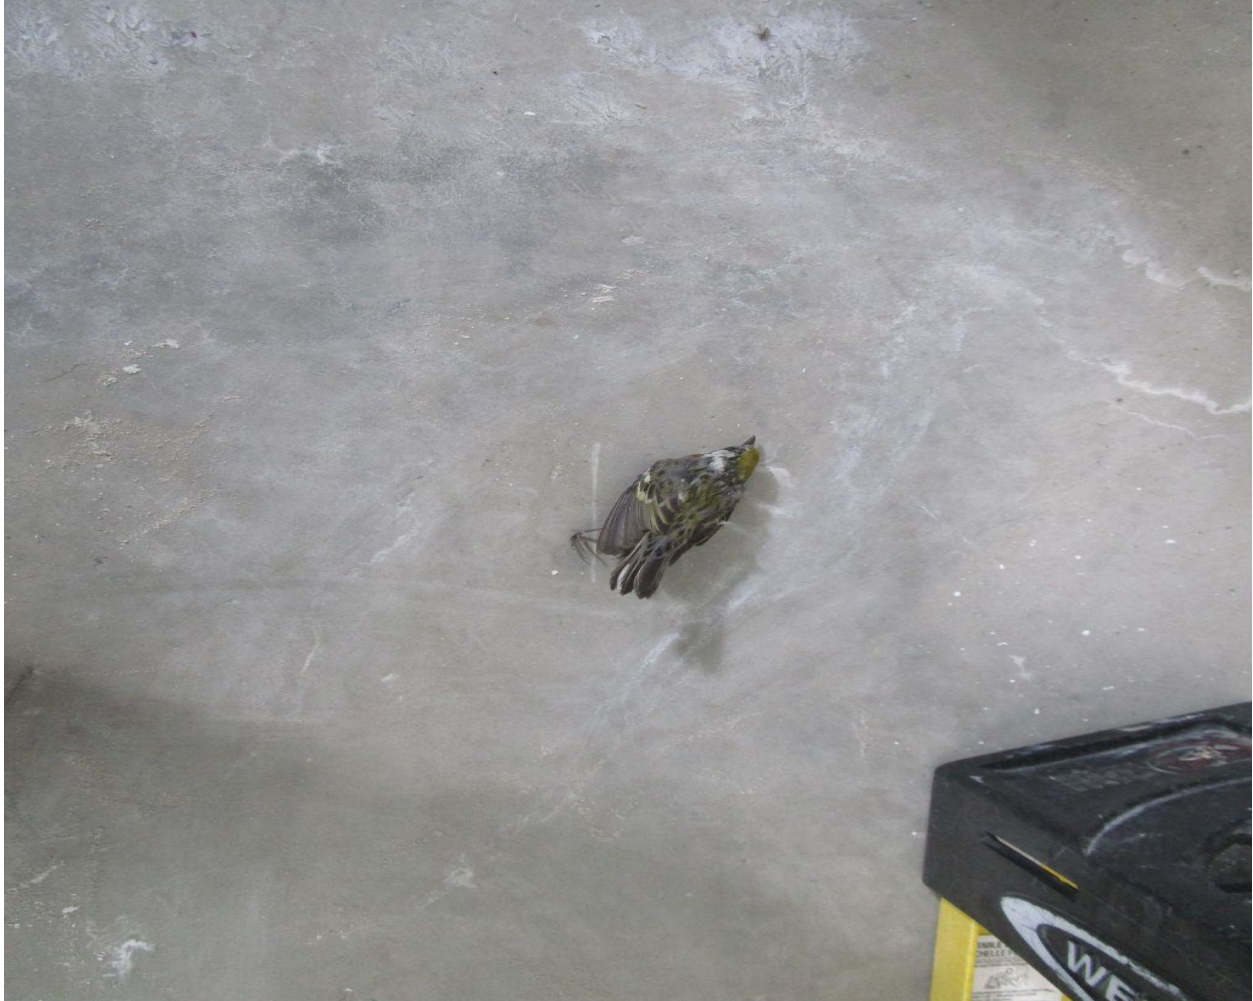
On June 2, 2019 at 1749 a deceased Chestnut-sided Warbler was discovered within the Water Treatment Plant which is currently under construction at the Tailings Management Area. (See photos below)

A contractor discovered the bird laying dead on the floor of the building and an assumption was made that it contacted some fans running on the ceiling. The doors of the building were open as construction is on going at the Water Treatment Plant but are closed whenever possible.

3.1. Location	Water Treatment plant in the Tailings area		UTMs	E:	N:
3.2. Species	Chestnut-sided Warbler		Number of Animals:	1	
3.3. Description of Incident and Outcome	A Chestnut sided Warbler was found on the floor behind the polymer tanks.				
	No one witnessed what happened to the bird however the building fans were running				
	It is suspected that the bird flew into the fan at some point.

3.4. Could the Incident Have Been Avoided? (If yes, describe how)	Yes <input checked="" type="checkbox"/> No <input type="checkbox"/>				
	If fan caused the mortality it could have been prevented by having them turned off				
	and having the doors closed. Fans were turned off and will remain off if the doors				
Need to be opened during construction					
<b>4. Additional Comments</b>					
Personnel were reminded to keep the doors closed when not required to be open and to leave fans off unless they					
Are absolutely needed.
