### Appendix 11A Blackwater Project – Reconnaissance Terrain and Terrain Stability Mapping. Rev0.

### RECONNAISSANCE TERRAIN AND TERRAIN STABILITY MAPPING

VA101-457/4-4 Rev 0 February 14, 2013

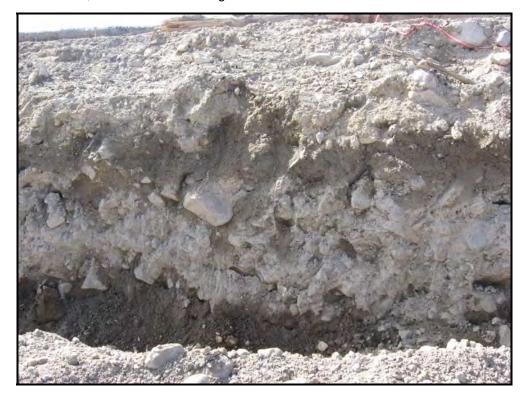
The interpreted surficial geology in the Study Area is shown on Drawings G0030 to G0032. The main surficial unit at the sites of the proposed mine facilities and along the proposed haul road alignments is a blanket of till (Mb). The till is stiff to very stiff or dense and is interpreted to be 'lodgement/basal till', as shown below in Figure 8.1 and in Photo 6.

## Figure 8.1 Exposure of Very Stiff Lodgement Till at the Site of the proposed Open Pit (WP 57)

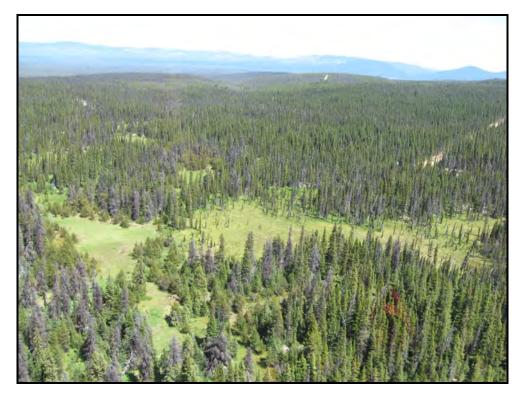
Organic soils have accumulated from the decomposition of organic material in poorly-drained settings, including swales, depressions and upland settings with shallow bedrock. Organic soils (eO<sub>p</sub>) were mapped in the footprint areas of the proposed 'NAG 4 Stockpile', 'Low Grade Stockpile' and 'NAG 3 Overburden Stockpile', as shown below in Figure 8.2, on Photo 10, and Drawing G0030.

Figure 8.2 Organic Soils in the Footprint Area of the proposed NAG 4 Stockpile

The organic soils are interpreted to extend over approximately 5 to 10% of the total footprint areas of these proposed stockpiles. The largest area of organic soils is approximately 800 m long (Drawing G0030 and Photo 10). The footprint area of the proposed NAG 4 Stockpile lies partly in this area of organic soils. Organic soils were also mapped locally within the footprint areas of the proposed Open Pit and TSF. A gently sloping apron of organic soil ( $eO_v$ ) was mapped locally at the margins of the floodplains along the incised portions of Davidson Creek and Creek 505659 (e.g. Polygons 209 and 190). The gently sloping apron of organic soil at Polygon 209 is shown on Photo 11. The downstream toe of the proposed 'Site D Main Dam' is located in this area (Drawing G0031). Photo 12 shows upland areas of organic soils in Polygon 270, in the southwest part of the Study Area.

The terrain mapping identified organic soils at the sites of the proposed NAG 3 Overburden Stockpile, NAG 4 Stockpile and Low Grade Stockpile. It is recommended that further site investigation be undertaken to determine the depths of the organic soils in these areas.

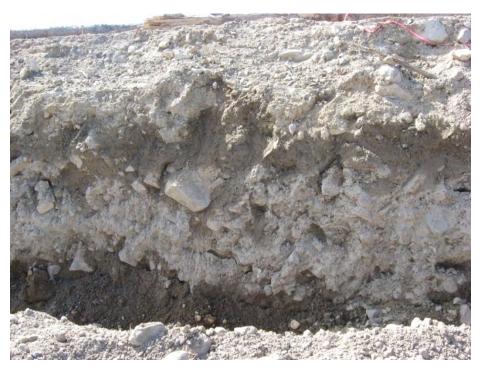
PHOTO 6 – Very Stiff Lodgement Till at the Site of the proposed Open Pit (WP 57)

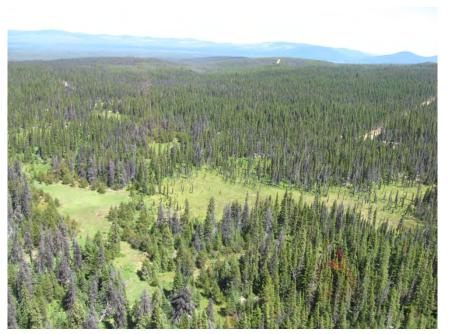
PHOTO 10 – Organic Soils in the footprint area of the proposed NAG 4 Stockpile (WP 60)

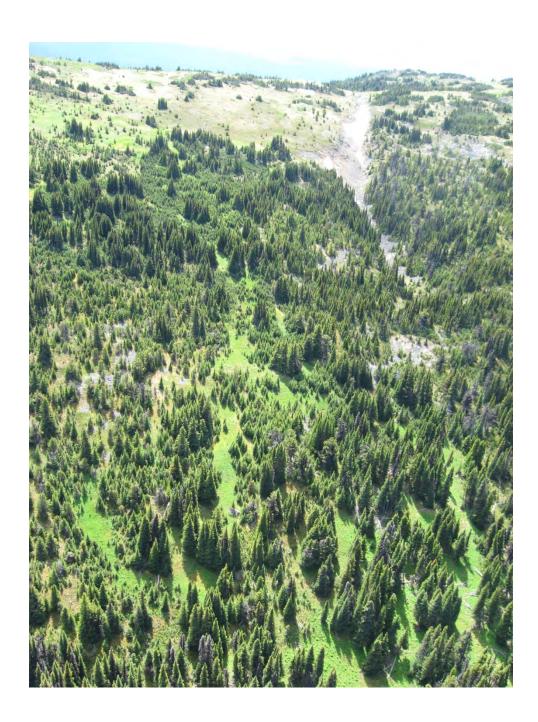
PHOTO 12 – Upland Organic Swamps in Polygon 270, in the Southwest part of the Study Area

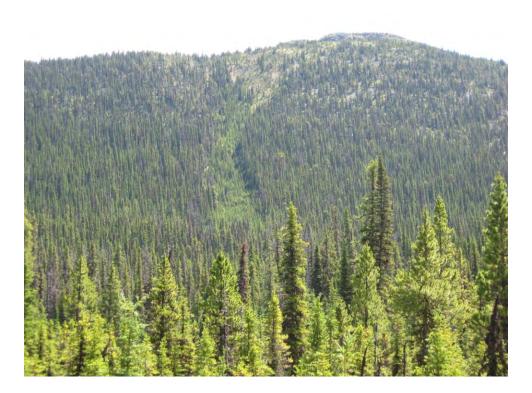
Relatively few landslides were identified in the Study Area. The landslides that were observed include debris slides, rockfalls and two possible relict rock avalanches, all of which occur in areas of natural terrain. 'Recent' debris slides were identified in Polygons 69 and 129, in the southwest part of the Study Area (Drawing G0030). The landslide in Polygon 69 occurred in an area of steep terrain. The 'recent' debris slide in Polygon 129 occurred in an area of gullied terrain. A possible 'relict' debris slide was identified at WP 32 (Drawing G0030). The natural slope angle at this site was measured to be approximately 60%. An area of hummocky terrain was identified on a 60% slope at WP 17. This area is interpreted to be a possible 'relict' slump. A thin veneer of colluvium overlies fluvial soils at WP 35. This site is situated at the toe of an area of incised terrain and is interpreted to have been subject to previous landsliding.

PHOTO 14 – Relict Rock Avalanche in Polygon 24, in the west part of the Study Area

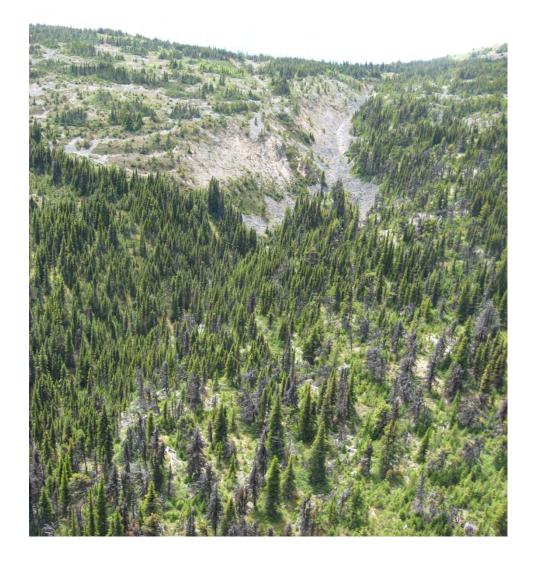
The terrain mapping did not reveal any widespread areas of sheet or gully erosion within the Study Area. Local areas of minor gully erosion were identified in Polygons 129 and 130 in the southwest part of the Study Area (Photo 15). A surface veneer of cobbles with some gravel was observed on moderately steep slopes adjacent to Davidson Creek at WP 5, in the vicinity of the site of the proposed 'Site D Main Tailings Dam' (Photo 16). This very coarse surficial soil is interpreted to be a lag deposit resulting from seepage erosion of the underlying glaciofluvial terrace deposit.

PHOTO 15 – Area of minor Gully Erosion in Polygon 129, in the southwest part of the Study Area

foundation preparation. The local presence of such soils with a relatively high susceptibility to surface erosion should be accounted for in the project 'Sediment and Erosion Control Plan'.

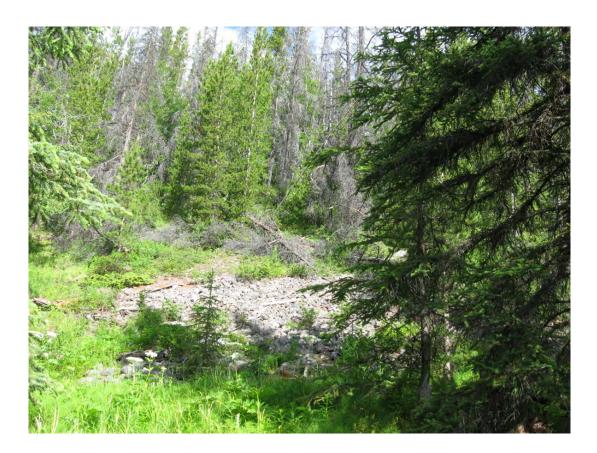
PHOTO 16 – Interpreted Lag Deposit resulting from Seepage Erosion (WP 5)
