CN Milton Logistics Hub

**Fish and Fish Habitat Follow-Up
Program– Construction Monitoring
Report 2022**

Final Report

December 22, 2022

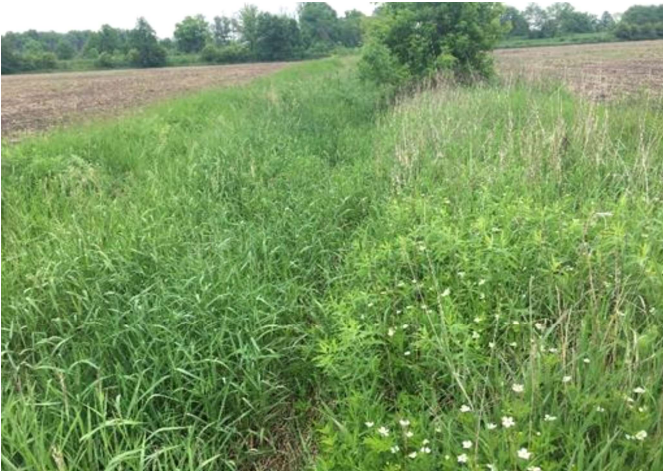
Photo 1: Pre-construction Tributary A (2020). Approximately 200 metres south of existing rail line. Facing upstream (north).

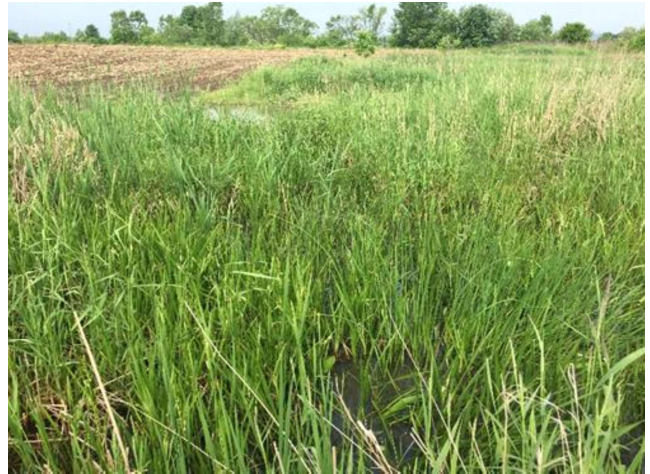
Photo 2: Pre-construction Tributary A (2020). Facing downstream (south).

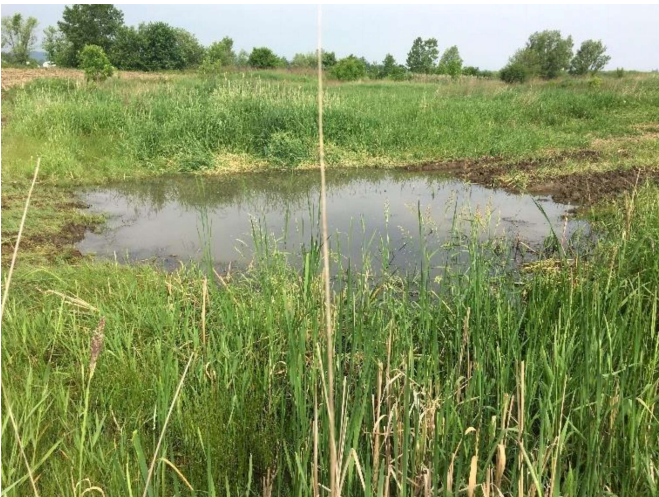
Photo 3: Pre-construction Tributary A (2020). Approximate mid-point between existing rail line and Tremaine Road. Facing west.

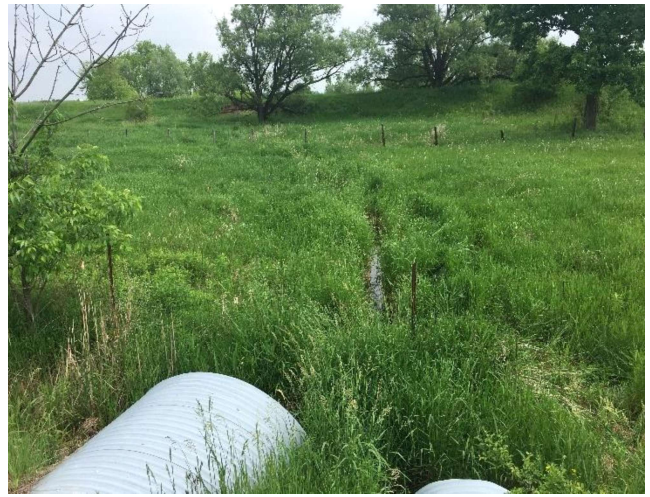
Photo 4: Pre-construction Tributary A (2020). At culverts under Tremaine Road facing upstream (north)

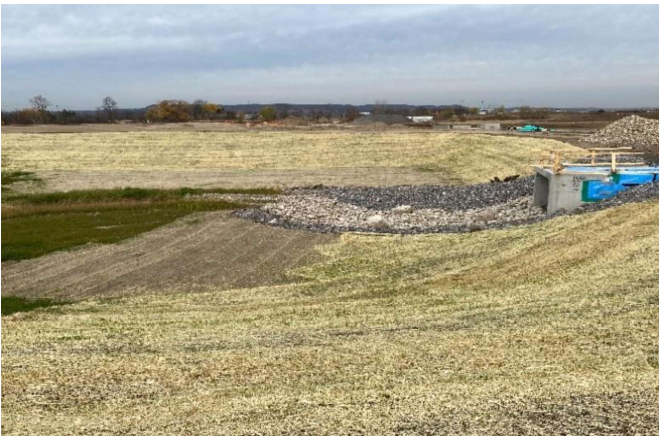
Photo 5: During construction Tributary A (2022). At new culvert downstream of existing main line. Facing west.

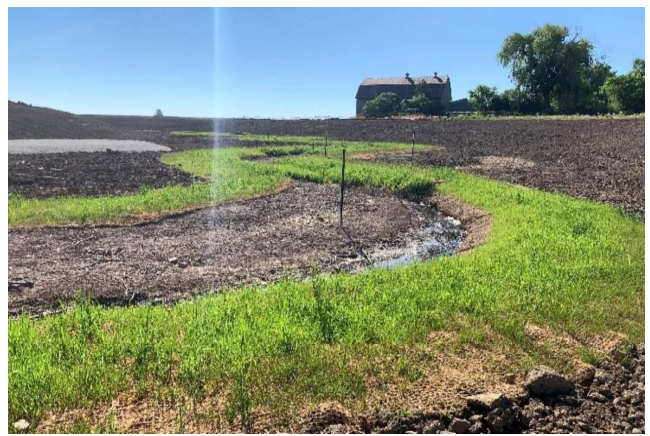
Photo 6: During construction Tributary A (2022). Downstream section facing downstream (southeast).

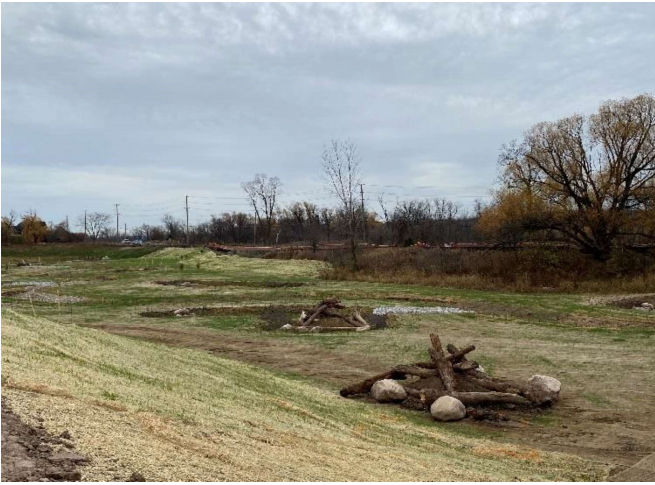
Photo 7: During construction Tributary A. South end of realignment. Off-line floodplain

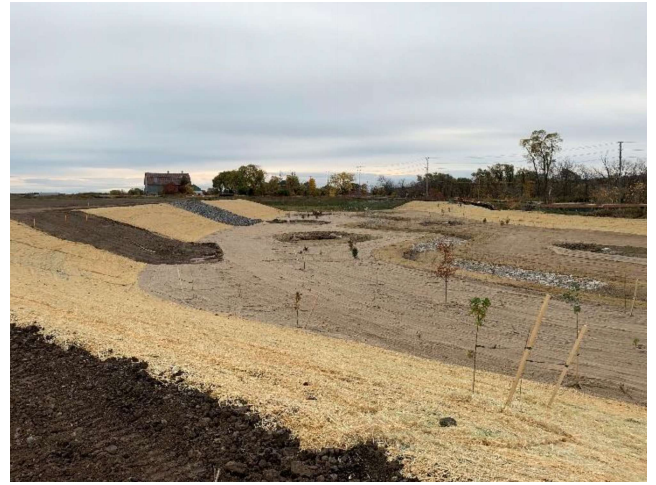
Photo 8: During construction Tributary A. South end of realignment facing Tremaine Road (southeast). Off-line floodplain

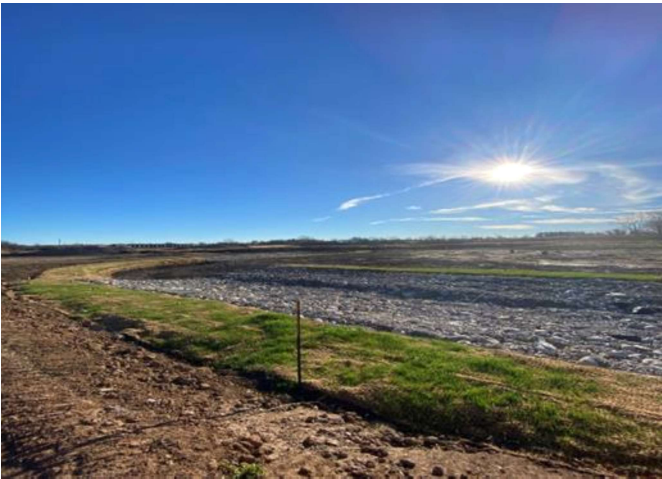
Photo 9: During construction Tributary A. Rock lined channel facing north.

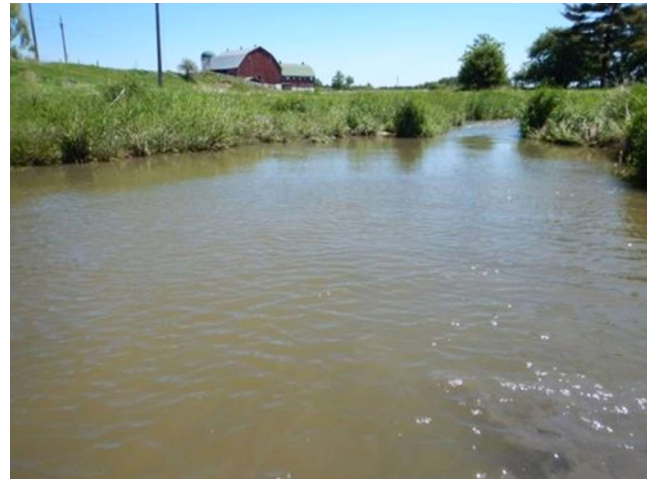
Photo 10: Pre-construction Indian Creek (2014). At Tremaine Road approximately 1 km northwest of Lower Baseline Road. Facing downstream (east)

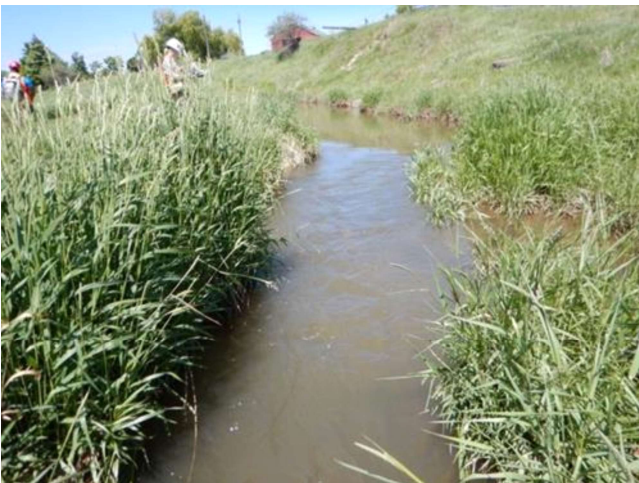
Photo 11: Pre-construction Indian Creek (2014). Approximately 300 metres downstream (east) of Tremaine Road. Facing west.

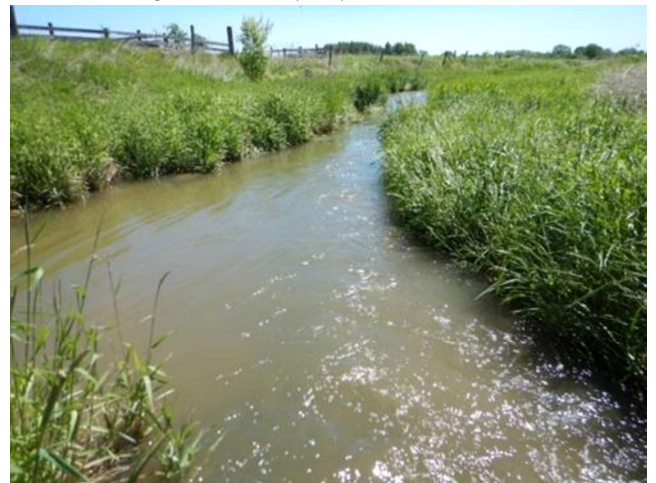
Photo 12: Pre-construction Indian Creek (2014). Approximately 300 metres downstream (east) of Tremaine Road. Facing downstream (east)

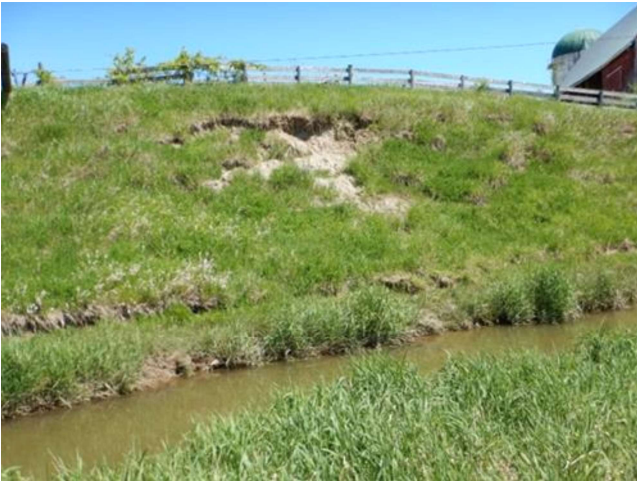
Photo 13: Pre-construction Indian Creek (2014). Approximately 250m downstream (east) of Tremaine Road. Facing the downstream left eroded bank.

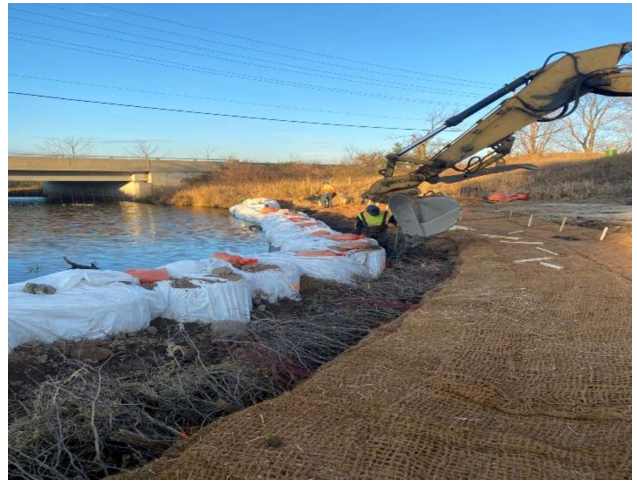
Photo 14: During construction Indian Creek (2022). Approximately 1 km northwest of Lower Baseline at Tremaine Road. Downstream left bank rehabilitation. Facing upstream (southwest)

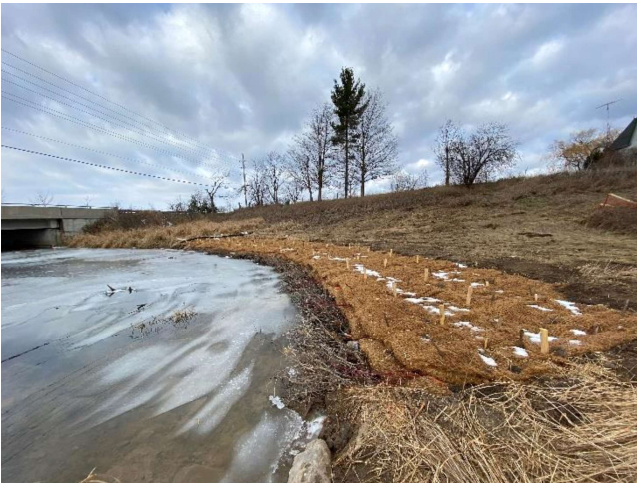
Photo 15: During construction Indian Creek (2022). Stabilized upstream right bank. Facing upstream (southwest)

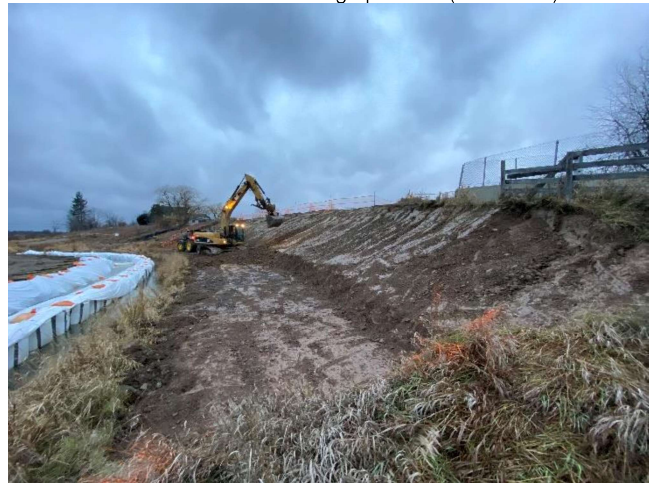
Photo 16: During construction Indian Creek (2022). Approximately 200 downstream (northeast) of Tremaine Road. Regrading downstream left eroding bank. Facing upstream (southwest).

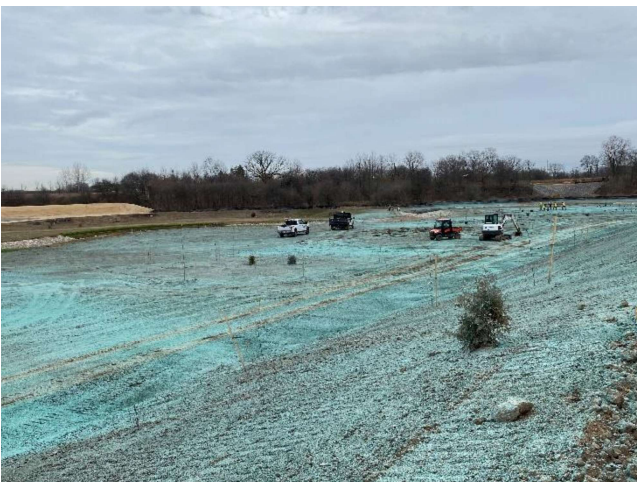
Photo 17: During construction Indian Creek floodplain (2022). Hydroseeding and tree planting
