RE: Deceased White-tailed Deer Fawn

newgoldTM Rainy River

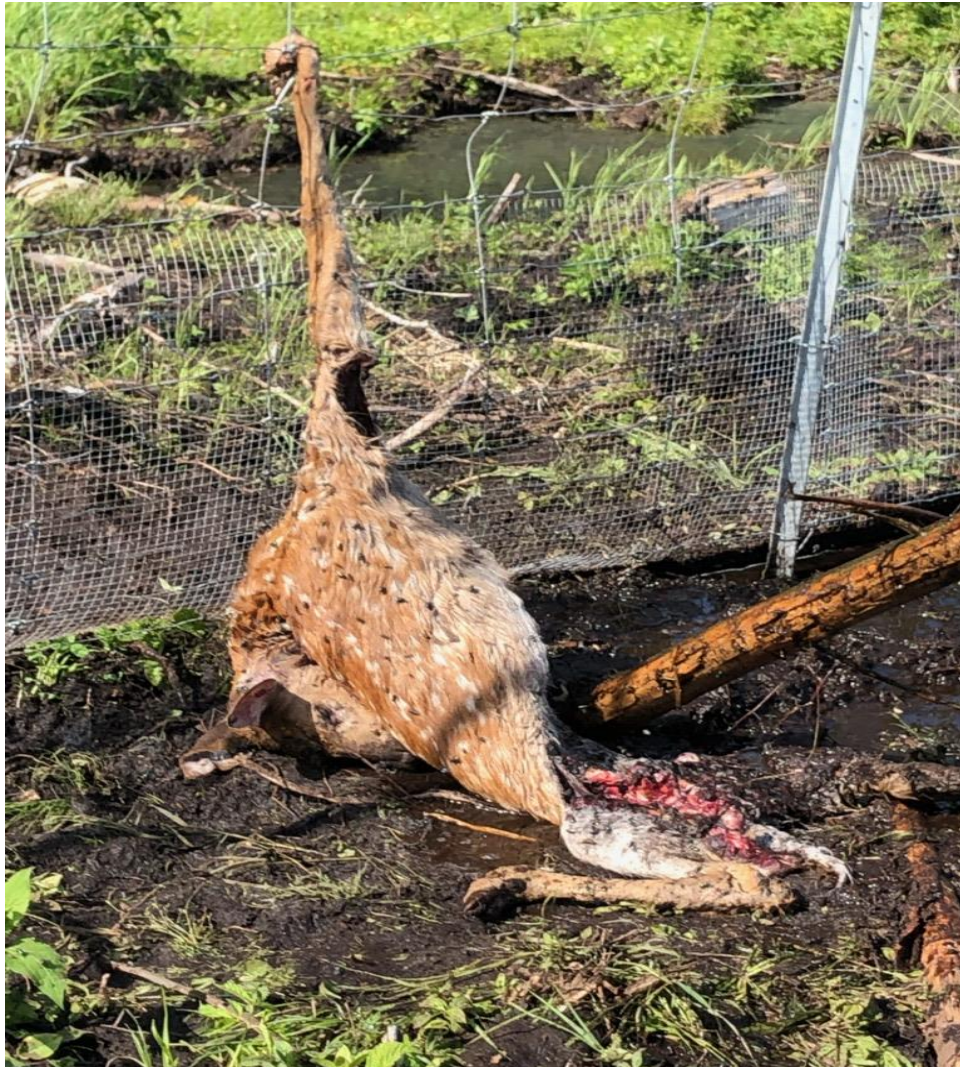
On July 12th, 2019 at 0705 a deceased White-tailed Deer Fawn was discovered entangled in the Wildlife Exclusion Fence. (See photo 1 below)

The Wildlife Exclusion Fence is over 14 kilometers long and not visible along its entirety. The services of a trapper are retained by New Gold. As part of his normal duties he patrols the fence to keep incidents like this from happening and ensure the fence is in good repair. His assessment of the tracks in the area led to the conclusion that a black bear had chased the fawn into and through the fence, which caused it to become entangled and die of exhaustion.

3.1. Location	Wildlife Exclusion Fence		UTMs	E:	N:
3.2. Species	Deer		Number of Animals:	1	
3.3. Description of Incident and Outcome	A Deer fawn was discovered entangled in the Wildlife Exclusion Fence and likely died of exhaustion. The tracks in the mud around the area lead the trapper to come the conclusion that a bear chased the fawn from the outside into the fence where it became entangled.

Should further incidents occur patrols may be increased and other options may also be explored.
