APPLICATION FOR AN
ENVIRONMENTAL ASSESSMENT CERTIFICATE /
ENVIRONMENTAL IMPACT STATEMENT
ASSESSMENT OF POTENTIAL SOCIAL EFFECTS

7.2.8 Visual Resources

This section presents potential effects of the proposed Blackwater Gold Project (the Project) on the Visual Resources Valued Component (VC). Two assessments were essentially carried out—one for baseline and one for Project Effects.

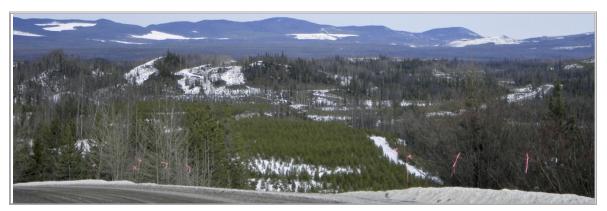
Photo 7.2.8-1: View from the Kluskus-Ootsa FSR onto the Davidson Creek Basin

Most of the visual resources study areas are strongly influenced by silviculture practices and the associated heavy vehicle traffic along the Kluskus FSR (**Photo 7.2.8-1**). Forest cut blocks have altered the natural setting. In particular, forests within the mine site RSA are characterized by differing stand heights, clear-cuts, and monoculture planting patterns.

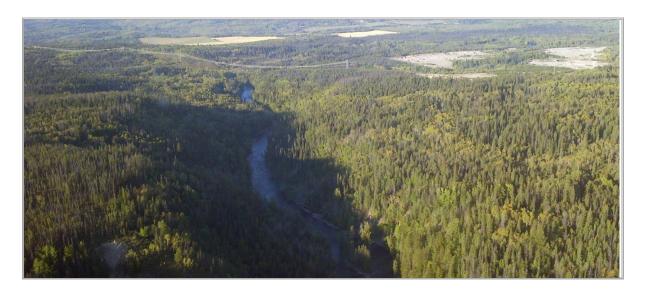
Photo 7.2.8-2: View of the Stellako River Valley crossing point near the existing transmission lines as seen from an aircraft

The transmission line alignment traverses the Stellako WMA, crossing the river valley 5 km downstream from its natural outflow of Francois Lake. The Stellako River VSU is within the WMA and has High visual sensitivity. The VSU is designated as Retention VQO, which prescribes that alterations should not be easily distinguishable from pre-construction landscapes to avoid alteration that could cause public concern.

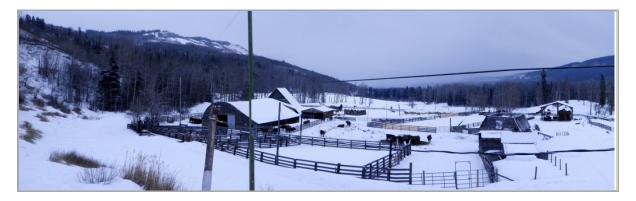
Photo 7.2.8-3: View East along Nithi Road toward Nithi Mountain (VP-12)

An area of High recreational significance spans Nithi Mountain. The mountain is located in an agricultural setting and is used primarily for rangeland and forestry practices, with many cut blocks evident along its central and eastern flanks. No locations were identified where recreational users congregate for a prolonged duration of time. An observation point was located at the Steiner Ranch in the Nithi Valley, where distant views are possible from some private land holdings located in the Nithi Valley to Nithi Mountain; (**Photo 7.2.8-3**).

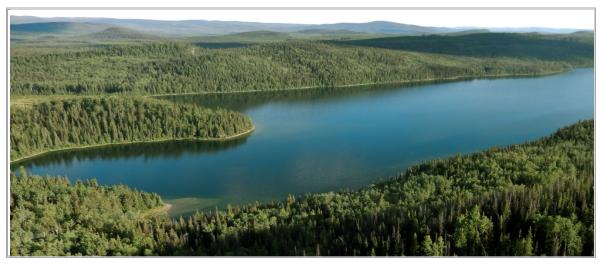
Photo 7.2.8-4: North Section of Tahultzu Lake with High Recreation Significance as seen from an aircraft

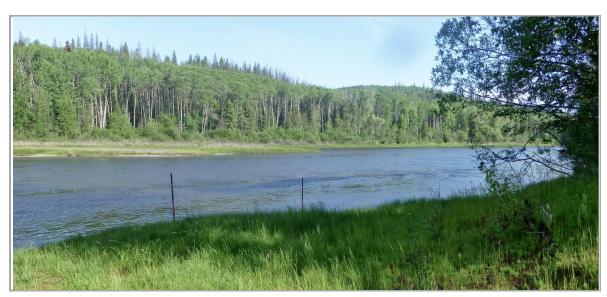
Photo 7.2.8-5: Downstream View of the Nechako River Valley from the Greer Creek Recreation Area

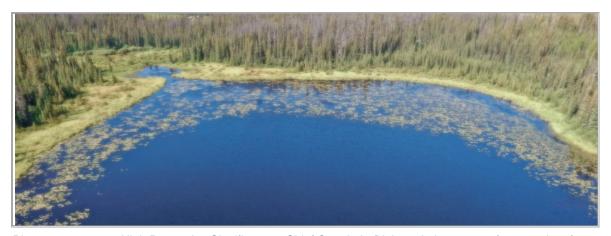
Photo 7.2.8-6: High Recreation Significance - Chief Gray Lake/Hobson Lake as seen from an aircraft

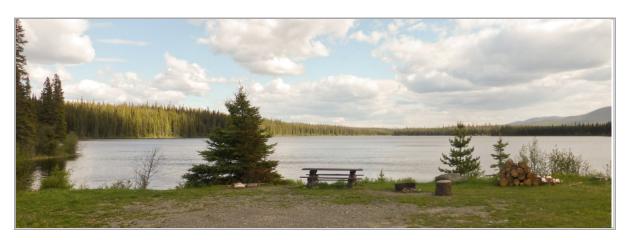
Photo 7.2.8-7: View Southeast, Viewpoint in the Brewster Lake Recreation Site

The Visual Resources Baseline Report highlighted this area as having the highest scenic quality in the visual resources study areas (**Photo 7.2.8-7**). The area is designated High recreation significance. From the main viewpoint in the Brewster Lake recreation site, scenic vistas span across a lake. The area is within a carefully managed viewscape, surrounded by a VSU with High visual sensitivity (**Figure 7.2.8-12**).

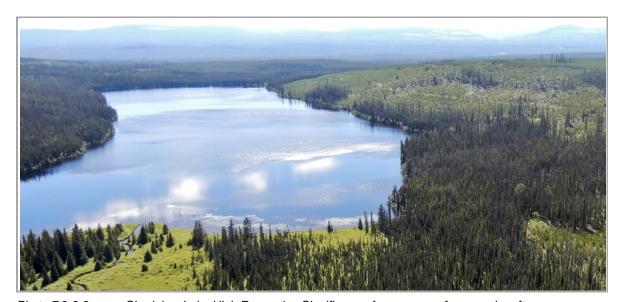
Photo 7.2.8-8: Chedakuz Lake High Recreation Significance Area as seen from an aircraft

No locations were identified where users congregate. A natural depression surrounds the two lakes, resulting in visibility being constrained within the immediate vicinity. The Chedakuz Lakes are located within an SPNM Access Zone. The area is not widely used according to local reports due to difficulty of access.

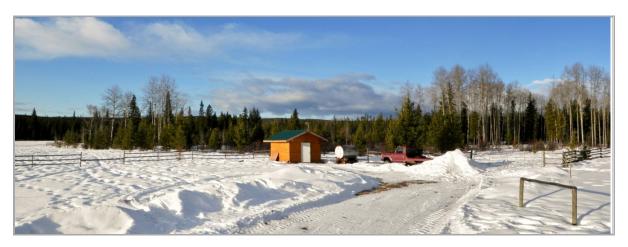
Photo 7.2.8-9: View toward the Mine Site – Tatelkuz Lake Ranch Resort (VP-01)

The Tatelkuz Lake Ranch Resort is located within a VSU with Very High visual sensitivity at the north section of Tatelkuz Lake (**Photo 7.2.8-9**). The resort accommodates visitors interested in recreational activities focusing on the lake.

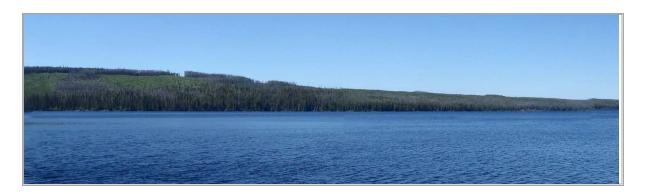
Photo 7.2.8-10: View in the Direction of the Mine Site from Tatelkuz Lake

Artificial light emanating from the mine site may be visible in the southwest skyline at night. As the mine site is located approximately 13 km from this viewpoint, artificial light effects can be minimized with the application of appropriate mitigation.

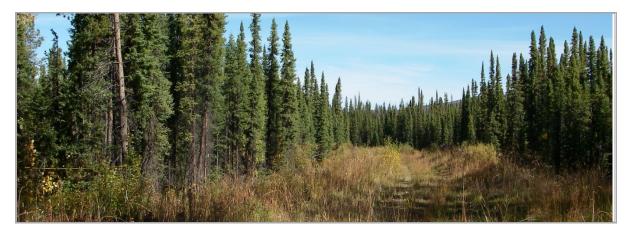
Photo 7.2.8-11: View toward the Mine Site from the Crossing Point of the Fresh Water Pipeline and the Messue Wagon Road Trail

The Messue Wagon Road Trail follows the contours along the west bank of the lake in dense forest. The trail is reportedly not heavily used. The mine site will not be visible to users of the trail as a result of the dense forest cover and undulating terrain. However, trail users may encounter the crossing points of both the fresh water pipeline and the transmission line (**Photo 7.2.8-11**). Since the mine site will not be visible from the trail, there is no expected visual effect.

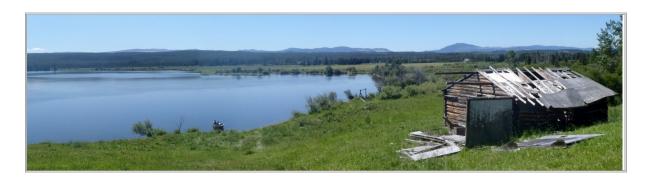
Photo 7.2.8-12: View towards Mount Davidson – Tatelkus Lake IR 28 (VP-02)

The terrain rises in elevation along the east bank of Tatelkuz Lake so that certain areas of the mine site become visible in the far distance as line of sight with some mine site facilities occurs above the ridgeline along the west bank. Viewshed analyses were generated from a cabin on the Tatelkus Lake IR 28 (**Photo 7.2.8-12**), Dykam Ranch, and the Tatelkuz Lake Southeast Recreation Reserve, indicating similar results with line of sight occurring with mine site facilities located on the higher elevations of Mount Davidson.

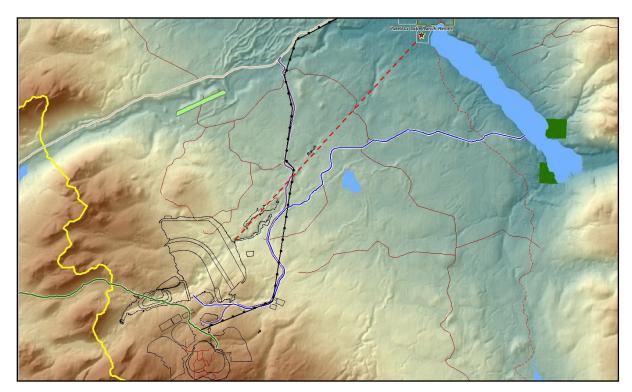
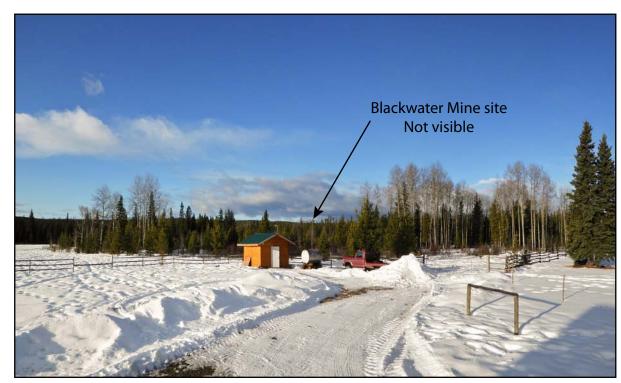
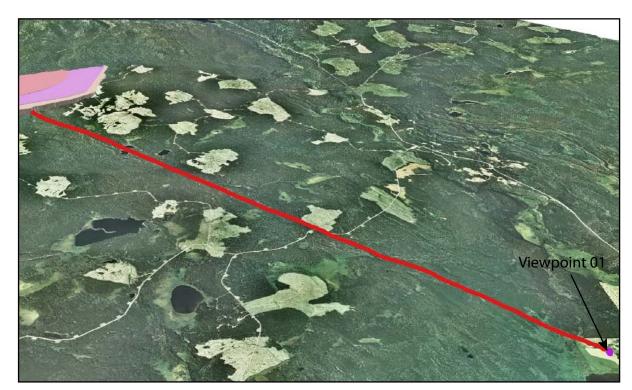
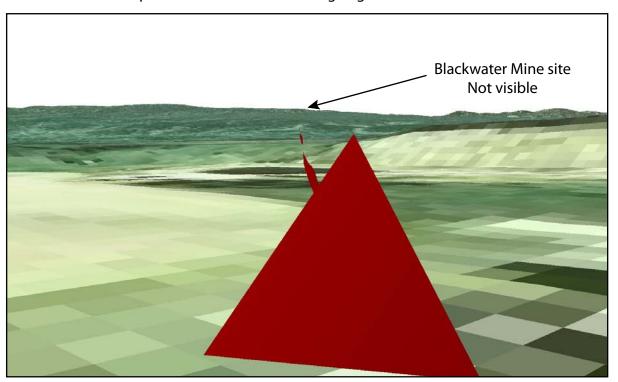
Viewpoint 01 location and bearing angle illustration in 2D View

Viewpoint 01 location and bearing angle illustration from field

Viewpoint 01 location and bearing angle illustration in 3D Arscene

Viewpoint 01 location and bearing angle illustration simulation in 3D Arcscene

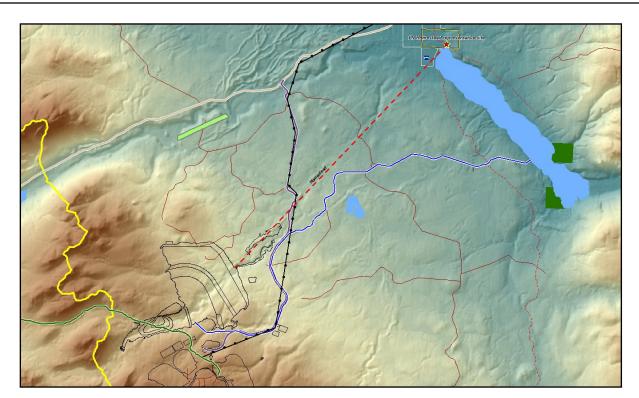
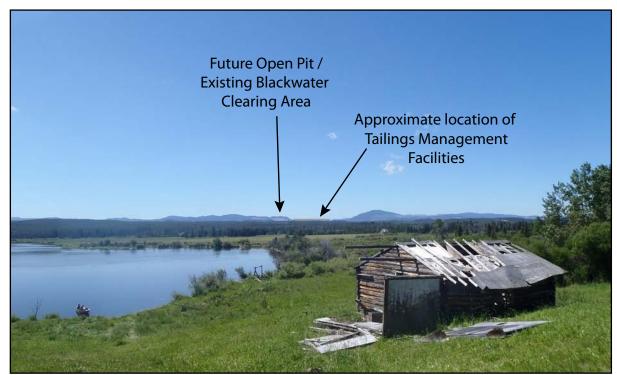
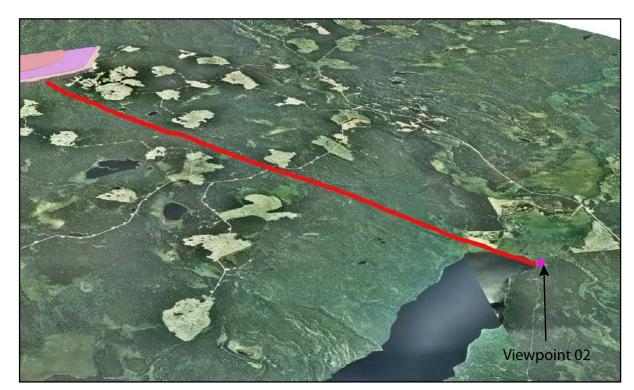
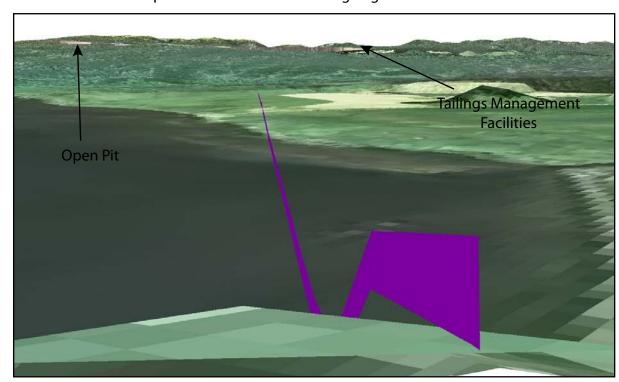
Viewpoint 02 location and bearing angle illustration in 2D View

Viewpoint 02 location and bearing angle illustration from field

Viewpoint 02 location and bearing angle illustration in 3D Arscene

Viewpoint 02 location and bearing angle illustration simulation in 3D Arcscene

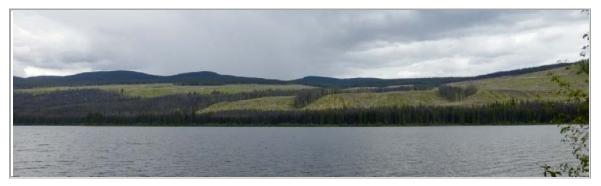
Photo 7.2.8-14: View from Top Lake toward the Fawnie Range (VP-03)

An area of High recreation significance surrounds Top Lake (**Photo 7.2.8-14**). The recreation site includes two campgrounds. The Vanderhoof Access Management Plan allows for a low degree of motorized access. No VSUs are present in the area.

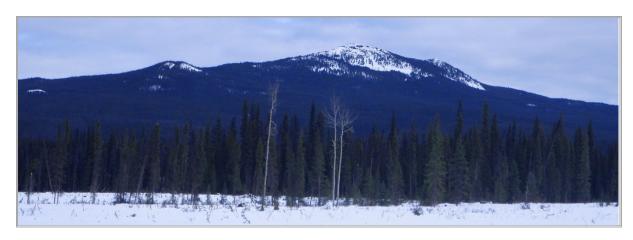
Photo 7.2.8-15: View toward the West-facing Slopes of Mount Davidson (VP-05)

The Mount Davidson Peak Site is located immediately south of the mine site. Mount Davidson is one of the most prominent features within the viewscape and is visible from many vantage points. Much of the evaluation site is located at a high elevation and spans the boundary between the Upper Eutsuk Lake and Lower Nechako Reservoir regional watersheds (**Photo 7.2.8-15**).

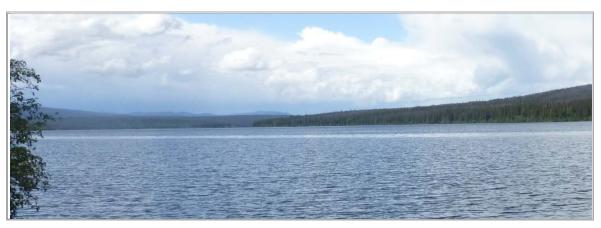
Photo 7.2.8-16: View from Kuyakuz Lake toward the Fawnie Range (VP-04)

The Kuyakuz Lake Recreation Site is located on the south shores of the lake with numerous camping sites offering rustic facilities to recreational users. The Chedakuz Creek valley presents a viewscape toward the mine site to the west-northwest, flanked by the Nechako and Fawnie Mountain Ranges.

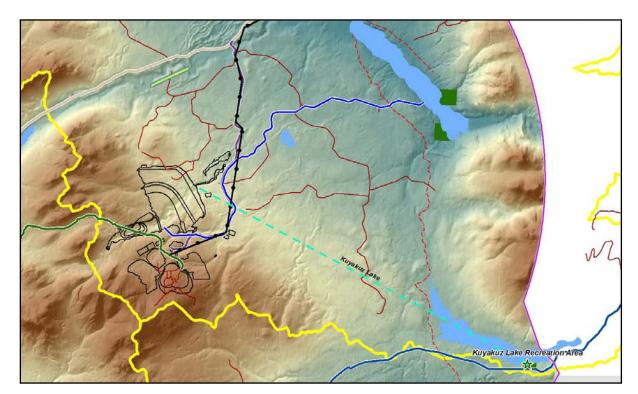
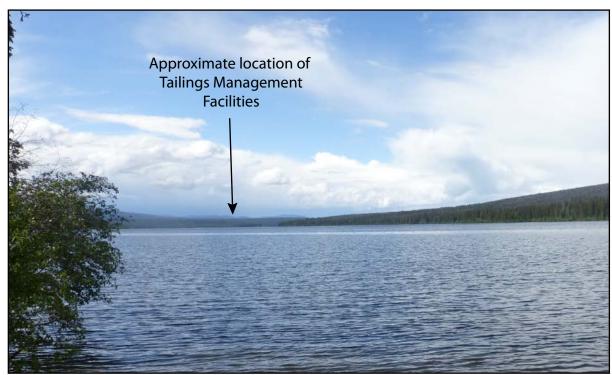
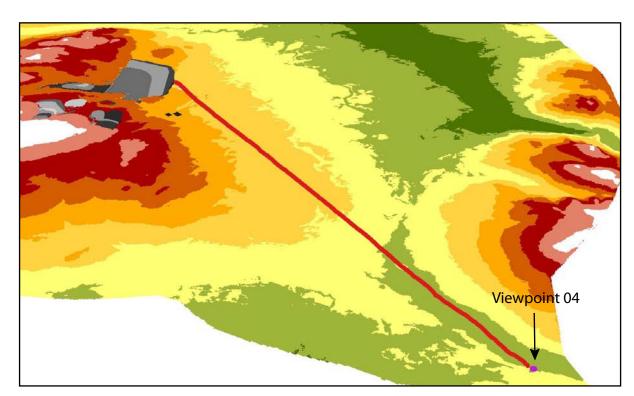
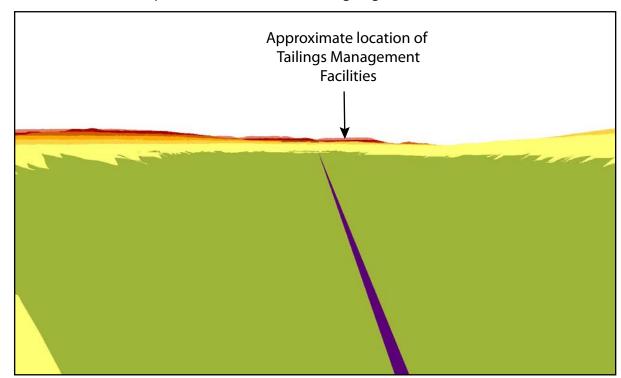
Viewpoint 04 location and bearing angle illustration in 2D View

Viewpoint 04 location and bearing angle illustration from field

Viewpoint 04 location and bearing angle illustration in 3D Arscene

Viewpoint 04 location and bearing angle illustration simulation in 3D Arcscene
