**BRUCEJACK GOLD MINE PROJECT**  
Application for an Environmental Assessment Certificate /  
Environmental Impact Statement

Screening of Stream Crossings against the MWWO

**DATE:** December 18, 2013  
**TO:** Max Holtby (Pretium Resources Inc.)  
**FROM:** Jaclyn Bowman and Ali Naghibi (ERM Rescan)  
**CC:** Greg Norton and Nicole Bishop (ERM Rescan)  
**SUBJECT:** Screening of Stream Crossings against the Minor Memorandum - Works and Waters Orders under the *Navigable Waters Protection Act*

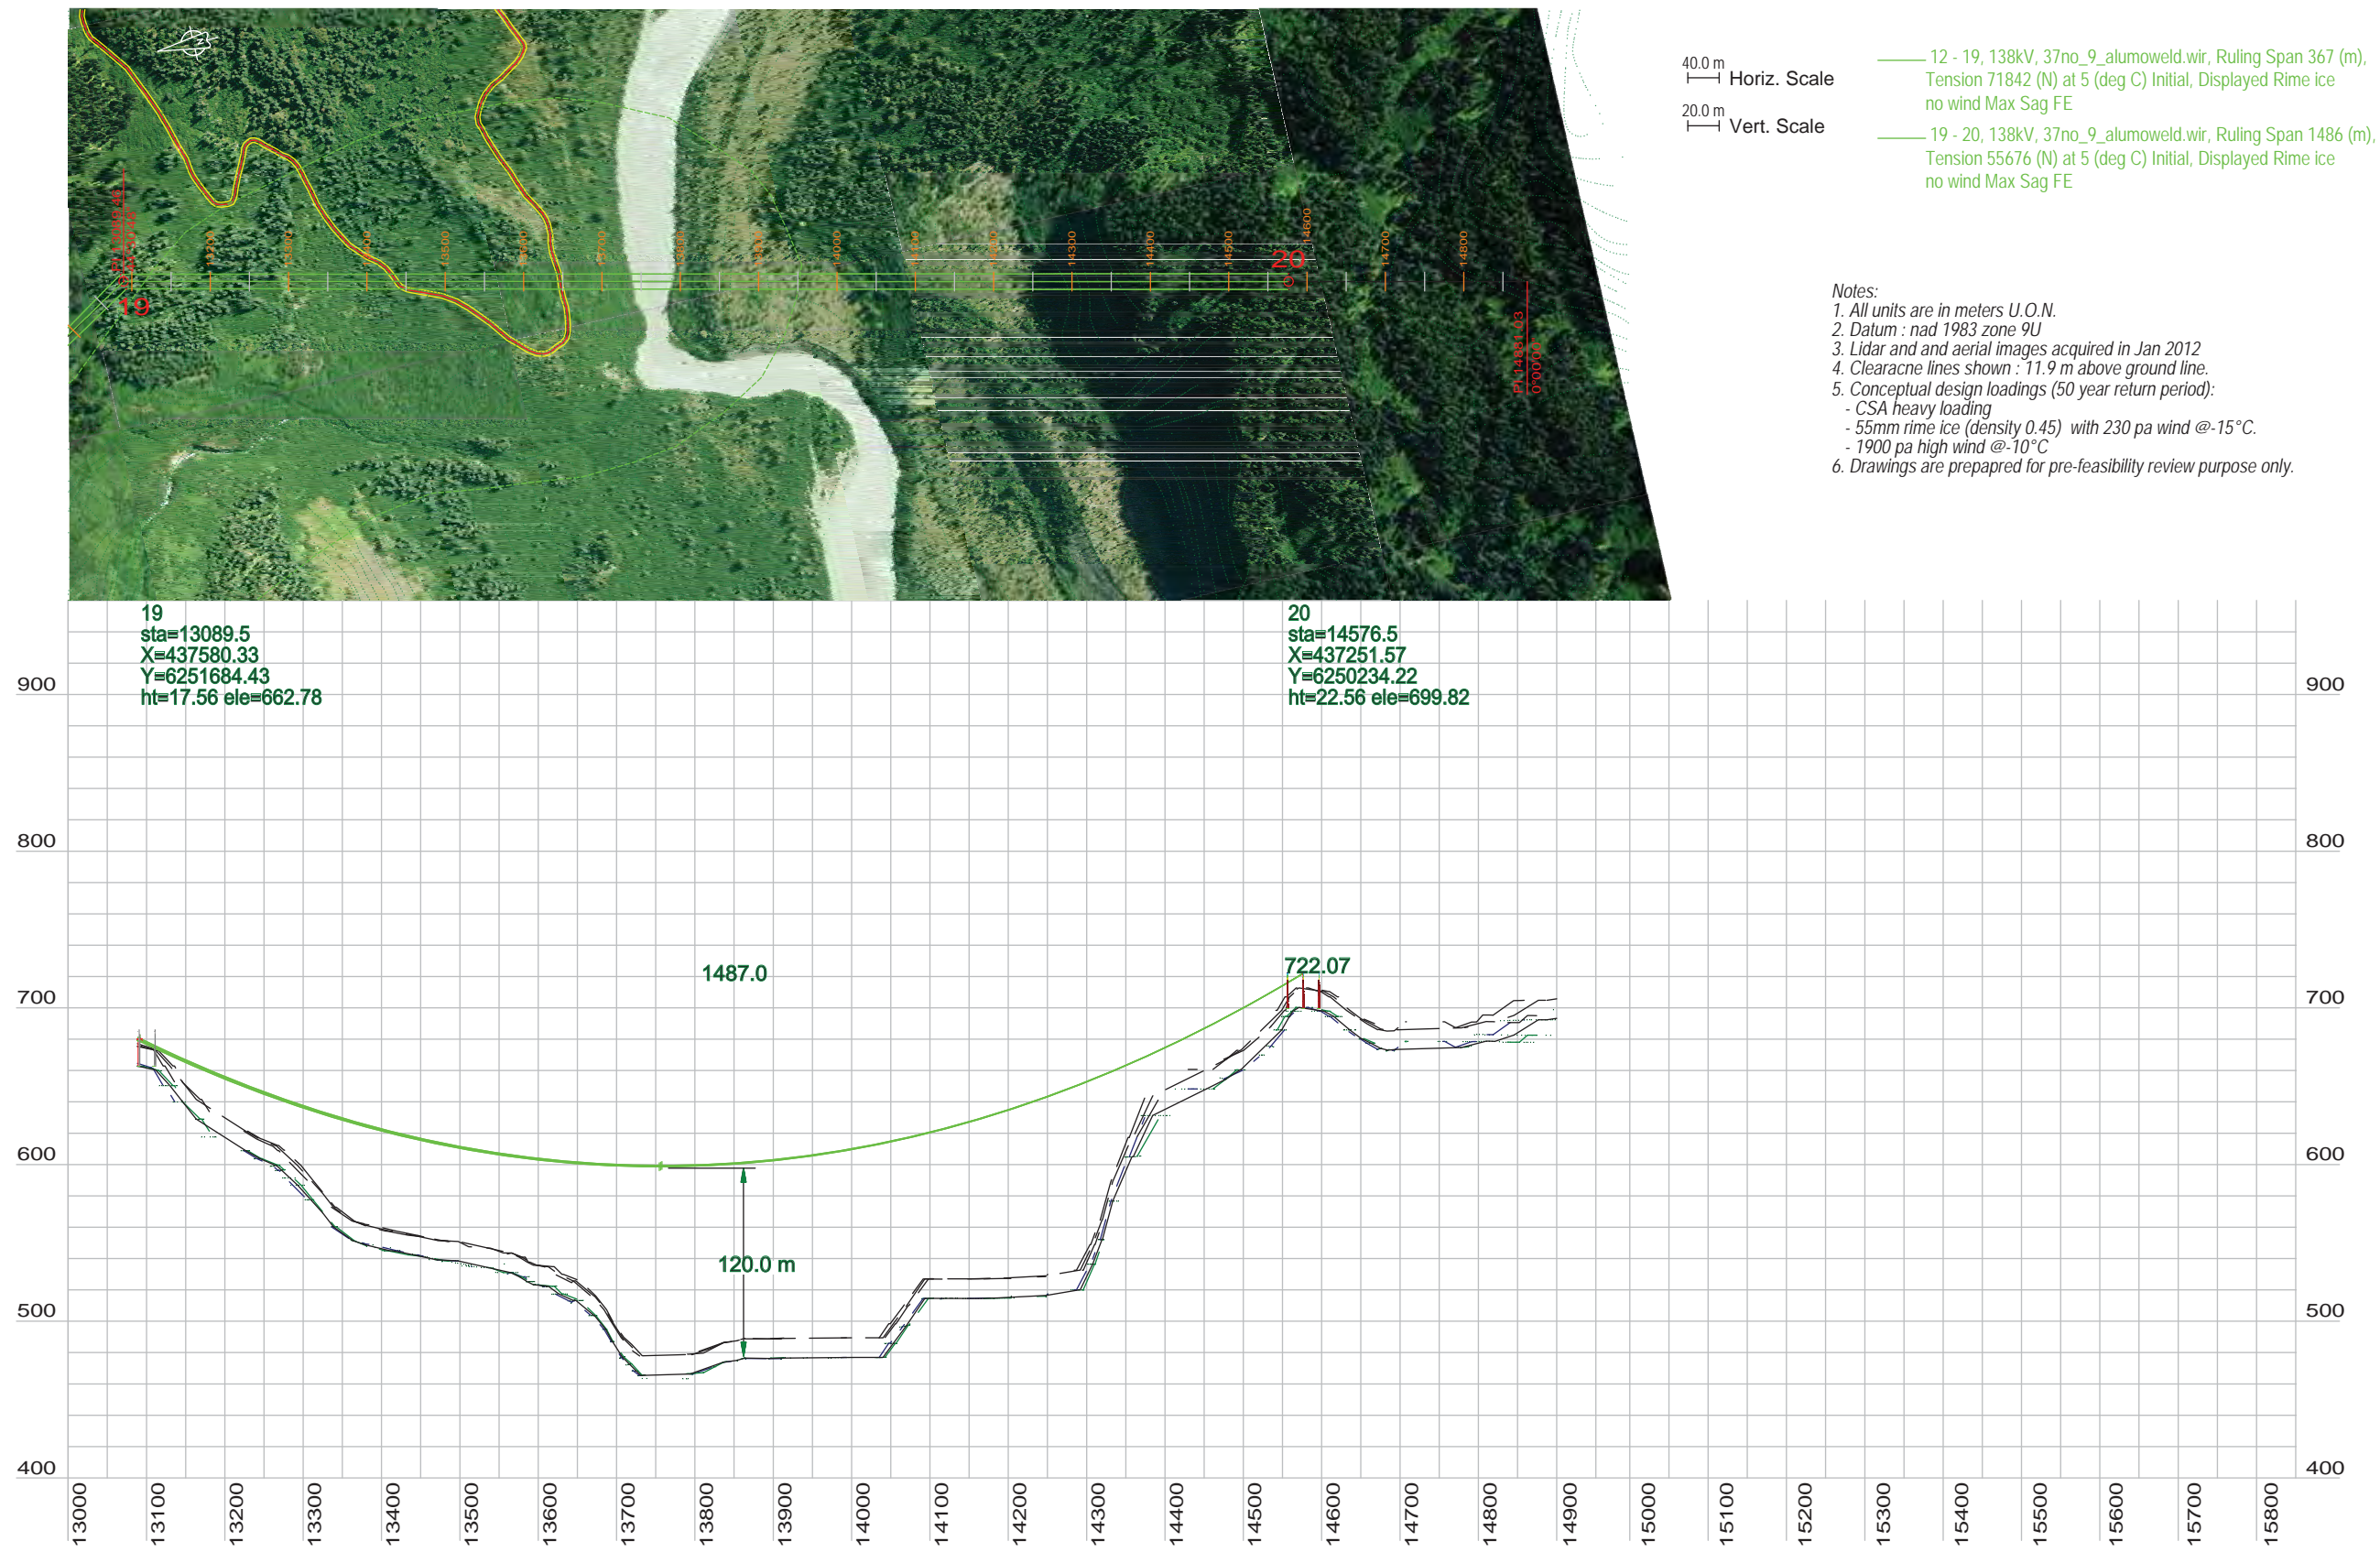
Figure A-1  
Transmission Line Crossing over Bowser River (Crossing Site No. 800)

<sup>2</sup> In the absence of further information, it was assumed that none of the streams are charted navigable waters or accessible to the public. One exception was crossing site no. 800 over Bowser River that was assumed accessible to the public.

<sup>3</sup> The plan and cross-section views for this crossing site are shown in Figure A-1.

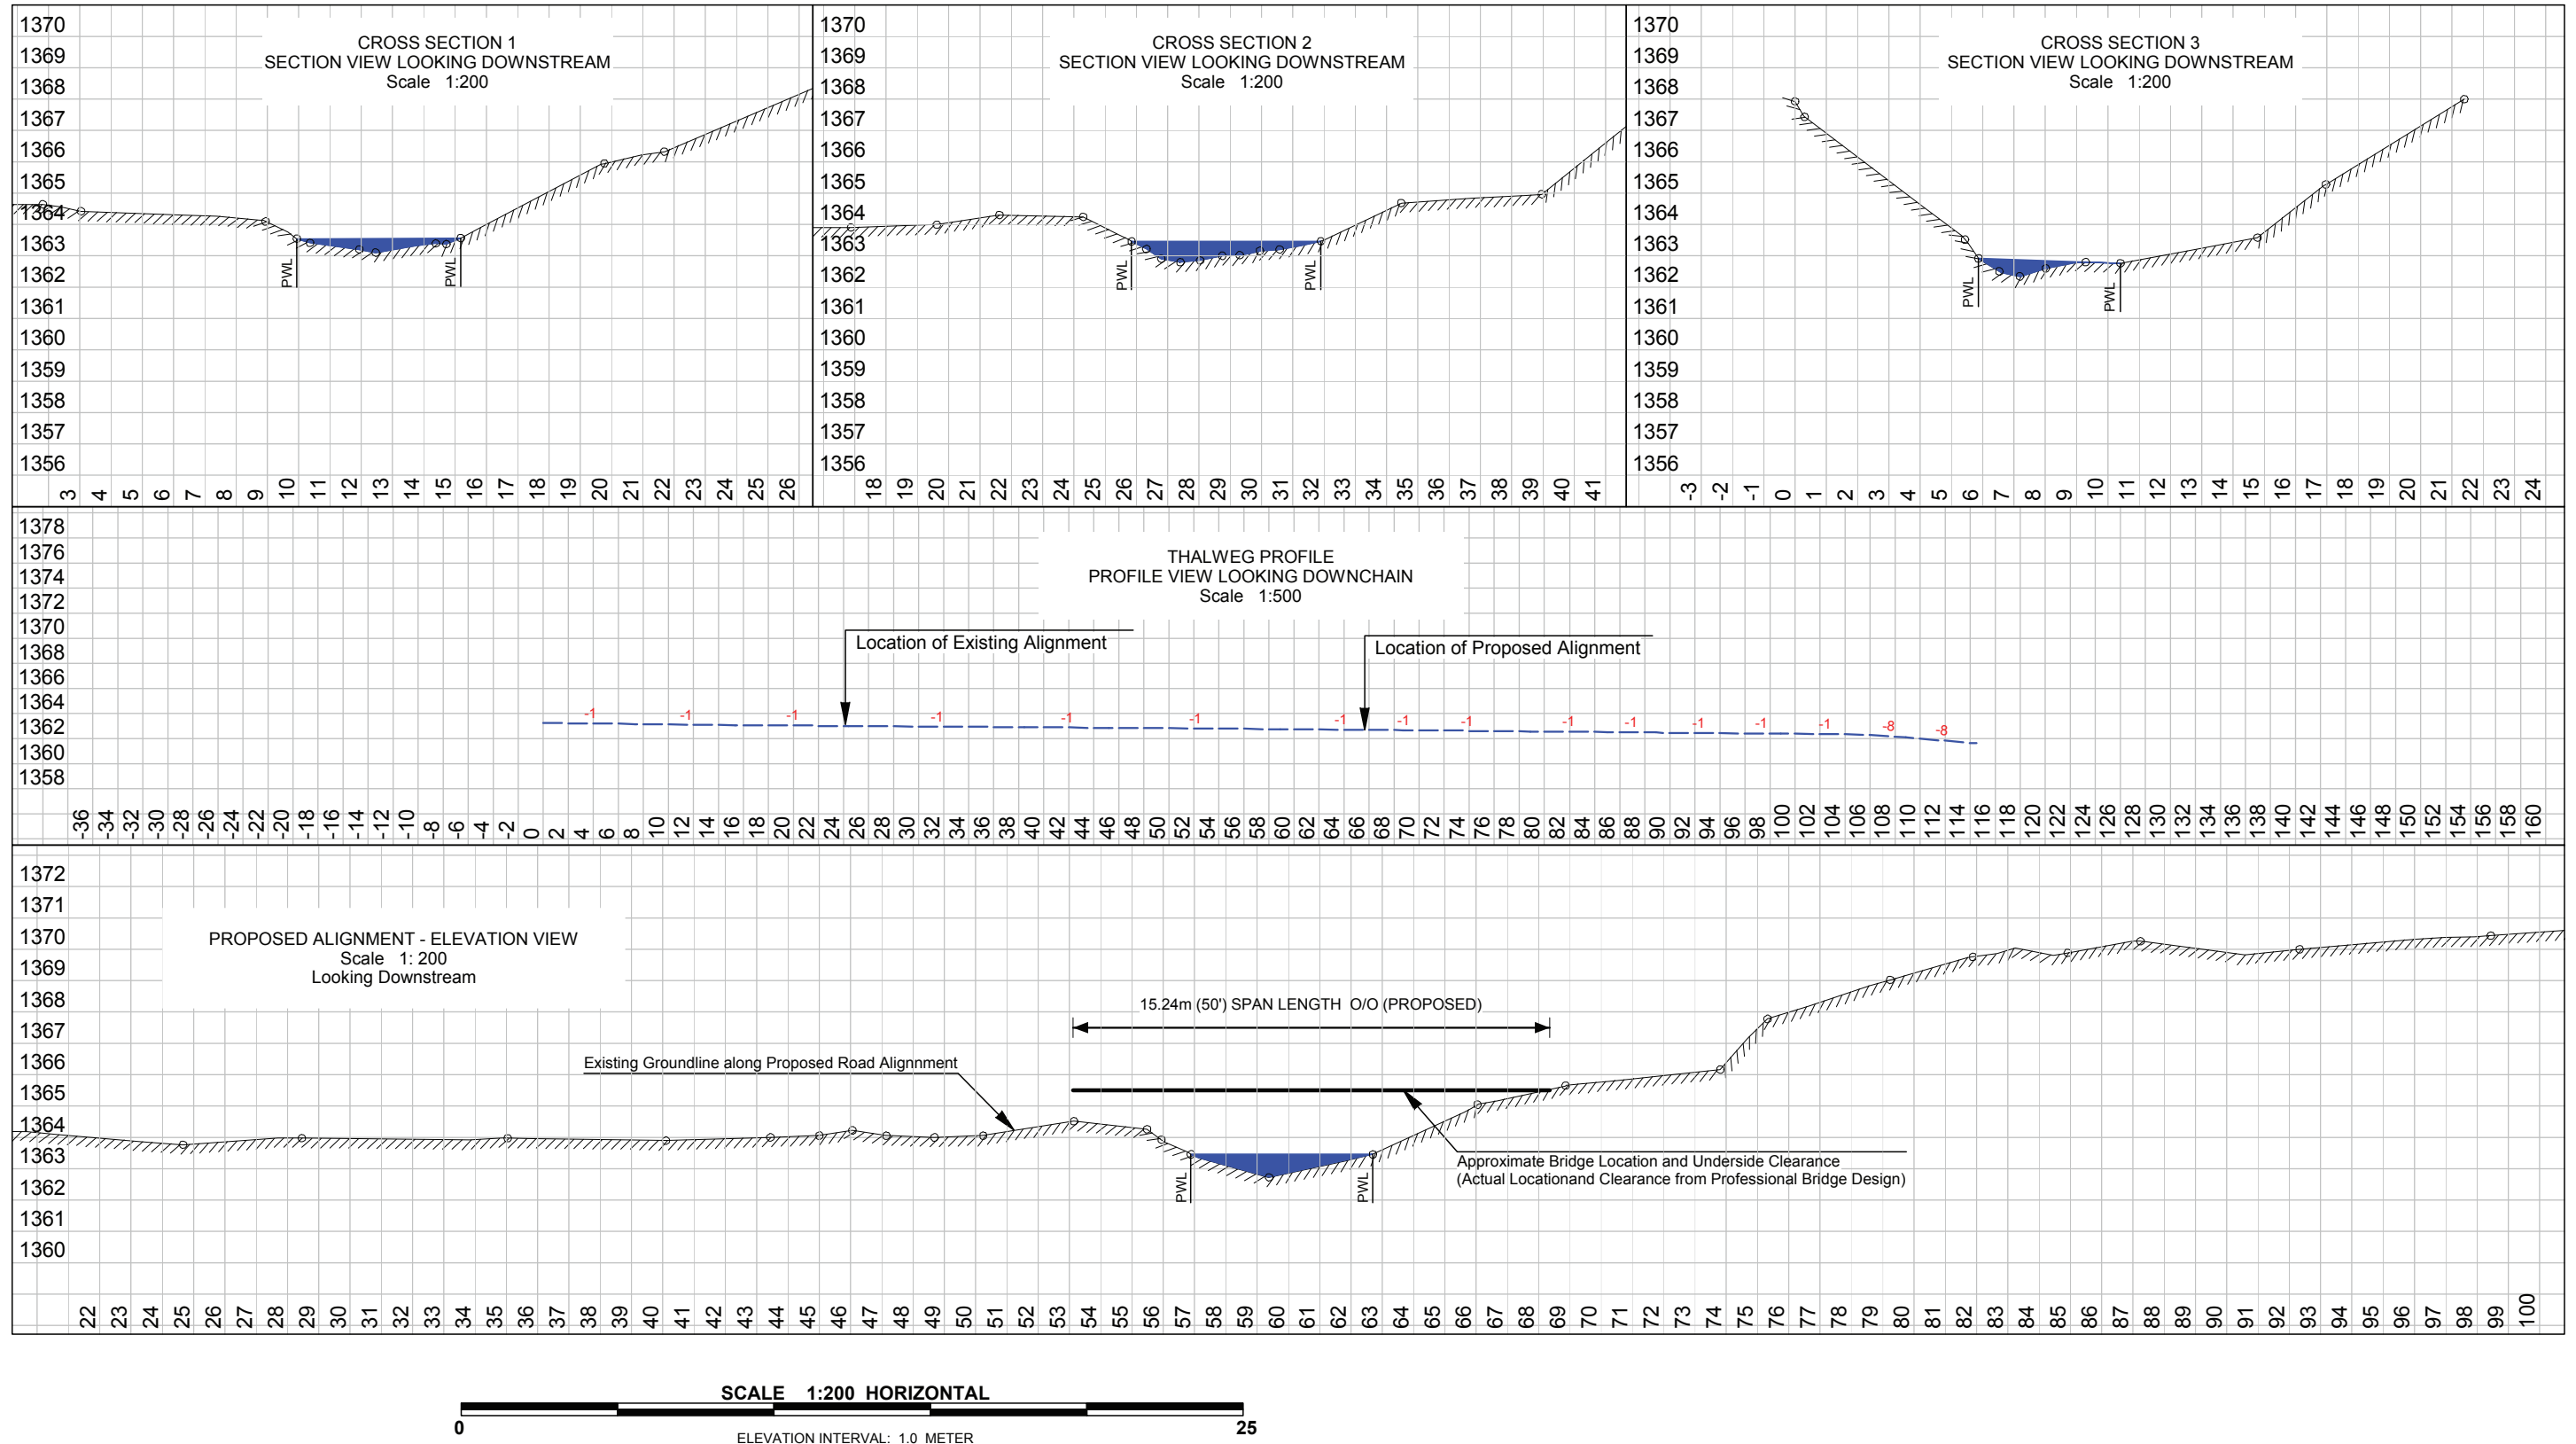
**Figure A-3**  
**Preliminary Cross Section View of the Road Crossing over Brucejack Creek**

One road crossing over Brucejack Creek was identified (Figures 1, A-2, and A-3). The approximate easting and northing coordinates of the crossing are 426,420 and 6,258,900 m, respectively.

Based on the preliminary drawings of the proposed road crossing (Figures A-2 and A-3), the Brucejack Creek width at high water level is greater than 3 m, therefore the crossing cannot be exempted from submission of an application under the NWP based on Transport Canada (2010) *minor waters* guideline.
