**BRUCEJACK GOLD MINE PROJECT**  
Application for an Environmental Assessment Certificate /  
Environmental Impact Statement

**Brucejack Project - Preliminary Identification of  
Geohazards for the Proposed Transmission Line**

<b>To:</b>	<b>Pretium Resources Inc.</b>	<b>Doc. no:</b>	<b>BJ-2012-26</b>
<b>Attention:</b>	<b>Ian Chang</b>	<b>cc:</b>	<b>Mike Wise</b>
<b>From:</b>	<b>Betsy Waddington</b>	<b>Date:</b>	<b>24 September 2012</b>
<b>Subject:</b>	<b>Brucejack Project – Preliminary Identification of Geohazards for the Proposed Transmission Line</b>		
<b>Project no:</b>	<b>1008-007-013-02</b>

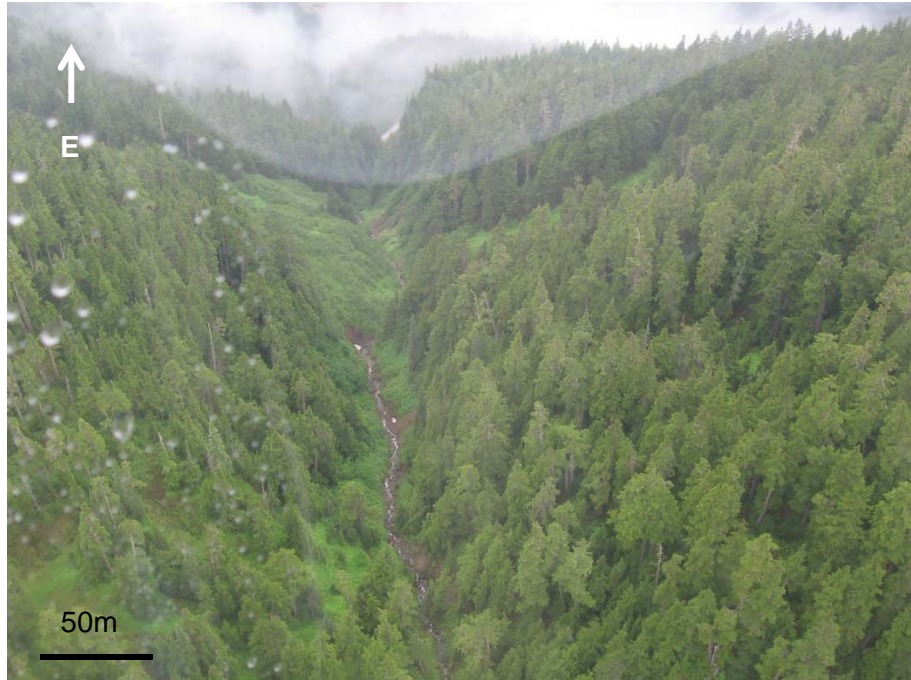
**Photograph 2-1. Looking upslope at a debris flow gully at approximately 12.5 km, transmission line crosses below photo. Gullies of this type can be spanned. Locating towers above the gully side-slopes will avoid any marginally stable slopes on gully sidewalls.**

<b>Kilometer from Stewart</b>	<b>Potential Hazard</b>
12.5 (<50m wide)	debris flow (Photo 2-1)
20.2 (<50m wide)	debris flow
21.5 (<50m wide)	debris flow
33.7 (<50m wide)	flood, channel avulsion, scour (Photo 2-2)
36.5 (50-150m wide)	flood, channel avulsion, scour
37.2 (50-150m wide)	flood, channel avulsion, scour
39.5 (200m wide)	rock fall
43.5 (350m wide)	rock fall (Photo 2-3)
50.3 (<50m wide)	rock fall
51 (200m wide)	Cross Bowser River, flood, channel avulsion, scour
54-64	rock fall

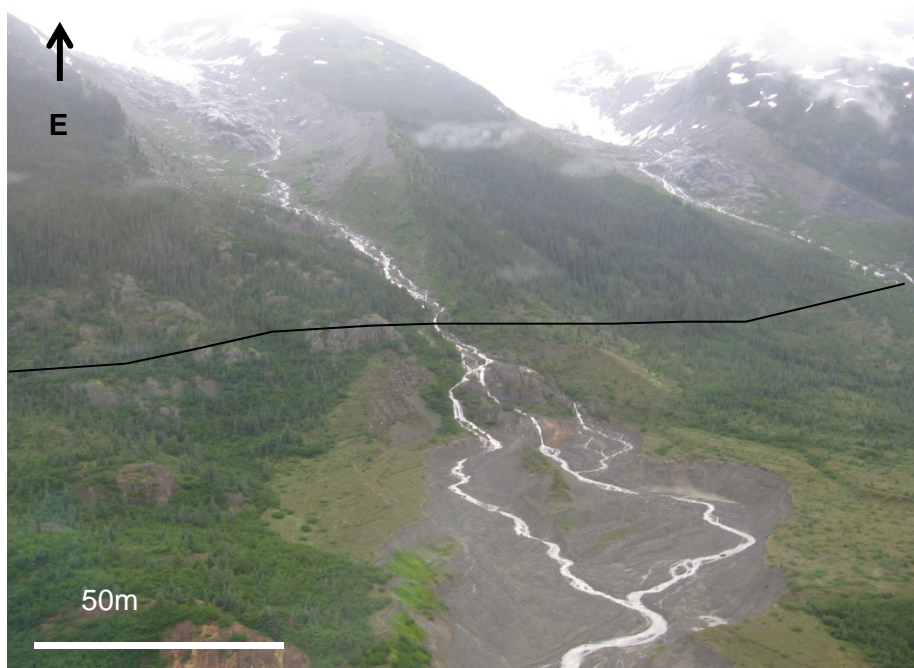
**Photograph 2-2. Active channel draining a glacier at approximately 33.5 km, approximate route of transmission line shown by black line. Crossing above the fan eliminates certain fluvial hazards.**

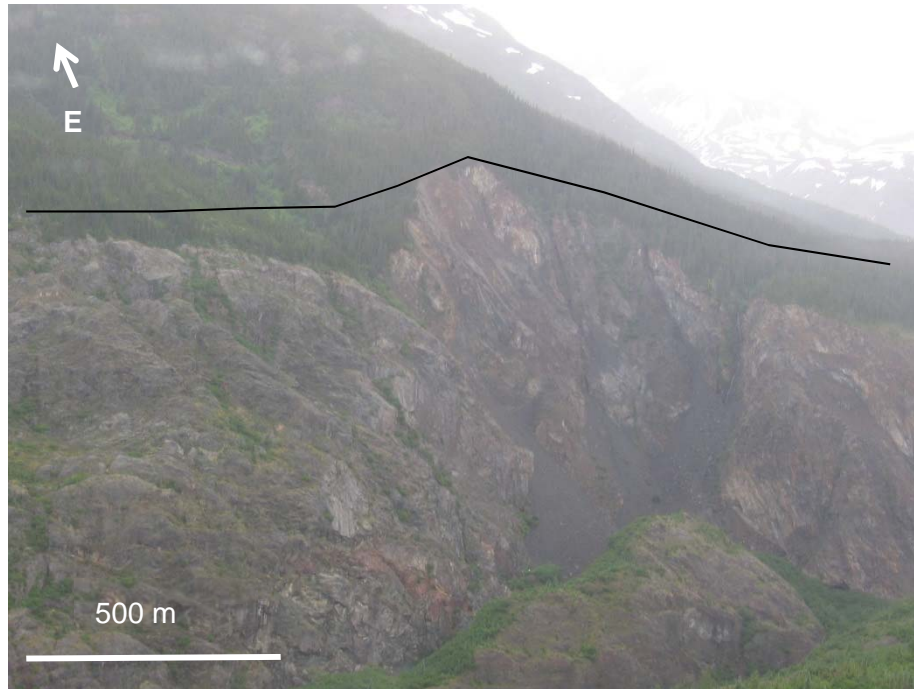
**Photograph 2-3. Area of active rock fall at approximately 43 km, approximate route of proposed transmission line shown in black. Retrogression of the rock face is possible at this location through progressive rock fall.**
