2018 Hydrogeological Field Data
Report

2018 Hydrogeological Field Data Report Crown Mountain Project, BC

SRK Consulting (Canada) Inc.
1CN028.002
January 2019

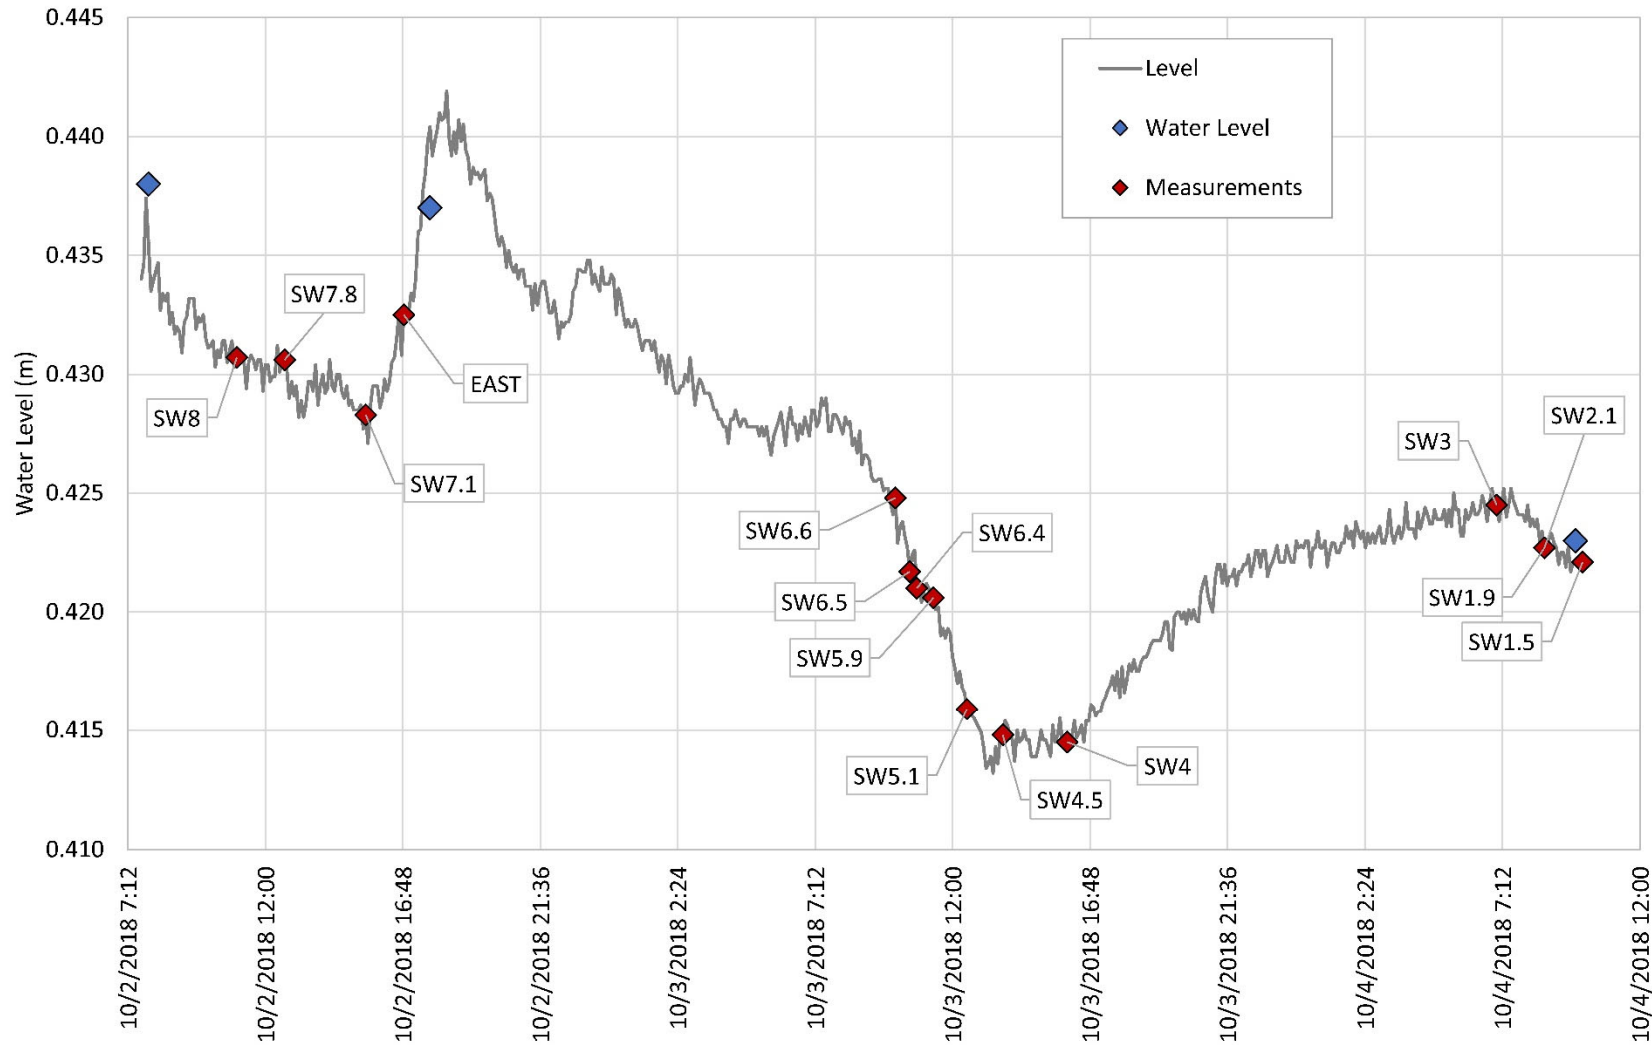
Figure 2. Continuous stage recorded at SW1.5. The total range of stage change at SW1.5 throughout the measurements was <2 cm (0.414 m to 0.433 m).
