# **Preliminary Field Reconnaissance**

Red Mountain Underground Gold Project  
Stewart, British Columbia

January 2016

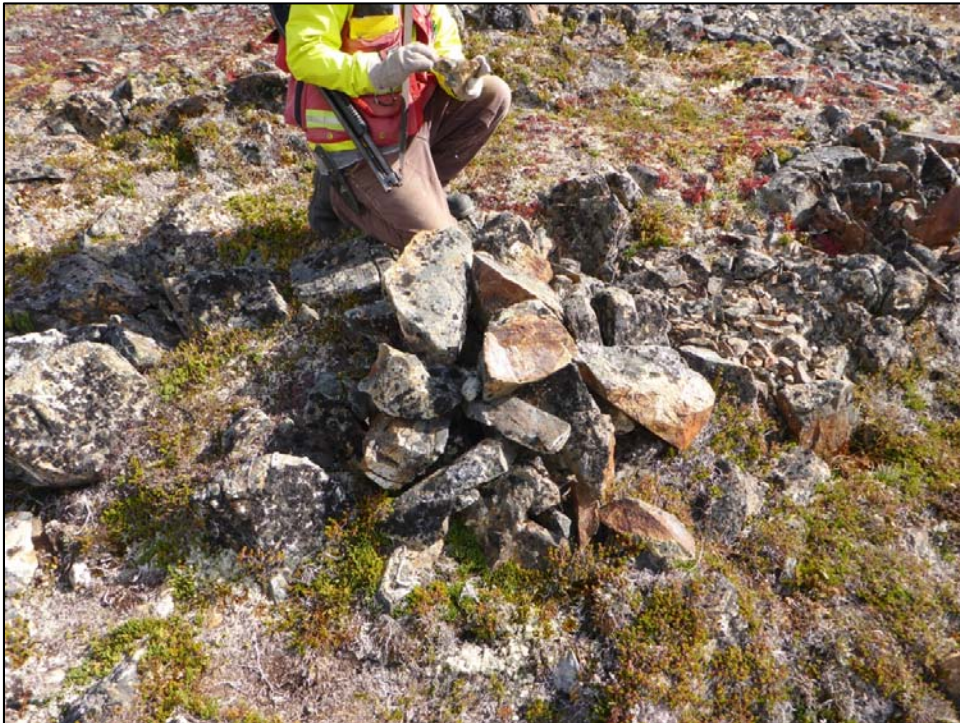
A small rock cairn was observed within the powerline right-of-way, south of the proposed mill site (Appendix, Image 4; Figure 3). The cairn is considered to be modern due to weathering and lichen growth patterns on individual stones which indicate that they were placed in their current positions recently. The cairn may have supported a survey stake or pole – several wooden stakes were observed in the area between the proposed mill site and tailings dam.

**Image 4:** Modern cairn located near powerline right-of-way, south of mill site.

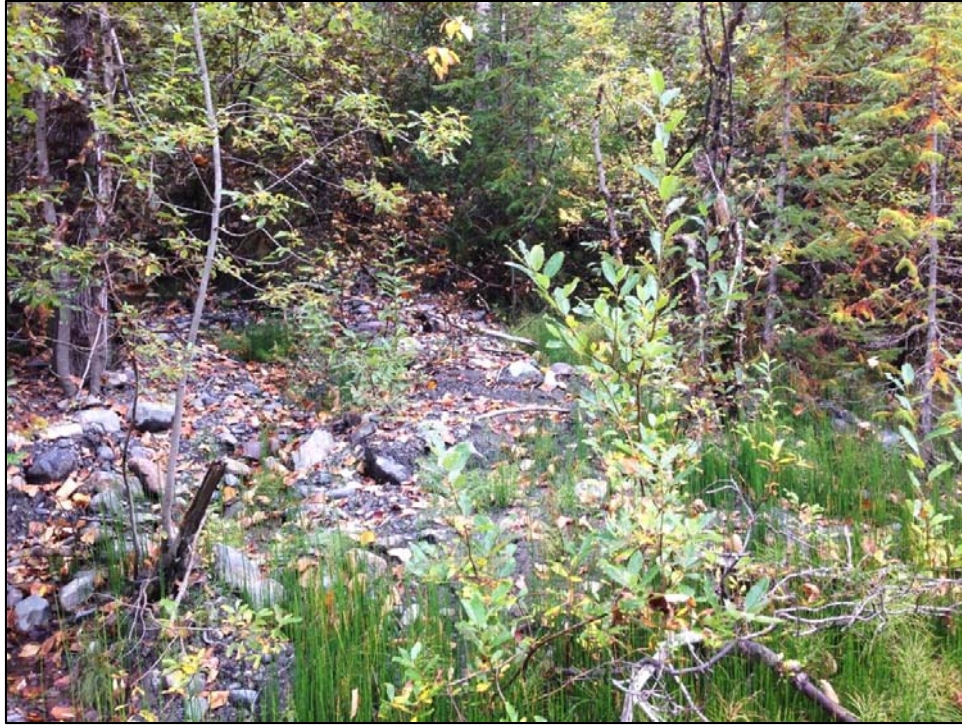
**Image 9:** View to slopewash debris and vegetation (willow and alder) indicating poorly-drained terrain, south of Hartley Gulch.

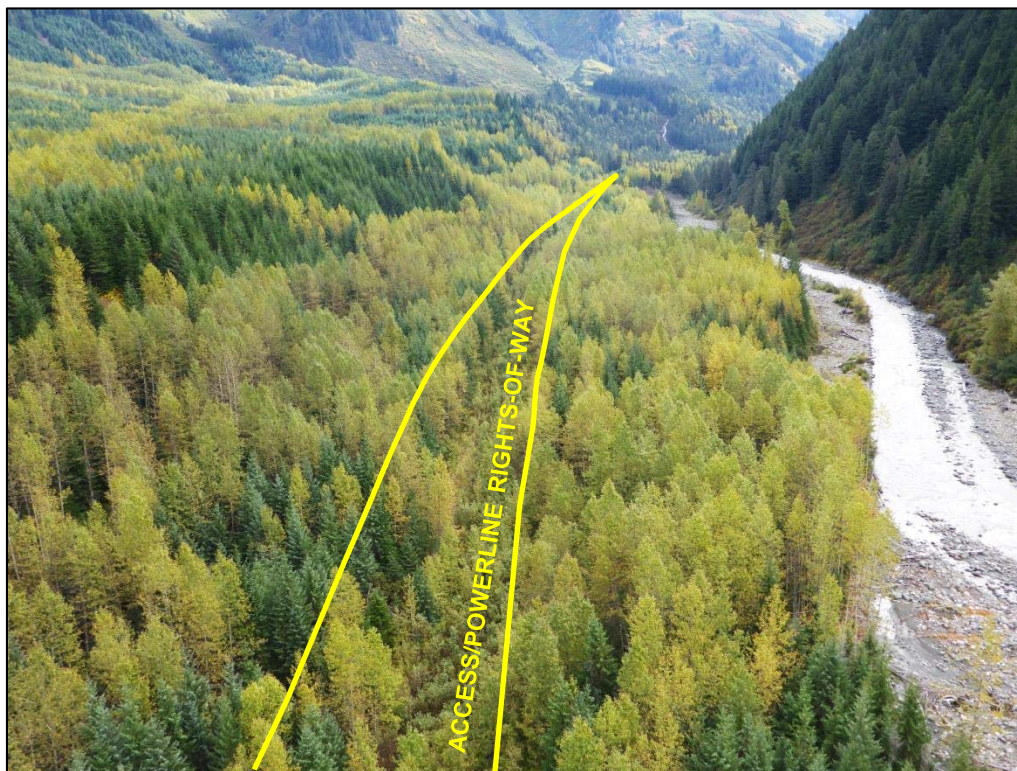
Extremely steep slopes lead into Goldslide Creek and the Bitter Creek Valley from the proposed mine. Heavy seasonal run-off has facilitated numerous slope-failures, from high on the valley walls in some areas, as well as considerable lateral washouts along Bitter Creek (Appendix, Image 11). An extensive network of overgrown roads from past logging and mining practices was observed where the valley broadens approaching Roosevelt Creek (Appendix, Image 10).

**Image 10:** Aerial view southeast from Roosevelt Creek along Bitter Creek (right) and access/powerline rights-of-way; note overgrown clearings (top left).

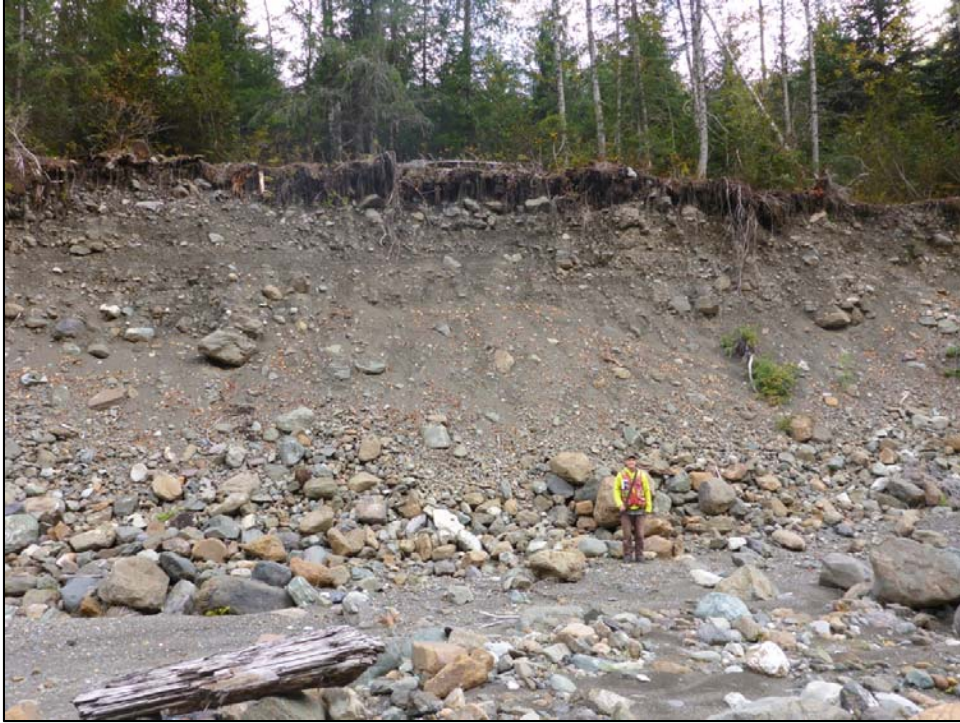
**Image 11:** View of east bank of Bitter Creek, south of Roosevelt Creek, showing significant natural erosion of remnant terrace.

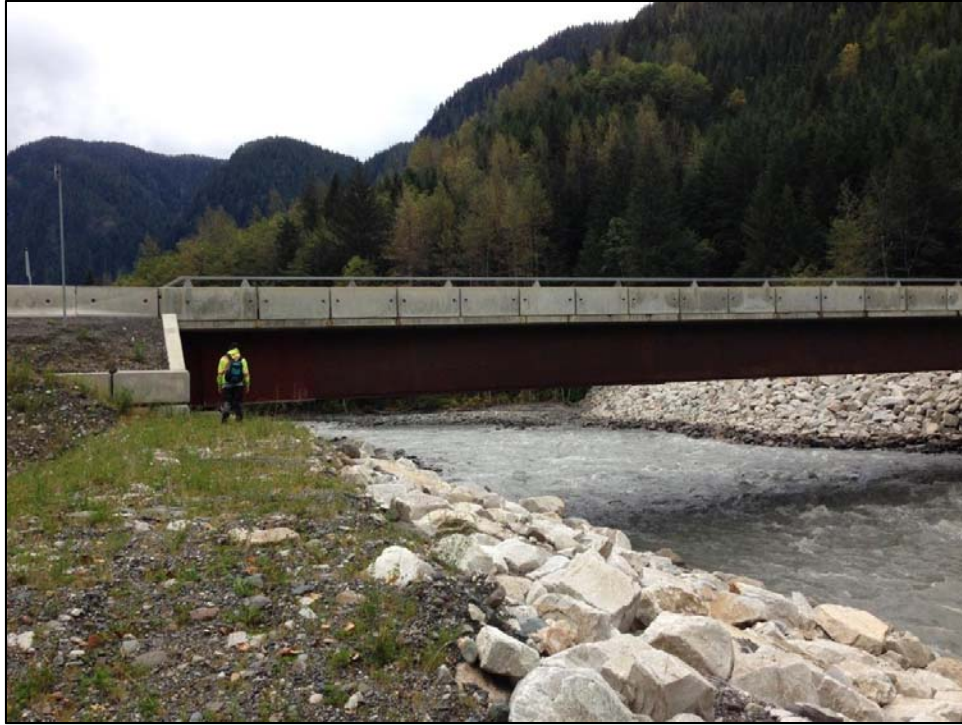
At the Bitter Creek – Bear River confluence, flooding in 2011 and the subsequent reconstruction of the Highway 37A Bridge has heavily impacted the area (Appendix, Images 15 and 16). Along Highway 37A to Glacier Creek terrain consists of low-lying, poorly drained, and/or inundated terrain which is highly susceptible to erosion (Appendix, Image 17). Ground disturbance is also extensive due to past logging, highway, and transmission line developments.

**Image 15:** View east (upstream) to Highway 37A at Bitter Creek Bridge.

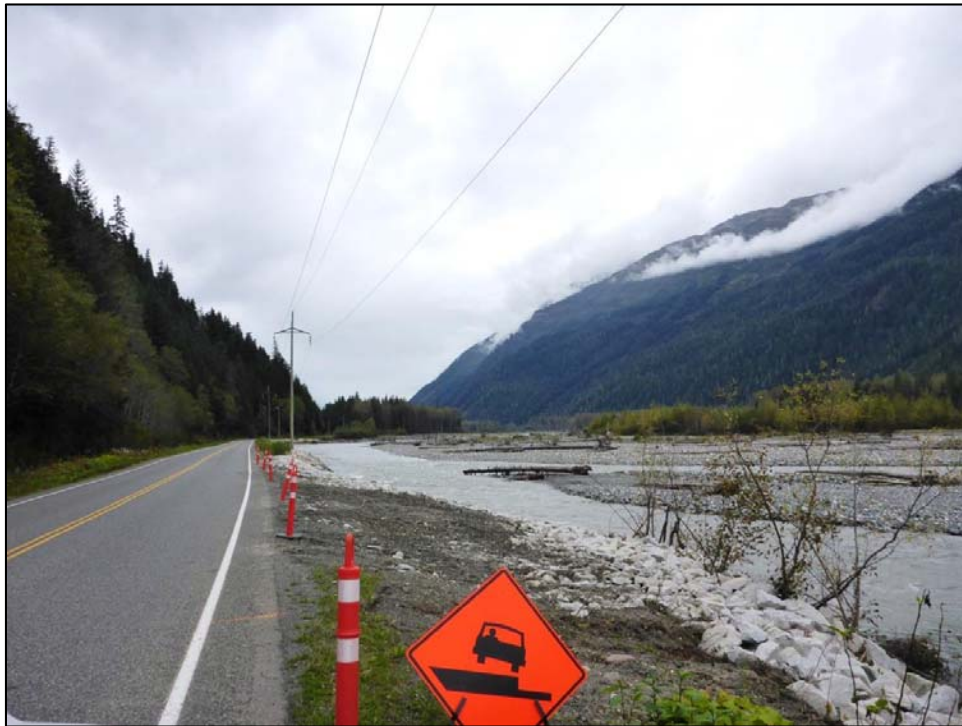
**Image 16:** View south to Bear River and Highway 37A washout.
