Appendix IR1-11-D Bitter Creek Hydrotechnical Assessment Report

Red Mountain Underground Gold Project
IDM Mining Ltd. Responses to
Canadian Environmental Assessment Information Request #1

Bitter Creek
Hydrotechnical Assessment

October 2017

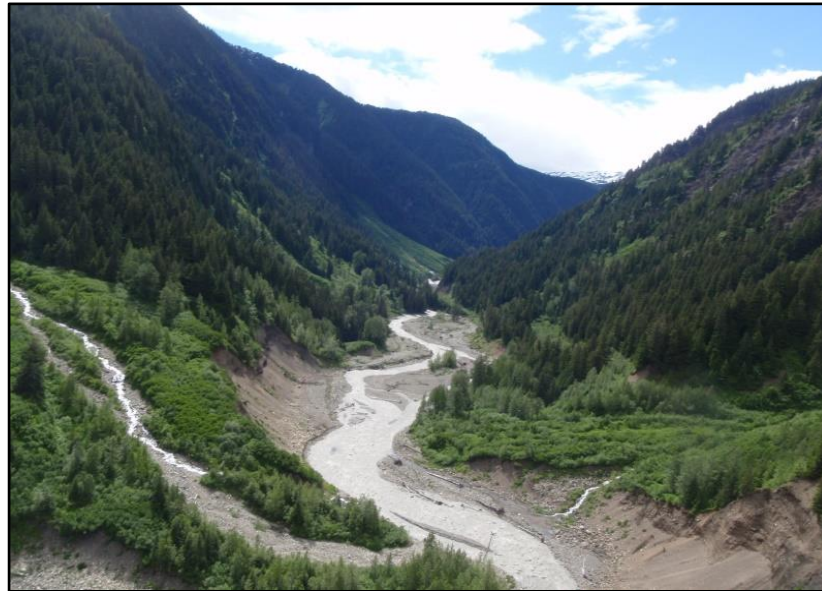
Figure 4-1 Looking upvalley along lower Bitter Creek

Along the valley's lower elevation slopes, the overlying surficial sediments varied from colluvium to moraine-based glacial tills. In places, unconsolidated glacio-fluvial sediments and interbedded glacio-lacustrine clayey silts were also present along the lower valley sideslopes. Local bank erosion and slope instabilities were observed along the outside edges of channel bends. The riparian vegetation along the lower slopes was dominated by stands of Western Hemlock and Amabilis Fir trees. Along hillslopes that have been subjected to snow avalanches and slope instabilities, deciduous mountain Willows and red Alder trees were present. Alders were also seen along the old access road corridor that exists along the north side of lower Bitter Creek (Figure 4-1).

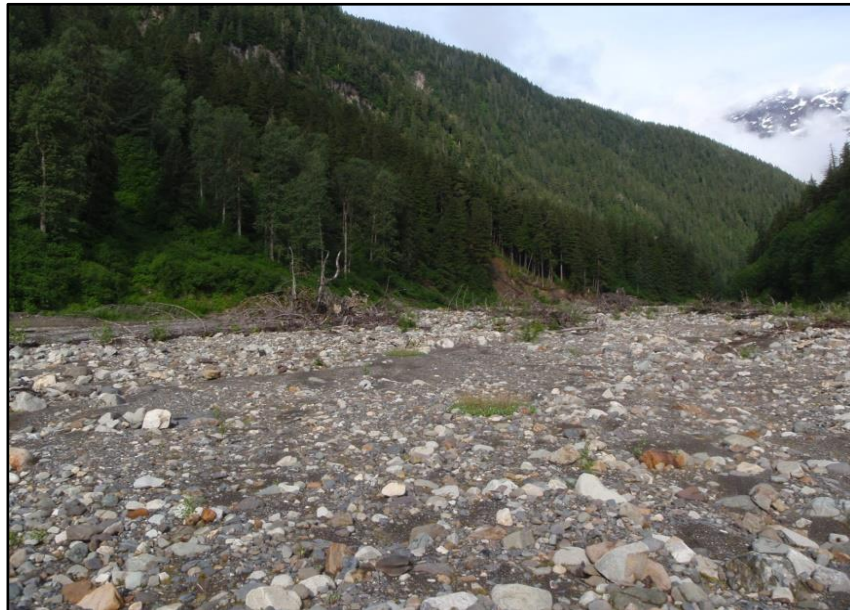
Figure 4-2 Looking downvalley across a flood terrace along lower Bitter Creek

Across the wider depositional flood terraces, the channel sediments were noted to be coarse sands and medium-to-fine pebble-size gravels, with cobble size clasts present in places. The median grain size diameter (D_{50}) was estimated to be 70 mm on average. In contrast, the channel bed materials along the main channel were larger and consisted of a more angular mixture of large cobbles, boulders and rock blocks. The median grain size diameter (D_{50}) was estimated to be 300 mm on average. These coarse bed materials were typically present along step-like channel profiles, and accounted for the naturally high hydraulic roughness and turbulence conditions that were consistently observed along lower Bitter Creek (Figure 4-2).

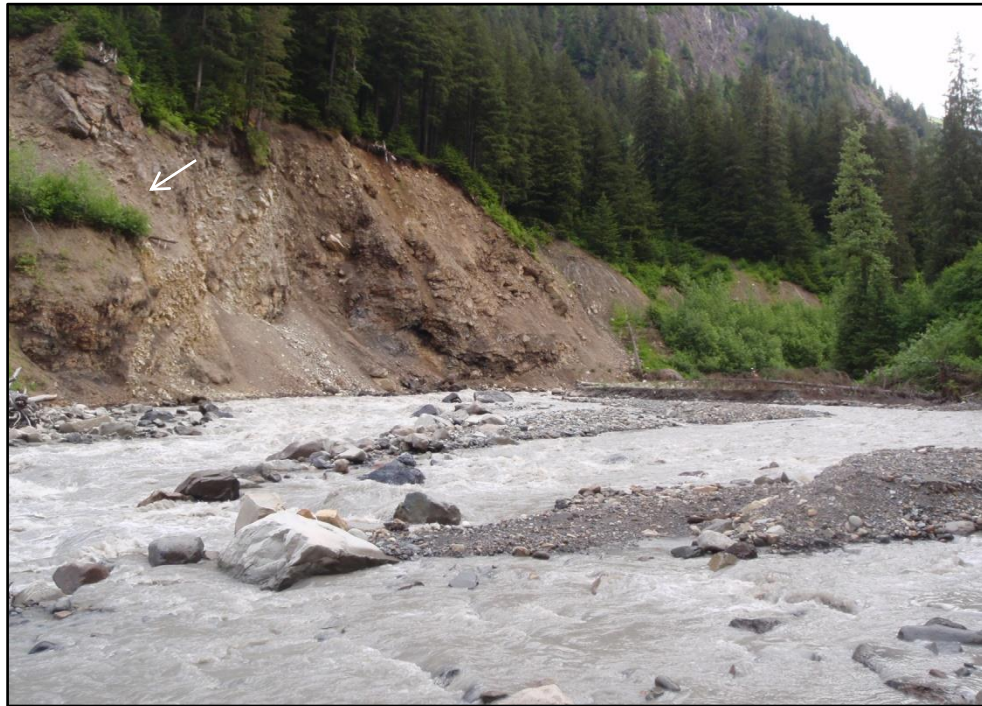
Figure 4-3 Looking upstream along the right bank of Bitter Creek towards the channel bend that is present between Stations 4+600 and 4+820. The Alders shown on the bank (see arrow) shows the location of the previously constructed road elevation.

The resource access road is planned to encroach and expand onto the perimeter of Bitter Creek's flood terrace and river channel area between Stations 4+020 and 4+820. As the road prism proceeds east and upvalley, it will enter an alternating sequence of channel bends between Stations 4+600 and 4+820. The channel is confined through this section of the river, with the outside bends bordered by steep, bed-controlled slopes. The base of the right and left banks are oversteepened and have been undercut by bank erosion and local hydraulic scour processes (Figure 4.3 and Figure 4.4). In contrast, the inside channel bend along the left bank features mid-channel, lateral and point bar deposits of unconsolidated sediments (i.e., mixtures of coarse sands, gravels, cobbles, boulders and rock) that extend downstream.

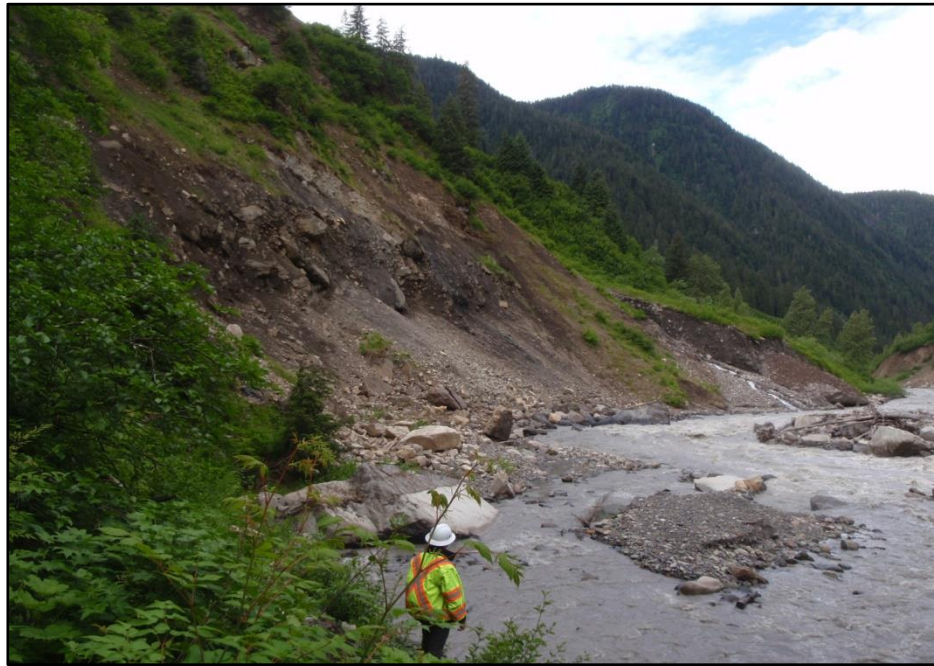
Figure 4-4 Looking along the downstream section of the channel bend's left bank between Stations 4+600 and 4+820

The construction of a road section along the north bank of Bitter Creek will reduce channel widths and produce a loss of available flow area in the order of 30% along the channel bend. This displacement of the channel will trigger a response whereby the river will likely have to redevelop its channel thalweg along the channel bed. Local erosion and scour of the channel bed and banks are also expected to increase along the channel perimeters of both channel bends. In addition, the loss of flow area will produce elevated flood water levels and superelevation effects as surface water volumes are concentrated through the alternating sequence of channel bends.

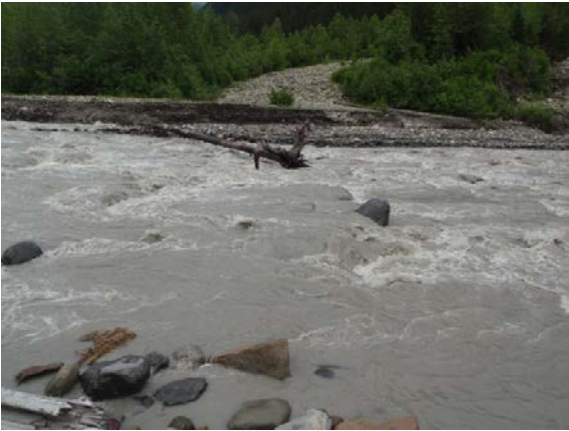
Photo 1: Looking across Bitter Creek towards stream tributary outlet in the vicinity of Stn 5+600. June 13, 2017.

- In places, deposits of colluvium and rock fall were observed at the base of valley hillslopes, as well as within and along the margins of the main channel. Coarse, non-cohesive gravels and sand-size sediments were also present at the outlets of some of the steep hillslope streams that drain down into Bitter Creek. Remnant deposits of snow were also observed in places along the margins of the main channel (**Appendix A, Photos 1, 3, 5, 6 and 9**).

- During the inspection period, the average water depth was estimated to be 0.9 m, with observed depths varying from 0.5 m to over 1.5 m in places. The channel's average wetted width was estimated to be 8 m, and ranged from 6 m to over 10 m along generally concave channel cross-sectional profiles (**Appendix A, Photos 1 to 12**).

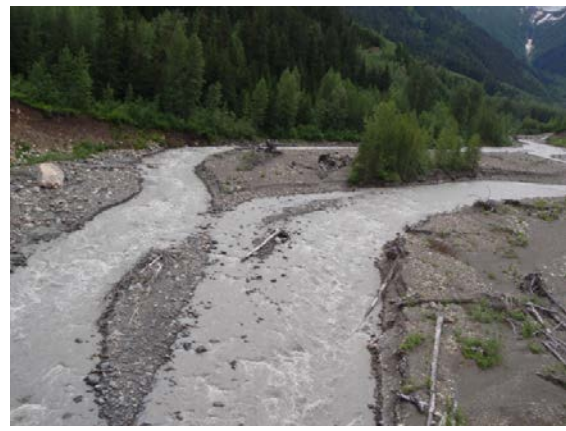
Photo 2: Looking upstream side, diagonal and mid-channel gravel bar deposits in the vicinity of Stn 5+350. June 13, 2017.

- Sediment availability and transport downstream along Bitter Creek is significant. Large volumes of sediment are stored as in-channel deposits of large gravel bars, mid-channel island complexes and relatively large flood terraces that are present across the wider valley floor sections. Cluster-like deposits of large woody debris were also observed in several places along the channel banks, gravel bars and flood terraces (**Appendix A, Photos 2, 3, 6 and 8**).

- There is a general downstream progression in the observed channel patterns, and sediment depositional features. The channel patterns varied from relatively long irregular meanders to short straight channel sections. Entrenched channel bends were present where the valley width narrows and is controlled by bedrock outcrops (**Appendix A, Photos 2, 4, 5, 8 to 10**).

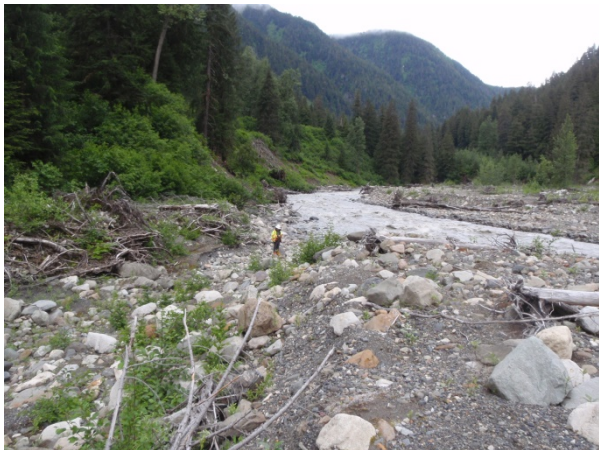
Photo 3: Looking downstream towards remnant flood channel and recent deposits of sediment & woody debris in the vicinity of Stn 5+200. June 13, 2017.

- Several flood channels were observed to extend laterally across and downstream along the broader flood terraces. The cross-sectional profiles varied between convex-shaped surfaces, with shallow concave sections present across the flood channel areas (**Appendix A, Photos 3, 7, 11 and 12**).

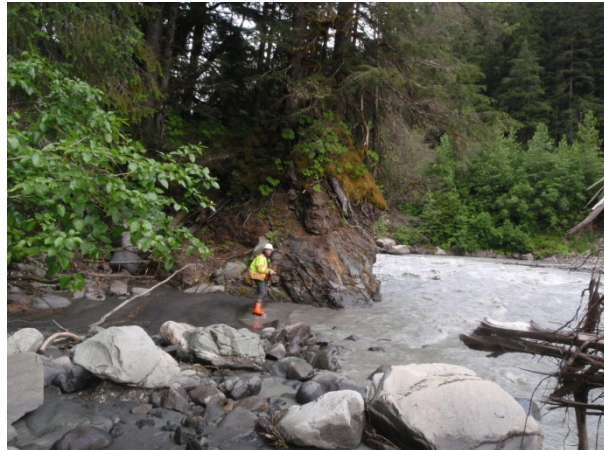
Photo 4: Looking downstream along left bank at existing bedrock outcrop that is deflecting flow across the channel in the vicinity of Stn 4+900. June 13, 2017.

- Bank erosion and evidence of hydraulic scour processes were observed along straight bank sections and at channel bends where lateral channel migration was being resisted and controlled by bedrock outcrops. This was most evident along the channel section that features three entrenched bends between Road Stations 5+000 and 4+500 (**Appendix A, Figure 2 and Photos 4 to 6**).

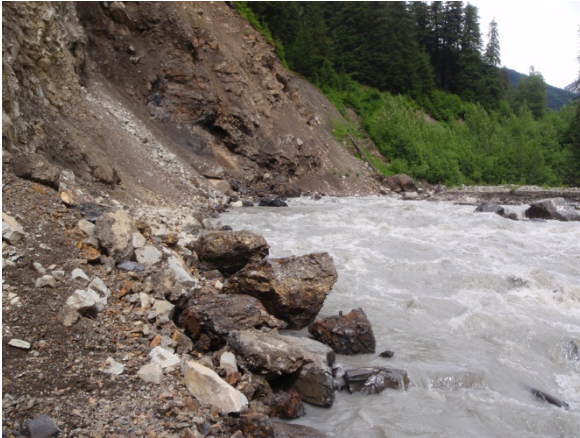
Photo 5: Looking upstream along bedrock controlled channel bend with eroding & over-steepened hillslopes in the vicinity of Stn 4+700. June 13, 2017

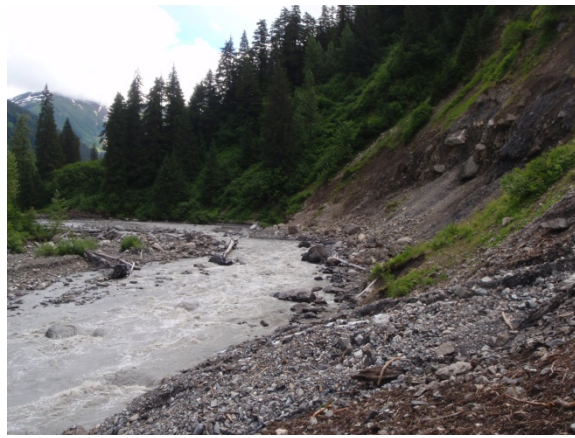
Photo 6: Looking upstream along left bank and steep partially undercut hillslopes in the vicinity of Stn 4+500. June 13, 2017.

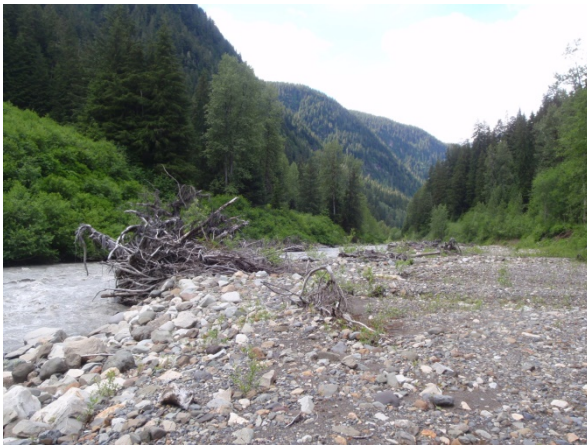
Photo 7: Looking downstream at woody debris and flood terrace in the vicinity of Stn 4+300. June 14, 2017.

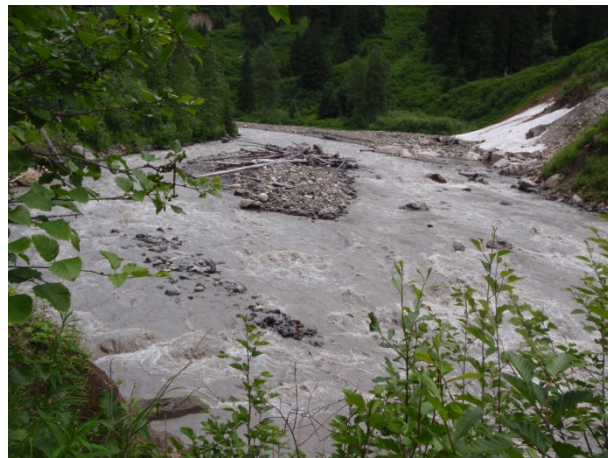
Photo 8: Looking upstream at side and mid-channel gravel bar deposits, with remnant snow deposits along the channel's left bank in the vicinity of Stn 4+100. June 14, 2017.

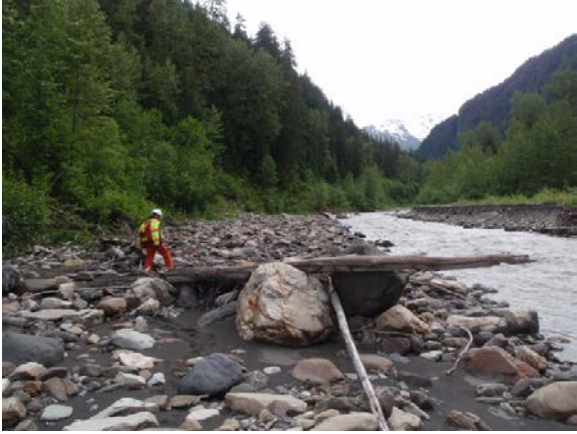
Photo 9: Looking upstream at gravel bar and woody debris deposits in the vicinity of Stn 3+800. June 14, 2017.

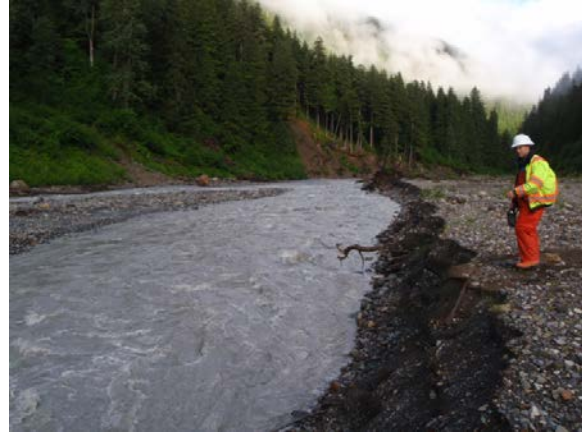
Photo 10: Looking downstream along main channel & eroding bank section in the vicinity of Stn 3+100. June 14, 2017.

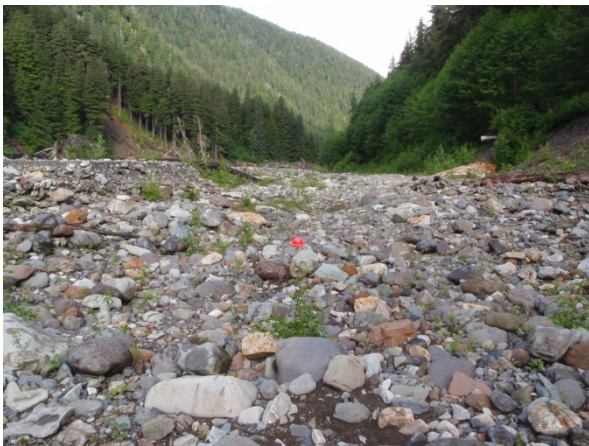
Photo 11: Looking downstream along flood terrace at a remnant flood channel beside an old road section in the vicinity of Stn 2+700. June 14, 2017.

- The flood terraces were observed to be up to 80 m wide in places. The flood terraces generally follow and are present along the inside regions of the irregular channel meanders. The alluvial sediments tended to be better sorted and displayed a wider distribution of sand and smaller size gravels across the exposed depositional surfaces. (**Appendix A, Figure 2 and Photos 11 to 12**).

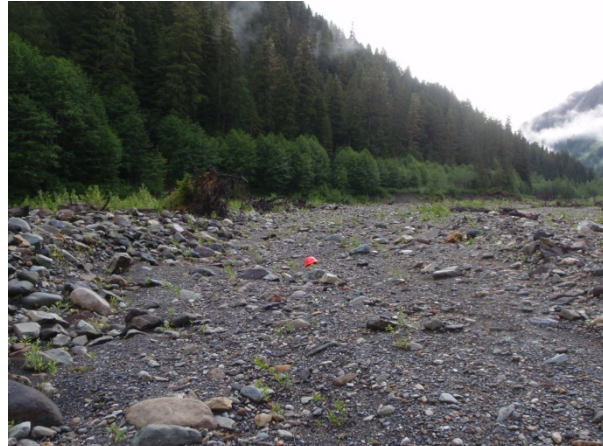
Photo 12: Looking east along flood channel area that extends upstream in the vicinity of Stn 2+300. June 14, 2017.

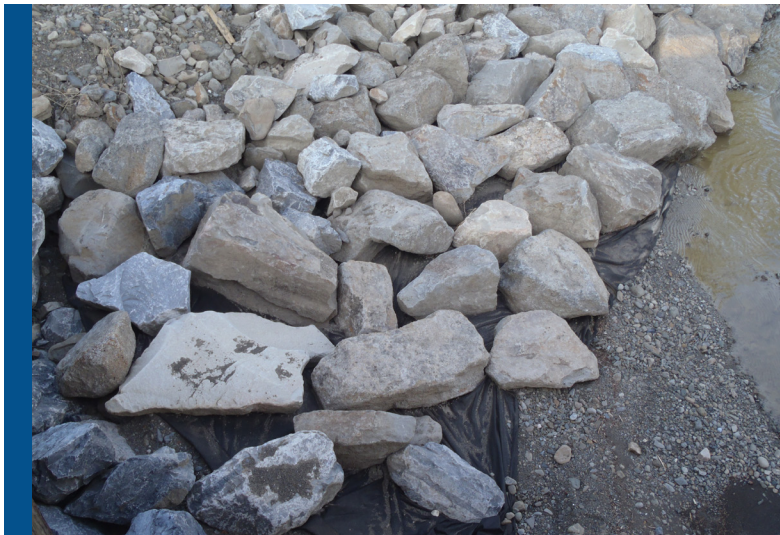
POOR INSTALLATION

- Single rocks (not graded)
- Toe not keyed
- Inadequate thickness
- Steep slope (not visible)

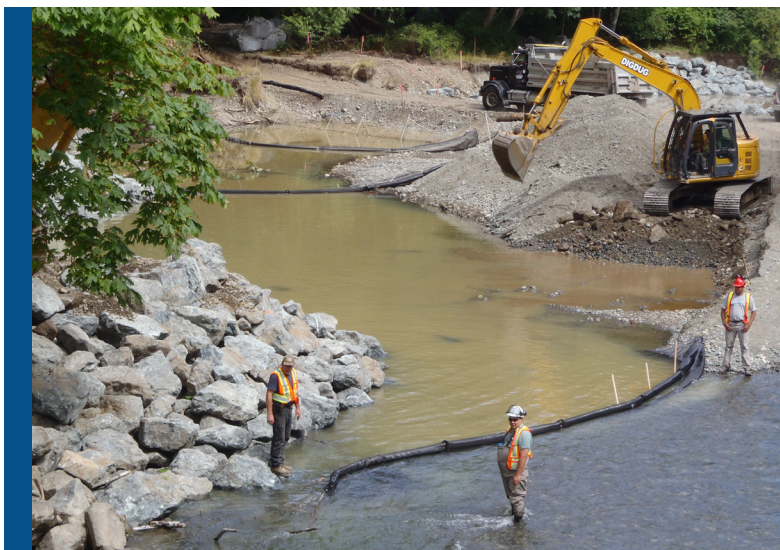
GOOD INSTALLATION

- Environmental monitor
- Good site separation
- Toe and Terminal Ends are keyed
- Well graded matrix
- Design slope
- Sufficient thickness
