**FINAL (Revised) – EXTENDED PHASE II
ENVIRONMENTAL SITE ASSESSMENT –
BEAVER DAM PROJECT PROPERTY**

181 Beaver Dam Mines Road, Marquette, NS

March 8, 2021

Stantec Consulting Ltd.
102-40 Highfield Park Drive
Dartmouth NS B3A 0A3

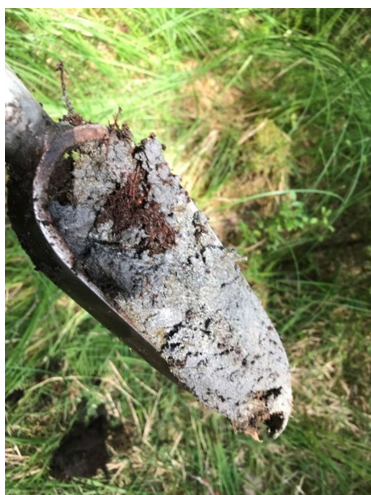
Photograph A Suspected Tailings from TP20-63

Based on field observations, including visible tailings within test pits and their proximity to Site features such as historical mining infrastructure/features (i.e., trenches, waste rock piles, stamp mill foundations, etc.), Stantec classified the test pit locations from both 2019 and 2020 as either non-impacted or impacted by historical mining activities. Of the impacted locations, Stantec further classified them as likely impacted by historical mine tailings or by mine waste rock. This impact classification assisted Stantec in our assessment of background levels and delineation, discussed below.

Sample photographs of observed suspected tailings and waste rock are included below, as well as in the photolog in Appendix E.

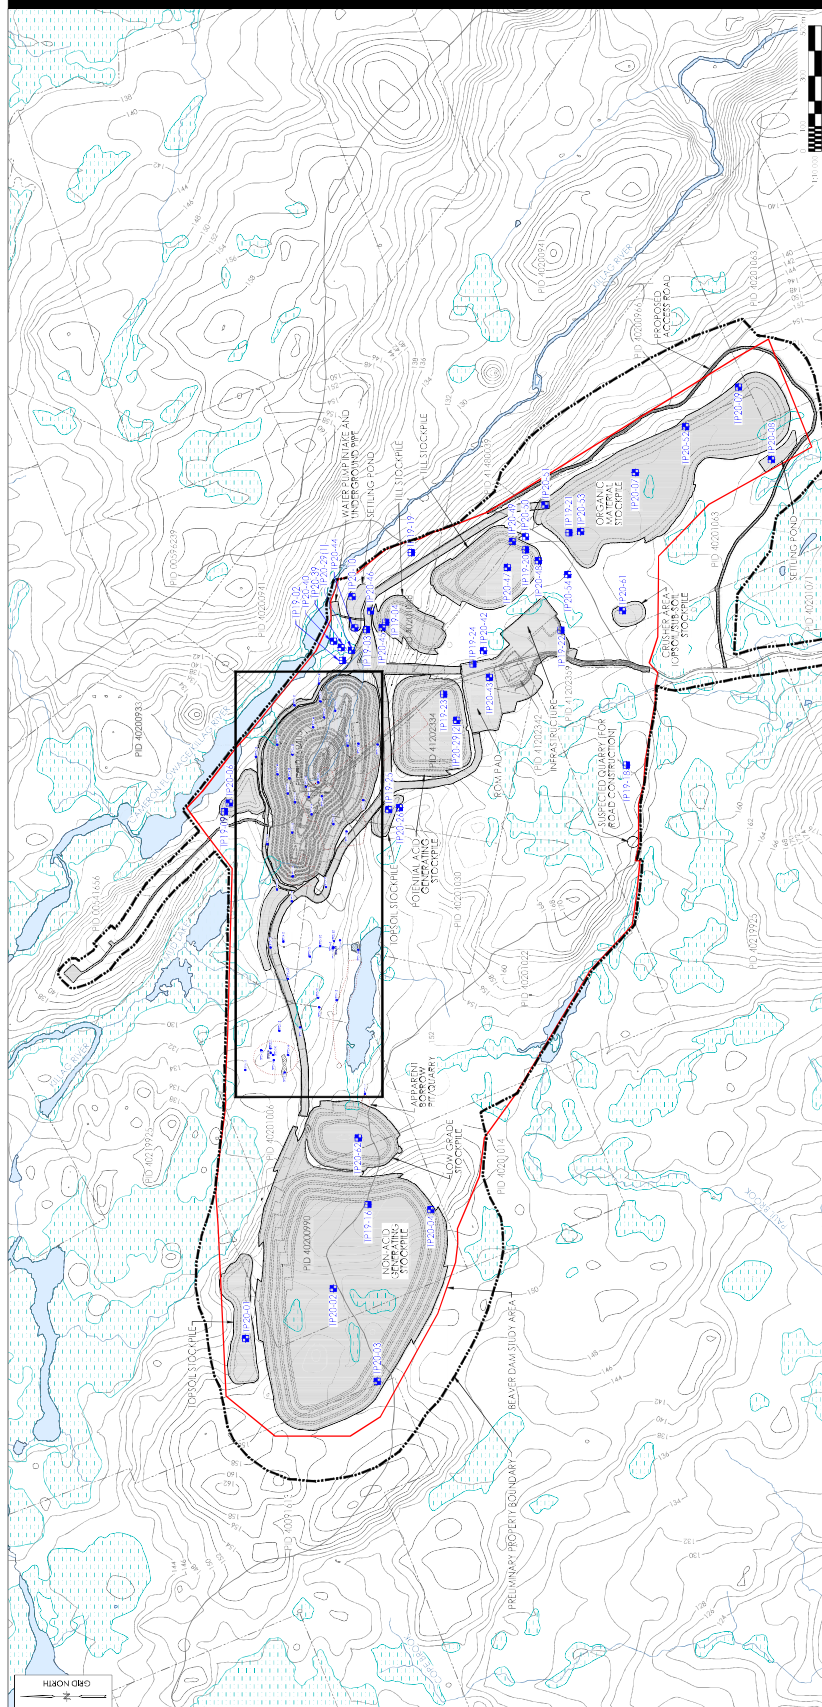
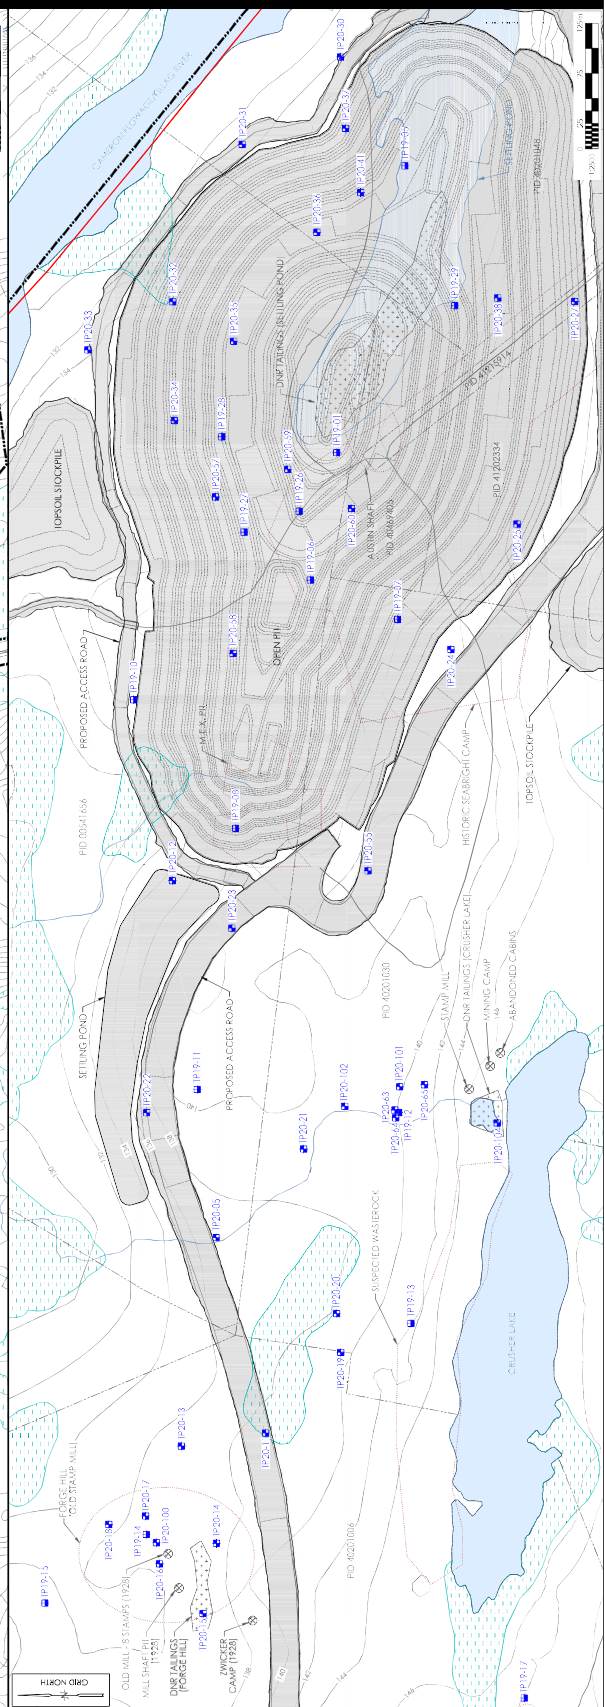
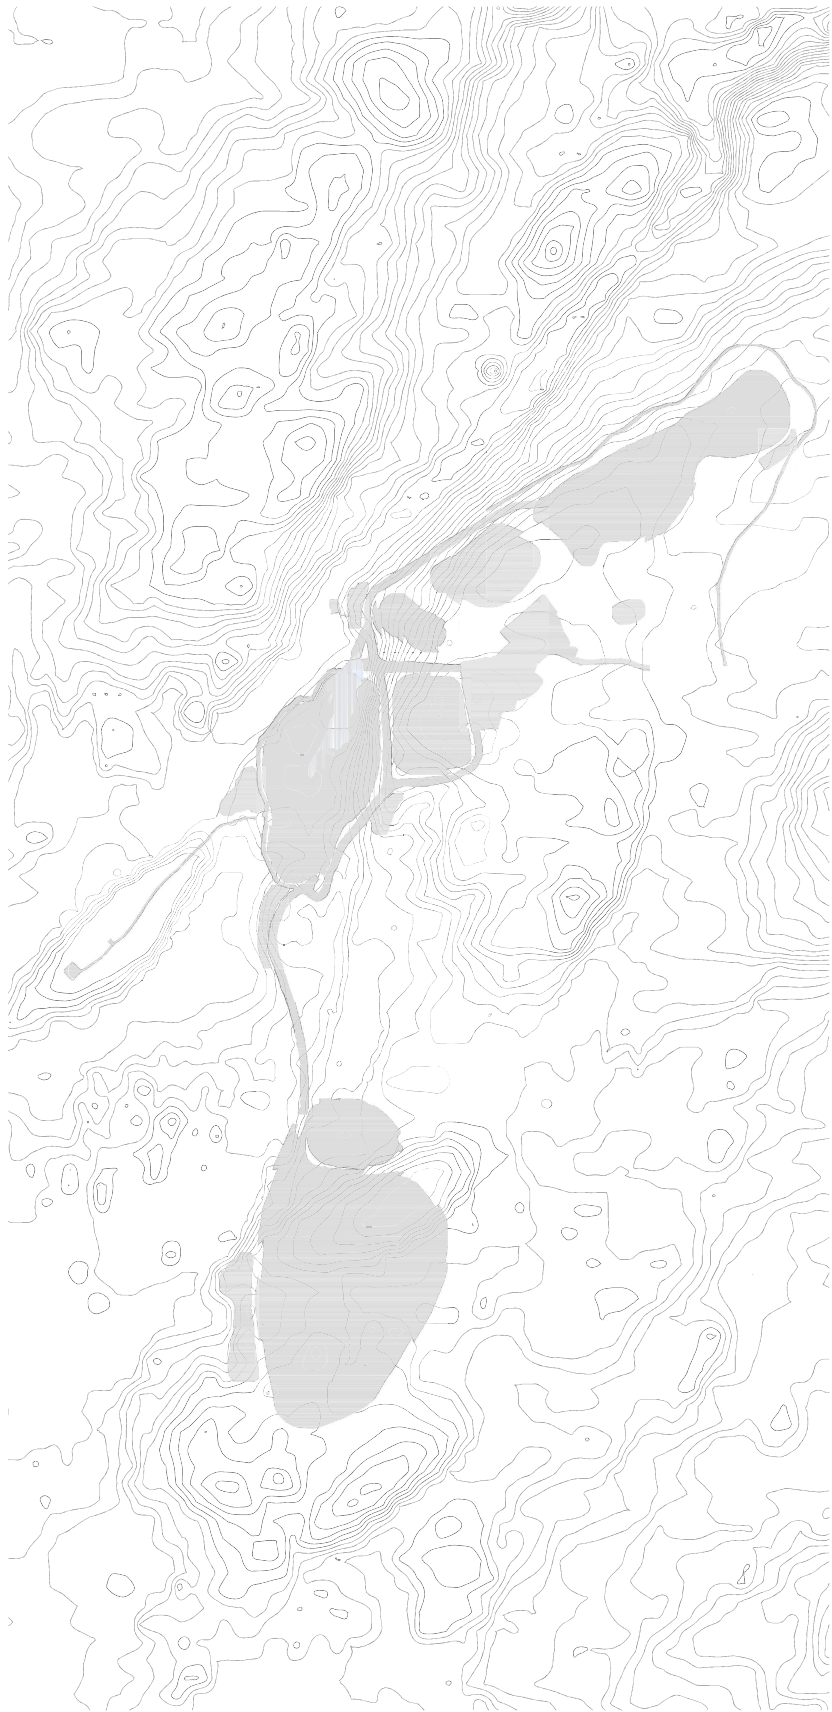
Drawing No. Sheet
A-2 2 of 7

Soil sample locations were modified in the field based on access and observations (e.g., thick vegetation, observed waste rock). Soil sample locations are shown on Drawing No. A-2, Appendix A.
