Phase I - Environmental Site Assessment (Beaver Dam),
- August 6, 2019
Completed for the Updated 2021 Beaver Dam Mine EIS

**FINAL -
Phase I Environmental Site Assessment**

Beaver Dam Property
181 Beaver Dam Mines Road, Marinette, NS

Prepared by:
Stantec Consulting Ltd.
40 Highfield Park Drive
Dartmouth, NS B3A 0A3

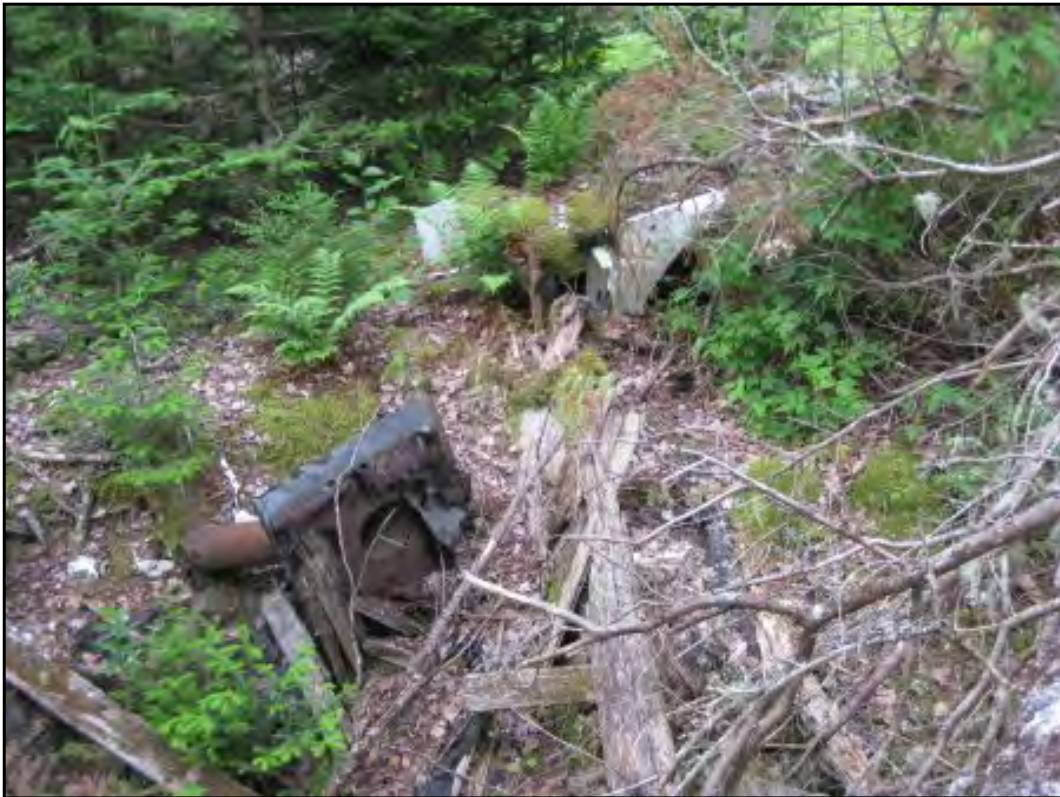
During the site visit a squatters camp was identified near the northeastern end of Crusher Lake. The camp consisted of four buildings; a "bunk house", a "cabin", a shed and an outhouse. Approximately 100 meters northwest of the camp accessed by following the brook from Crusher Lake and over several small wooden bridges, there was a tree-stand hunting blind. The foundation of a suspected former log cabin was discovered near the brook leading from Crusher Lake.

Ruins of a suspected cabin that dated from at least the 1960s

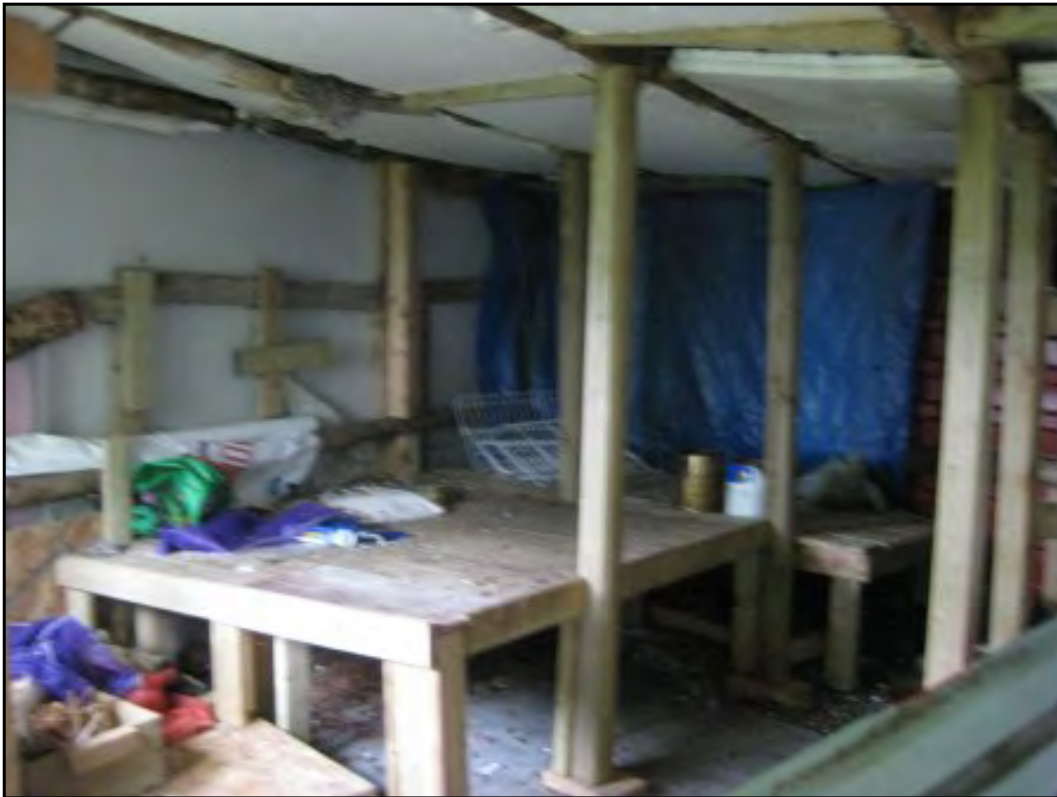
Based on the condition of the squatters camp there may be mould in the various buildings observed. As these buildings are to be demolished and are not occupied the potential presence of mould is not considered a potential concern.

Interior of the "Bunk house"

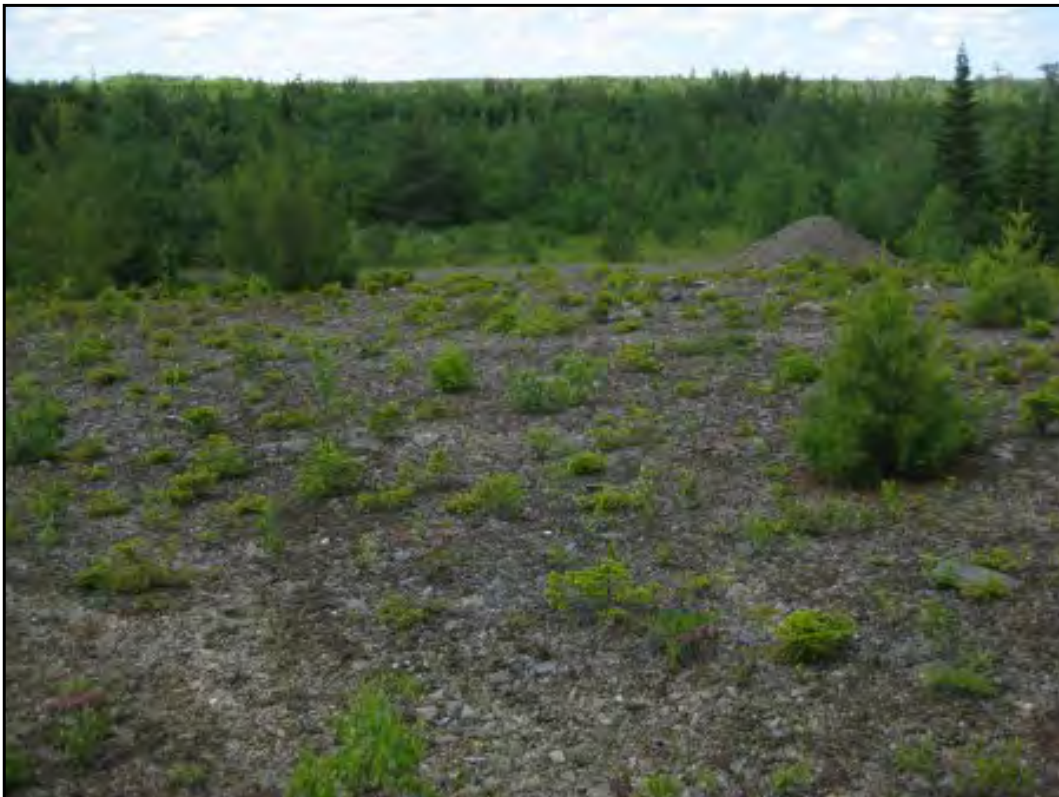
There are areas of exposed suspected historical waste rock at the Site. Based on information obtained during the document review, the Seabright area of mining in the 1980s produced 135,000 tonnes of rock of which 41,000 tonnes was shipped off-site. The remaining rock appears to have been used to regrade the areas disturbed during the operations on-site. Smaller piles of suspected waste rock were noted in the Forge Hill area and along the northern side of Crusher Lake.

Suspected waste rock on the south side of the access road to Crusher Lake
