Lake St. Martin Emergency Outlet Channel  
Assessment of Effects and Development of Offsetting

**Aquatic Habitat Supporting Volume (AHSV)**

May 2015

A report prepared for  
Manitoba Infrastructure and Transportation  
by  
North/South Consultants Inc. and KGS Group

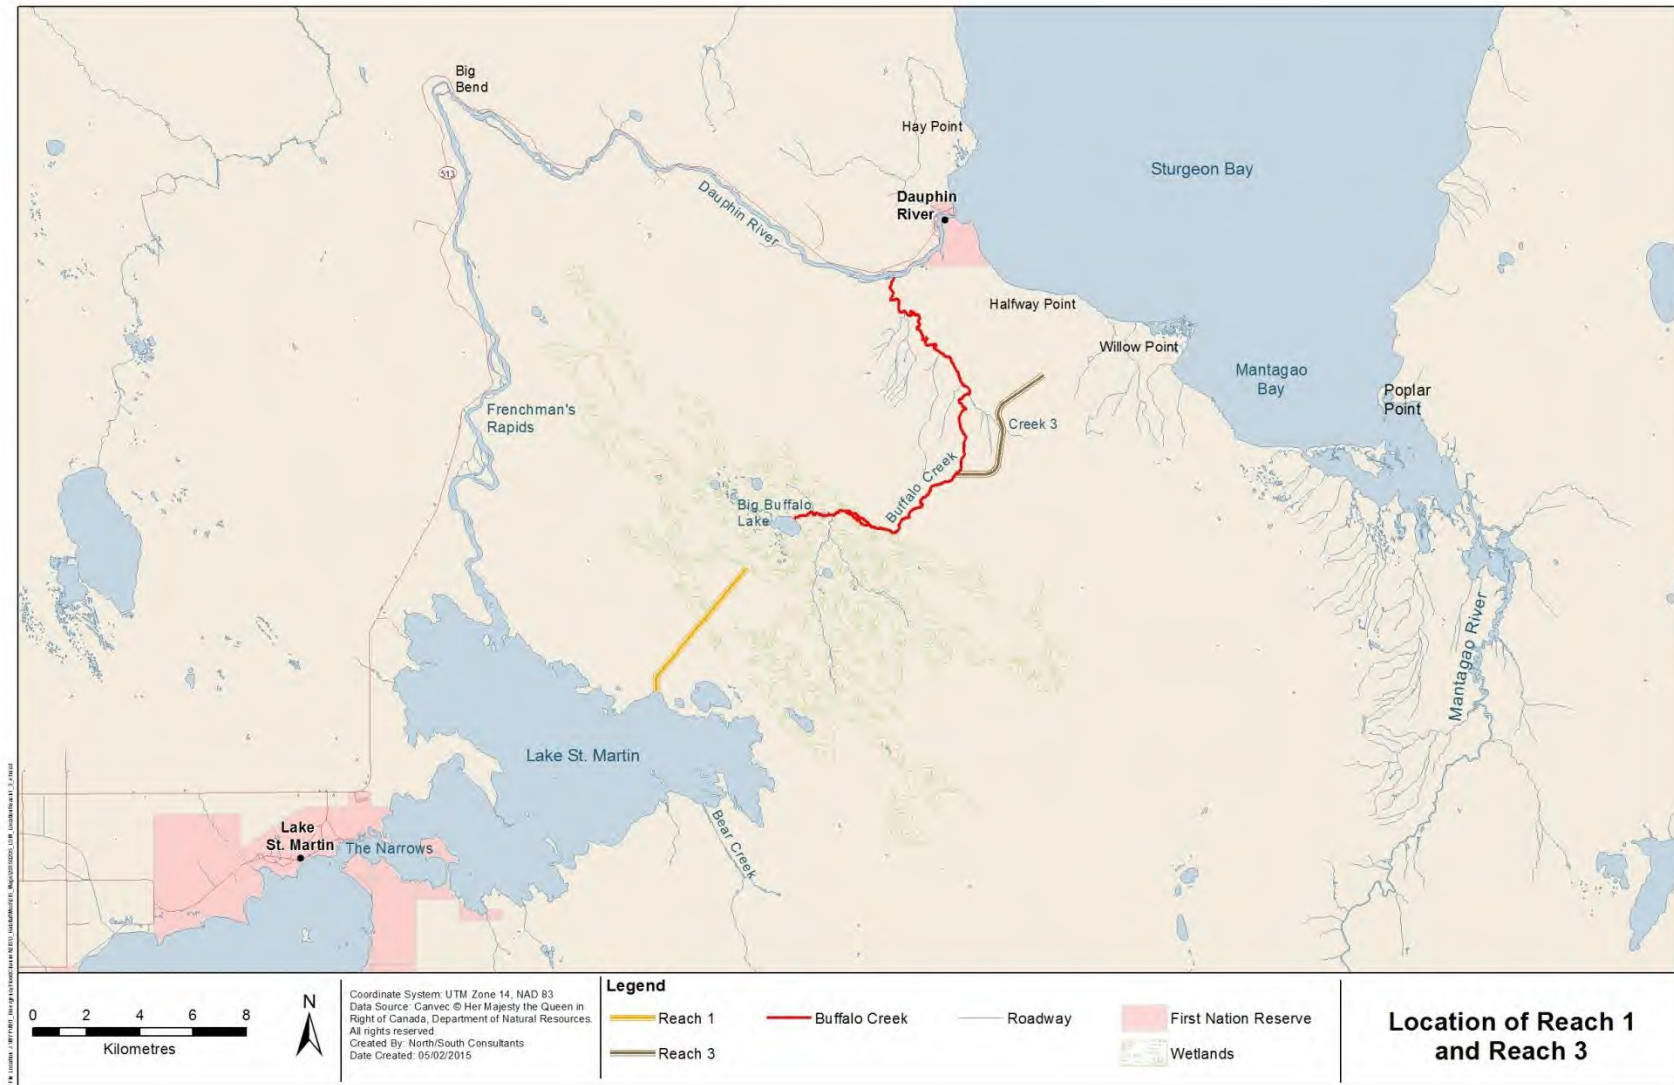
Figure 6.1-1. Location of the Reach 1 Emergency Outlet Channel, the Reach 3 Emergency Channel, and the Buffalo Creek Drainage System in relation to Lake St. Martin, the Dauphin River and Sturgeon Bay.

Widespread record flooding throughout southern Manitoba during 2011 led to water levels in Lake Manitoba and Lake St. Martin that were several feet higher than desirable, resulting in significant damage to hundreds of properties, restricted road access to several communities, and long-term evacuation of four First Nations communities in the vicinity of Lake St. Martin. As part of emergency relief measures, the Province of Manitoba, through Manitoba Infrastructure and Transportation (MIT), constructed the Lake St. Martin Emergency Outlet Channel System (LSMEOC system), which is comprised of two emergency channels (Figure 6.1-1).

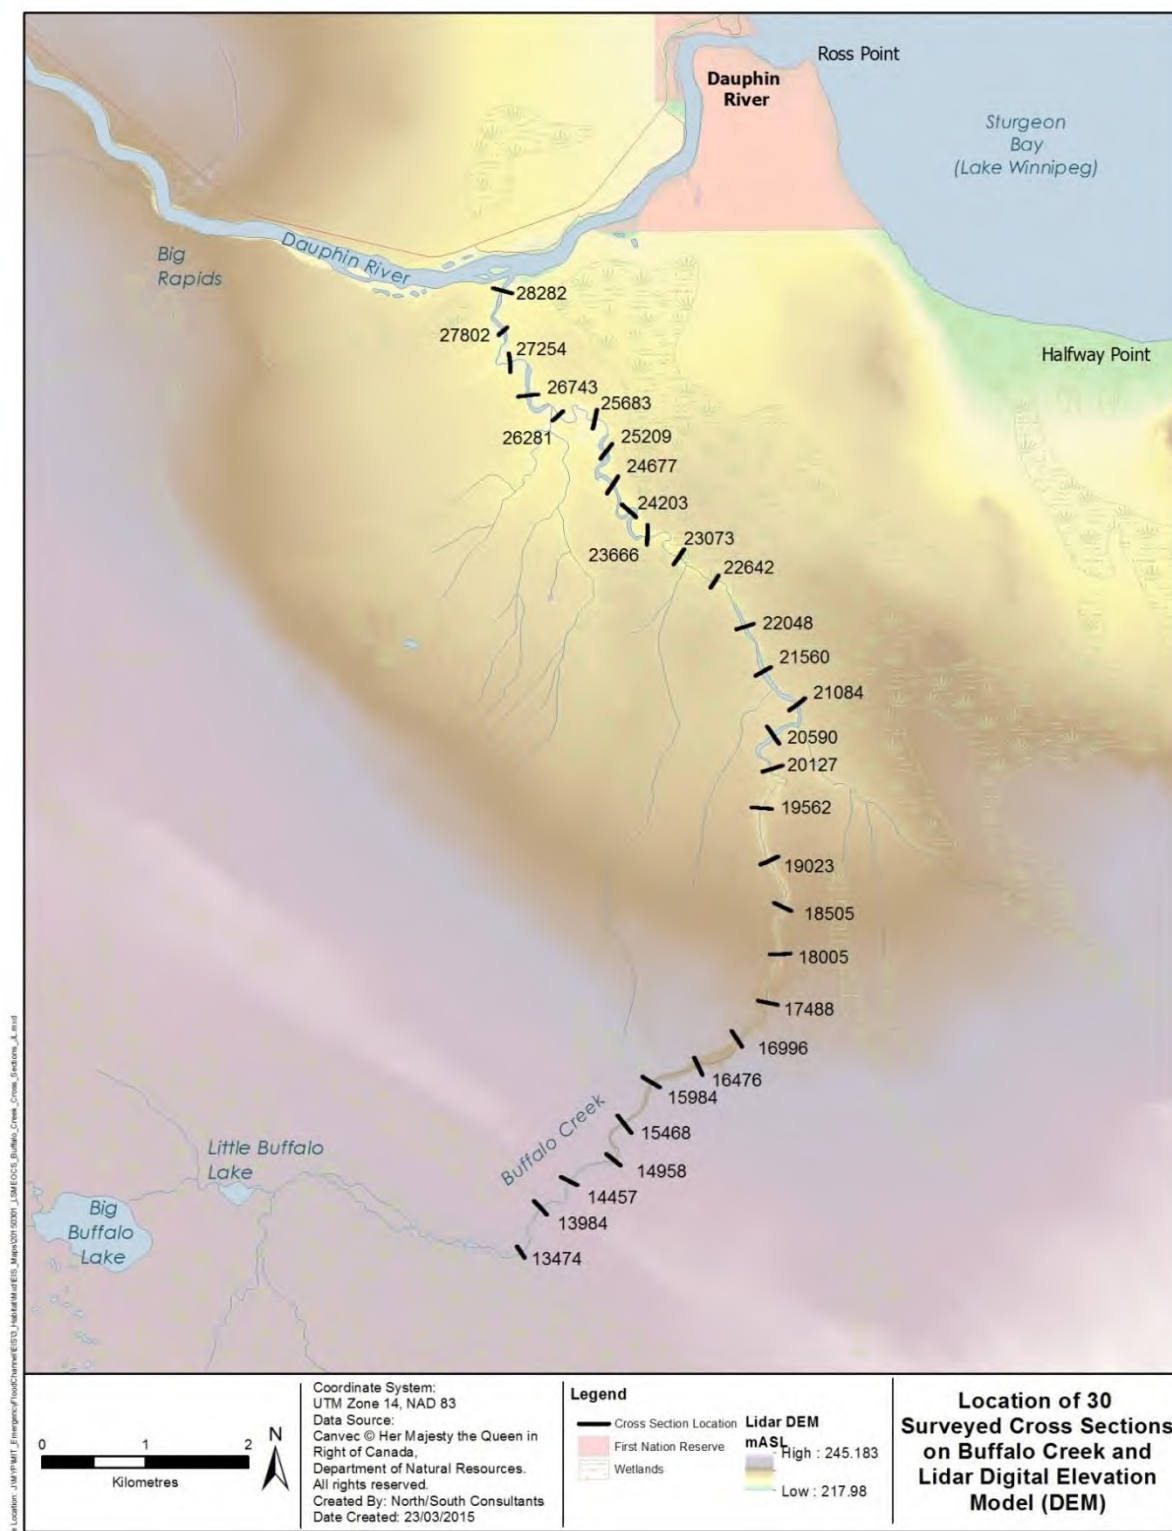
Figure 6.2-8. Map showing the location of the 30 surveyed cross sections along Buffalo Creek, the LiDAR based digital elevation model is shown in the background.

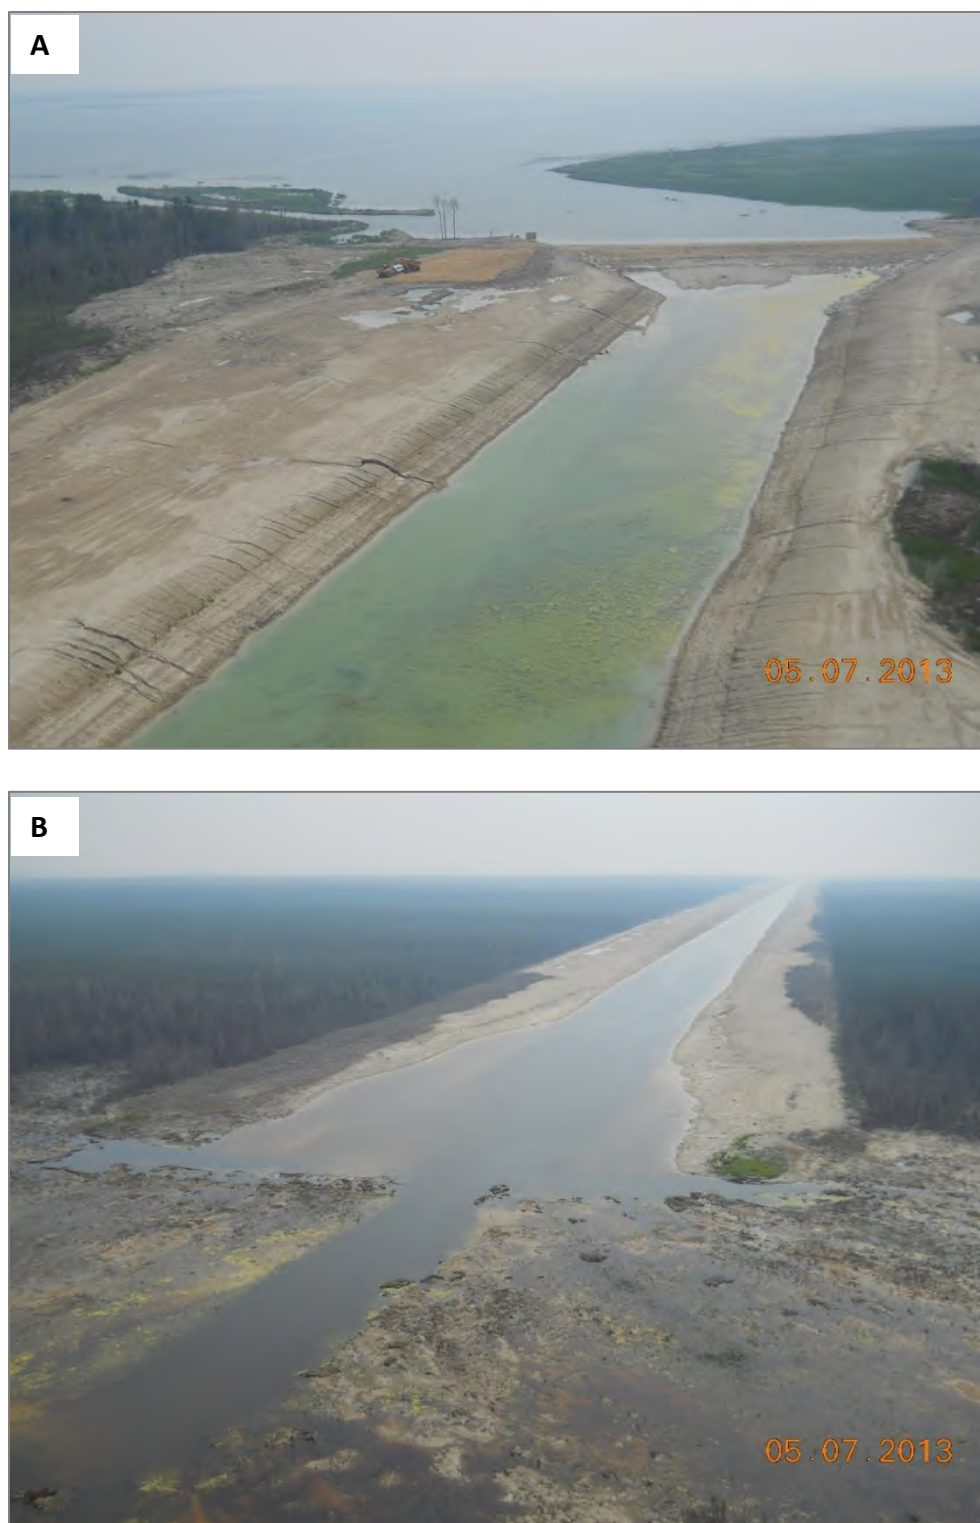
Figure 6.4-4. Aerial photographs of the Reach 1 at the (A) inlet from Lake St. Martin, and (B) outlet into the Big Buffalo bog complex during 2011/2012 Closure.

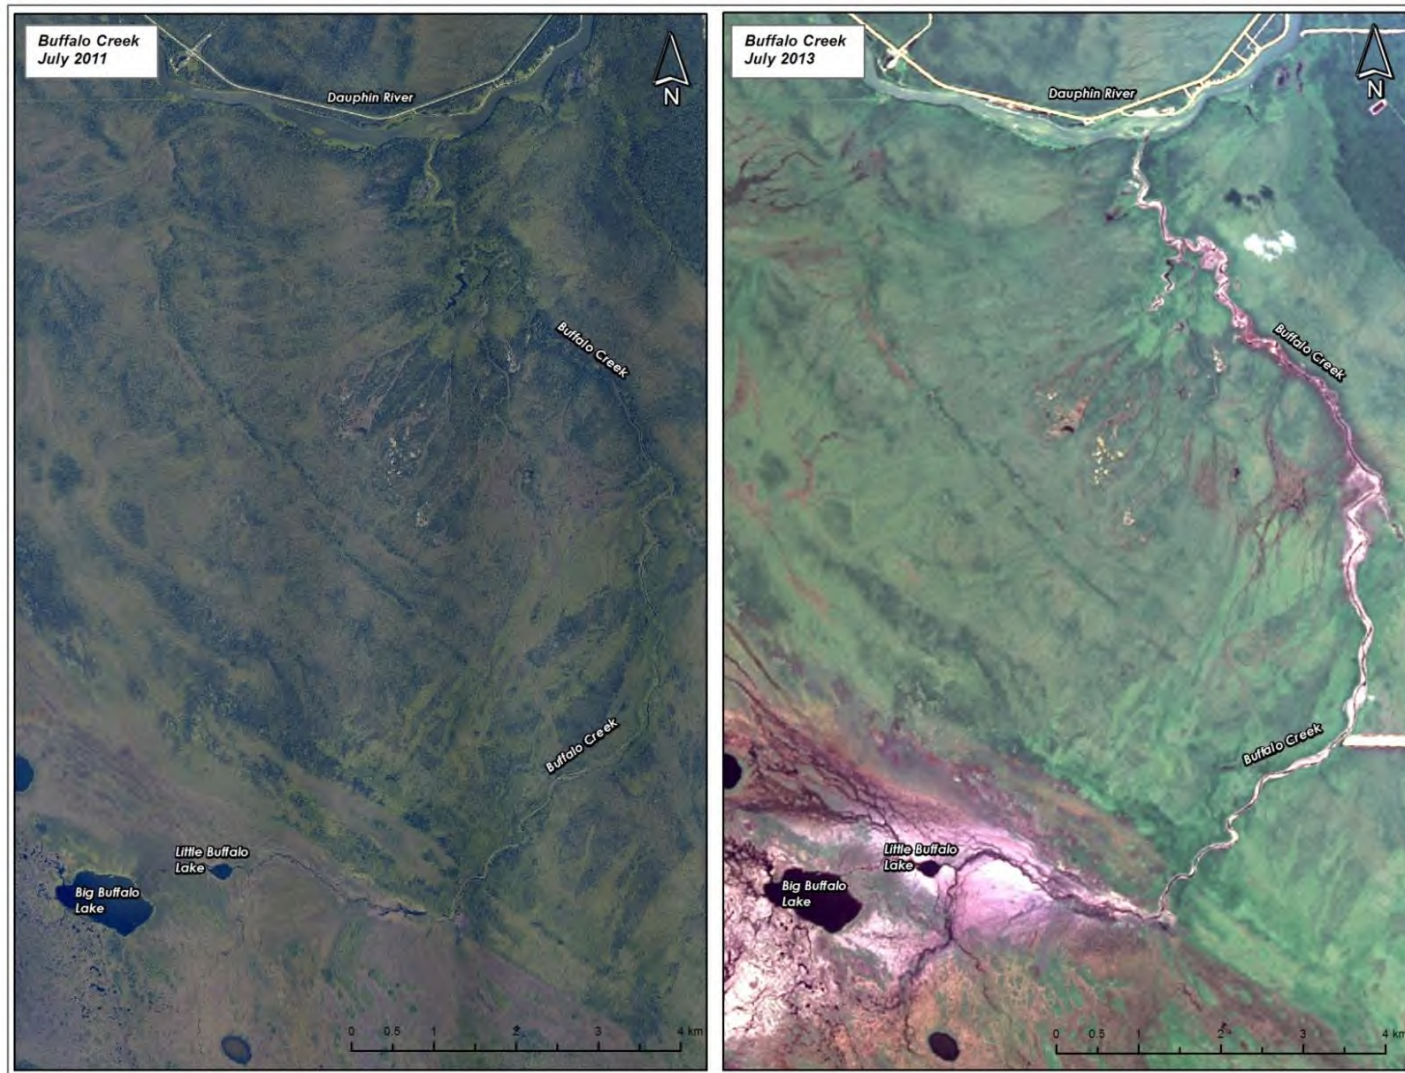
Figure 6.4-12. Satellite image overview of the Buffalo Creek watershed comparing Pre-Operation (July 2011) and 2011/2012 Closure (July 2013). Areas of bare soil resulting from flooding appear bright white, while light to dark brown areas are dead shrubs and trees.

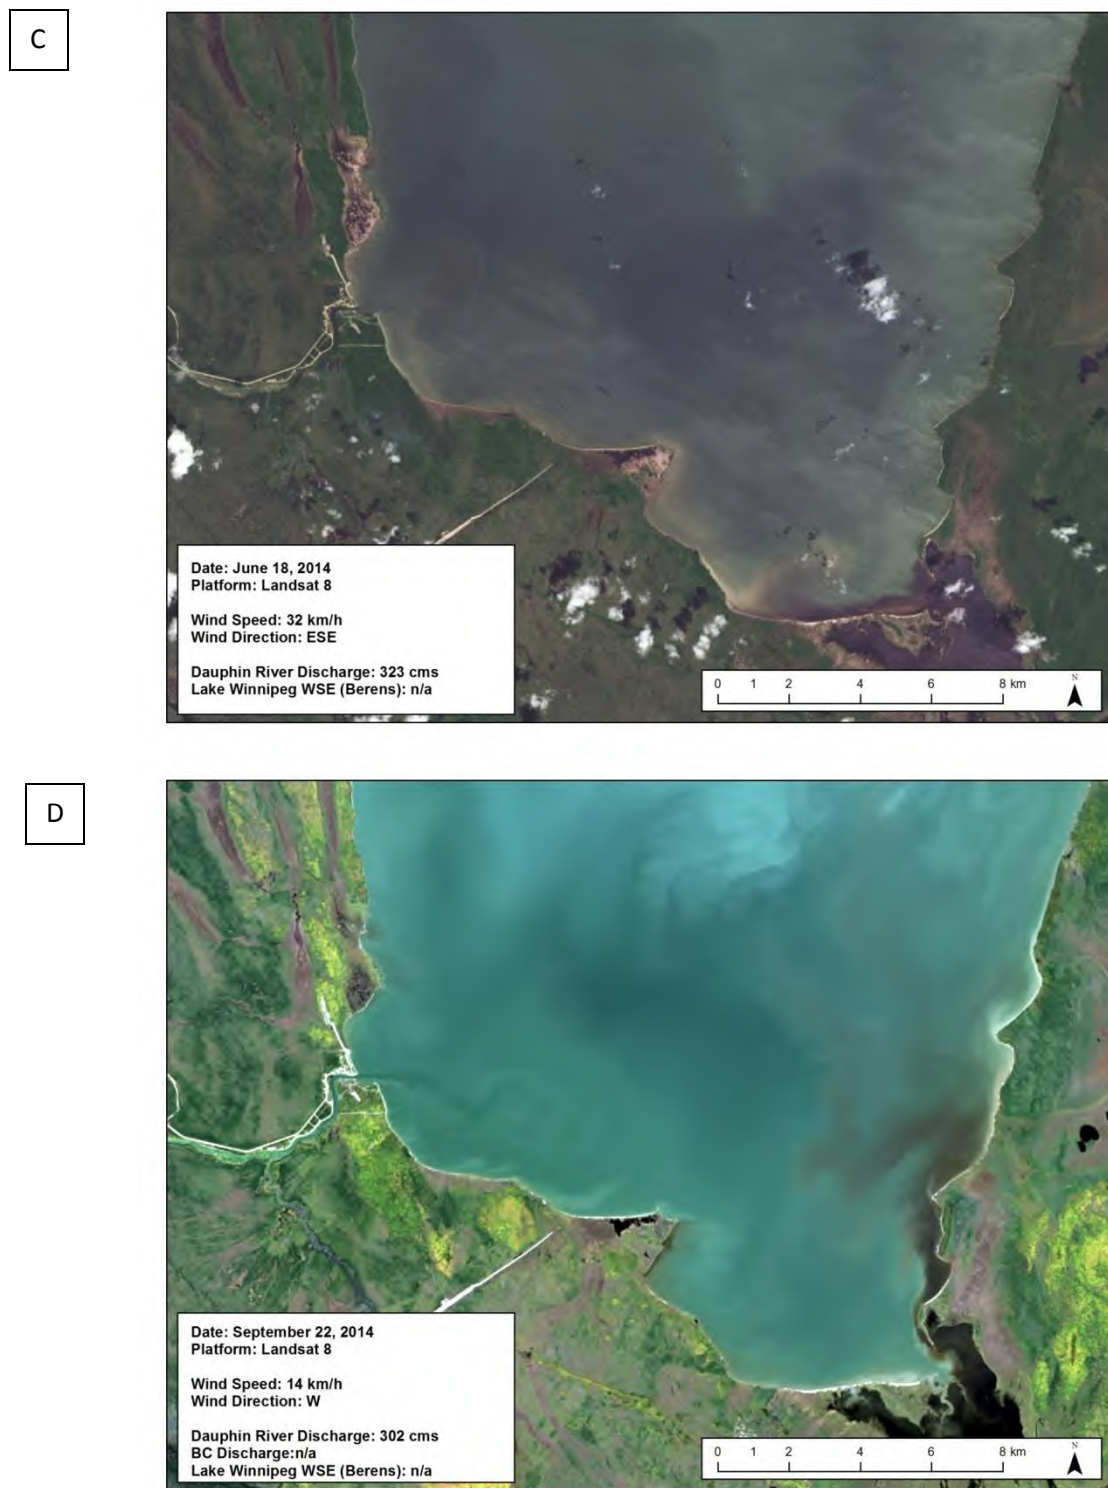
Figure 6.6-9. Satellite imagery of Sturgeon Bay under different wind conditions during the 2011 Flood period (A and B), 2011/2012 Closure (C), and 2014/2015 Operation (D).

Selected Landsat images (Table 6.2-4) were used to show the dynamic and turbid nature of Sturgeon Bay during variable wind conditions.
