Client: MIT  
 File No: 11-0300-18 - 1000.4  
 Project: Emergency Reduction of LMB and  
 LSM Water Levels - Flow Metering  
 Sheet: 1 of 1  
 Date: 10-Aug-12 By: GW  
 Checked: 14-Aug-12 By: PAL

PROJECT:  
 EMERGENCY REDUCTION OF LAKE MANITOBA AND LAKE ST. MARTIN WATER LEVELS

EMERGENCY REDUCTION OF LMB & LSM  
WATER LEVELS – ANALYSIS & MONITORING  
OF DISCHARGES & ICE PROCESSES

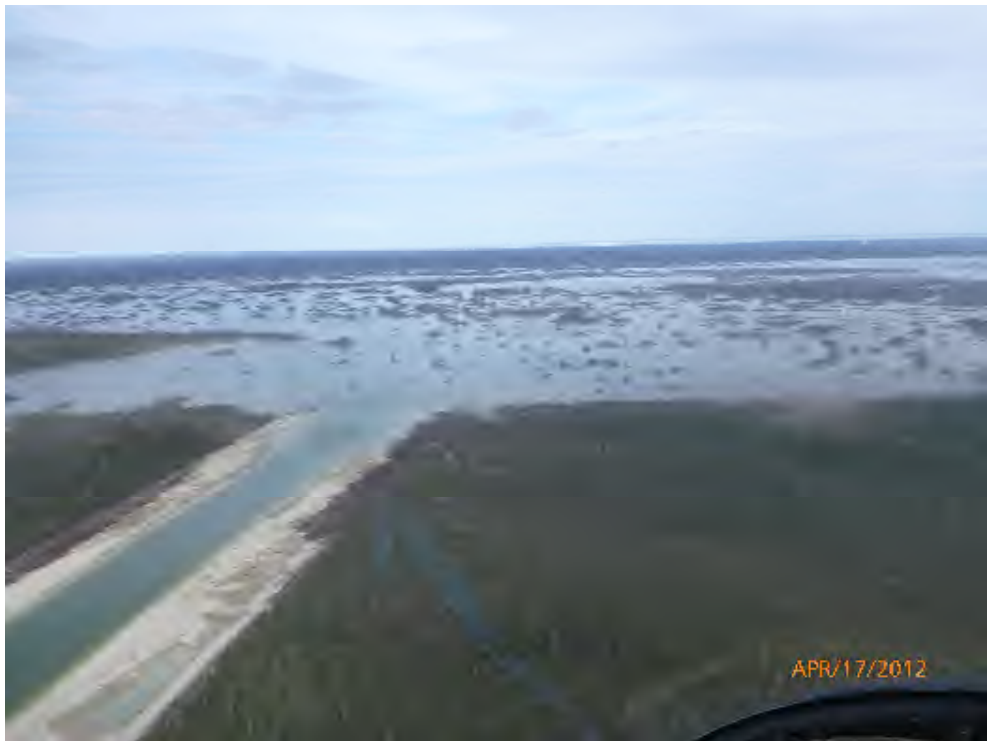
**Photo 4  
Reach 1 Emergency Channel Outlet**

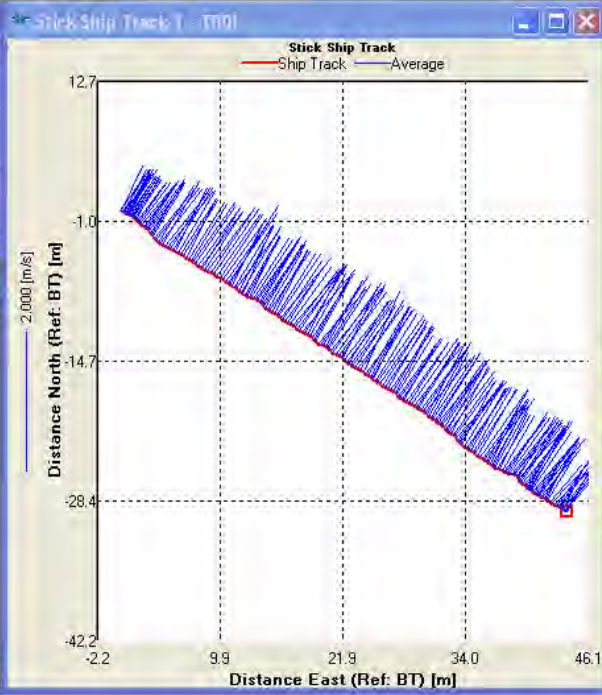
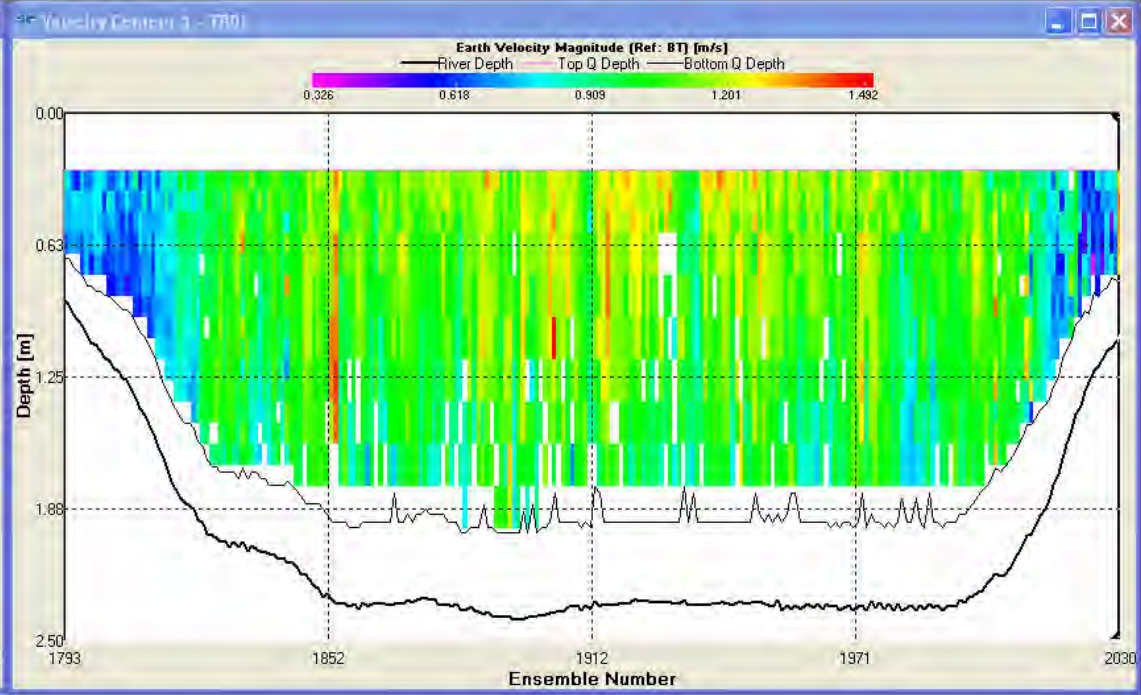
Measurement 011 - TRDI

Ens. Nmb.	Nmb. of Ens.	Last Ens.
2030	238	0
Bad Ens.	%Bad Bins	Delta Time
0	3%	0.61
<b>May 12, 2012 23:35:00.85</b>		
Pitch	Roll	Heading
-2.80°	-1.40°	243.90°
Temp.	Press. Sensor	
21.06°C	NA	
Discharge (Ref: BT) Left to Right		
Good Bins	5	
Top Q	15.920	[m <sup>3</sup> /s]
Measured Q	74.891	[m <sup>3</sup> /s]
Bottom Q	21.926	[m <sup>3</sup> /s]

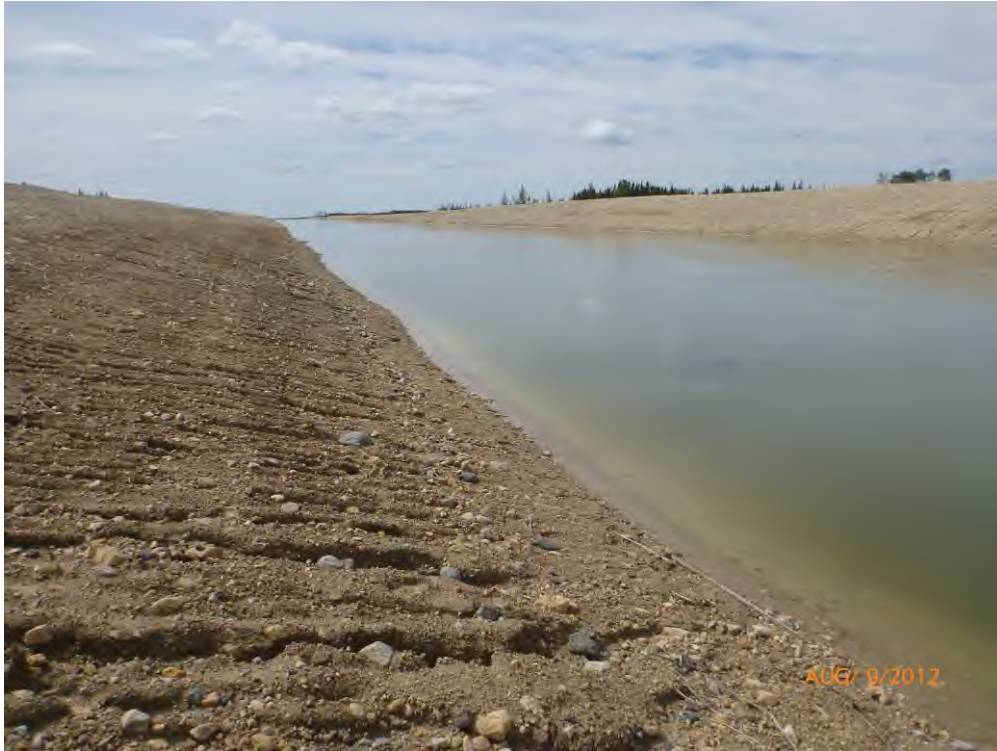
**Photo 1**  
**Reach 1 Emergency Channel Looking Upstream of Metering Location**

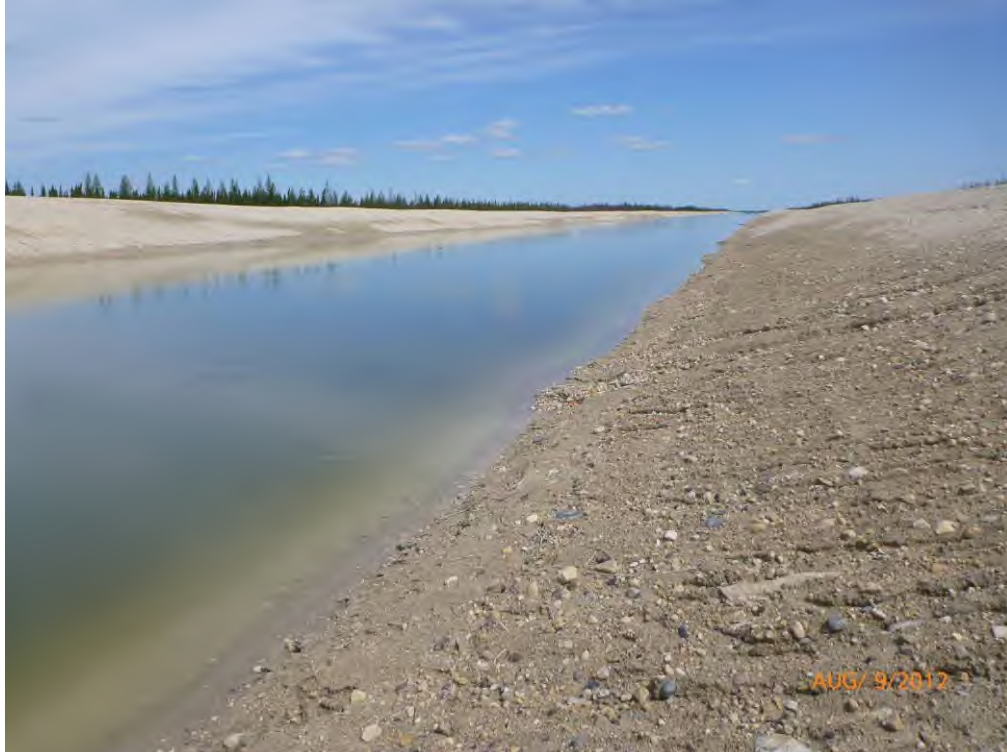
**Photo 2**  
**Reach 1 Emergency Channel Looking Downstream of Metering Location**

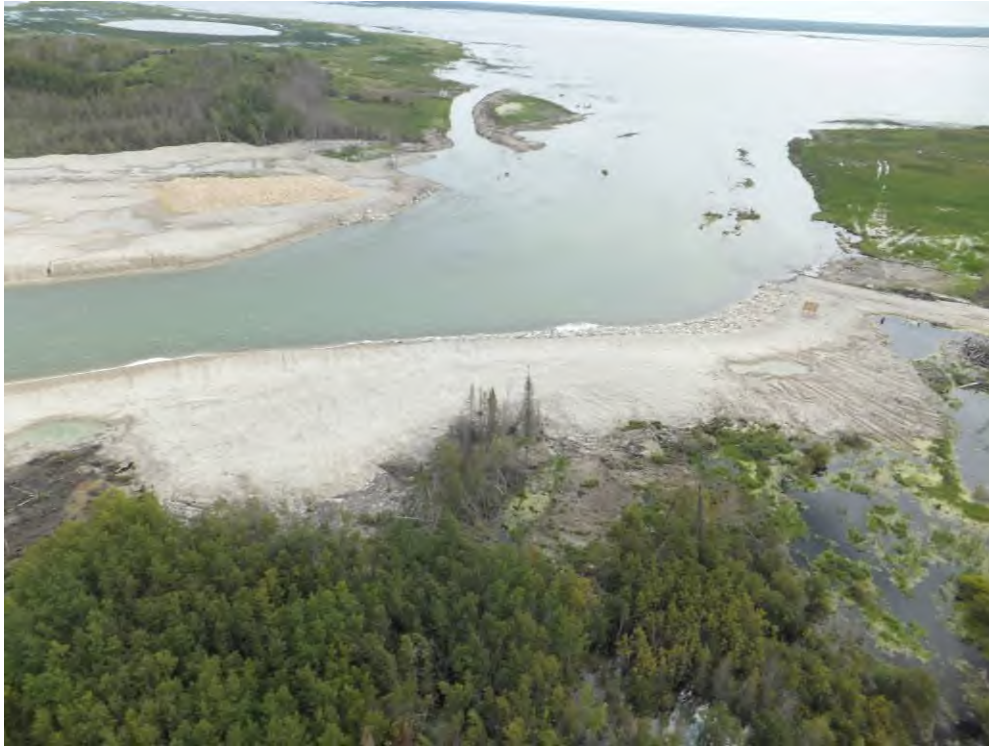
**Photo 3**  
**Reach 1 Emergency Channel Inlet**

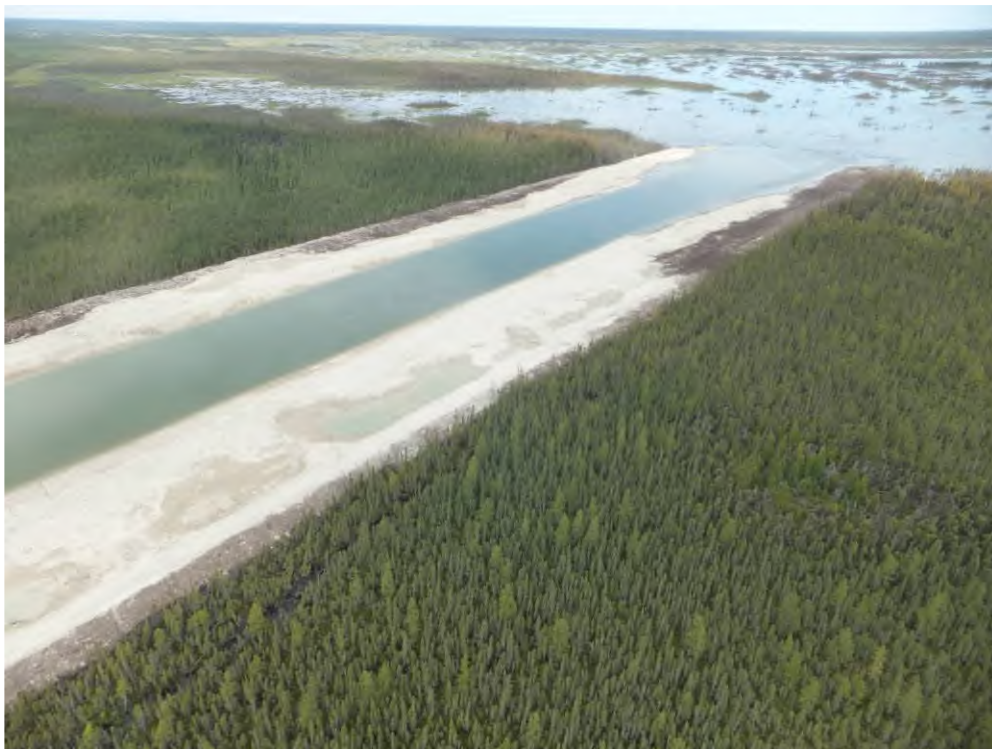
**Photo 4**  
**Reach 1 Emergency Channel Outlet**

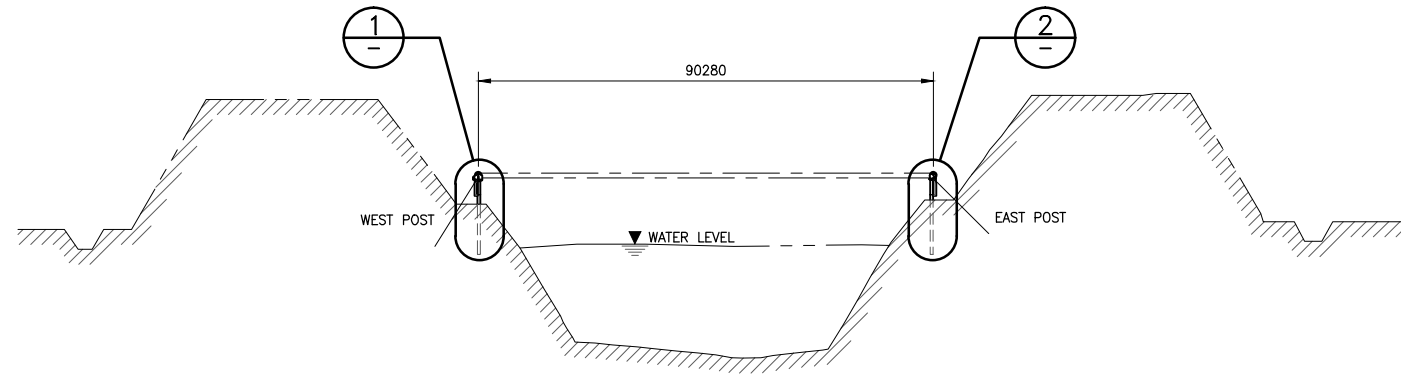
DWG. NO. 11-0300-18 S04 REV: 0

**TYPICAL CROSS SECTION**  
SCALE: NTS (LOOKING DOWNSTREAM)

- CABLE PULLED TO AN INITIAL UNLOADED SAG OF 2 FEET.
- ALL ELEVATIONS ARE GIVEN IN METRES AND CAN BE CONVERTED TO FEET BY MULTIPLYING BY 3.28083.
- SPANMASTER MODEL SMK1 IS DESIGNED AND MANUFACTURED BY HYDROLOGICAL SERVICES PTY LTD.
- ALL CONNECTIONS COMPONENTS MANUFACTURED BY MACMOR INDUSTRIES LTD. UNLESS OTHERWISE NOTED.
- STRUCTURAL AND MISCELLANEOUS STEEL FABRICATION AND ERECTION IN ACCORDANCE WITH CAN/CSA S16 (LATEST).
- STANDARD PIPE MET THE REQUIREMENTS OF ASTM A53.
- CABLEWAY PULLEY CAN BE OPERATED WITH HAND CRANK OR POWER DRILL USING A 17mm SIZE SOCKET.

DWG. DESCRIPTION:  
 ADCP CABLEWAY & SUPPORTS SECTIONS & DETAILS

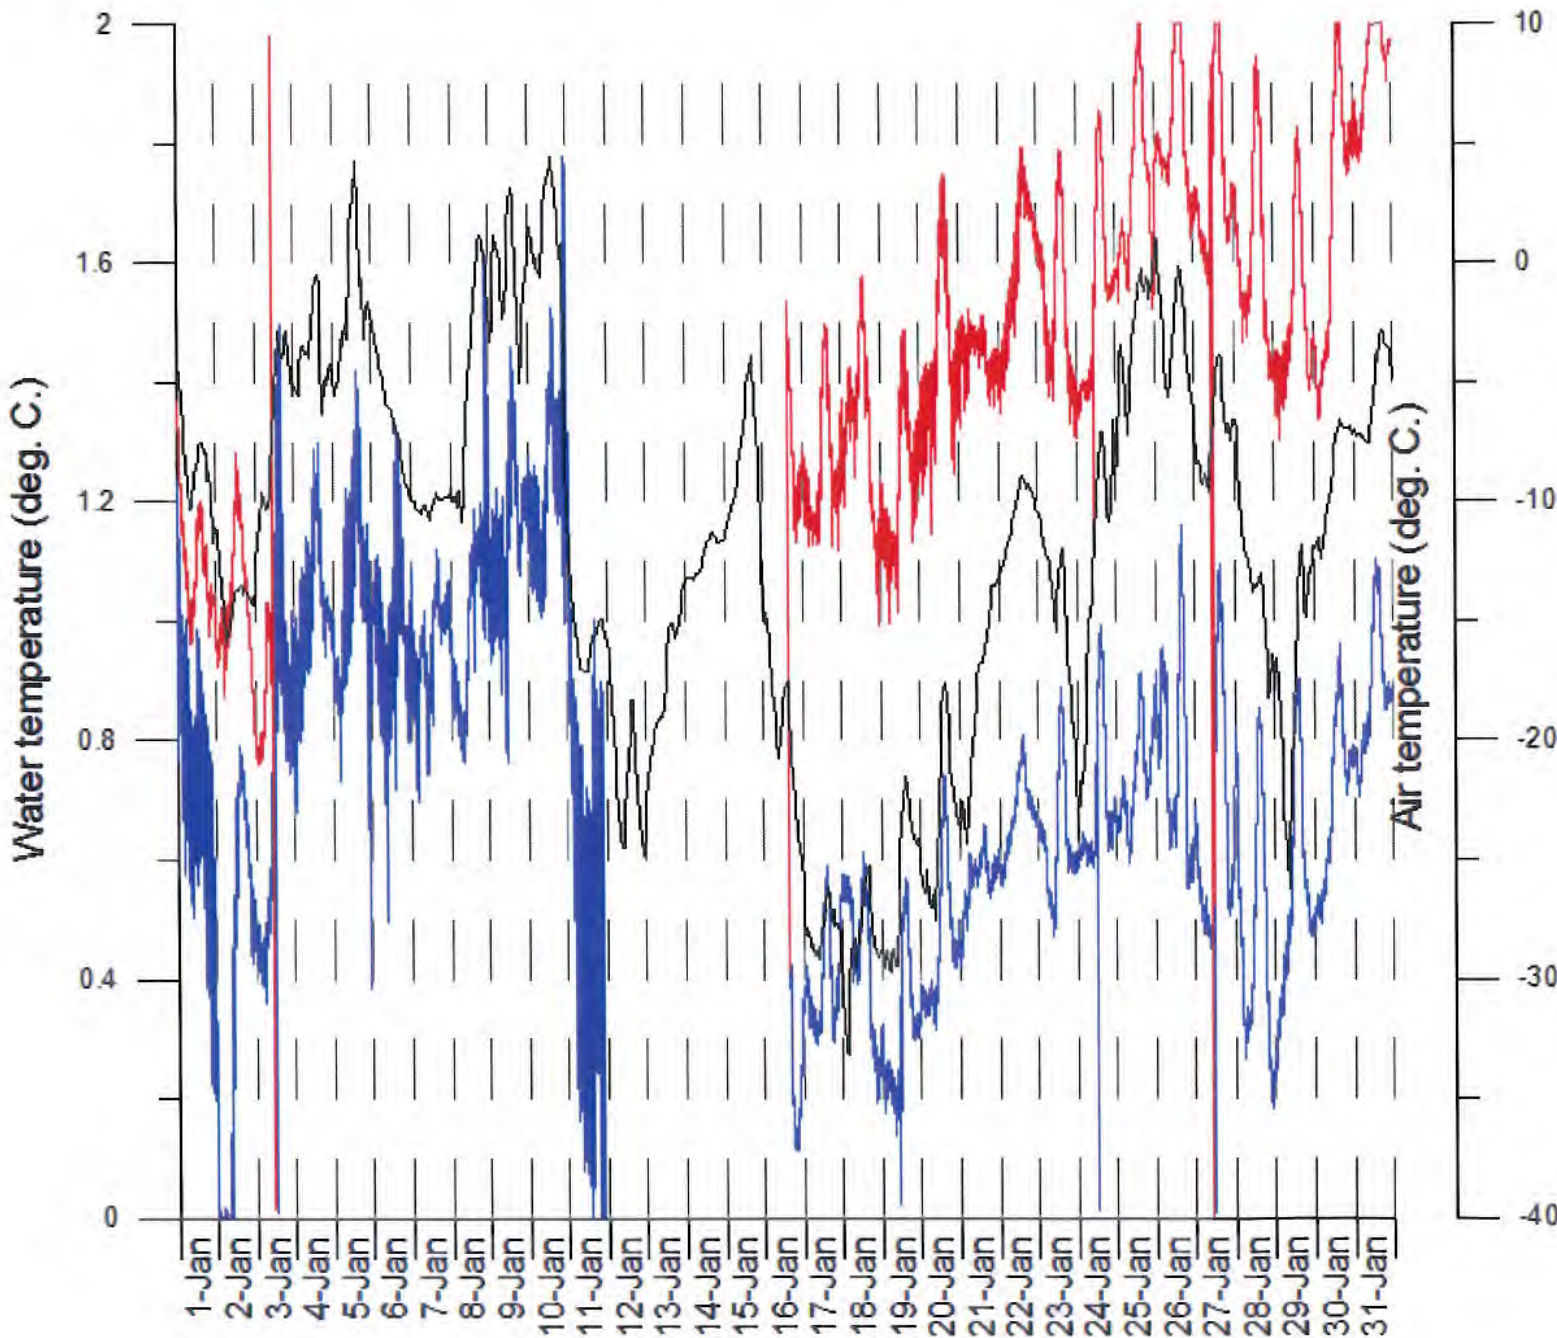
### January 2012 Water Temperatures

- Water temperature at Railway Bridge (22)
- Water temperature at Fairford Dam (21)
- Air temperature at Fisher Branch (hourly)

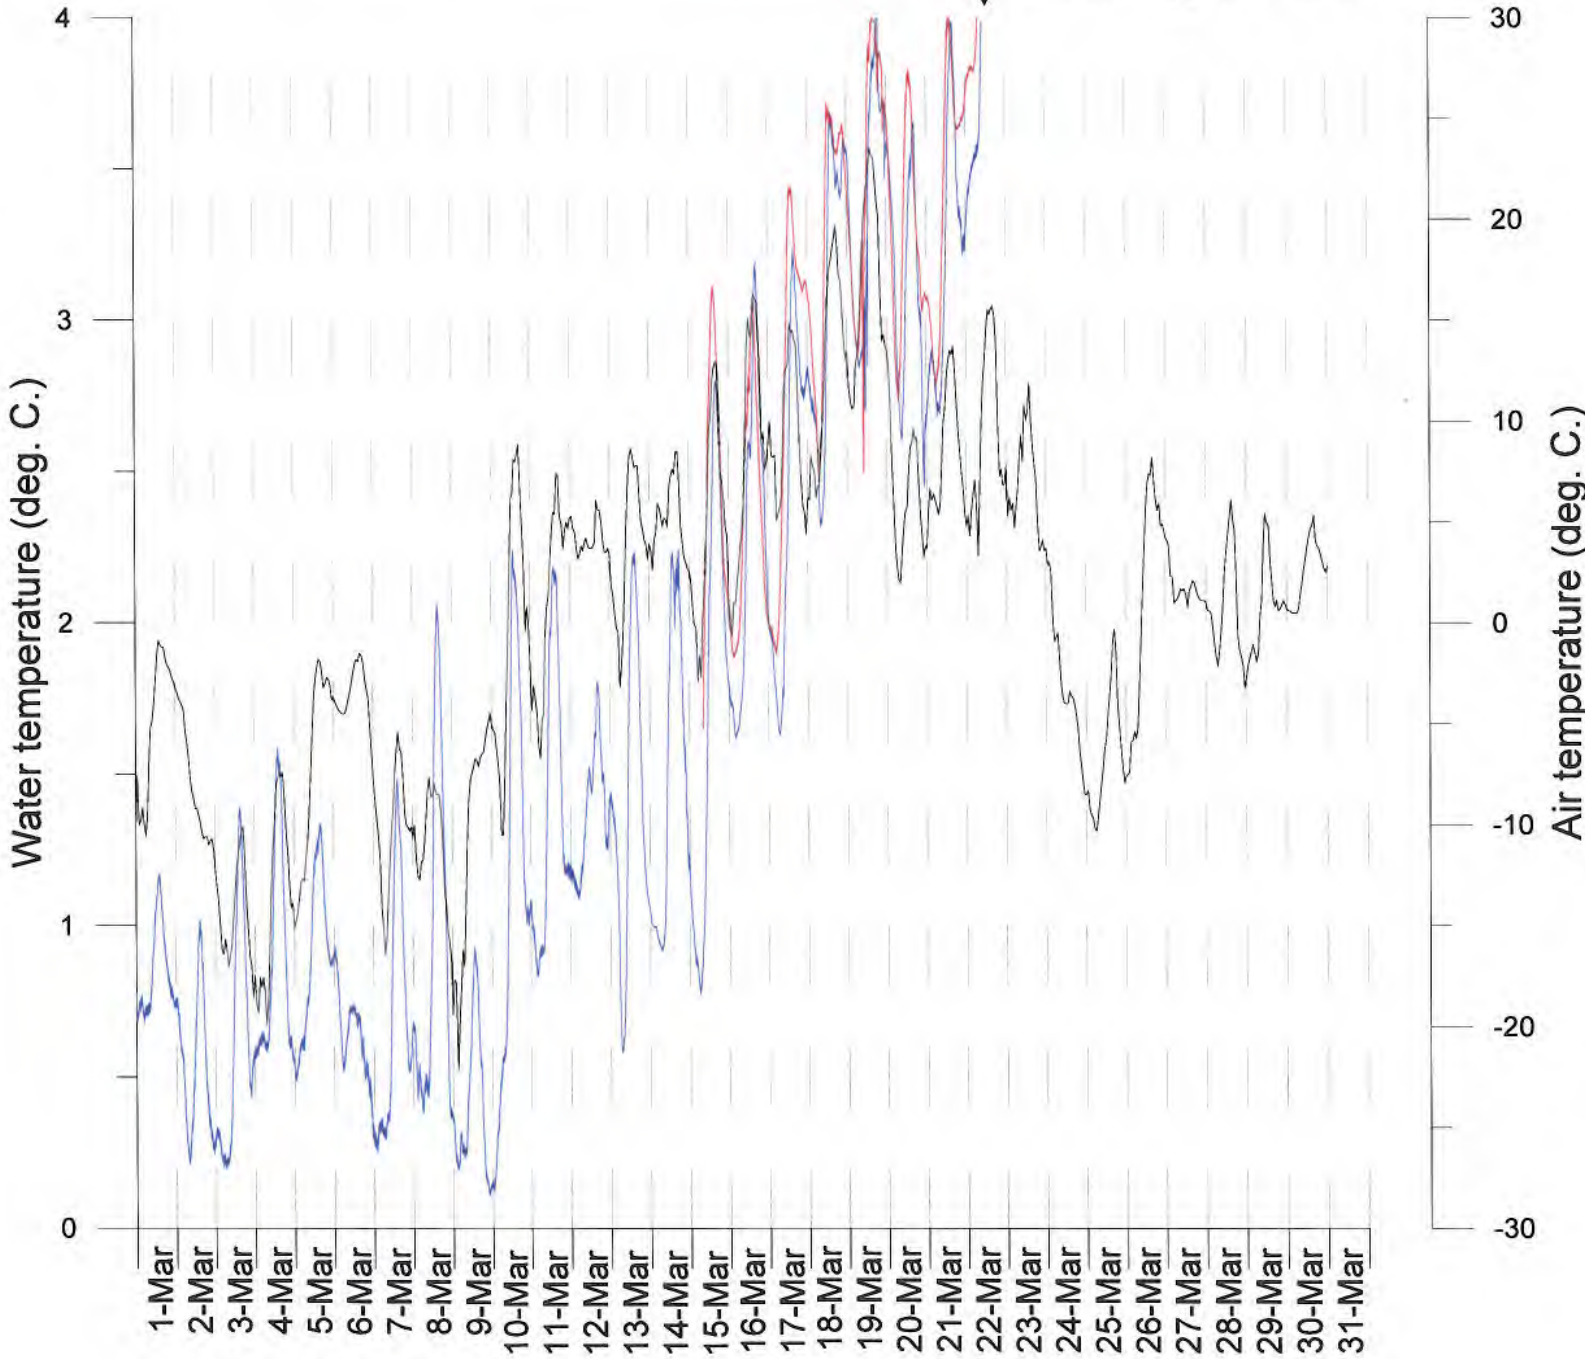
### March 2012 Temperatures

- Water temperature at Railway Bridge (22)
- Water temperature at Fairford Dam (21)
- Air temperature at Fisher Branch (hourly)

recording terminated  
and loggers removed

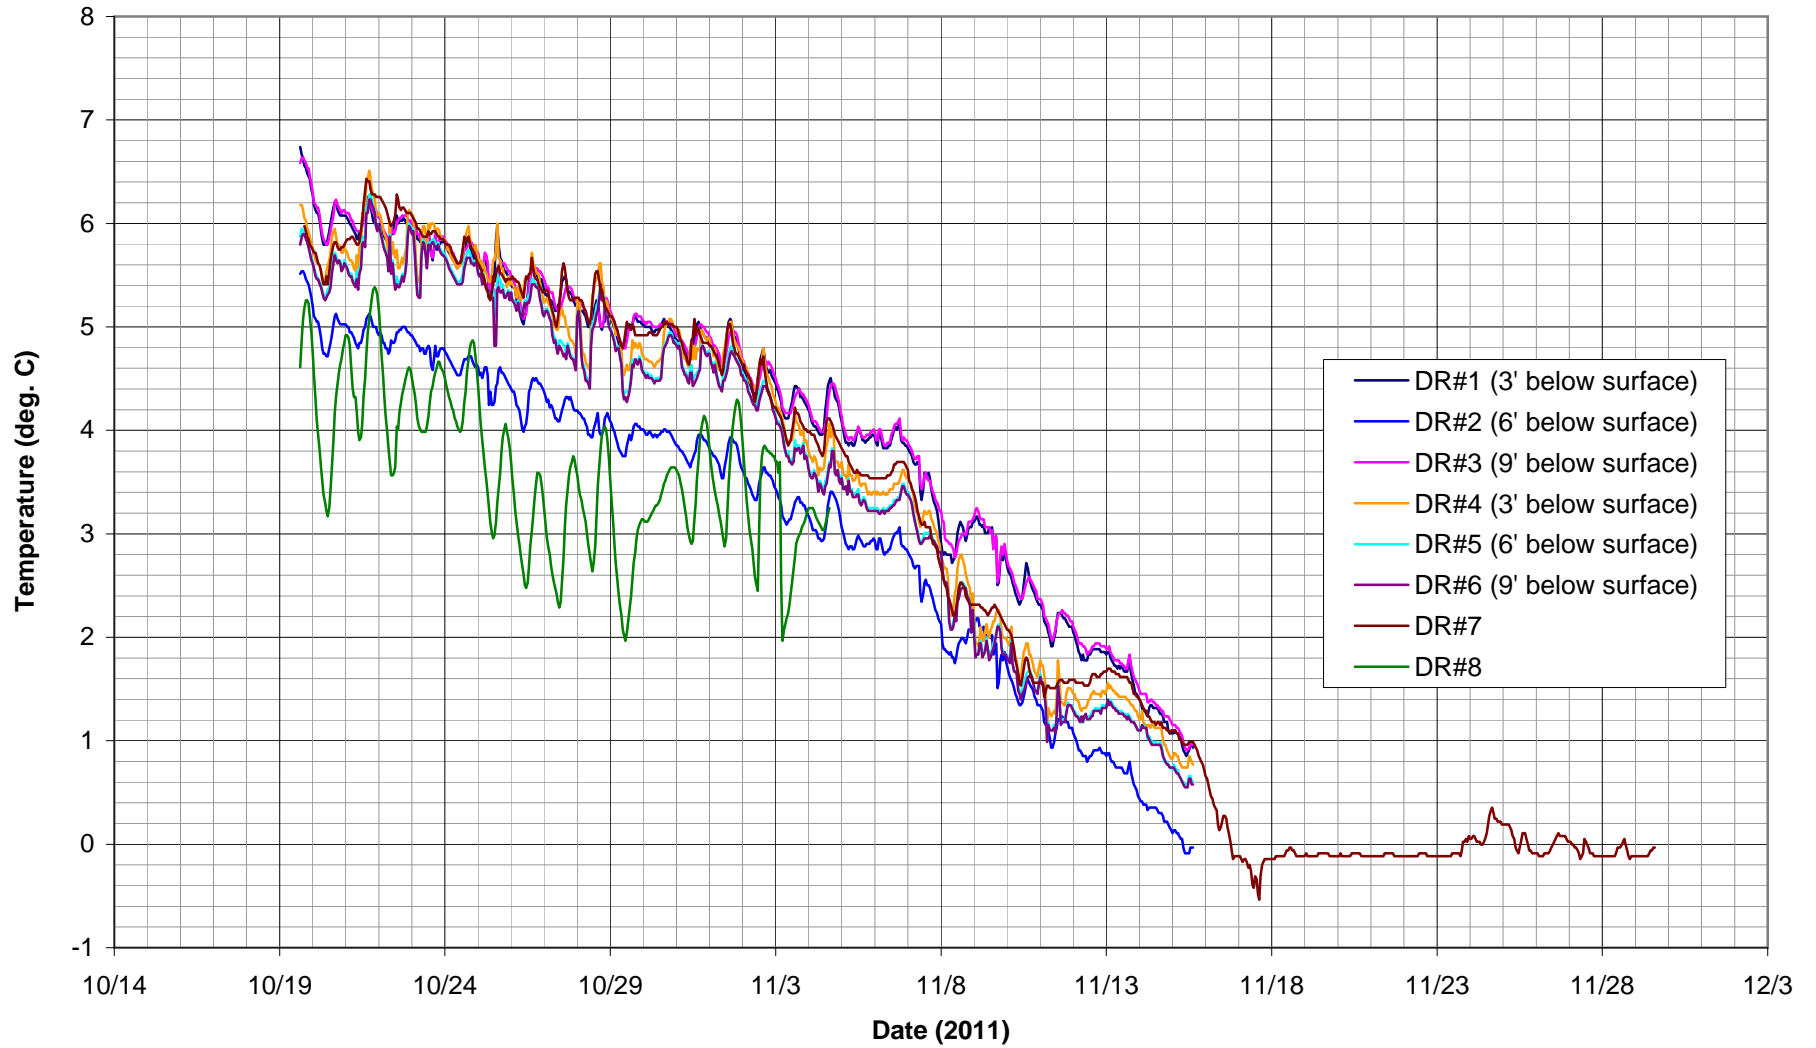
**FIGURE E2-2**  
**Dauphin River Temperature Data 2011**  
*Lake Winnipeg - North of Dauphin River Mouth*
