# *Lake St. Martin Outlet Channel Proposed All Season Access Road Fisheries and Aquatic Habitat Assessment*

**LAKE ST. MARTIN OUTLET CHANNEL  
PROPOSED ALL SEASON ACCESS ROAD  
FISHERIES AND AQUATIC HABITAT ASSESSMENT**

October 2016

**AAE Tech Services Inc.**

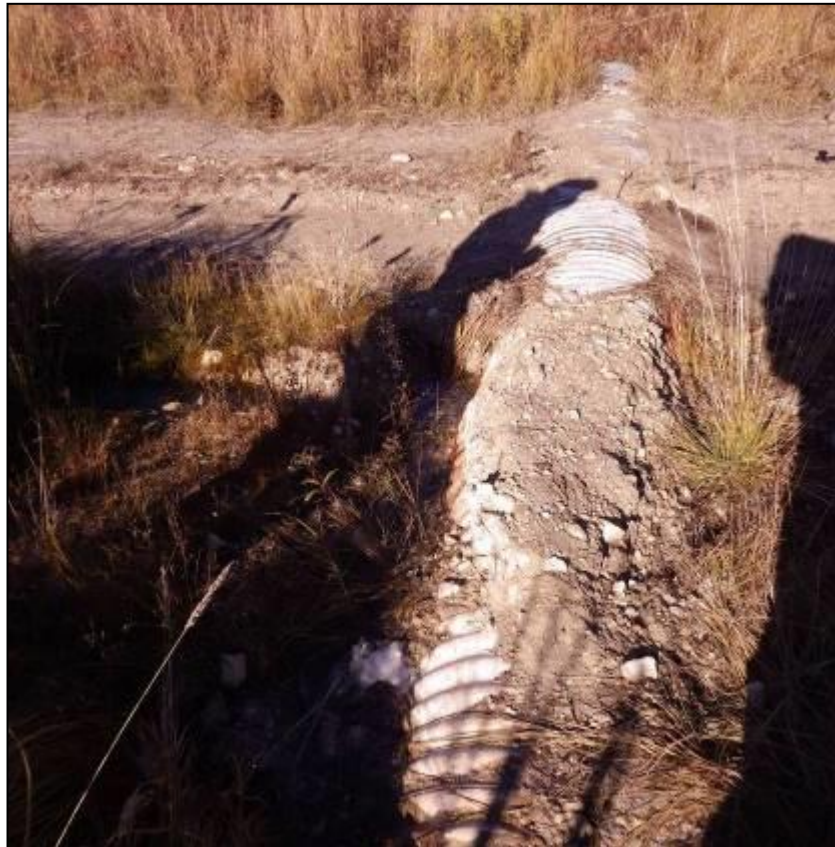
Habitat connectivity was found to be limited at all three Crossing sites, as well as across the entire project area. Culvert crossings at all three sites were found to be blocked and/or damaged. While grubbing and cleaning were noted at Crossing 2 in October of 2015 (Section 6.2.1), the culvert was again blocked the following spring, and continued beaver activity had resulted in numerous road washouts and extensive culvert blockage/damage along the extent of the proposed ASR. Blockages at Crossings 2 and 3 resulted in extensive damage (Figure 6) and washout (Figure 7) of the forestry road in the spring of 2016.

**Figure 6.** One of three culverts at Crossing 3, exposed across road and completely blocked at upstream end.

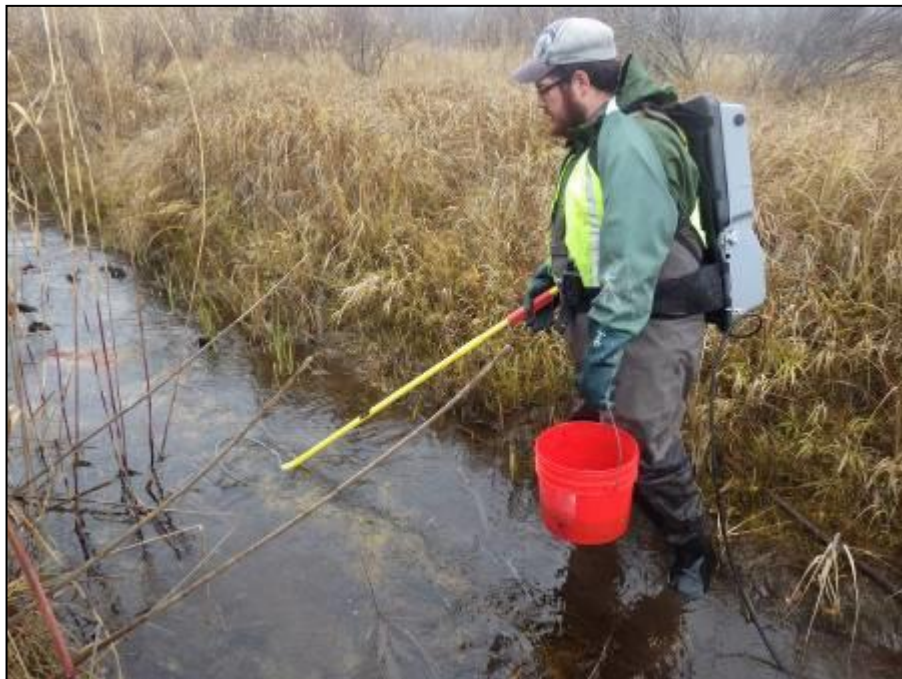
Backpack electrofishing with a Smith-Root LR24 was used to assess the fish communities at each creek crossing within the study area during the 2015 fall field season, and again in the spring 2016 season, to target both small- and large-bodied fish (Figure 8). As backpack electrofishing is limited to depths of 1.3 m or less, sampling was performed within select areas in upstream and downstream reaches for each crossing, ensuring that all habitat types were studied (Figures 10 - 12). Due to culvert blockage and a subsequently wider upstream sampling area at all three crossings, two upstream transects were performed for each crossing (i.e. one on each side of the culvert) and combined for results. A single downstream transect was performed at Crossing 1 and Crossing 3 whereas, due to easy accessibility, two downstream transects were performed at Crossing 2 to document both proximal and distal downstream fish species. All fish captured were held temporarily in a live well prior to being identified to species, enumerated, measured for fork length and released unharmed into similar habitat from which they were collected. If identification was not possible on site due to similar external morphologies of two species, fish were identified to genus and a small number of representative voucher specimens were preserved in 10% formalin for further analysis in the AAE laboratory.

*Figure 8. Backpack electrofishing, distal downstream reach of Crossing 2.*

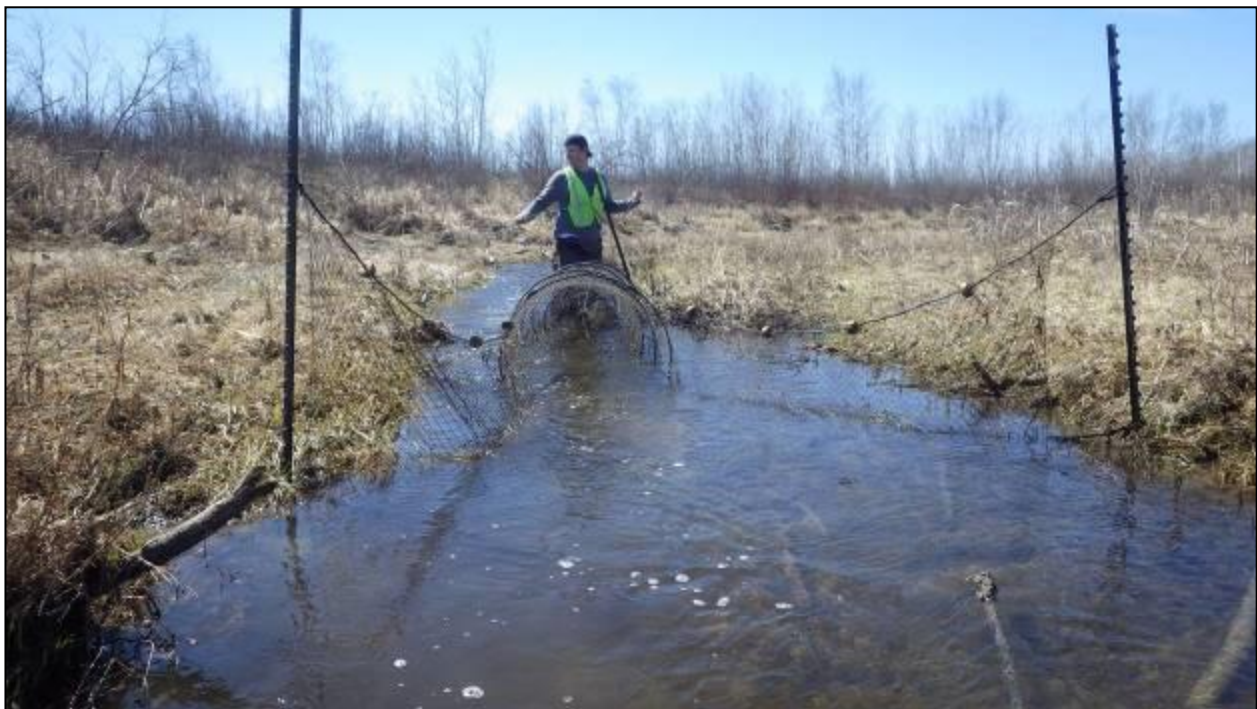
As backpack electrofishing is limited to depths of 1.3 m or less, spring investigations focused on the study of fish utilization within the deeper mid-channel areas not assessed during fall sampling, which were suspected to contain large-bodied fish. These deeper areas were assessed using trap netting and gill netting. Trap nets were utilized to capture fish at Crossing 2 and Crossing 3 along the roadway area. One trap net was set downstream of each crossing at a location of sufficient depth to enable effective capture of fish travelling upstream (depth > 0.8 m). Although depths immediately downstream of Crossing 3 enabled setting of trap nets, shallow depths immediately downstream of Crossings 1 and 2 precluded effective trap netting. Consequently, a trap net was instead set immediately downstream of a large beaver dam approximately 50 m downstream of Crossing 2. Trap nets were each 1.2 m in diameter and constructed of 1.85 cm<sup>2</sup> nylon mesh. Two 4.5 m wings were attached to the downstream opening of each net to direct fish into the traps (Figure 9).

**Figure 9.** Trap net installation at Distal Downstream reach of Crossing 2.

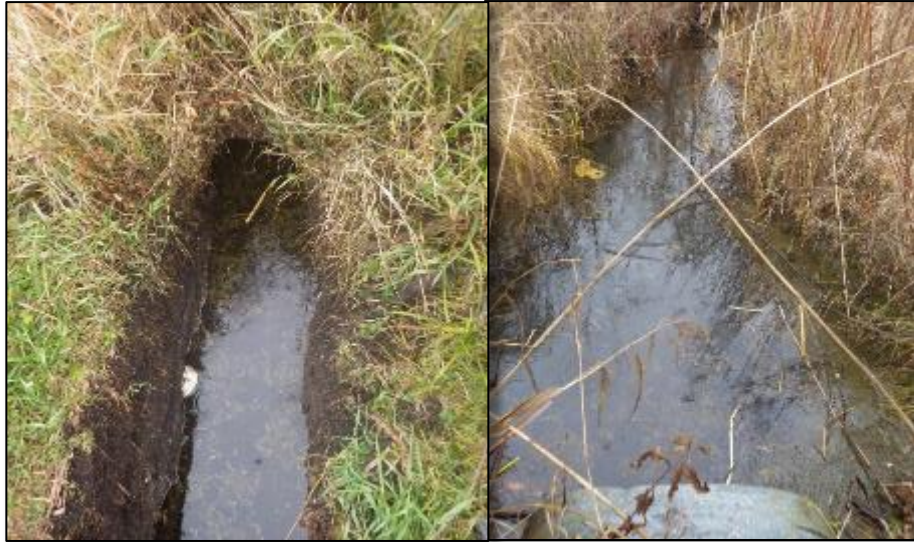
**Figure B-1.**  
Upstream (left)  
and downstream  
(right) views of  
Culvert 1 shortly  
after clearing.

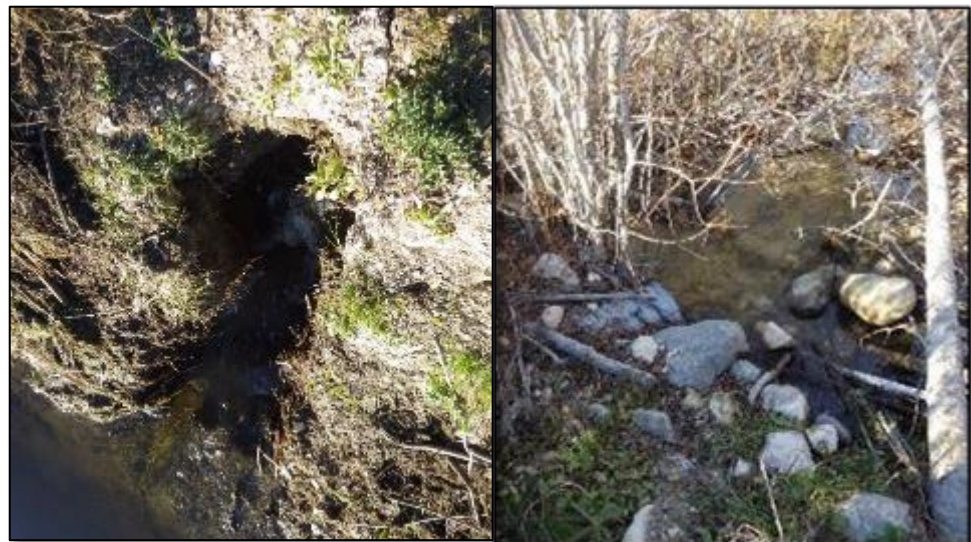
**Figure B-2.**  
Upstream (left)  
and downstream  
(right) views of  
Culvert 2 shortly  
after clearing.

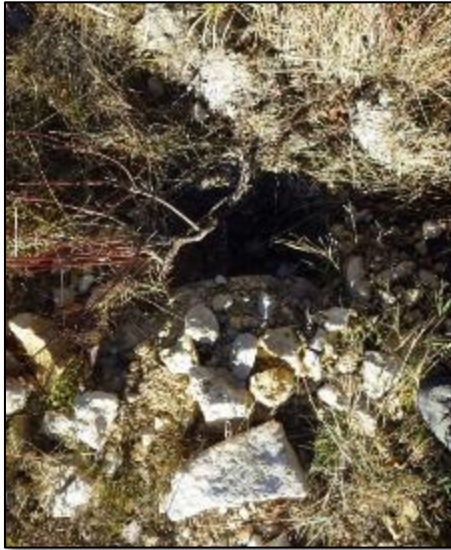
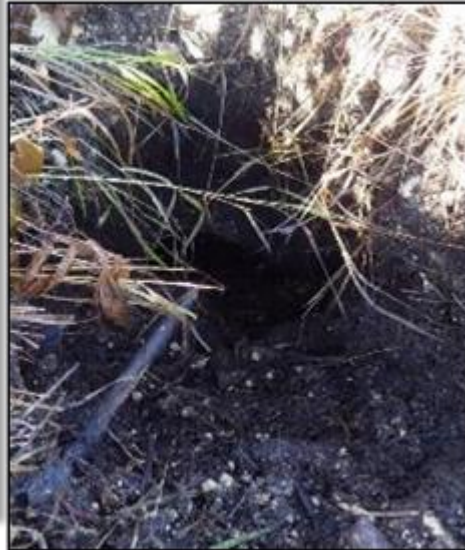
**Figure B-3.**  
Upstream (left) and  
downstream (right)  
views of Culvert 3A.  
The culvert was  
buried deep in the  
ground.

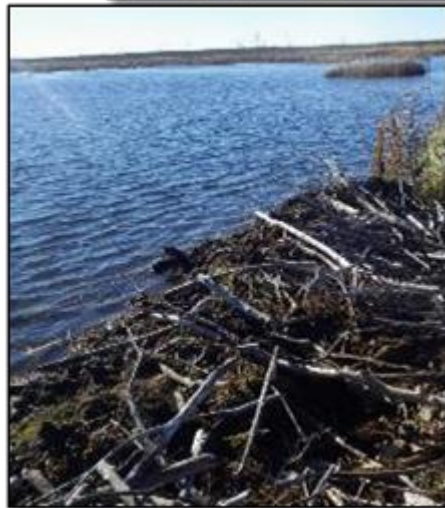
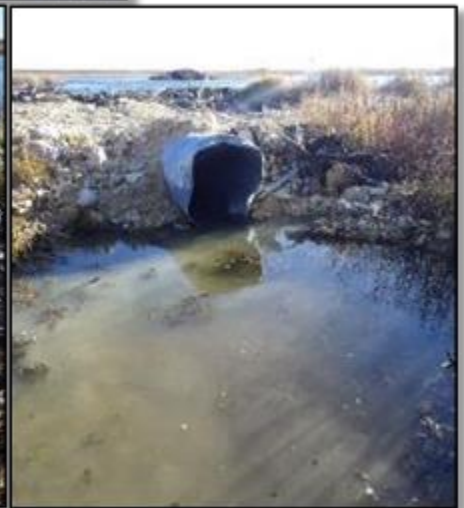
**Figure B-4.**  
Upstream (left) and  
downstream (right)  
views of Culvert 3B.  
The upstream side  
was completely  
buried in woody  
debris and the  
downstream side was  
somewhat damaged.

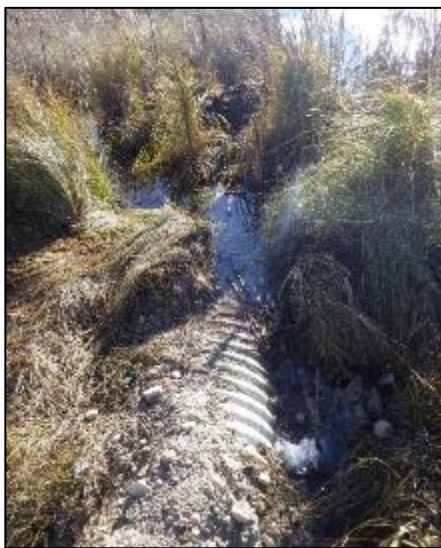
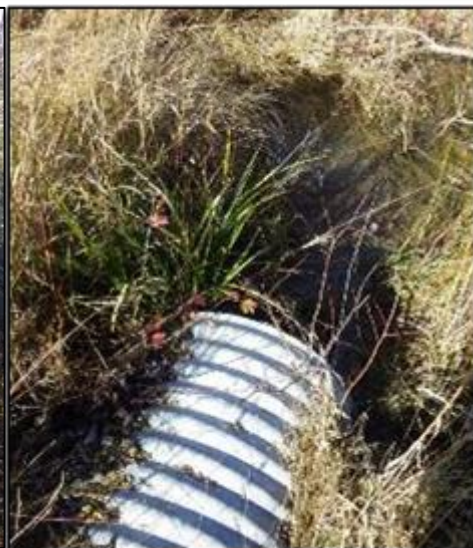
**Figure B-5.**  
Upstream (left) and  
downstream (right)  
views of Culvert 3C.  
The upstream side  
was blocked by debris  
and vegetation;  
blockage resulted in  
water flowing across  
the road.

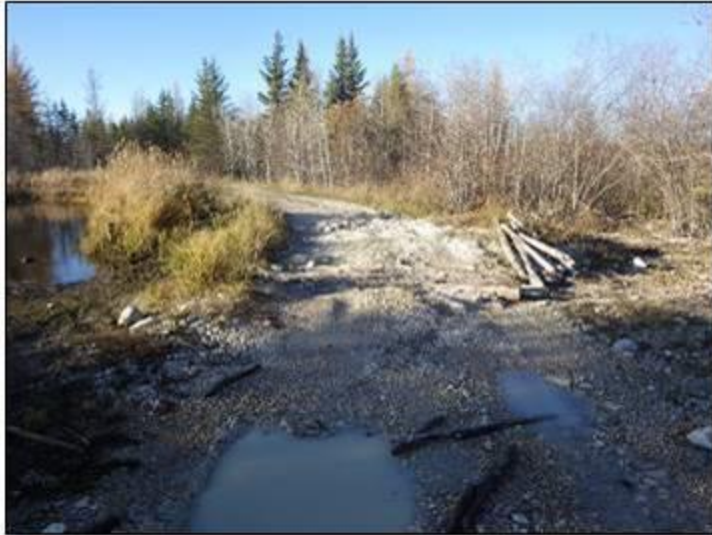
**Figure C-7.** Access road at Crossing 2. Road was washed out prior to clearing and grubbing of culvert.

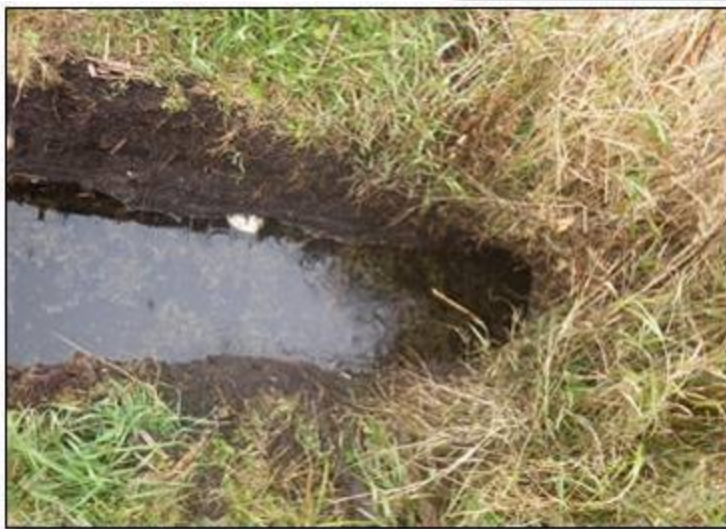
**Figure C-9.** Culvert at Crossing 2 shortly after clearing and grubbing.

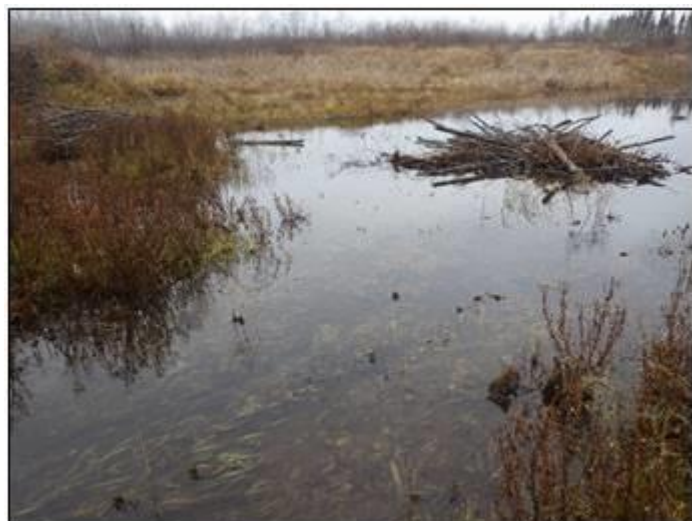
**Figure C-12.** Downstream boundary of distal downstream reach of Crossing 2. Note beaver activity present.

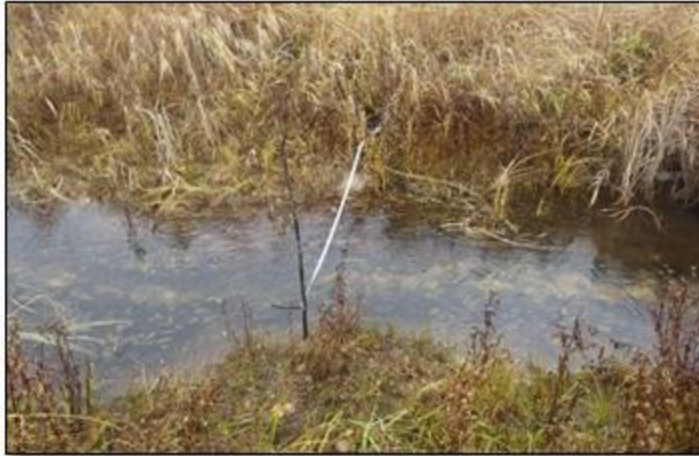
**Figure C-13.** Cross-section profile conducted within distal downstream reach of Crossing 2.

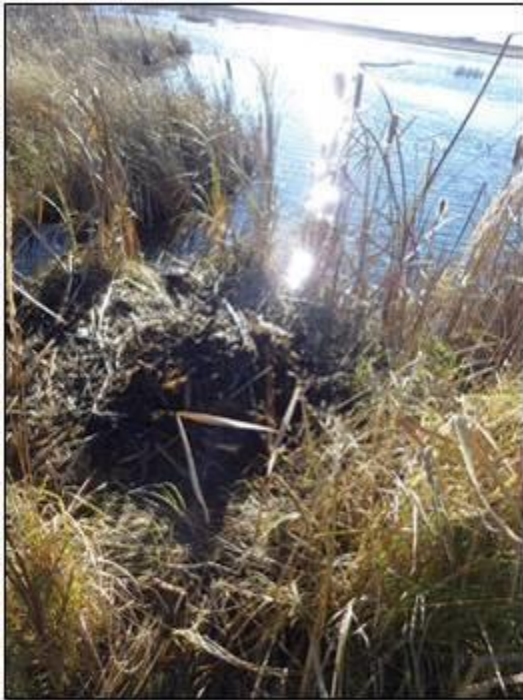
**Figure C-16.** Plugged culvert at Crossing 3.
