**Lake St. Martin Emergency Relief Channel
Monitoring and Development of Habitat Compensation
Physical Processes**

DRAFT / MIT-009-13_002_REV B

KGS Group 13-0431-001
March 2016

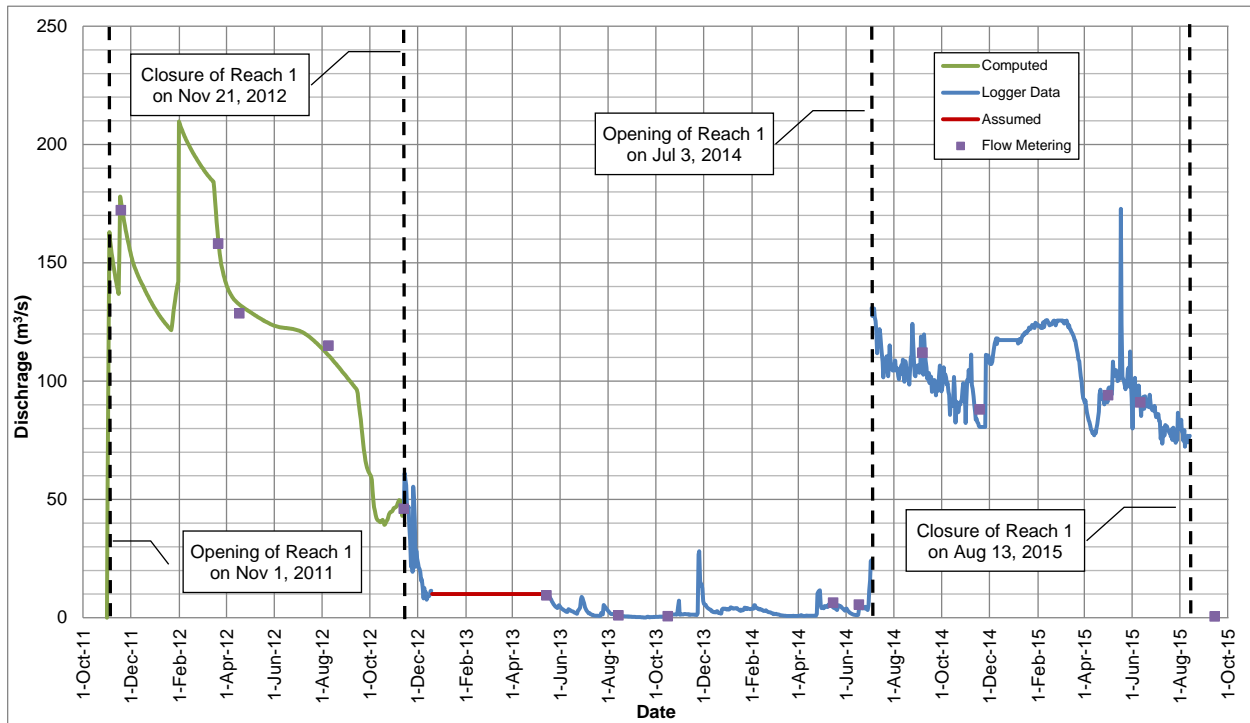
**FIGURE 3.1-2
 BUFFALO CREEK FLOWS PRE- AND POST-OPERATION**

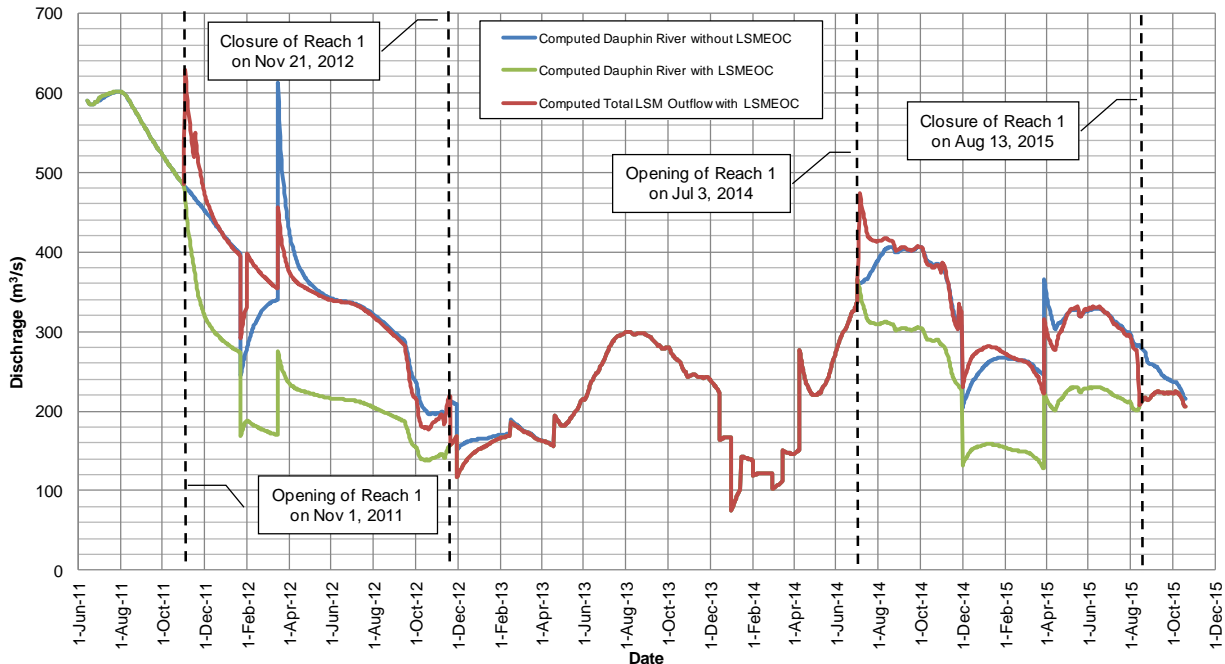
**FIGURE 3.1-3
 DAUPHIN RIVER FLOWS PRE- AND POST-OPERATION**

Data obtained from WSC at Gauge No. 05LM006 (Dauphin River near Dauphin River) combined with knowledge of ice conditions from the Upper Dauphin River Ice Reconnaissance Survey and results from the Analysis & Monitoring of Discharges & Ice Processes Report (KGS Group, 2014), extended to 2015, was used to develop a flow hydrograph for the Dauphin River upstream of Buffalo Creek. This was necessary because the hydrometric data available on Dauphin River from WSC can be affected by ice conditions in the river during the winter. The computed flows on Dauphin River upstream of Buffalo Creek prior to and post closure of Reach 1 is provided in Figure 3.1-4. The total Lake St. Martin outflow during operation of the LSMEOC, which is the summation of the Buffalo Creek and Dauphin River discharges, is also shown on Figure 3.1-3.

The Dauphin River sediment transport analysis (discussed in Section 4.0) required the development of a synthetic flow hydrograph of the Dauphin River assuming that the LSMEOC System was not operated. This had already been developed by KGS Group for the Analysis & Monitoring of Discharges & Ice Processes Report (KGS Group, 2014) from November 2011 to July 2012. The results from the previous analysis (KGS Group, 2014) were extended to October 2015 based on the additional data collected for this study. The synthetic flow hydrograph is a prediction of what flows would have occurred in the Dauphin River without operation of Reach 1 should all other conditions (e.g. inflow to Lake St. Martin, ice conditions in Dauphin River, etc.) remain the same. The computed synthetic flow hydrograph on Dauphin River without operation of the LSMEOC System is provided in Figure 3.1-3.

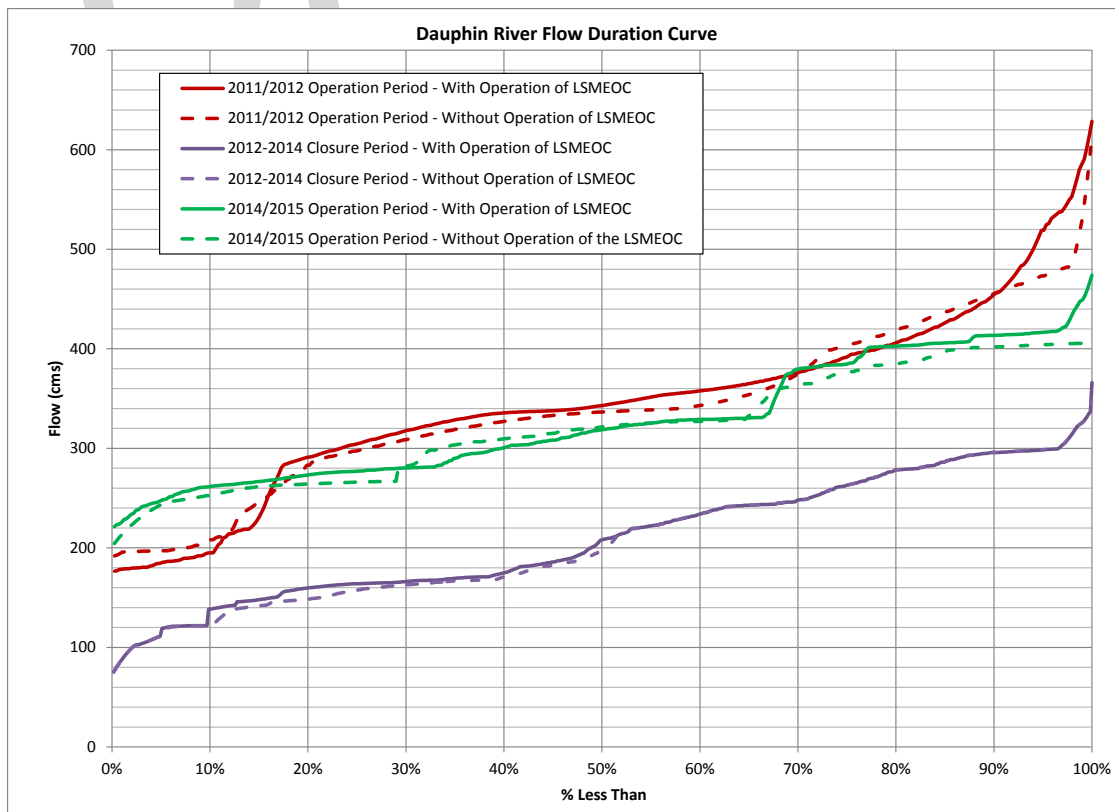
**FIGURE 3.1-5
 DURATION CURVES OF COMPUTED TOTAL OUTFLOW FROM LAKE ST. MARTIN**

Dauphin River duration curves of the total Lake St. Martin outflow (Dauphin River outflow plus LSMEOC outflow) are shown on Figure 3.1-6. Duration curves are shown for conditions with operation of the LSMEOC and also for conditions assuming that the LSMEOC System was not operated. The 10th, 50th, and 90th percentile flows for the three operating periods are summarized in Table 3.1-3.

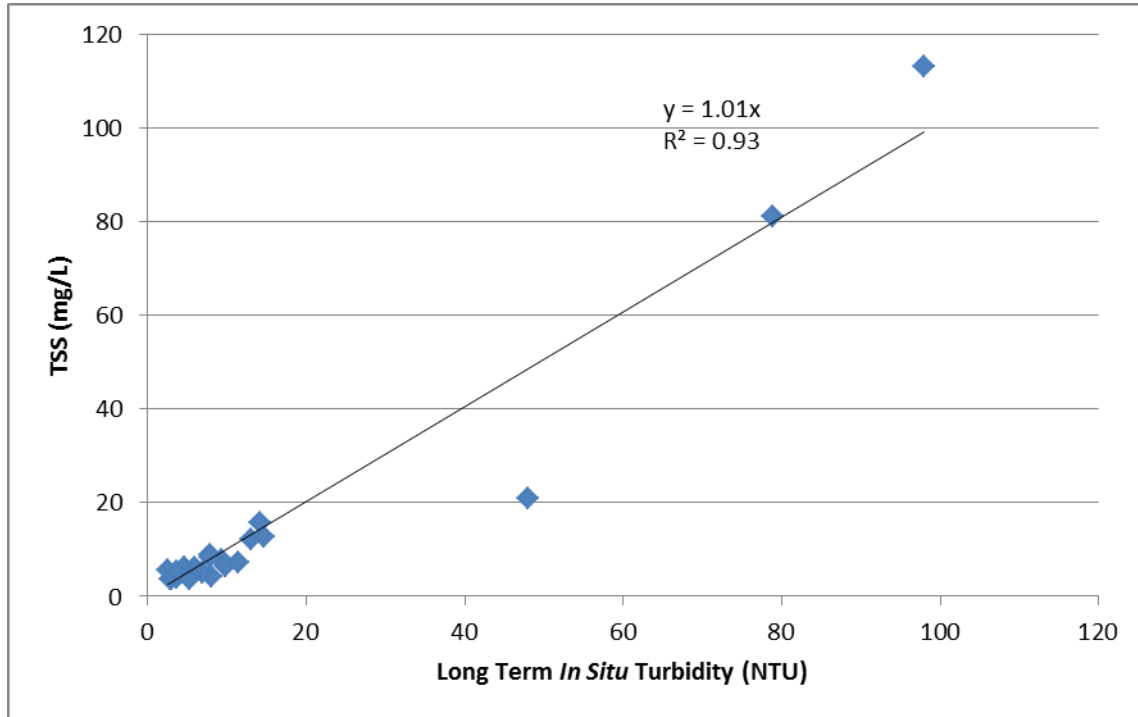
FIGURE 3.2-2
CORRELATION OF INSITU TURBIDITY AND LABORATORY ANALYZED
TURBIDITY MEASURED IN BUFFALO CREEK (BC-TM) AND DAUPHIN RIVER (DR-TM)

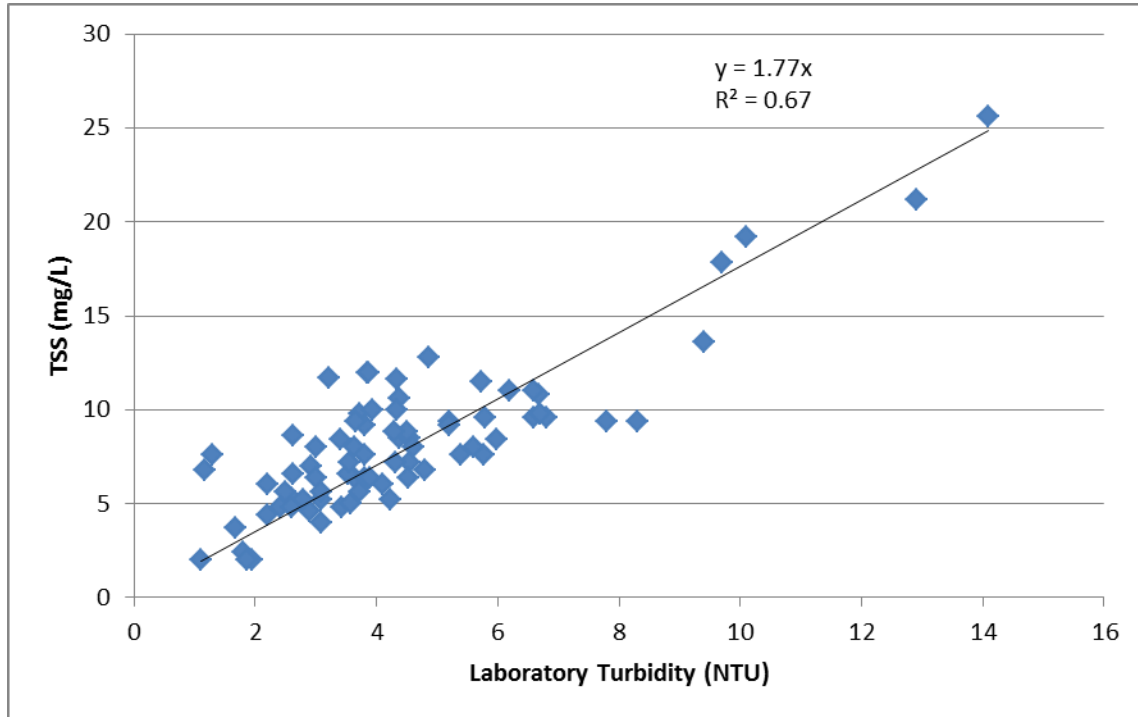
**FIGURE 3.2-3
CORRELATION OF LABORATORY ANALYZED TURBIDITY AND
TSS MEASURED IN DAUPHIN RIVER (DR-TM & DR1)**

The linear regression completed to correlate laboratory analyzed turbidity and TSS within the Dauphin River also included data collected from the sample location DR1 to supplement the limited data collected at DR-TM. Since DR1 was located upstream of the confluence with Buffalo Creek in close proximity to DR-TM, it was assumed that it had representative conditions. In comparison, DR3 and DR2C, which are located downstream of the confluence point, were not used in the analysis as they could have been influenced by Buffalo Creek or Lake Winnipeg. Within the Dauphin River the laboratory turbidity values measured at DR-TM and DR1 correlated well ($R^2 = 0.67$) with TSS having a linear relationship of $TSS = 1.77 \times \text{Turbidity}$ as shown in Figure 3.2-3. This linear relationship was used for estimating TSS concentrations (mg/L) from the long-term insitu turbidity based on the 1:1 relationship between laboratory analyzed turbidity and insitu turbidity.

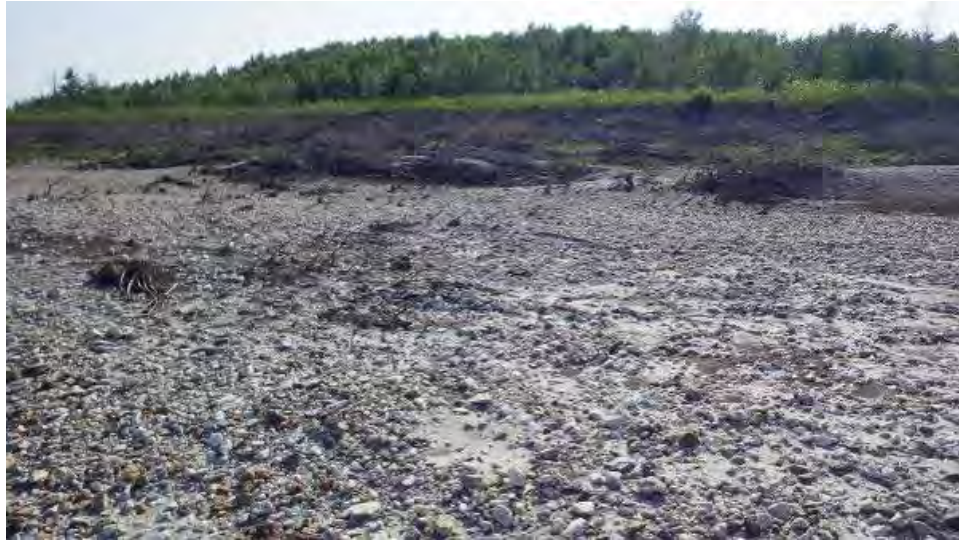
PHOTO 1
“BARE” SUBSTRATE OBSERVED AT 18+000

The four representative cover types are shown in Photos 1 to 4 below. Photos comparing the difference between survey periods are found within the field inspection forms provided in Appendix A2. Digital photograph logs of the surveys were compiled and are provided in Appendix E.

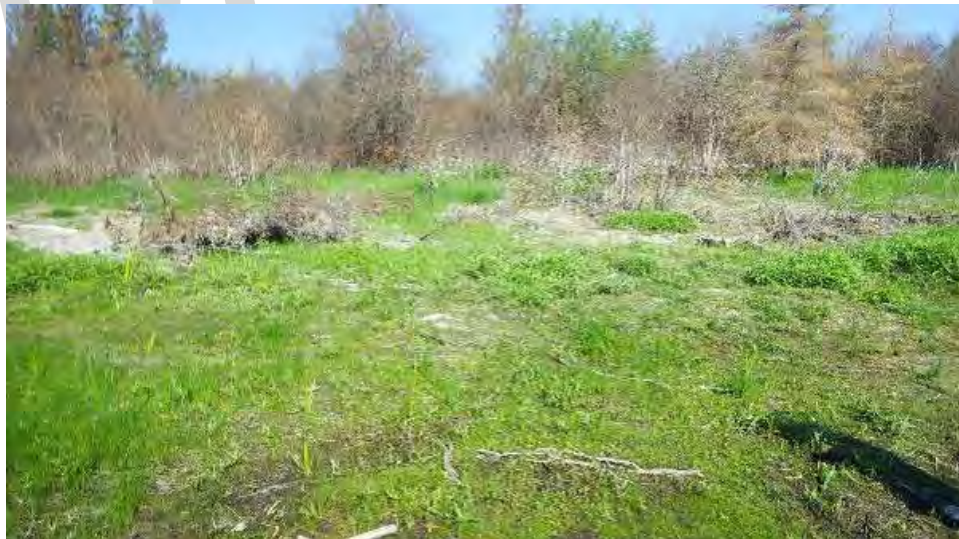
PHOTO 2
“GRASS” VEGETATION OBSERVED AT 13+500

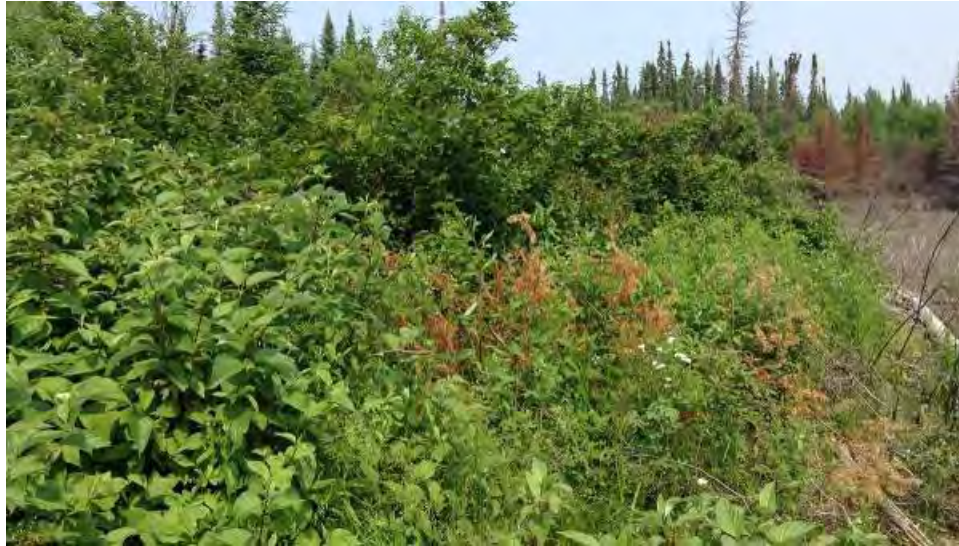
PHOTO 3
“SHRUB” VEGETATION OBSERVED AT 26+000

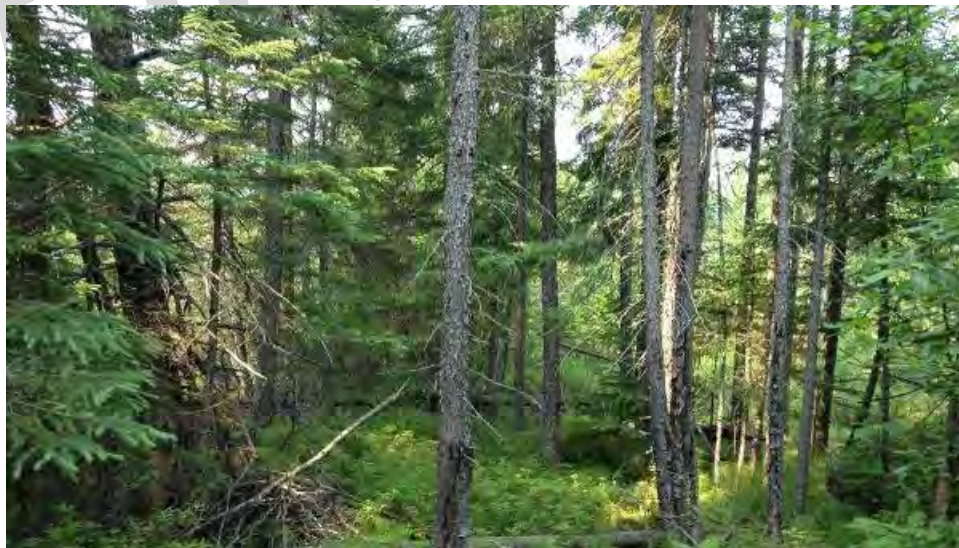
PHOTO 4
“TREED” VEGETATION OBSERVED AT 25+000

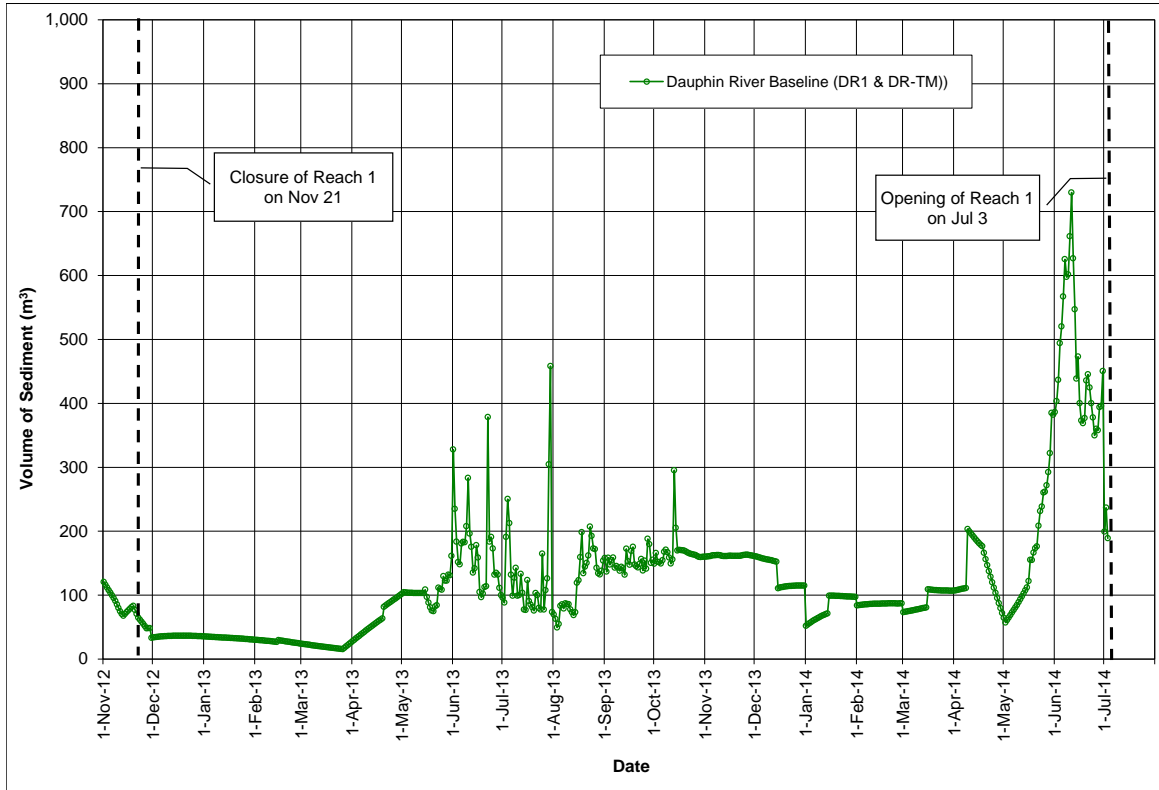
FIGURE 4.1-14
ESTIMATED DAILY SUSPENDED SEDIMENT VOLUMES
IN LOWER DAUPHIN RIVER DURING CLOSURE PERIOD (2012-2014)

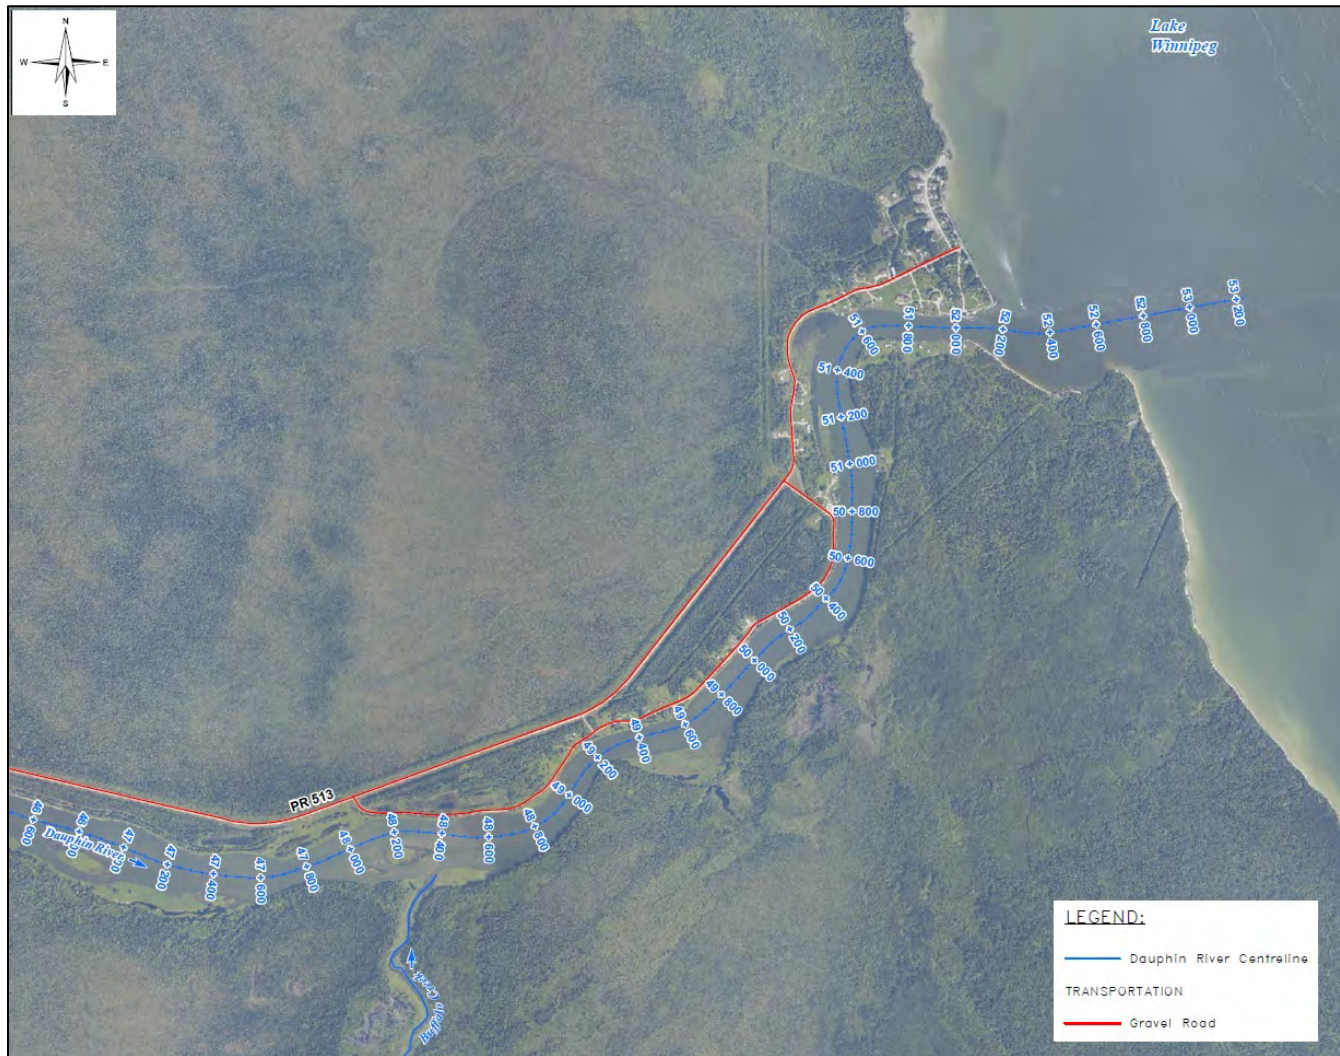
FIGURE 4.3-1
2D MODEL STUDY AREA FOR LOWER DAUPHIN RIVER DOWNSTREAM OF BUFFALO CREEK
(FROM STATION 47+800 TO 53+100)

The MIKE 21 model encompassed a reach of the lower Dauphin River located between Station 47+800 (upstream of Buffalo Creek) to Station 53+200 (in Sturgeon Bay) as shown in Figure 4.3-1. A digital elevation model (DEM) was built for this analysis with data obtained from different sources. The bathymetry data in the Dauphin River and Lake Winnipeg was derived from the sonar survey data conducted in 2011 and 2012 by KGS Group (Section 3.5). The topographic data outside of the river and the lake was obtained from the LiDAR data completed in June/July 2011. The integrated DEM for 2011 included the river bathymetry data based on a sonar survey in 2011 and the LIDAR data completed in 2011. The DEM for 2012 was built based on the river bathymetry sonar survey in 2012 and the LIDAR data completed in 2011. The 2011 and 2012 DEM are shown on Figures 4.3-2 and 4.3-3, respectively.

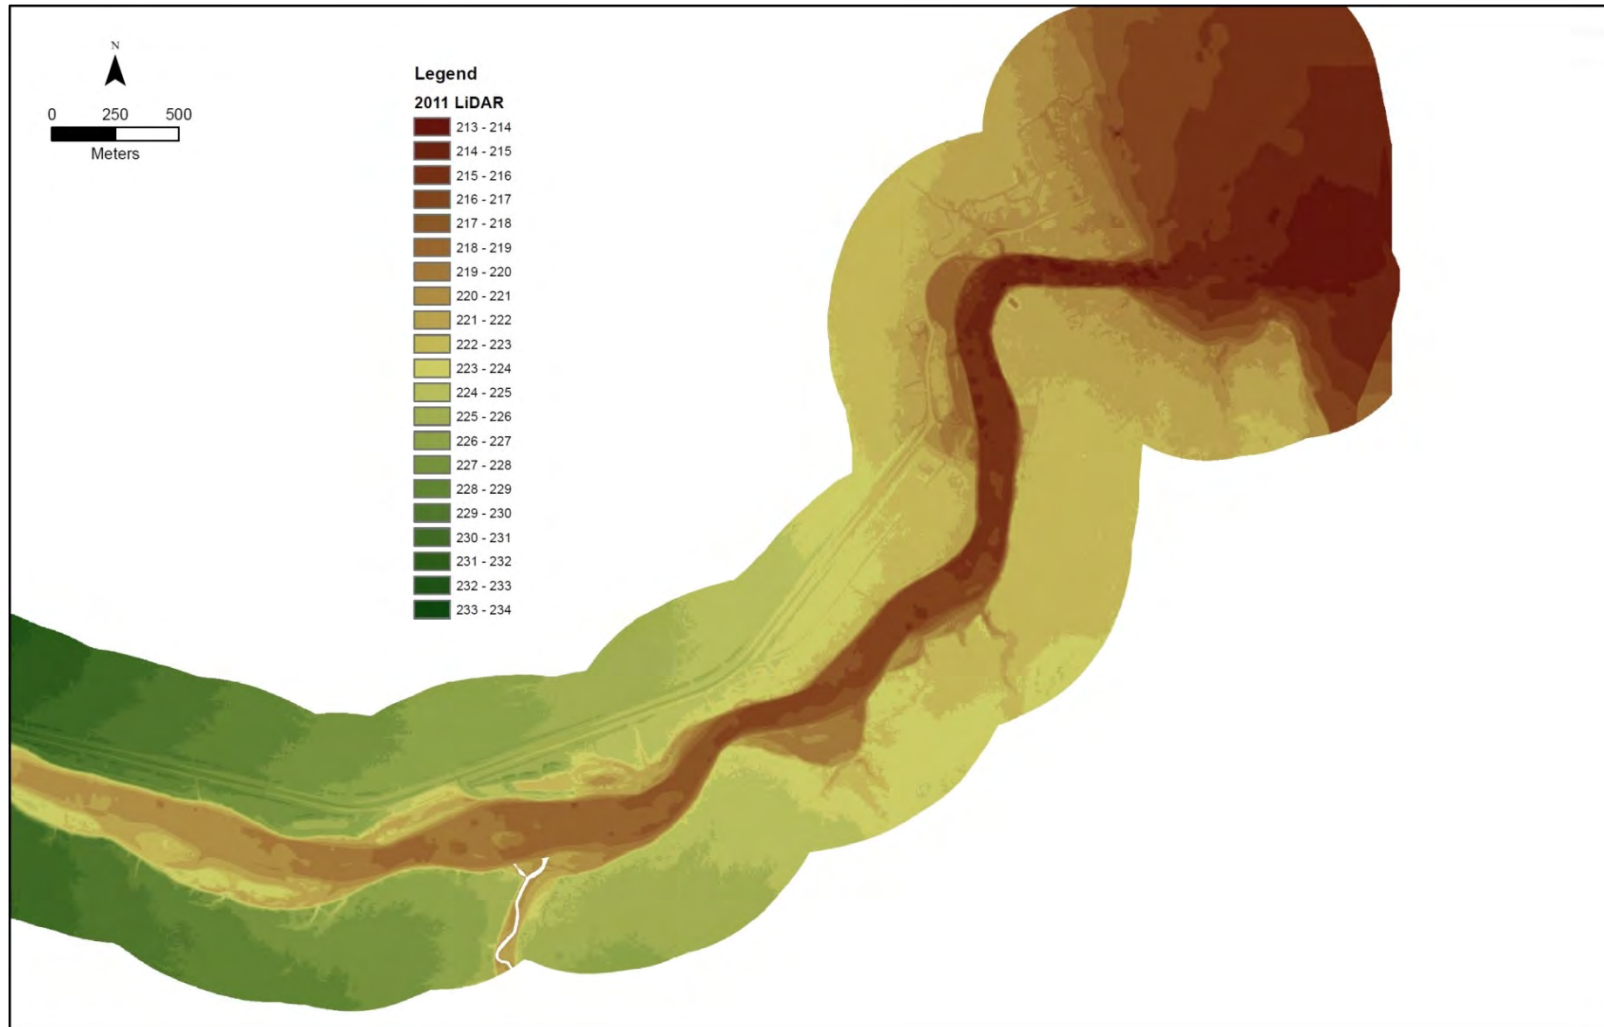
FIGURE 4.3-2
2011 DIGITAL ELEVATION MODEL BUILT BASED ON 2011 RIVER SONAR SURVEY DATA AND 2011 LIDAR SURVEY DATA

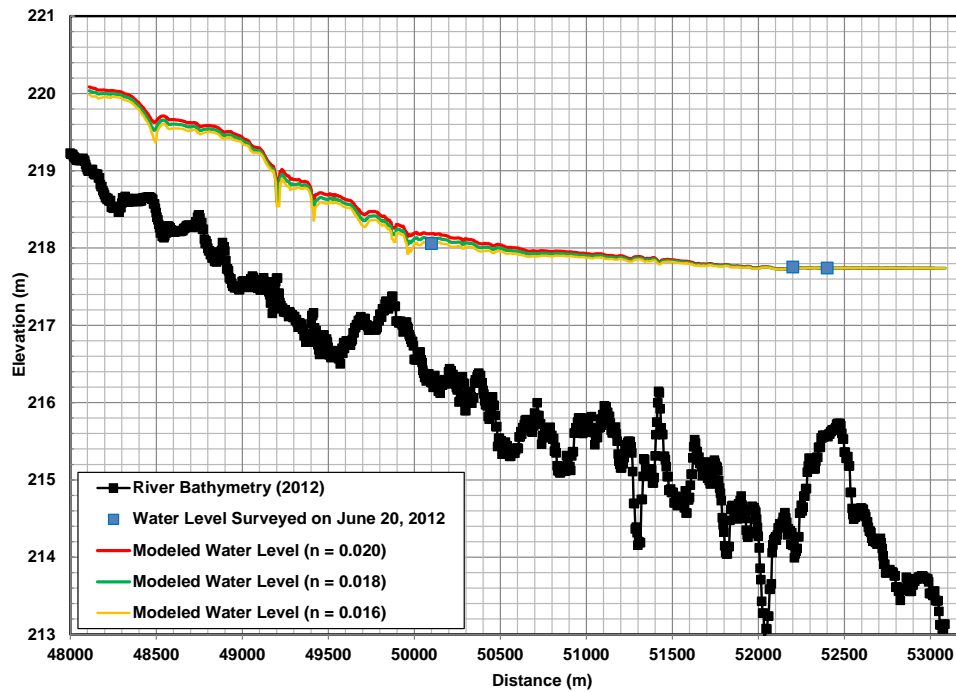
FIGURE 4.3-6
LOWER DAUPHIN RIVER MIKE 21 MODEL CALIBRATION USING 2012 SUMMER FLOW

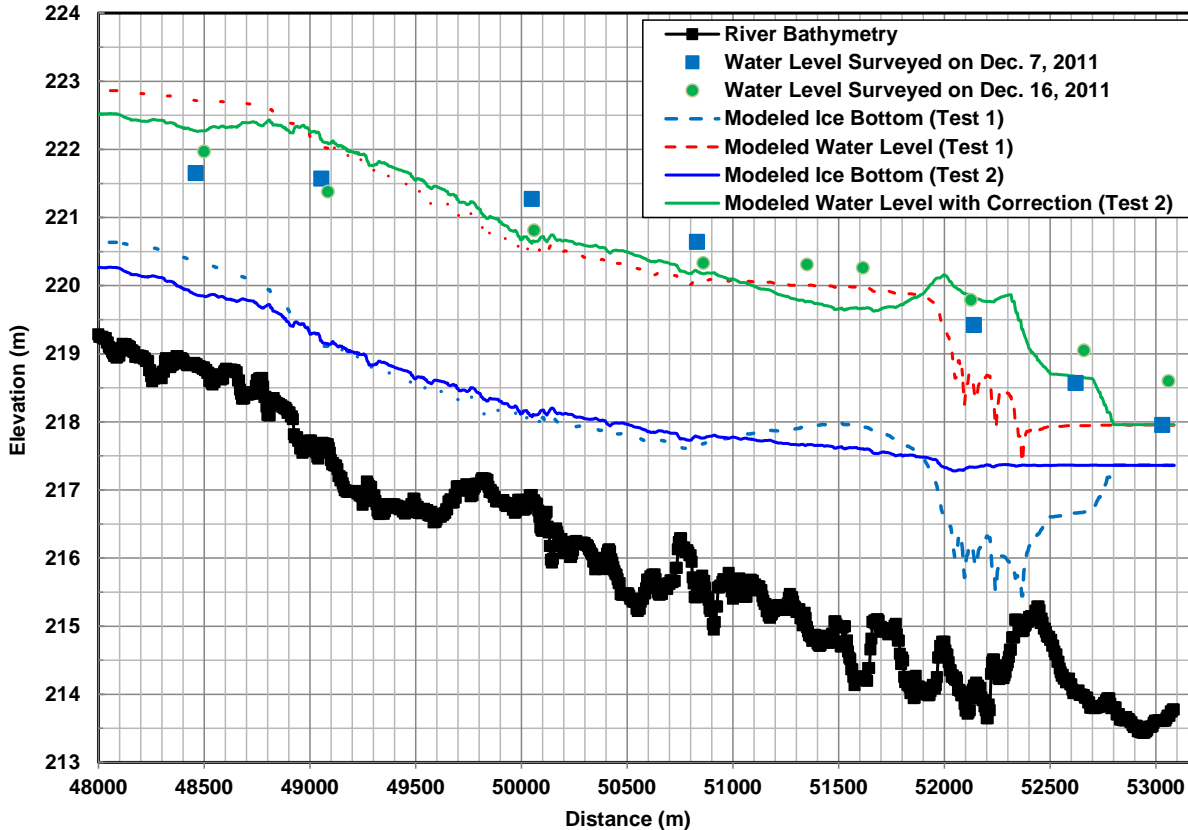
**FIGURE 4.3-7
 LOWER DAUPHIN RIVER
 ICE MODELING TESTS USING MIKE 21 MODEL OF THE DAUPHIN RIVER**

Ice covered conditions were also simulated with the MIKE 21 model. The calibration of the MIKE 21 model with presence of an ice cover was completed by adjusting the roughness coefficient of the ice-cover. The value of the ice-cover roughness coefficient can be defined as a variable dependant on its thickness.

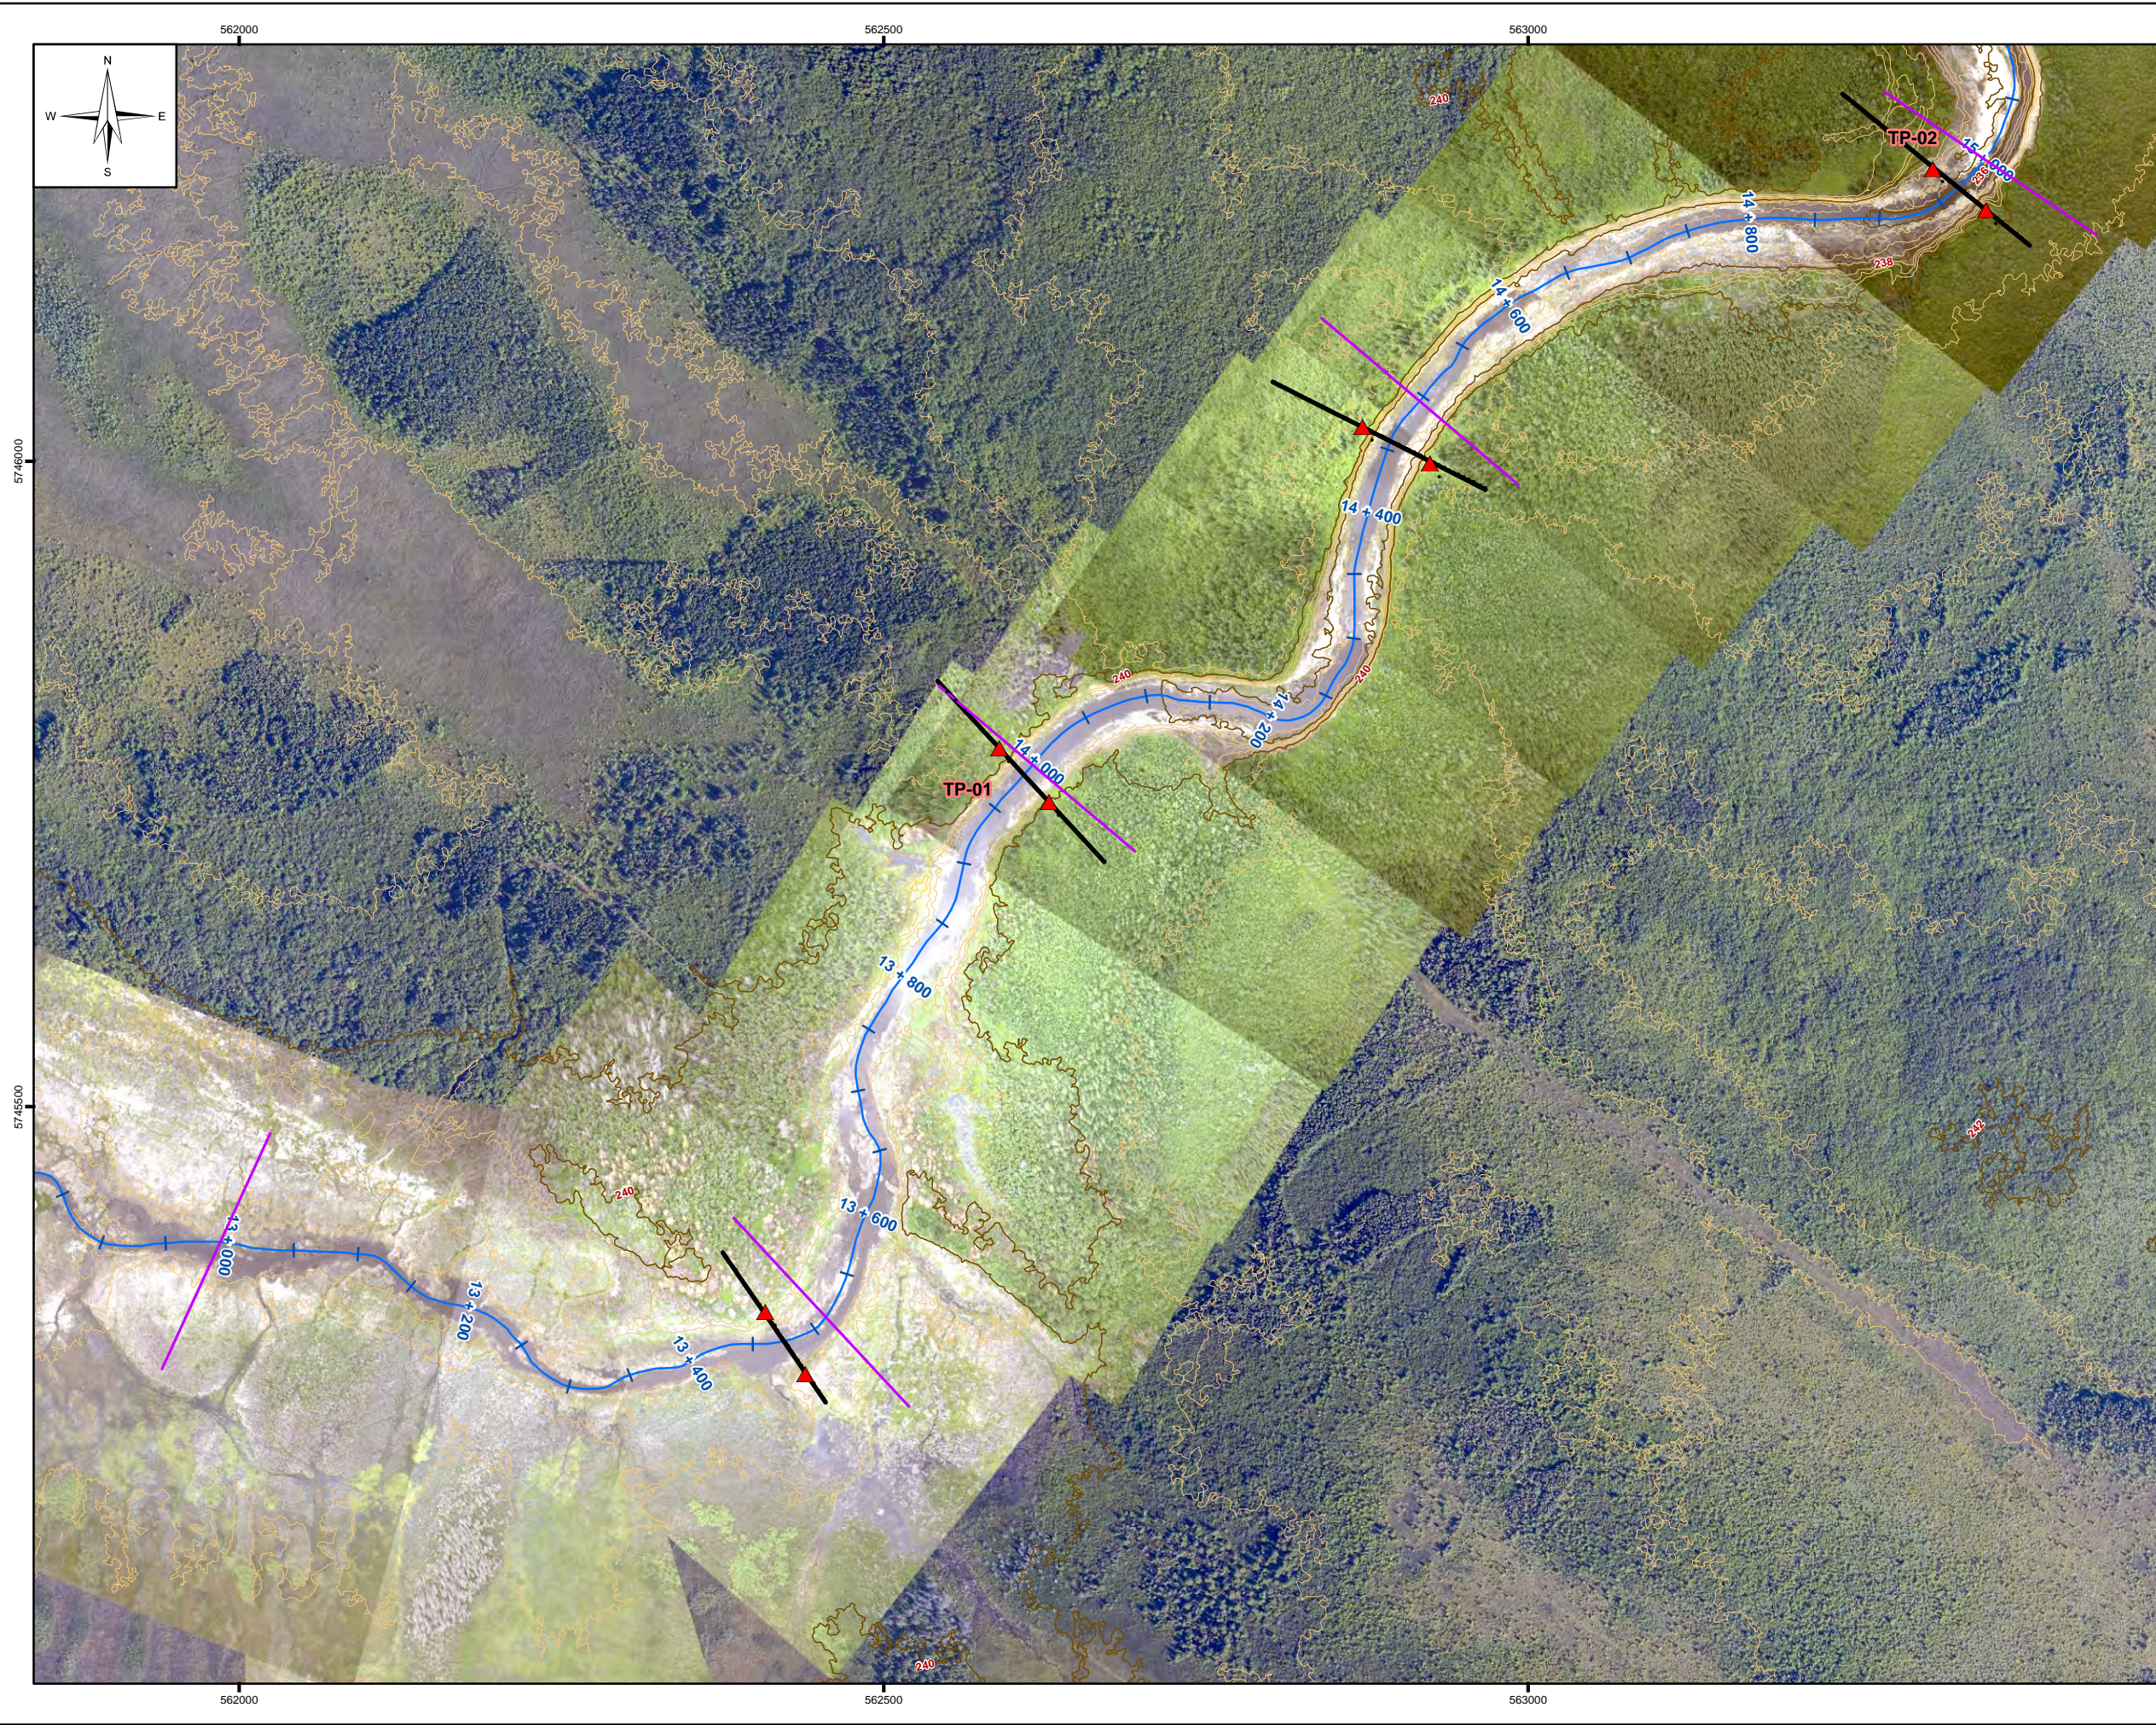
| MARCH 2016 | DRAWING 2 | REV: B |

LOCATIONS OF BUFFALO CREEK CROSS SECTIONS AND VEGETATION COVER TRANSECTS

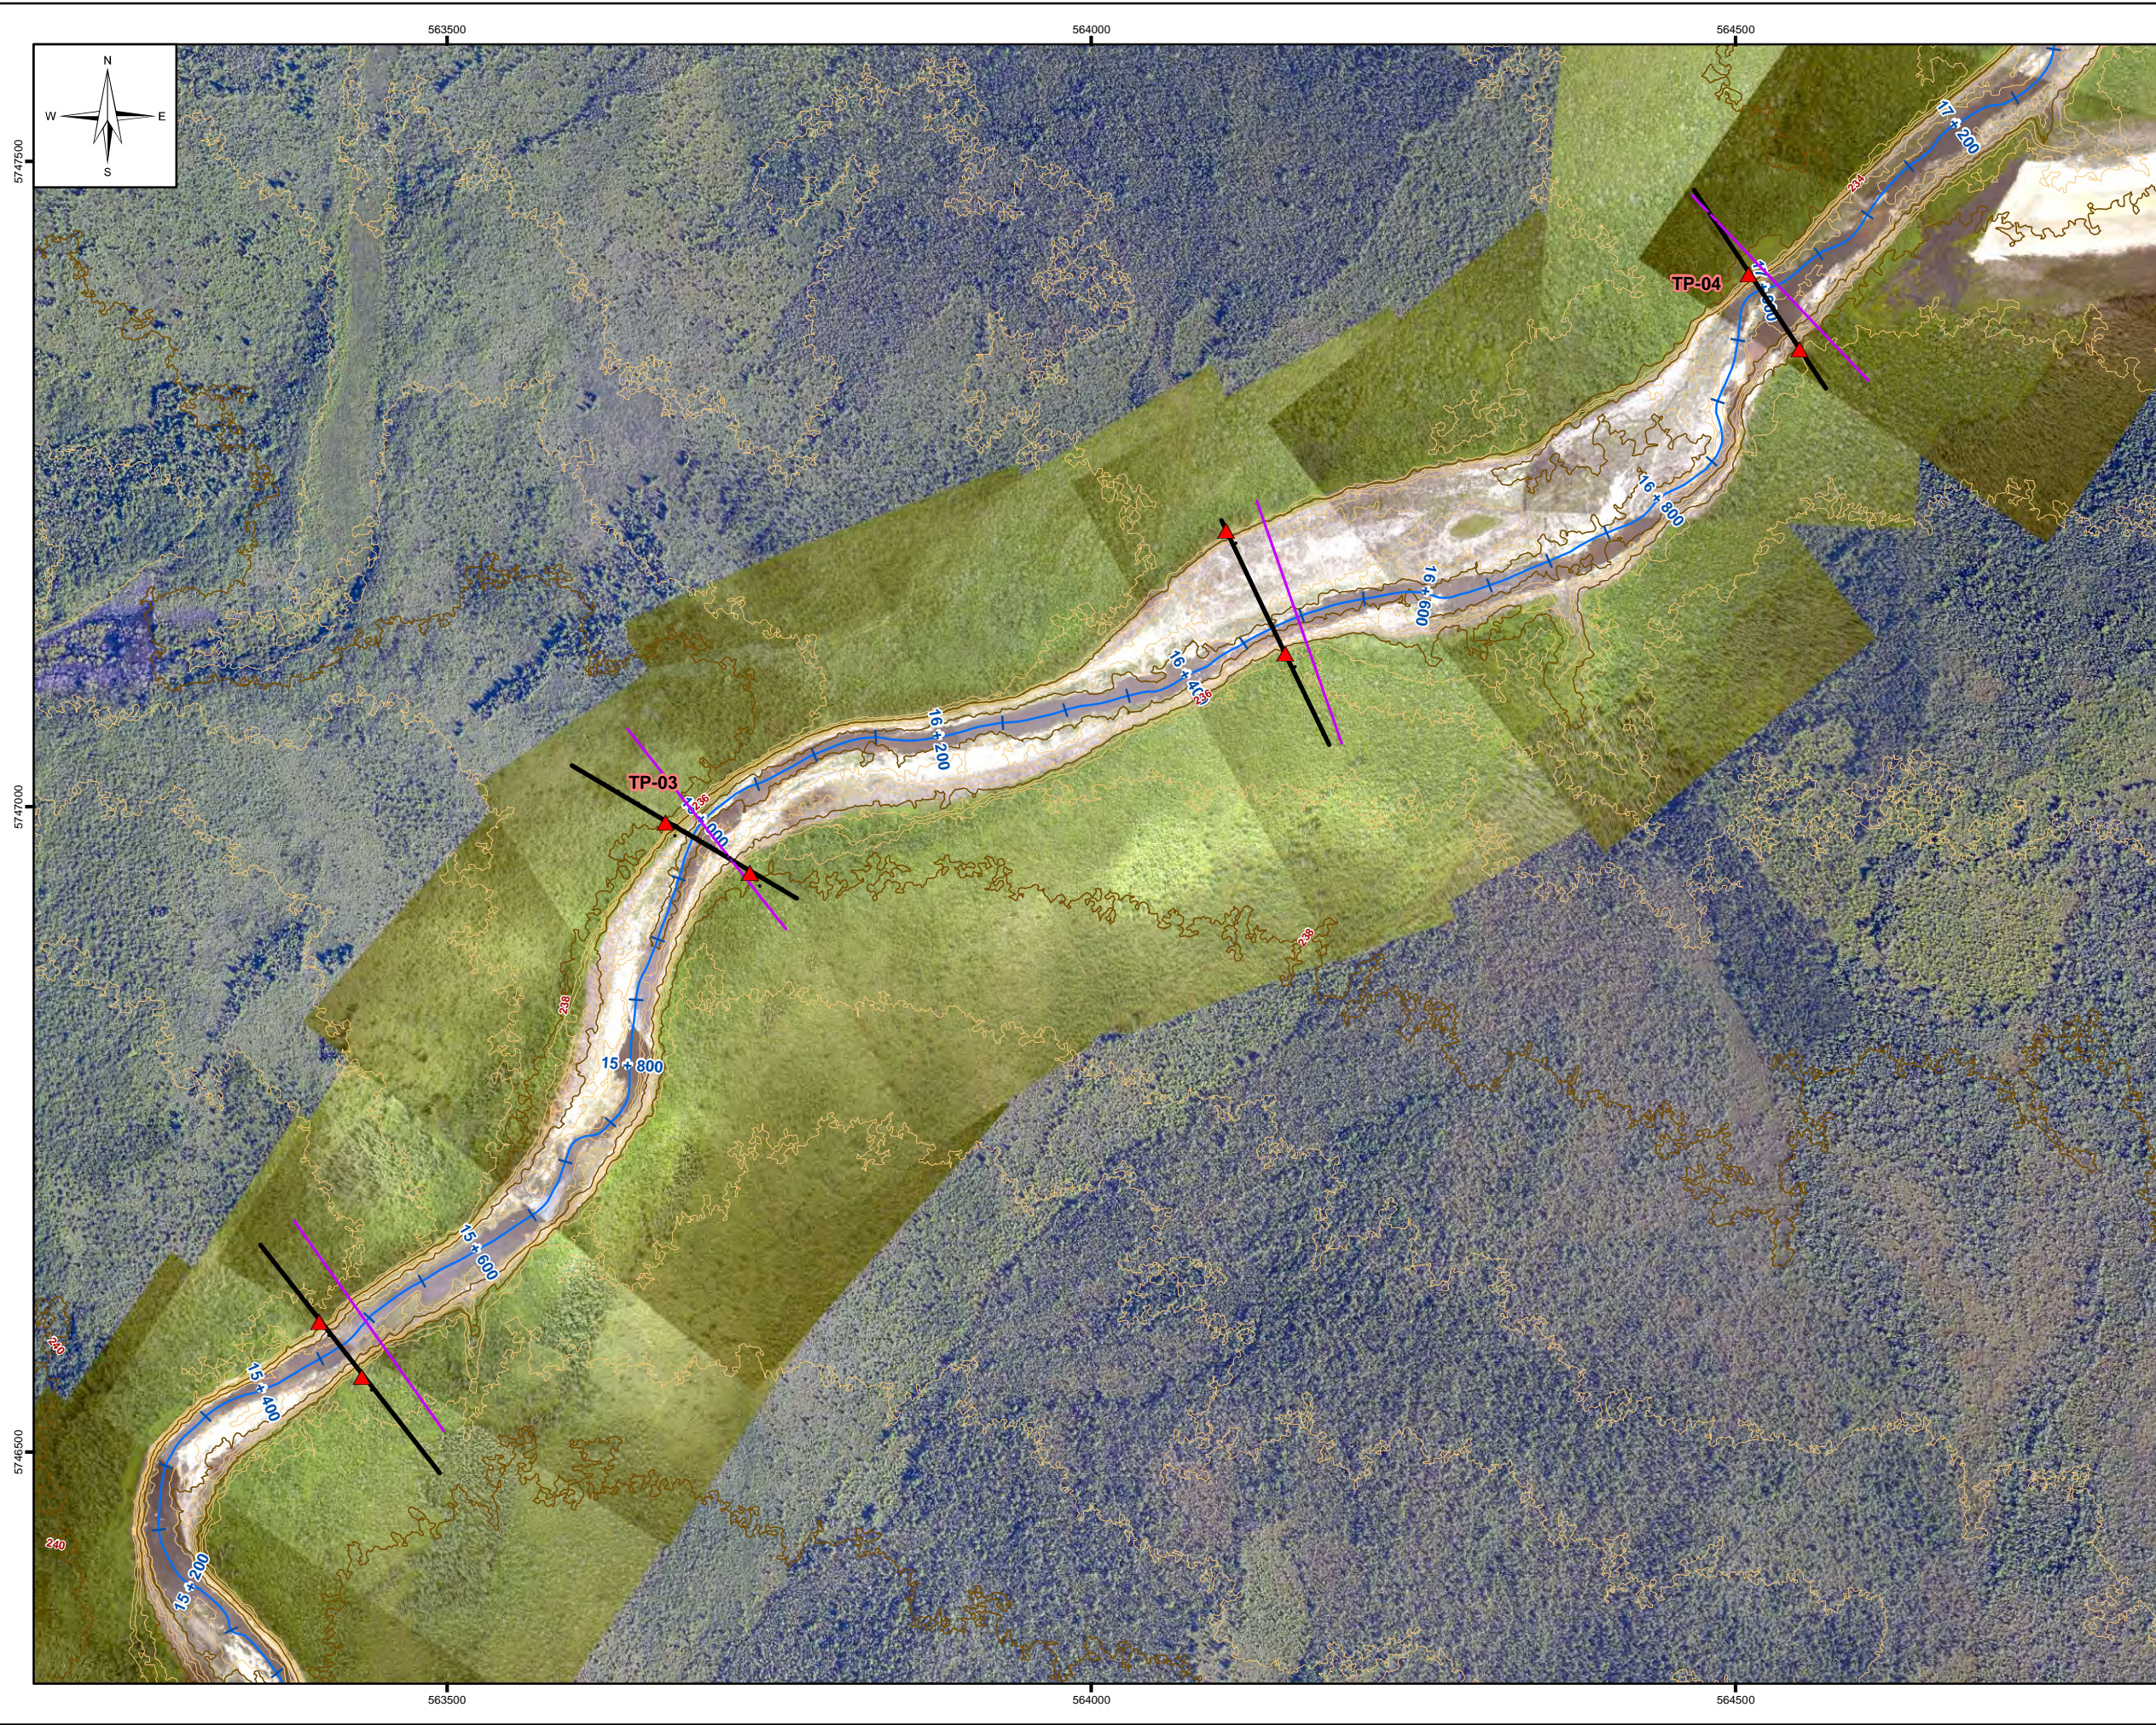
| MARCH 2016 | DRAWING 3.1 | REV: B |

LSM EMERGENCY RELIEF CHANNEL MONITORING & DEVELOPMENT OF HABITAT COMPENSATION
 DETAILED LOCATION PLAN OF CROSS SECTIONS, VEGETATION COVER SURVEYS AND TILL SURVEY ON BUFFALO CREEK. (SHEET 1 OF 8)
