**Lake St. Martin Emergency Relief Channel
Monitoring and Development of Habitat Compensation
Physical Processes**

DRAFT / MIT-009-13_002_REV B

KGS Group 13-0431-001
March 2016

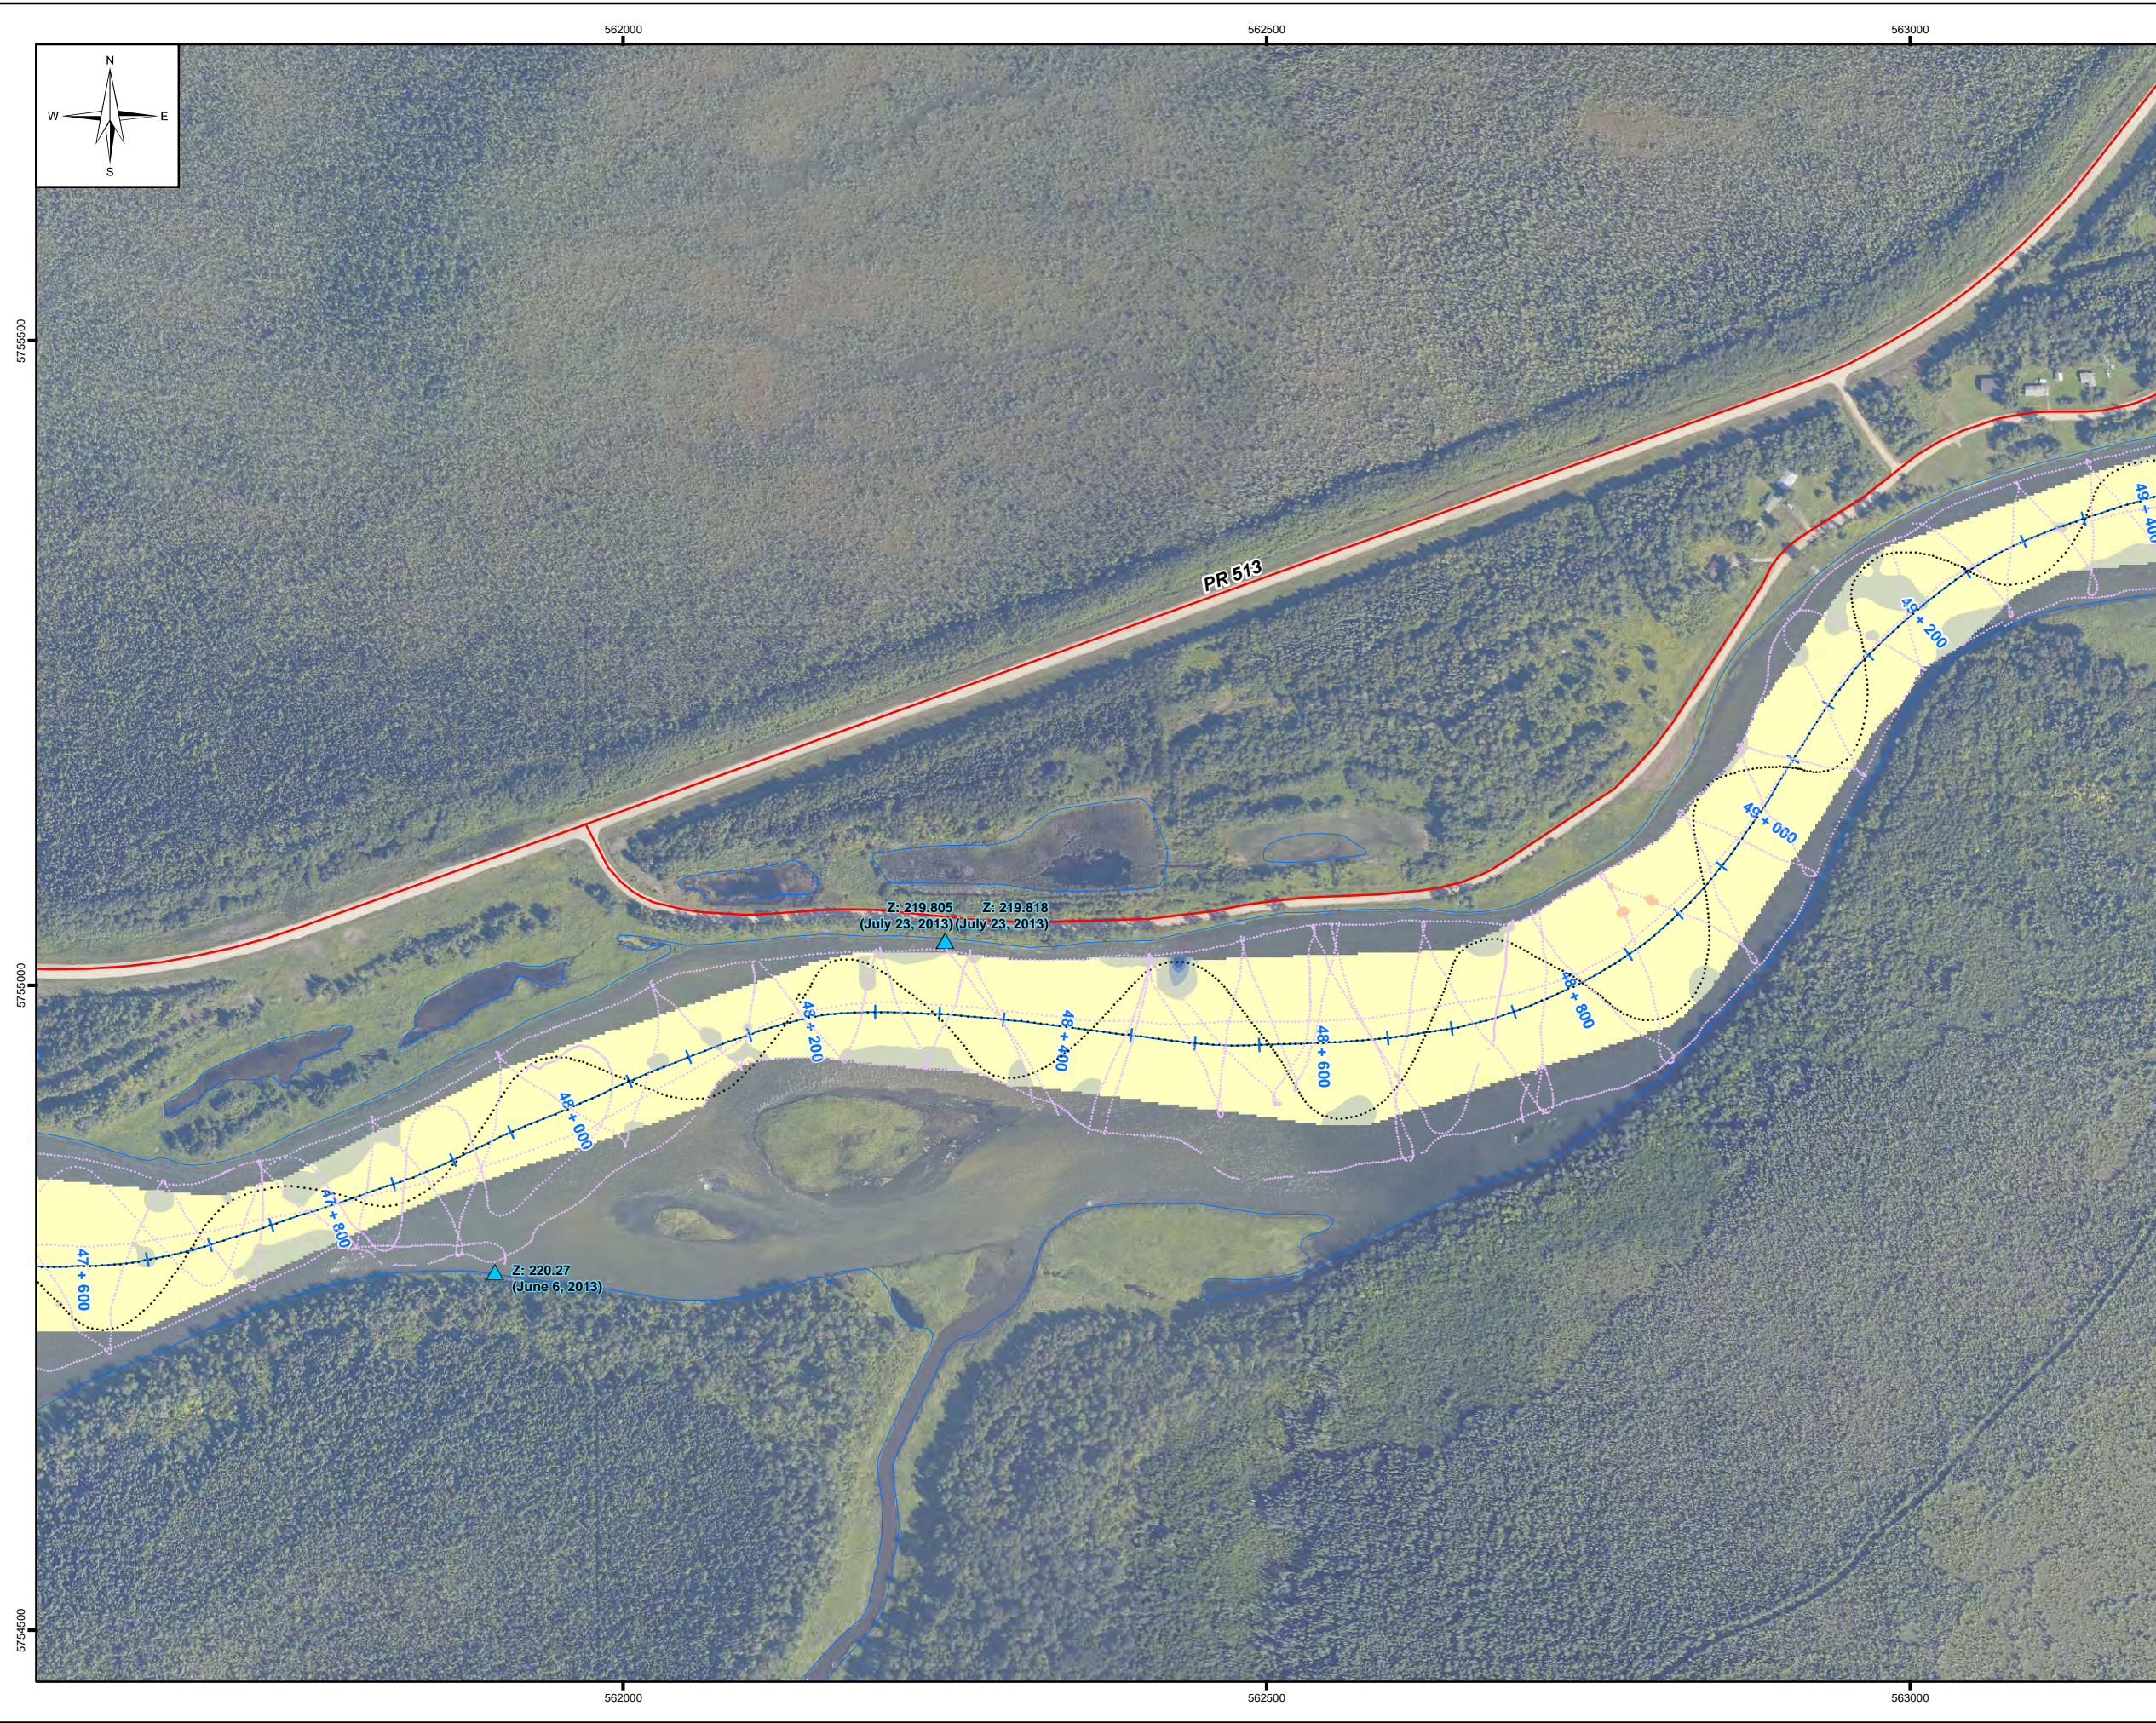
MARCH 2016 DRAWING 6.1 REV: B

LSM EMERGENCY RELIEF CHANNEL MONITORING & DEVELOPMENT OF HABITAT COMPENSATION
LOWER DAUPHIN RIVER BATHYMETRY DIFFERENCES OF 2011 TO 2013 (SHEET 1 OF 4)

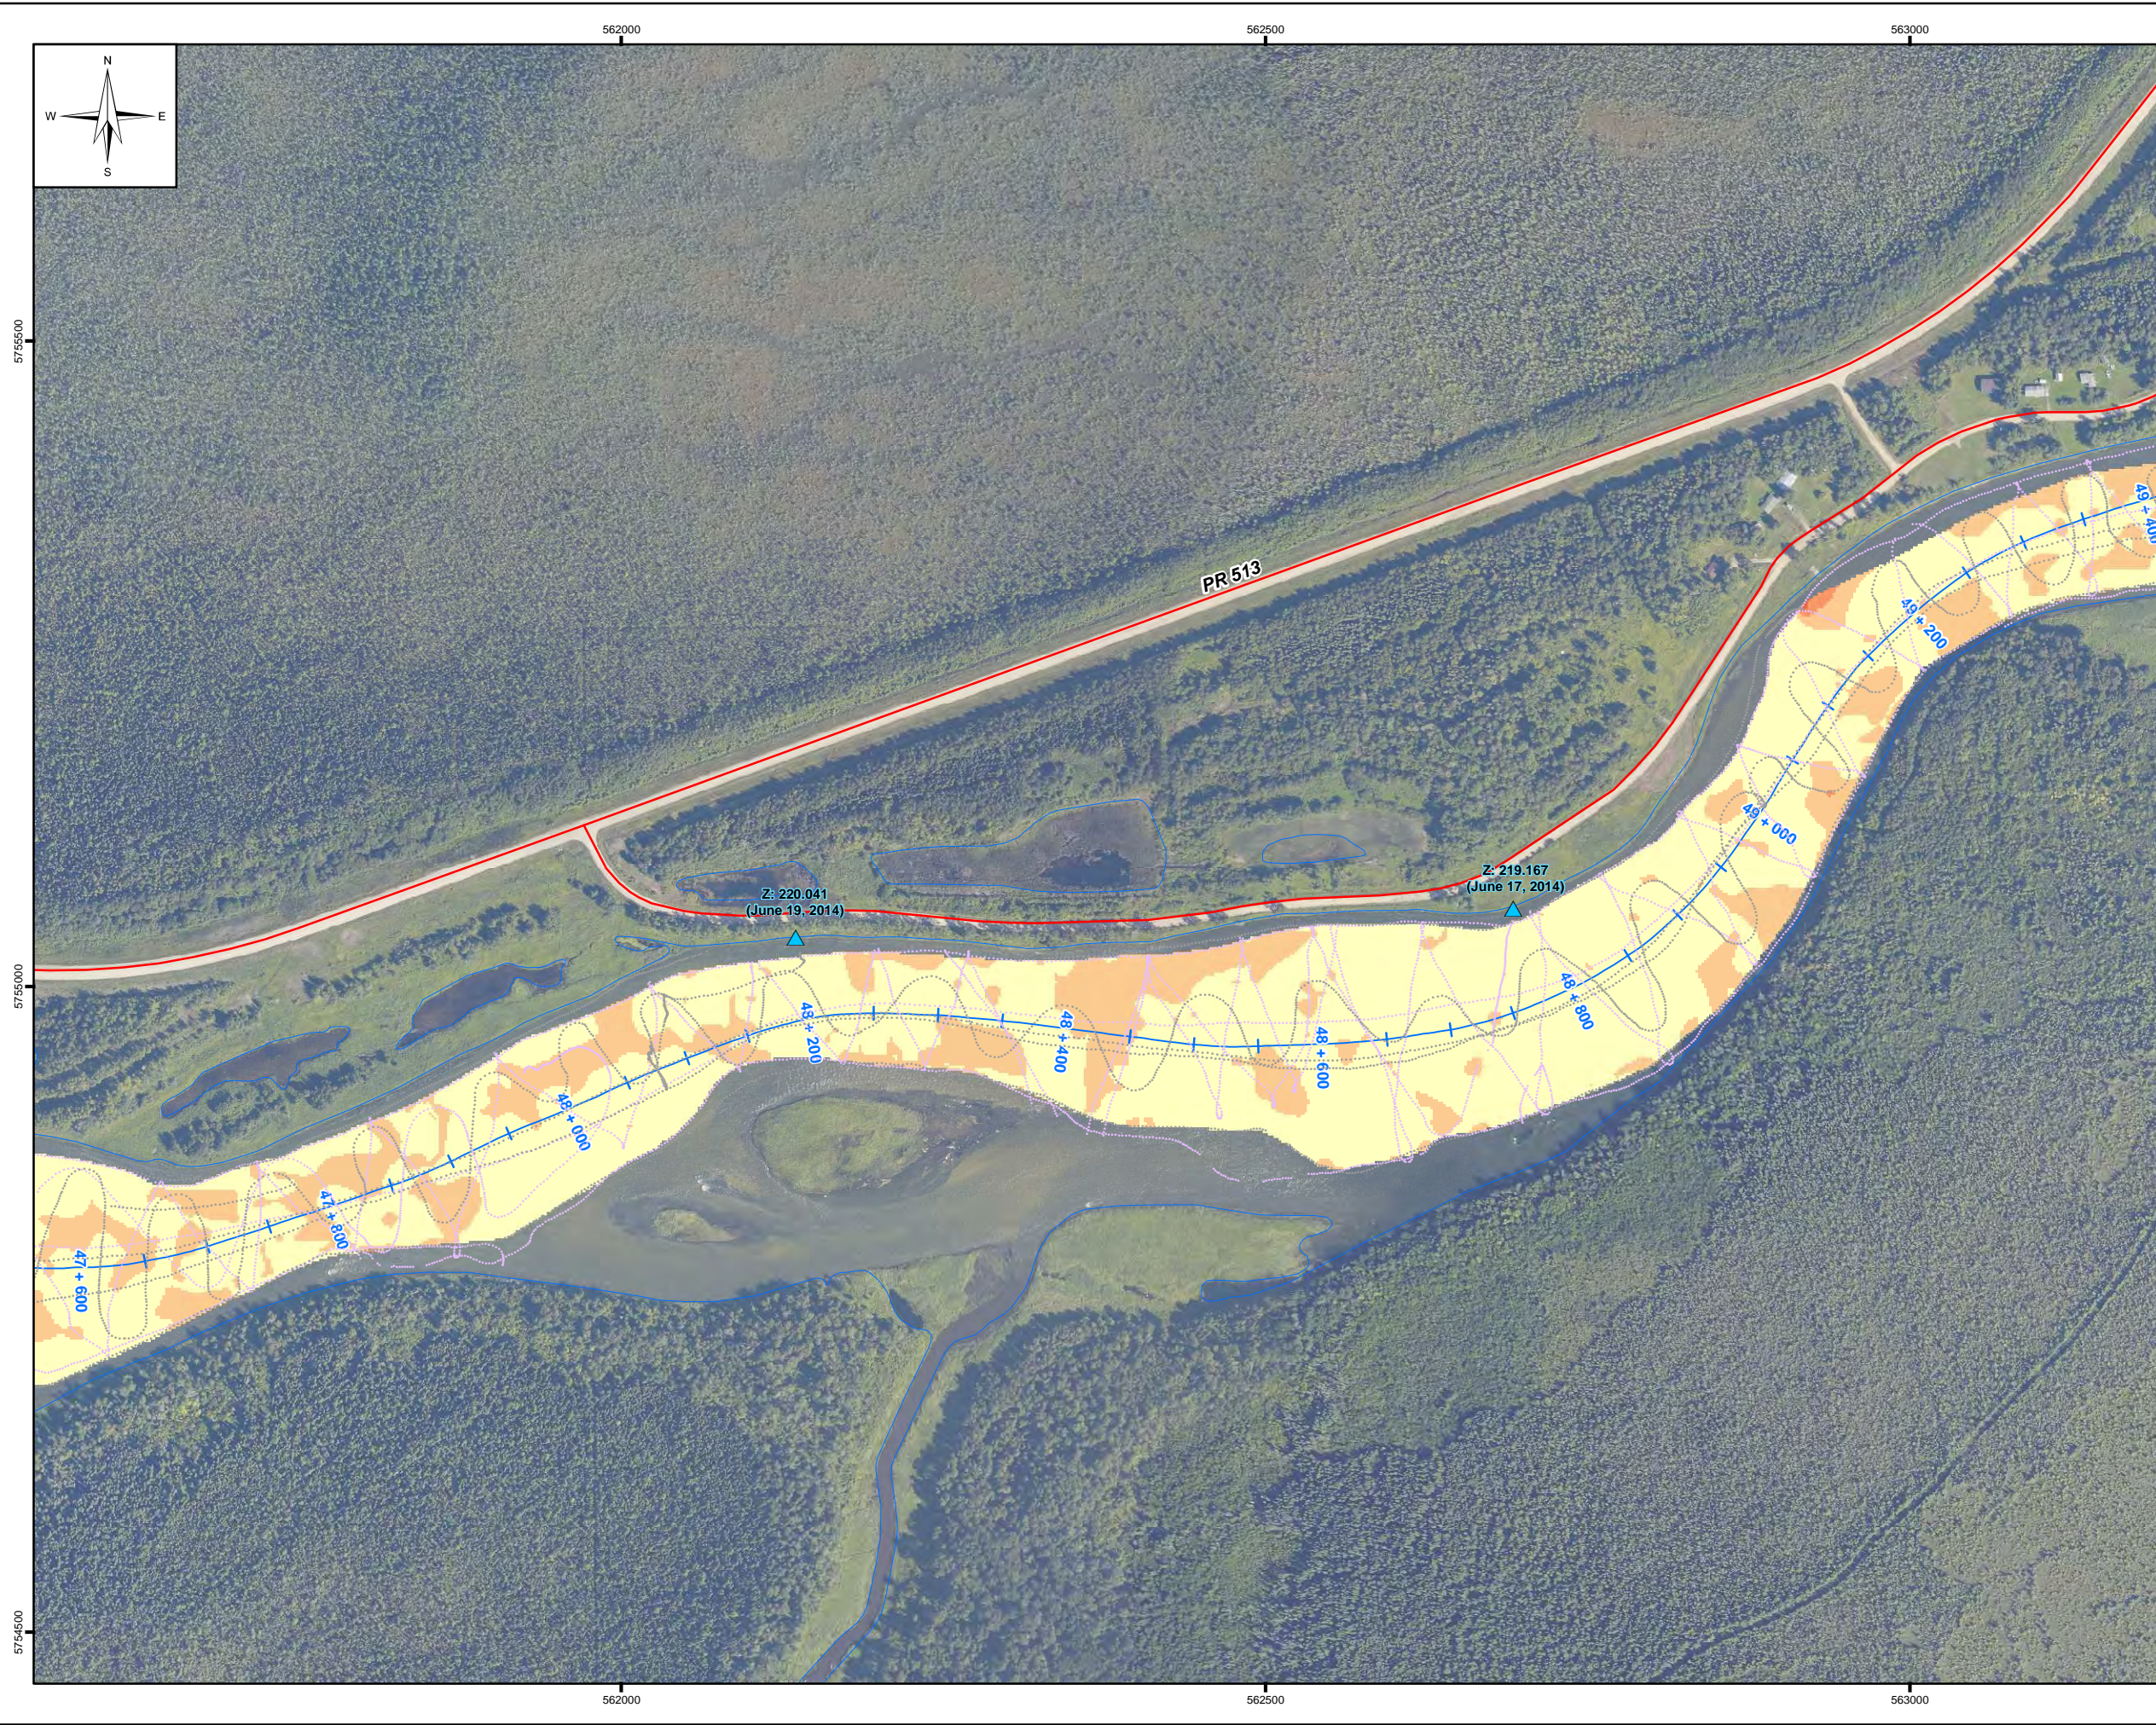
MARCH 2016 DRAWING 7.1 REV: B

LSM EMERGENCY RELIEF CHANNEL MONITORING & DEVELOPMENT OF HABITAT COMPENSATION
 LOWER DAUPHIN RIVER BATHYMETRY DIFFERENCES OF 2013 TO 2014
 (SHEET 1 OF 4)
