Lake Manitoba Outlet Channel Shoreline Morphology Review

# Final Report

JDMA Project #2018-026

Hatch Document Number: E358159-1000-228-230-0001 Rev. 0

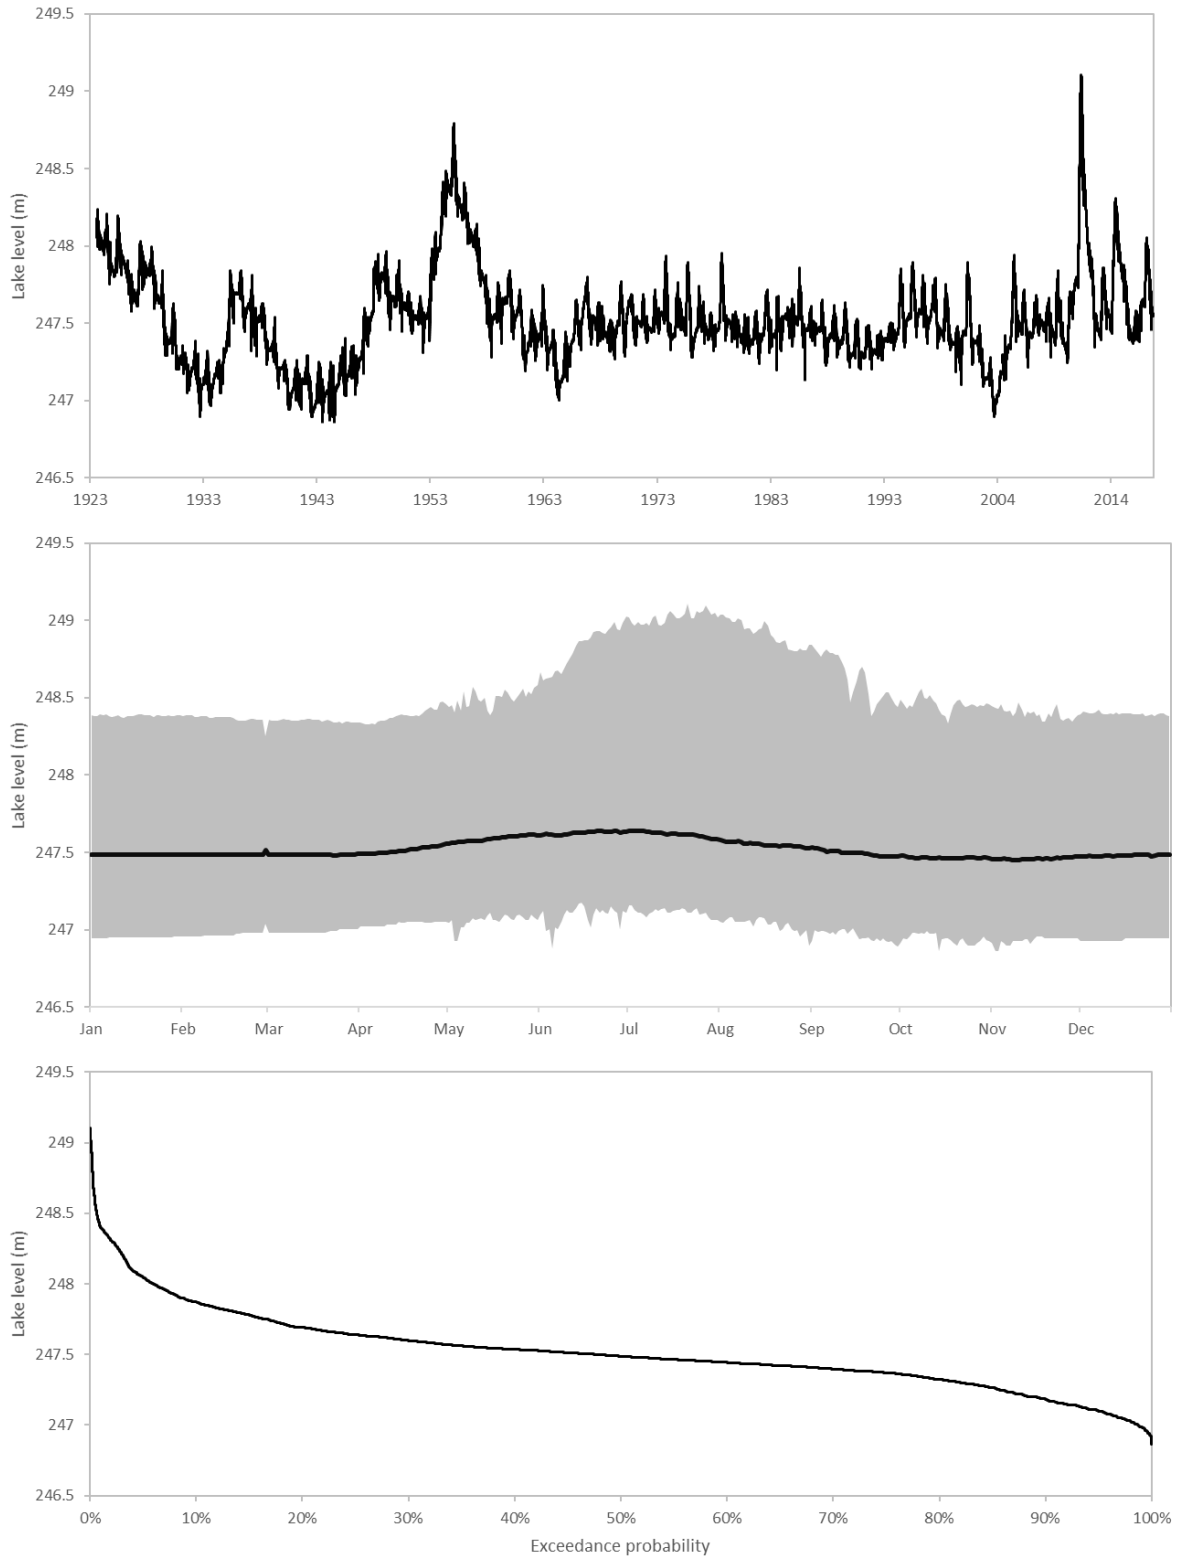
Figure 5: Lake Manitoba (05LK002) hydrometric summary showing daily hydrograph, annual average hydrograph and total range of flows, and exceedance probability curve.

Lake Manitoba is regulated by both inflow and outflow. In 2013, changes were made to the way that Lake Manitoba is regulated. Lake Manitoba can fluctuate between 246.89-247.50 m (810-812 feet). Above and below this range intervention is taken with respect to opening and closing the Fairford River Control Structure (Manitoba Infrastructure 2015). This range was 0.15 m higher (247.04-247.65 m) prior to the operating adjustment made in 2013.

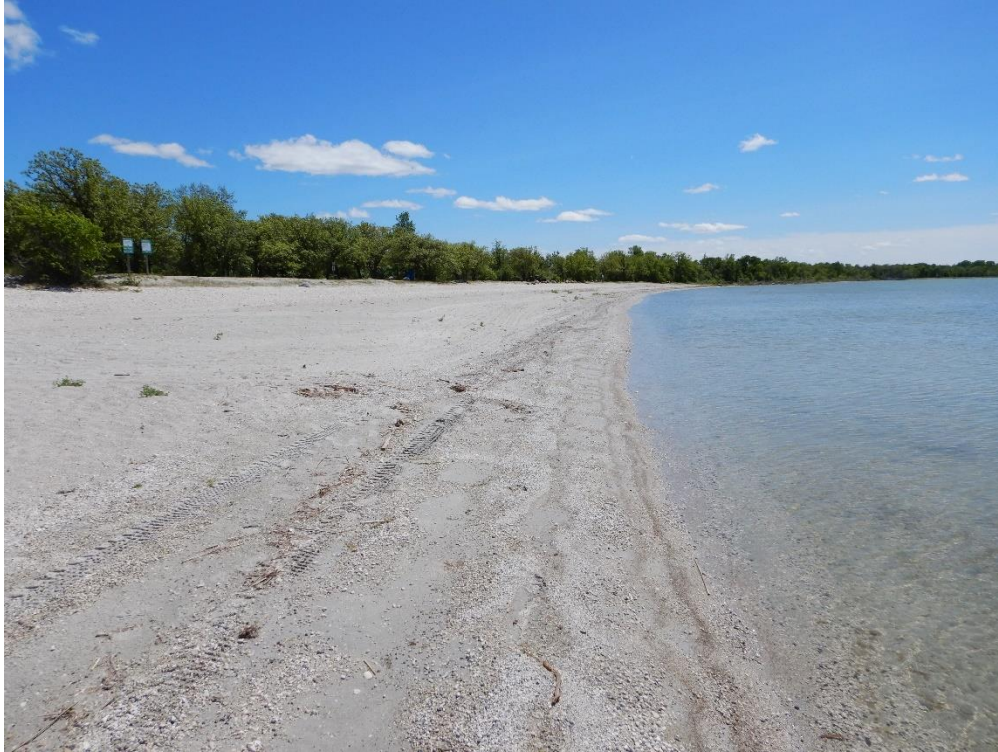
Figure 6: Field photograph taken on June 11, 2019 at Watchorn Beach in Watchorn Bay. Photograph shows a primarily sand and fine gravel on the beach. Looking S.

Field photographs show sand and gravel as the dominant material on Watchorn Beach (Figure 6). Near the inlet location beach sediment is considerably coarser, dominated by cobbles and boulders with sand washed into the interstices by wave run-up (Figure 7 and Figure 8) Sediment in the raised beach ridge includes boulders, cobbles and gravel.

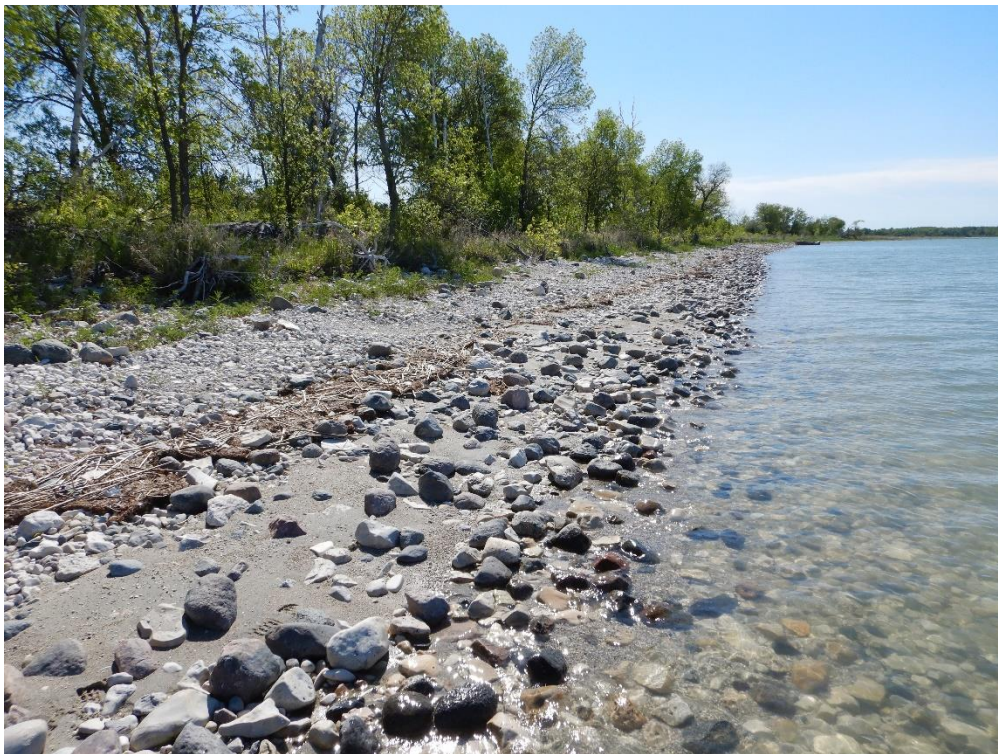
Figure 7: Field photograph taken on June 11, 2019 near the inlet channel at Watchorn Bay. Photograph shows gravel, cobbles and boulders on the beach with sand washed up by wave run-up. Looking SE.

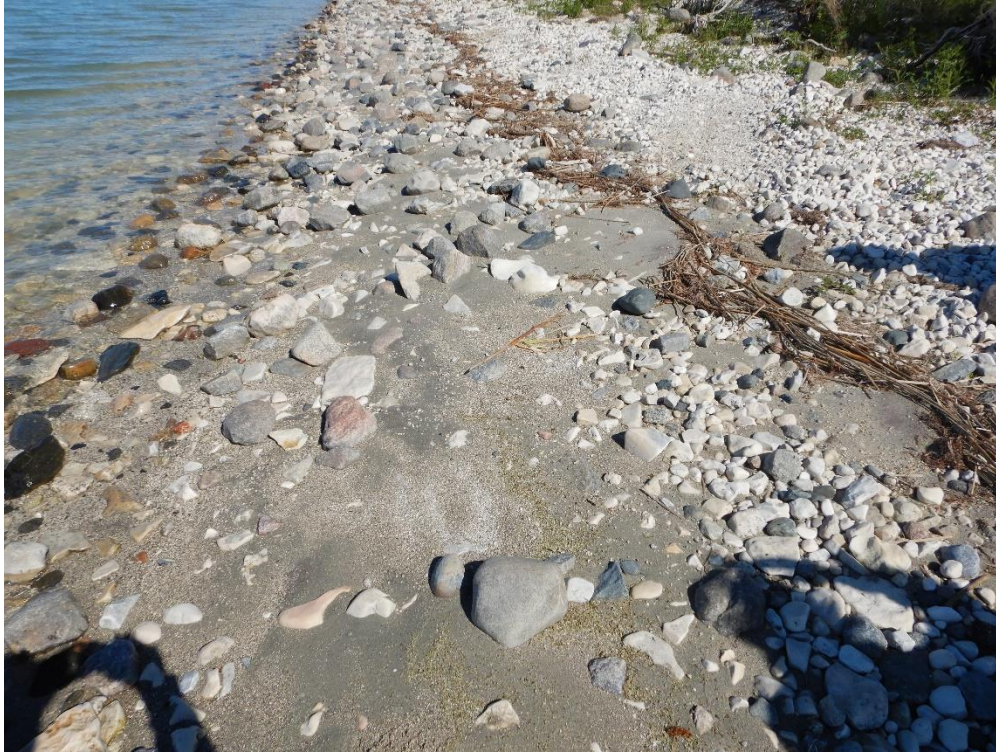
Figure 8: Field photograph taken on June 11, 2019 near the inlet channel at Watchorn Bay. Photograph shows gravel, cobbles and boulders on the beach with sand washed up by wave run-up. Looking NW.

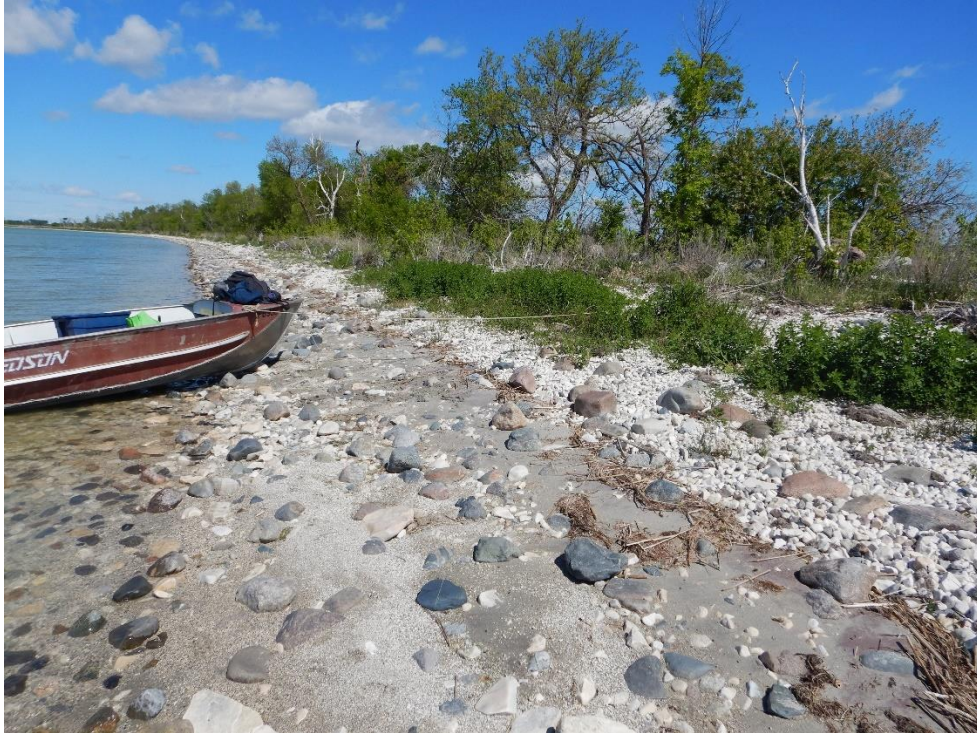
Figure 9: Field photograph of approximate channel centerline position in Watchorn Bay. The beach material is dominantly gravel, cobbles and boulders with sand washed into the interstices by wave run-up on the lower beach slope.

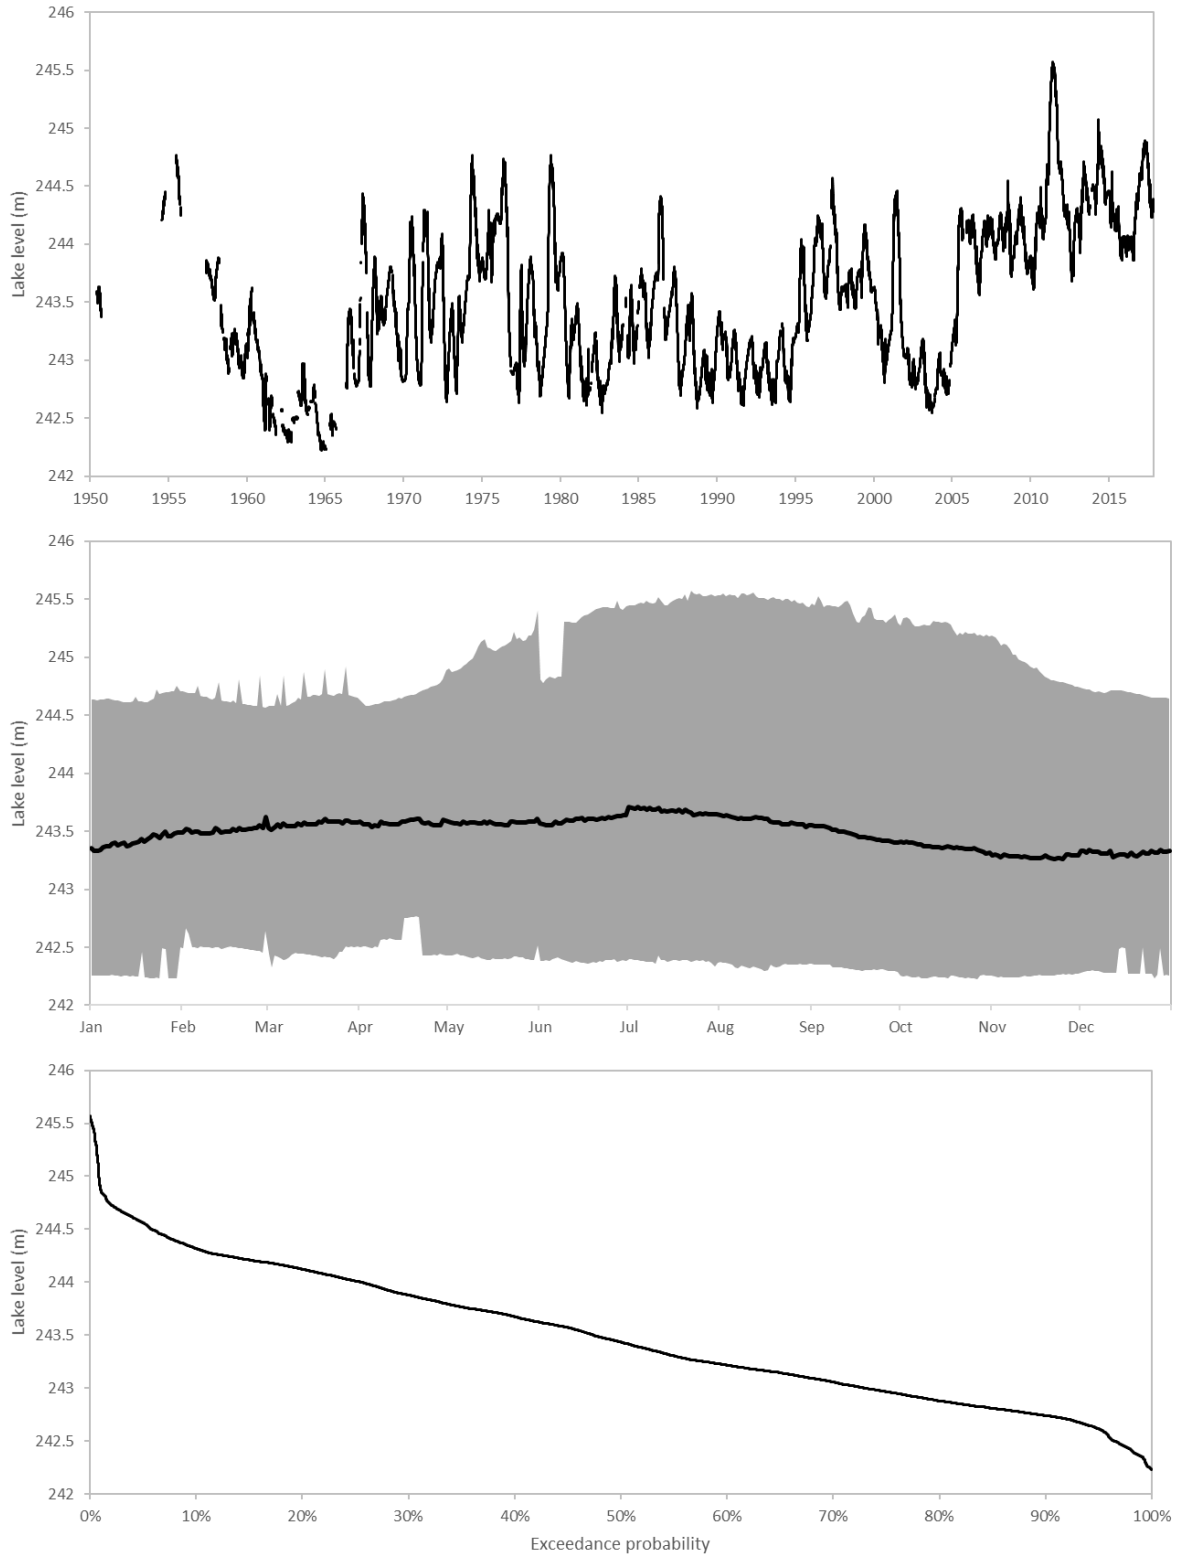
Figure 10: Lake St. Martin (05LM003 and 05LM005) hydrometric summary showing daily hydrograph, annual average hydrograph and total range of flows, and exceedance probability curve.

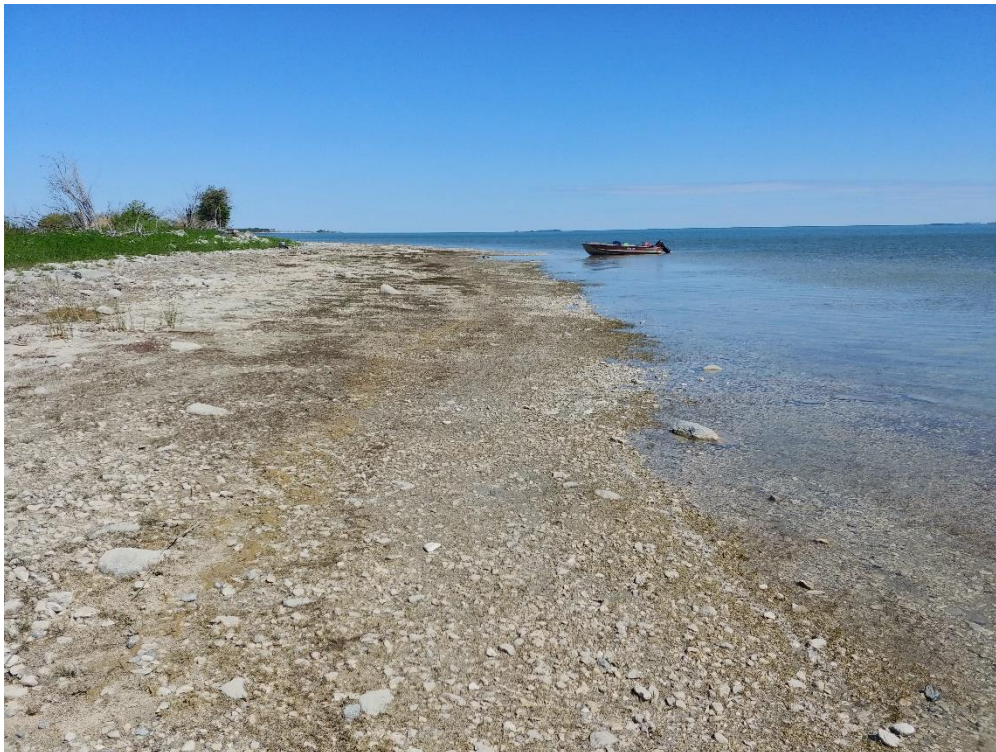
Figure 11: Field photograph of the shoreline of Birch Bay in Lake St. Martin. The beach sediment is mainly sand and gravel with scattered cobbles and boulders. Looking north.

The bathymetry of the Birch Bay is characterized by a gently sloping lake bottom with depths reaching 2-3 m approximately 400-500 m offshore (Map 13 and Map 14). Nearshore slopes range from 1°-2.5°. Map 14 shows four (4) bathymetric profiles along the western and southern shores of Birch Bay. In three of the four cases shown, the lake bottom slopes gently and uniformly into deeper portions of the bay. The one exception is profile XS-3 which crosses a submerged ridge approximately 200 m offshore. The top of this ridge, with an elevation of approximately 243.2 m, is exposed at low water levels. Its presence in historical air photos indicates that it is a long-lived geomorphic feature. Given that no bathymetric transect was taken overtop of this feature the actual elevation of it is unknown and may be underestimated in the cross section on Map 14. Figure 11 shows a typical view of the Birch Bay shoreline.

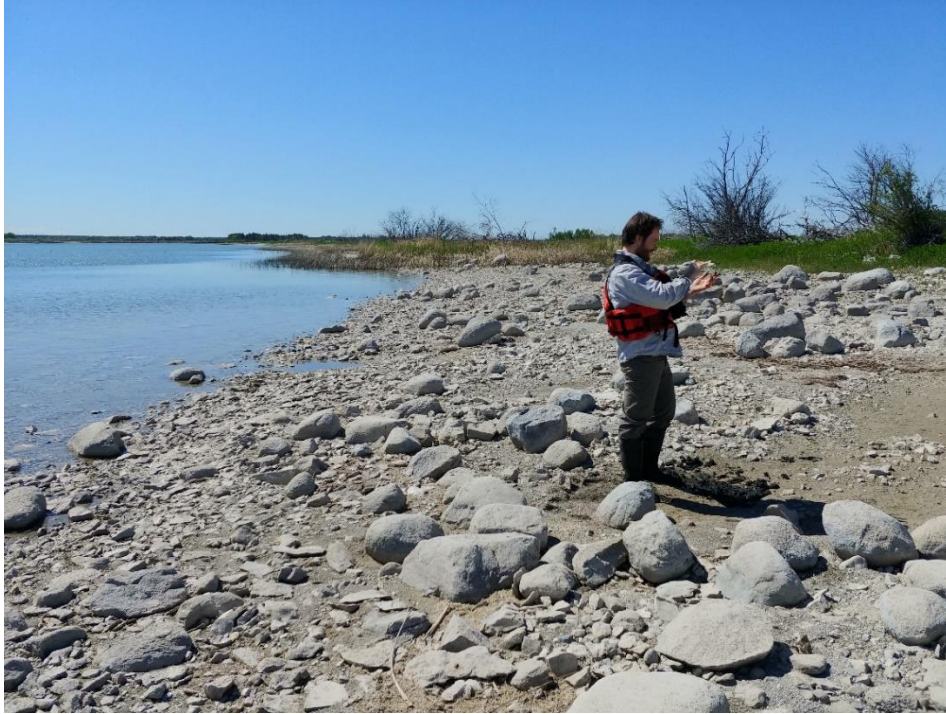
Figure 12: Field photograph showing the shoreline of Birch Bay in Lake St. Martin. The beach sediment at this location is mainly gravel, cobbles and boulders with sand in the interstices. In the background aquatic vegetation grows along the shoreline where it is sheltered from north winds. Looking south.

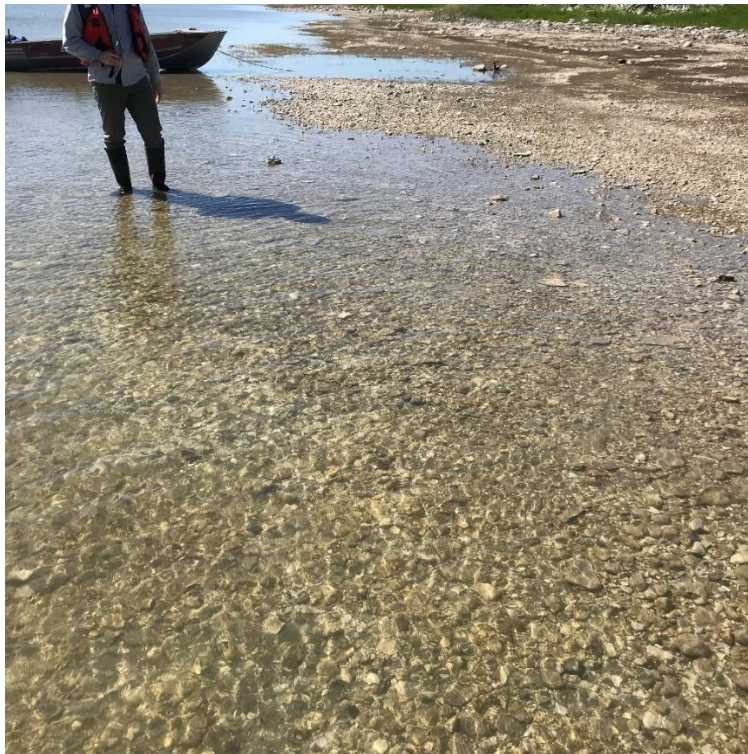
Figure 13: Field photograph showing nearshore sand and gravel substrate in Birch Bay. Photograph is located near the centerline of the channel corridor. Looking south.

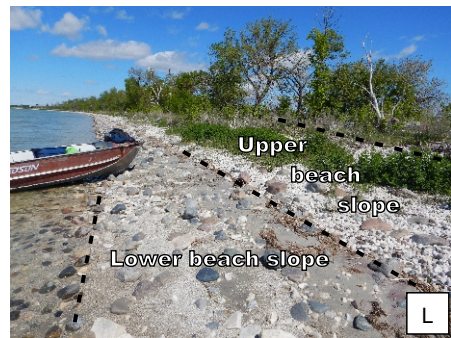
Sand deposited on coarse sediment on lower beach slope. Upper reach of sand and washed organic debris indicates high-water line from Spring 2019. Beach sand can also be transported offshore when it is eroded and re-suspended during falling water levels.

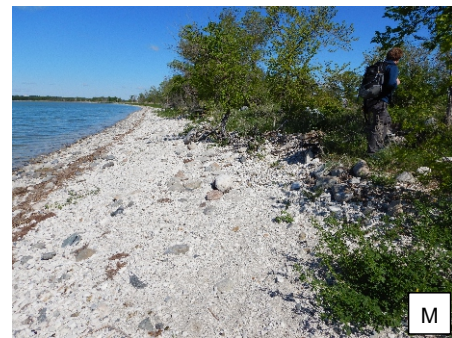
Gravel, cobbles, and small boulders on mid-to upper beach slope. Low scarp and edge of vegetation indicate high-water line in recent years.

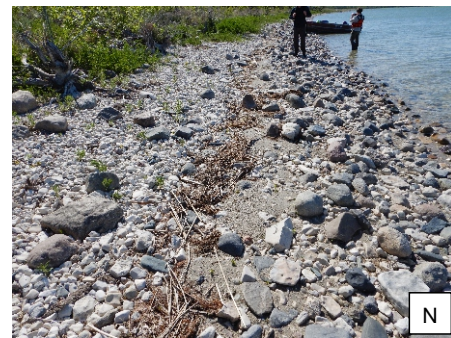
Gravel, cobbles, and small boulders on mid-to upper beach slope. Low scarp and edge of vegetation indicate high-water line in recent years. Washed organic debris indicates high-water line in Spring 2019. Boat is parked near the centerline of the proposed channel inlet.

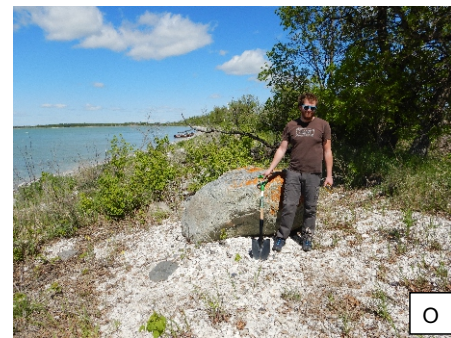
Large boulder on top of the raised gravel beach ridge that extends across this entire shoreline reach. Boulder likely transported by ice-shove processes under high-water conditions. Raised beach is likely an ancient feature and possibly raised in elevation by glacio-isostatic rebound.

The four photos in the upper left panel of Map 9 (A-D) provide examples of the large boulders that are located near the top of the raised beach ridge. Given the size and elevation of these boulders, the likely transport mechanism was ice rafting and ice shove under high-water level conditions. This interpretation is supported by observations of recent ice shove features on the lower beach slope. A number of these features are shown in the four photos in the upper right corner of Map 9 (H-K).

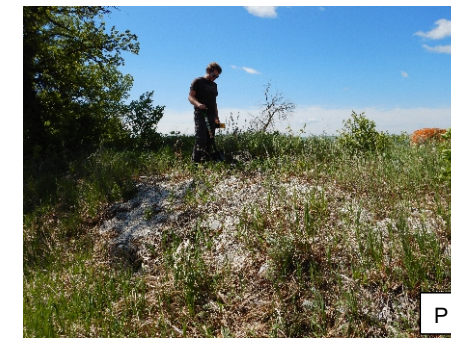
Gravel deposited on the back side (landward side) of the raised beach ridge. Indicates water overtopped the beach ridge at this location in the recent past, likely during the 2011 flood event.

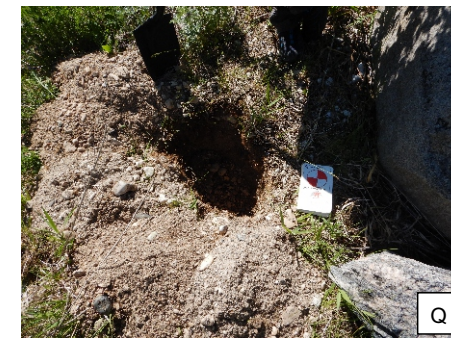
Gravel exposed in a 60 cm deep test pit beside a large boulder on top of the raised beach ridge. It is possible that large boulders are present throughout the height of the beach ridge intermixed with granular beach sediment.

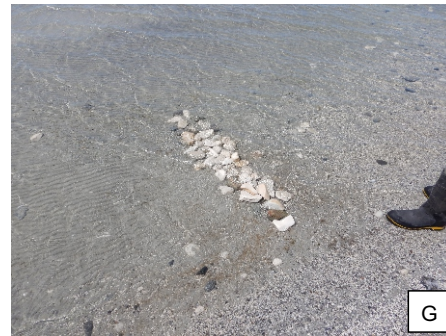
Coarser gravel beach sediment toward the southeast end of Watchorn Beach (H:I).

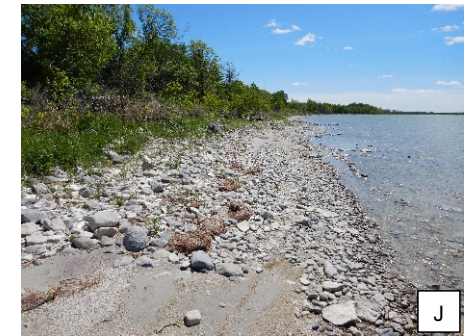
Abrupt transition to gravel, cobble, and boulder beach at southeast end of Watchorn Beach. Grass and trees are growing on a raised beach ridge above the wave-washed beach. Some large boulders are present on the raised beach ridge.

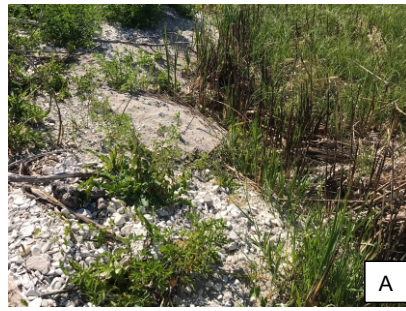
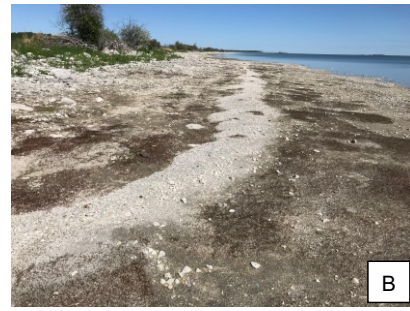
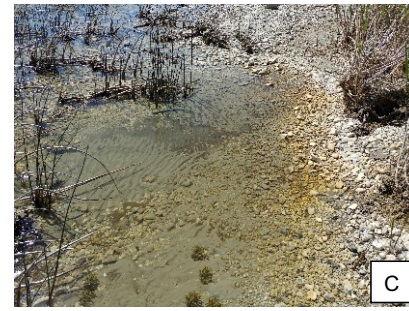
Gravel washed over the crest of the raised beach ridge

A recent granular beach ridge

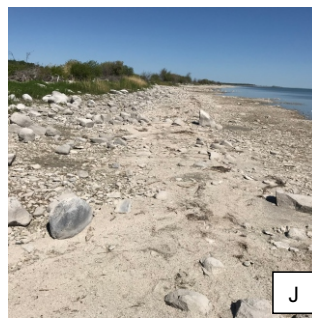
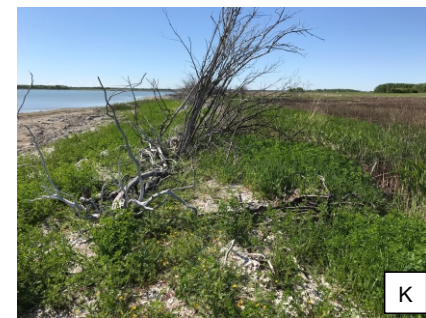
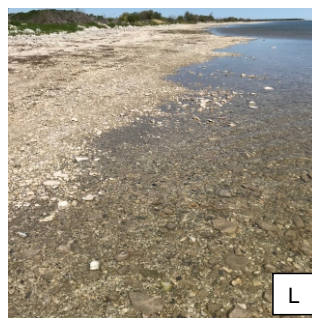
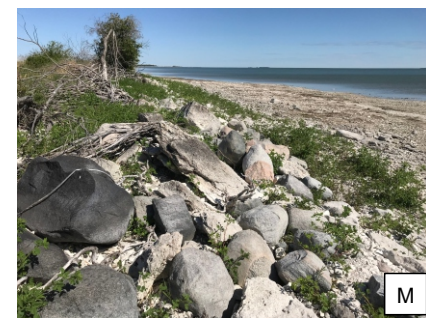
Gravel beach sediment and nearshore substrate

Ice-shove boulders on lake side of raised beach ridge

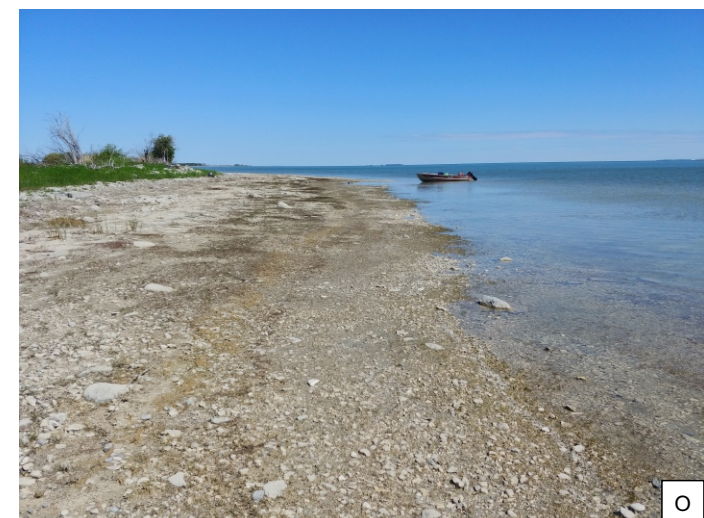
View south of approximate centerline

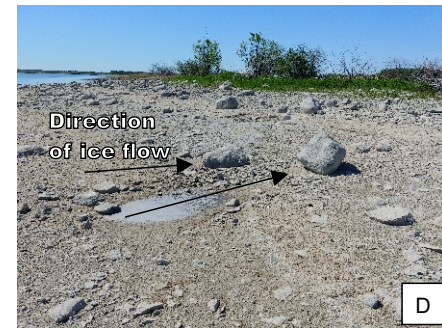
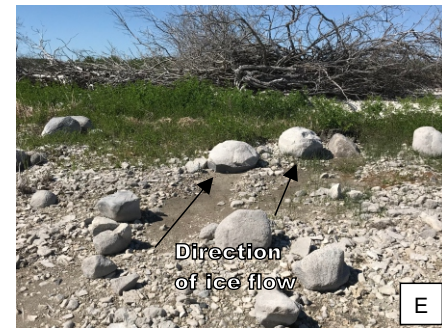
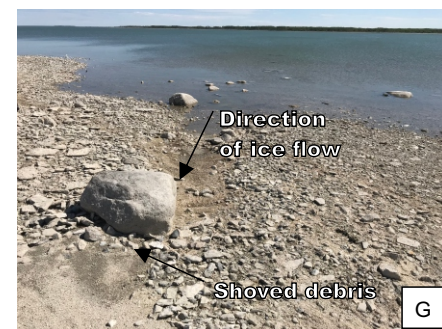
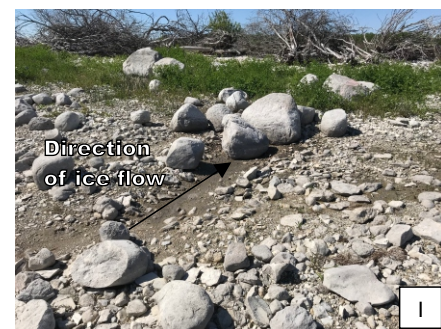
Ice shoved boulders. Up to 5m displacement noted

Boulder zone on upper beach slope

5. Many ice-shoved boulders are present on the beach, indicating that ice shove processes are very active at this location. Ice shove boulders are identified by the presence of a clear slide path on the lake side of the boulder and in some cases shoved debris on the landward side of the boulders, although these features become less visible over time if waves subsequently wash across the beach. The presence of clear ice shove slide paths suggests that many of the observed ice-shove boulders were displaced in spring 2019. The maximum amount of displacement measured was approximately 5 m. Boulders in shallow nearshore areas may be displaced by ice shove in subsequent years, and additional boulders may be transported towards the shore by ice rafting. Boulders may also be subjected to repeated ice shove over time, gradually moving closer and closer to the raised beach ridge. This process has created a concentration of boulders on the lakeward side of the raised beach ridge.

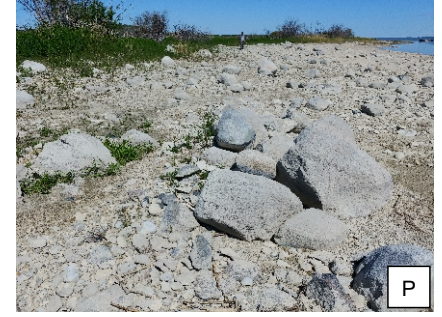
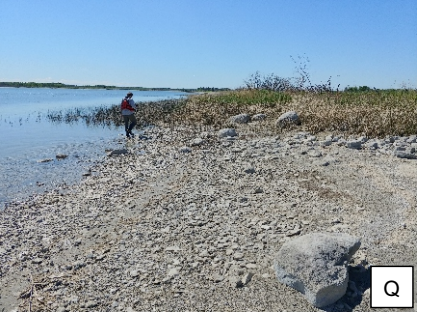
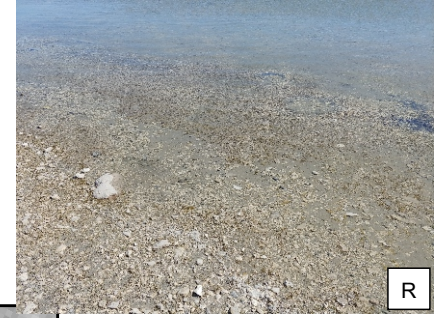
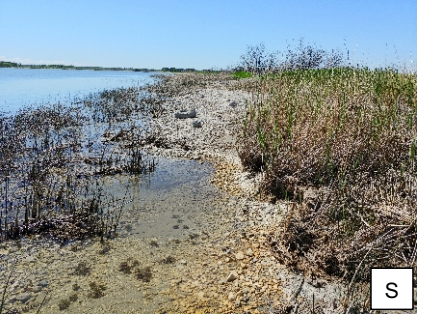
Gravel substrate near shoreline

Gravel and sand sediment along vegetated shoreline

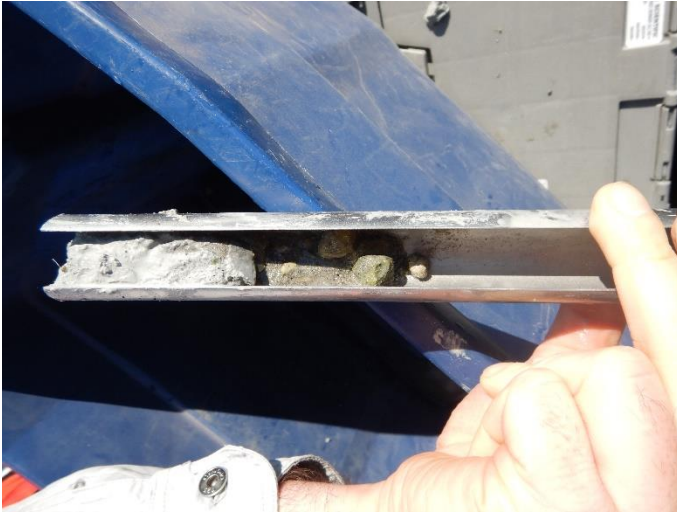
Watchorn Bay Sample 1

Photo ID: DSCN 3585  
Dominant material: Fine sand and silt  
Secondary material: Fine gravel  
Top size: 2 cm  
Description: Material extracted from bed using hand auger.

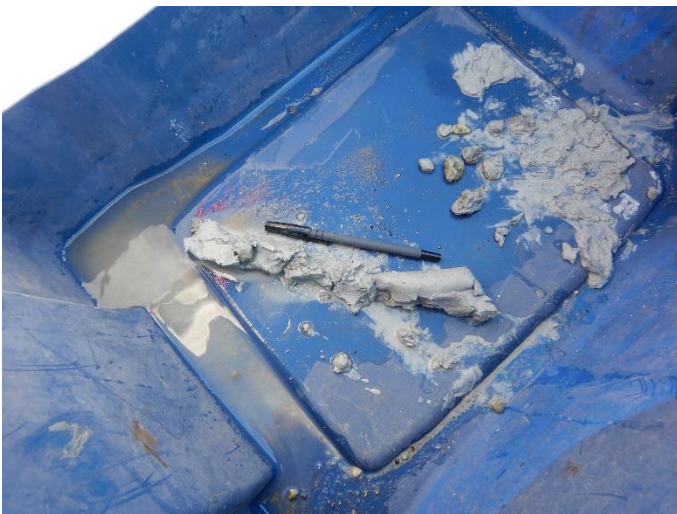
Photo ID: DSCN 3589  
Dominant material: Fine sand and silt  
Secondary material: Fine gravel  
Top size: 2 cm  
Description: Material extracted from bed shown in a pail. Pen for scale.

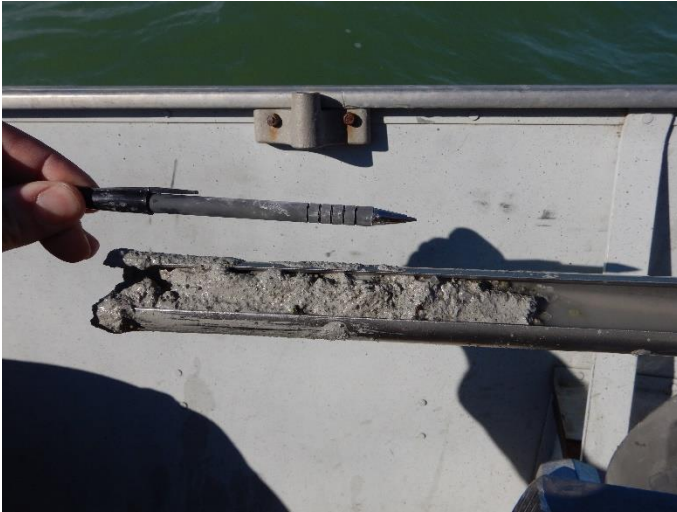
Watchorn Bay Sample 2

Photo ID: DSCN 3590  
 Dominant material: Fine sand and silt  
 Secondary material: Fine gravel in upper 10 cm  
 Top size: 2 cm  
 Description: Material extracted from bed using hand auger.

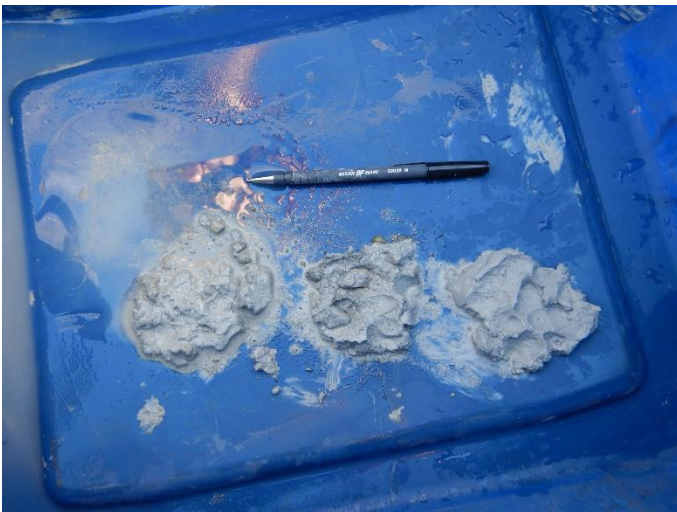
Photo ID: DSCN 3591  
 Dominant material: Fine sand and silt  
 Secondary material: Fine gravel in upper 10 cm  
 Top size: 2 cm  
 Description: Material extracted from bed shown in a pail. Pen for scale points to the top of the core.

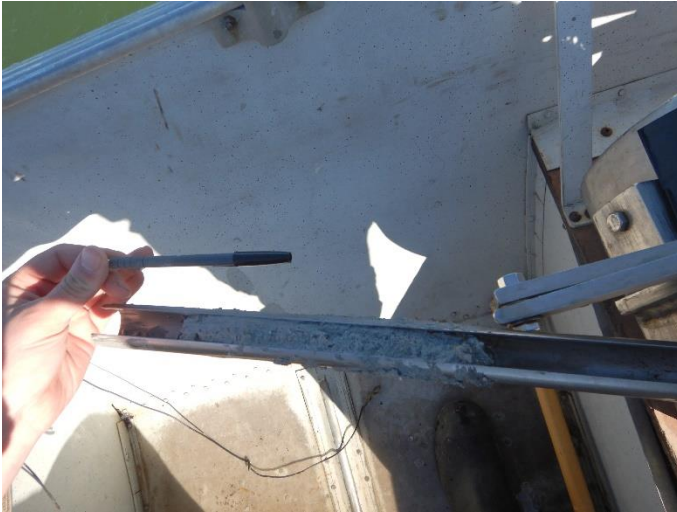
### Watchorn Bay Sample 3

Photo ID: DSCN 3595  
Dominant material: Fine sand and silt  
Secondary material: Fine gravel in upper 5 cm  
Top size: 1 cm  
Description: Material extracted from bed using hand auger.

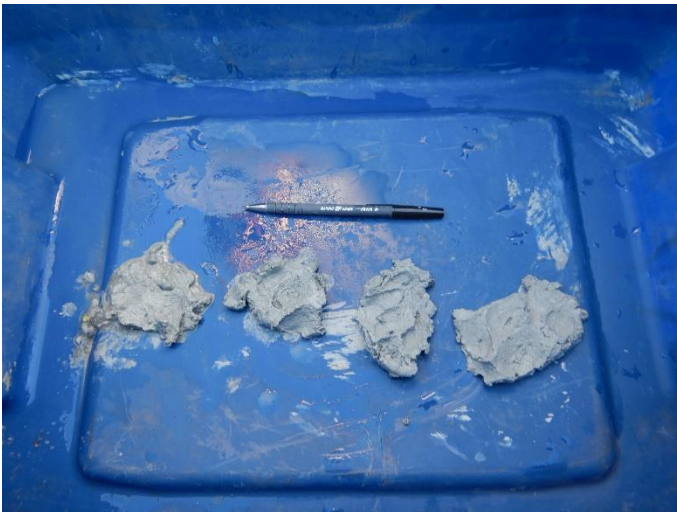
Photo ID: DSCN 3596  
Dominant material: Fine sand and silt  
Secondary material: Fine gravel in upper 5 cm  
Top size: 1 cm  
Description: Material extracted from bed shown in a pail. Pen for scale points to the top of the core.

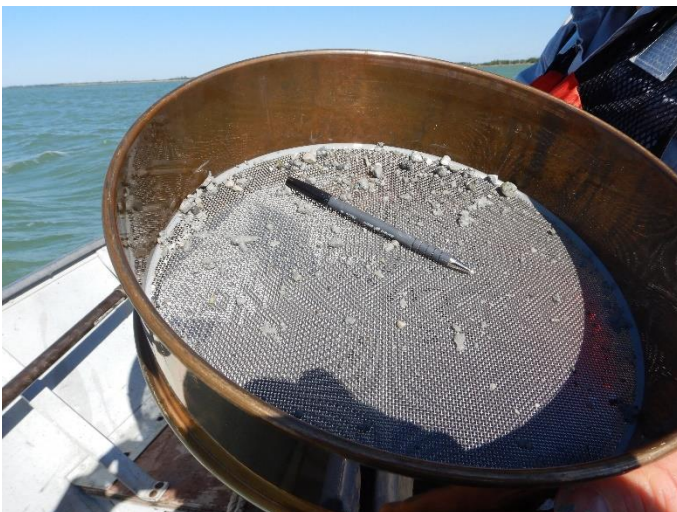
Photo ID: DSCN 3597  
Dominant material: Fine sand and silt  
Secondary material: Fine gravel in upper 5 cm  
Top size: 1 cm  
Description: Material extracted from bed shown washed through a 1.18 mm sieve plate.

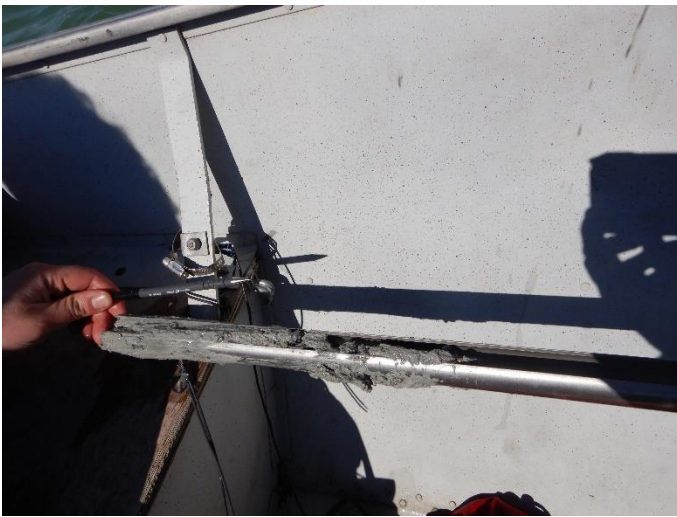
### Watchorn Bay Sample 4

Photo ID: DSCN 3600  
Dominant material: Fine sand and silt  
Secondary material: Gravel and clay plug at bottom of core  
Top size: 3 cm  
Description: Material extracted from bed using hand auger.

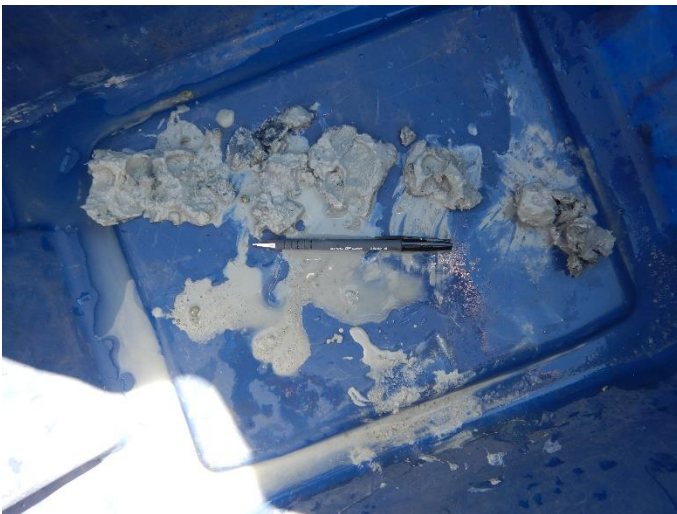
Photo ID: DSCN 3601  
Dominant material: Fine sand and silt  
Secondary material: Gravel and clay plug at bottom of core  
Top size: 3 cm  
Description: Material extracted from bed shown in a pail. Pen for scale points to the top of the core.

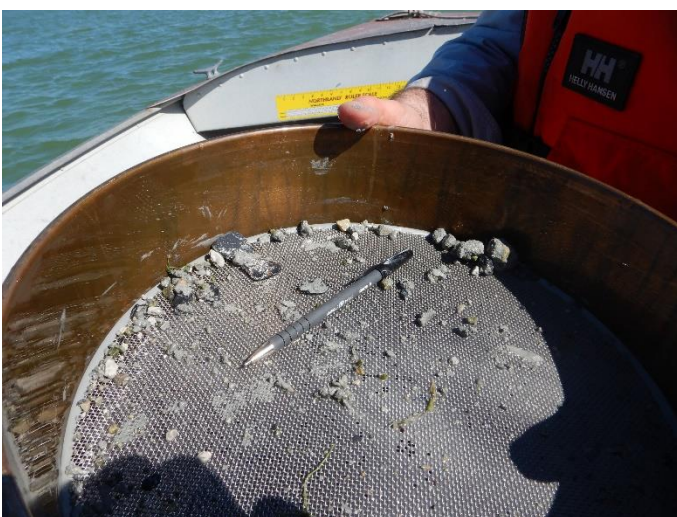
Photo ID: DSCN 3602  
Dominant material: Fine sand and silt  
Secondary material: Gravel and clay plug at bottom of core  
Top size: 3 cm  
Description: Material extracted from bed shown washed through a 1.18 mm sieve plate.

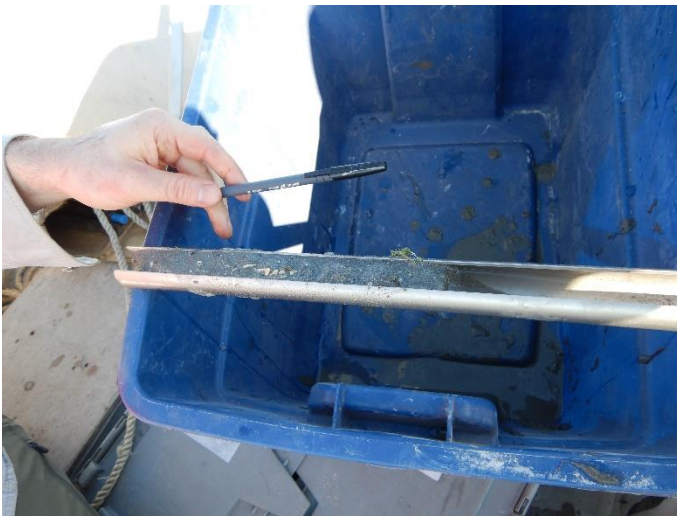
### Birch Bay Sample 1

Photo ID: DSCN 3746  
Dominant material: Fine sand and silt  
Secondary material: Fine gravel  
Top size: 1 cm  
Description: Material extracted from bed using hand auger.

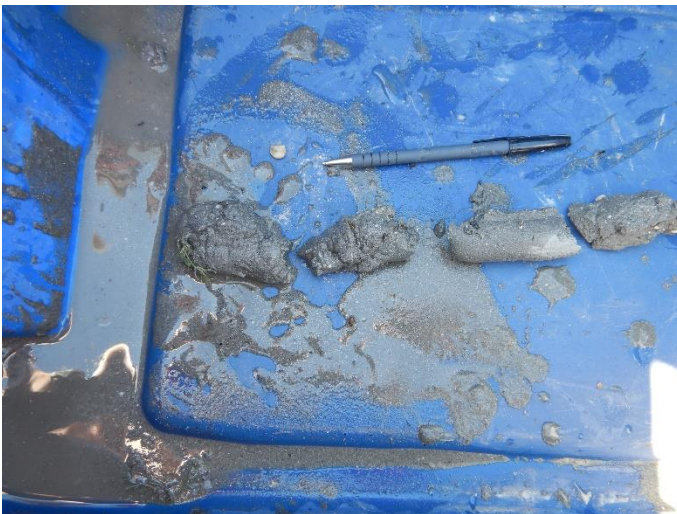
Photo ID: DSCN 3748  
Dominant material: Fine sand and silt  
Secondary material: Fine gravel  
Top size: 1 cm  
Description: Material extracted from bed shown in a pail. Pen for scale points to the top of the core.

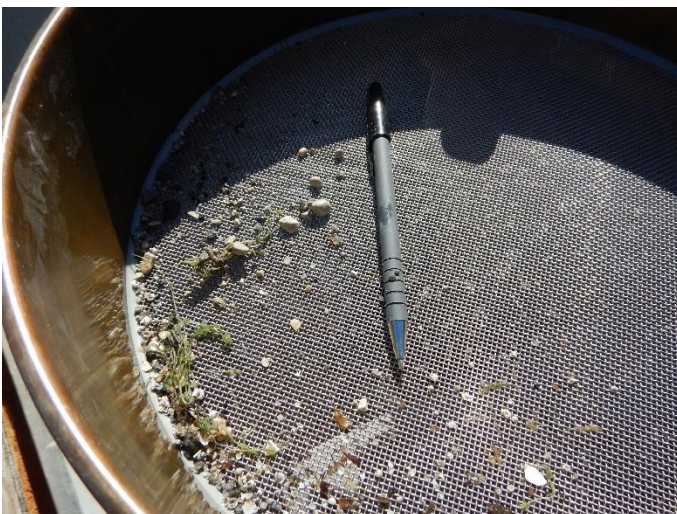
Photo ID: DSCN 3749  
Dominant material: Fine sand and silt  
Secondary material: Fine gravel  
Top size: 1 cm  
Description: Material extracted from bed shown washed through a 1.18 mm sieve plate.

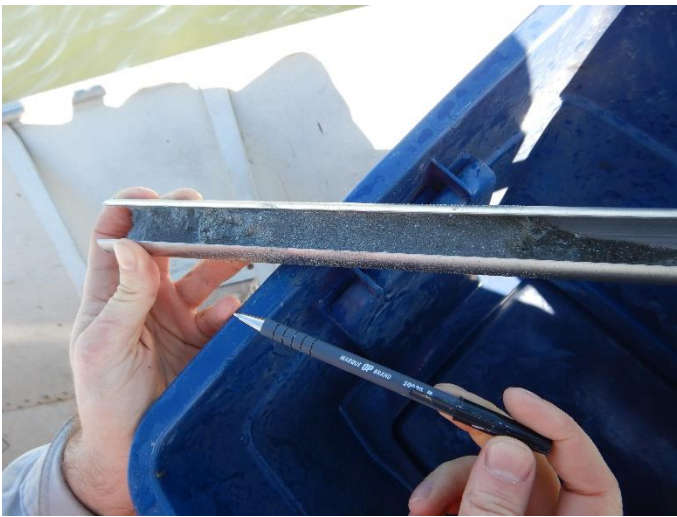
Birch Bay Sample 2

Photo ID: DSCN 3751  
Dominant material: Fine sand and silt  
Secondary material: N/A  
Top size: 3 mm  
Description: Material extracted from bed using hand auger.

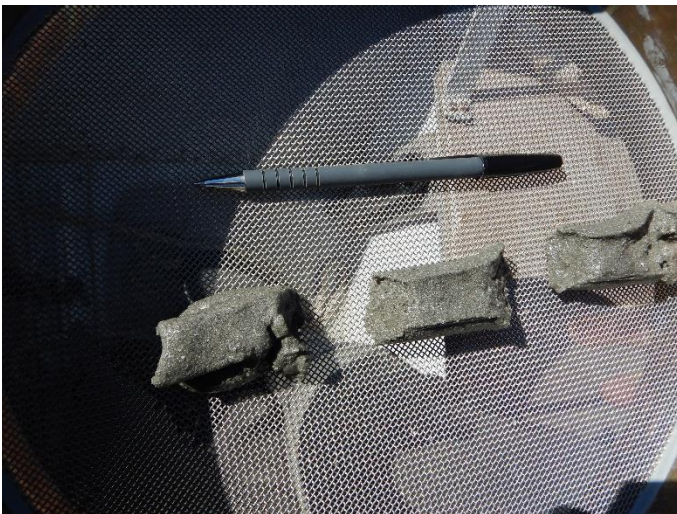
Photo ID: DSCN 3752  
Dominant material: Fine sand and silt  
Secondary material: N/A  
Top size: 3 mm  
Description: Material extracted from bed shown on a sieve plate. Pen for scale points to the top of the core.

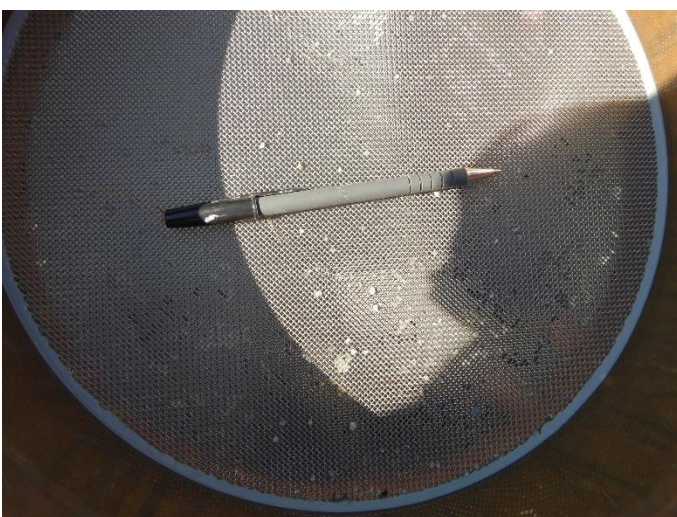
Photo ID: DSCN 3753  
Dominant material: Fine sand and silt  
Secondary material: N/A  
Top size: 3 mm  
Description: Material extracted from bed shown washed through a 1.18 mm sieve plate.

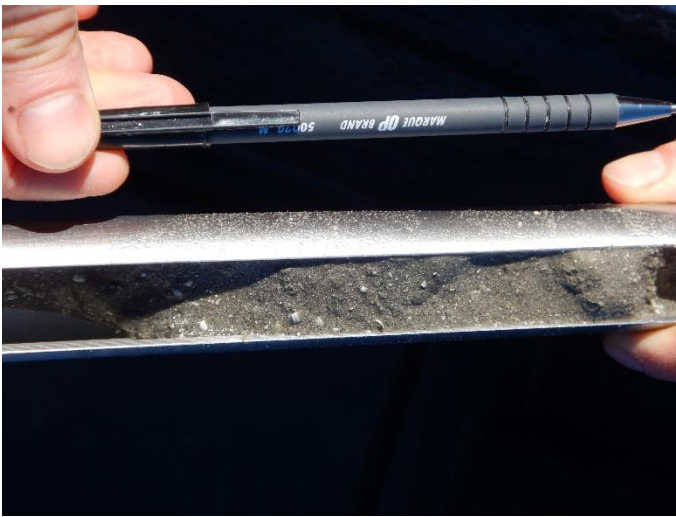
Birch Bay Sample 3

Photo ID: DSCN 3761  
 Dominant material: Fine sand and silt  
 Secondary material: N/A  
 Top size: 5 mm  
 Description: Material extracted from bed using hand auger.

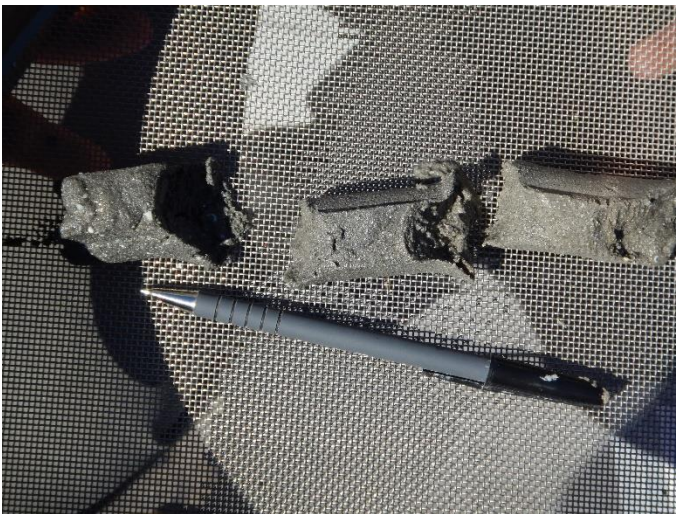
Photo ID: DSCN 3762  
 Dominant material: Fine sand and silt  
 Secondary material: N/A  
 Top size: 5 mm  
 Description: Material extracted from bed shown on a sieve plate. Pen for scale points to the top of the core.

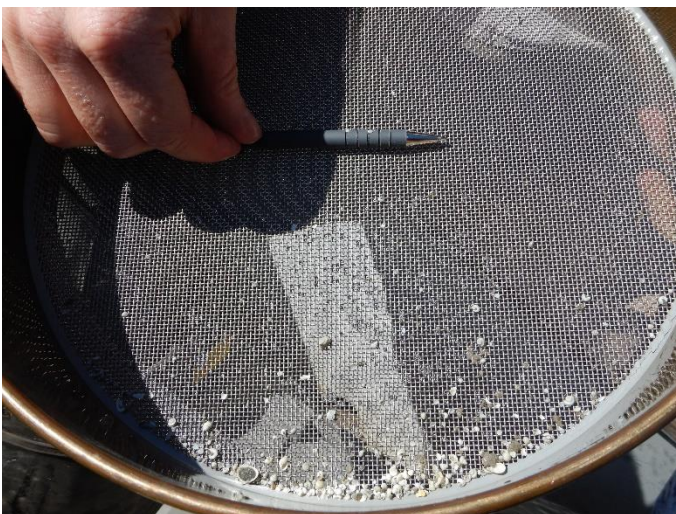
Photo ID: DSCN 3763  
 Dominant material: Fine sand and silt  
 Secondary material: N/A  
 Top size: 5 mm  
 Description: Material extracted from bed shown washed through a 1.18 mm sieve plate.

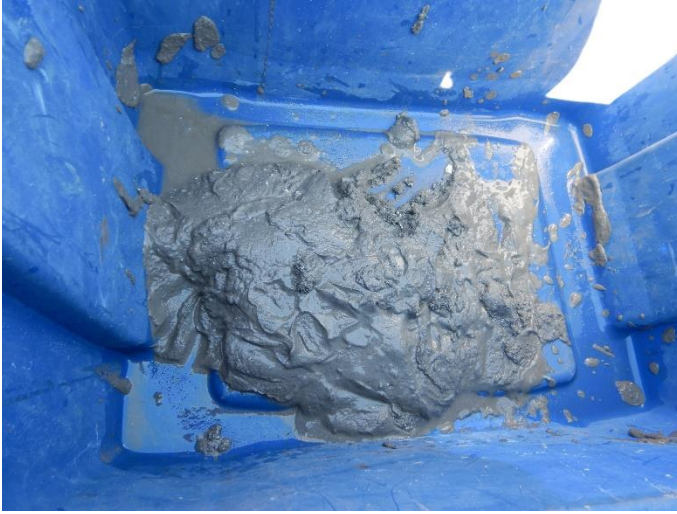
Birch Bay Sample 4

Photo ID: DSCN 3765  
Dominant material: Upper 14 cm very soft organic rich mud, lower layer is fine sand and silt  
Secondary material: Shells in upper 14 cm  
Top size: N/A  
Description: Photo shows the Ponar grab sampler material extracted from the lake bed.

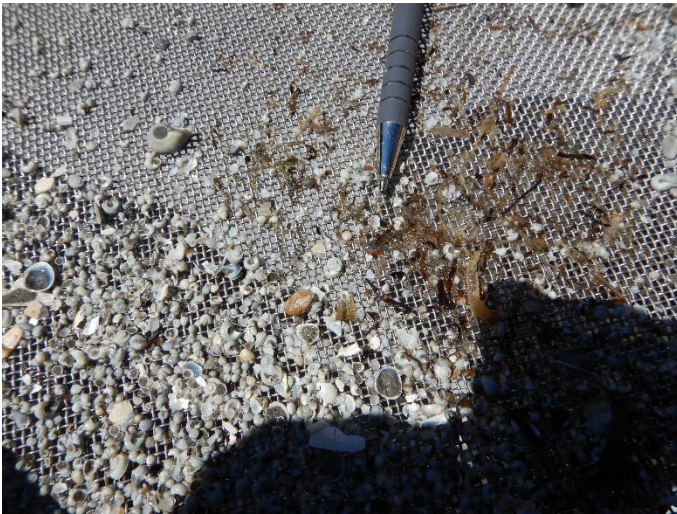
Photo ID: DSCN 3767  
Dominant material: Upper 14 cm very soft organic rich mud, lower layer is fine sand and silt  
Secondary material: Shells in upper 14 cm  
Top size: N/A  
Description: Material extracted from bed shown washed through a 1.18 mm sieve plate. No mineral sediments were retained. Only small shells were retained on the sieve.
