Lake Manitoba Outlet Channel Shoreline Morphology Review

# Final Report

JDMA Project #2018-026

Hatch Document Number: E358159-1000-228-230-0001 Rev. 0

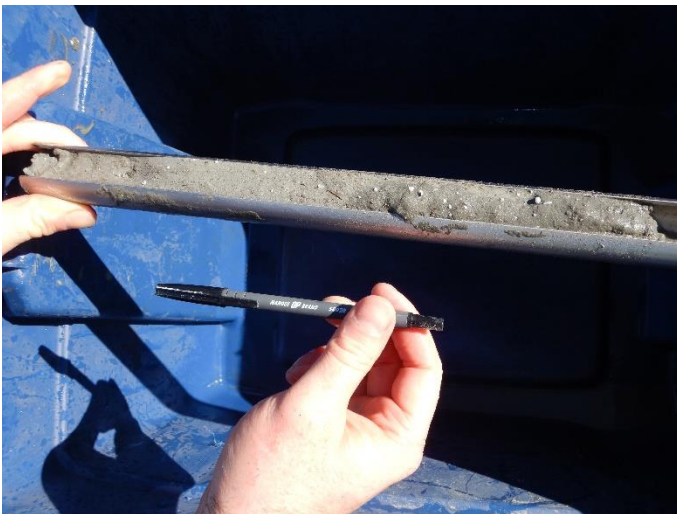
Photo ID: DSCN 3769  
Dominant material: Upper 14 cm very soft organic rich mud, lower 18 cm fine sand and silt  
Secondary material: Shells in upper 14 cm  
Top size: N/A  
Description: Material extracted from bed using hand auger.

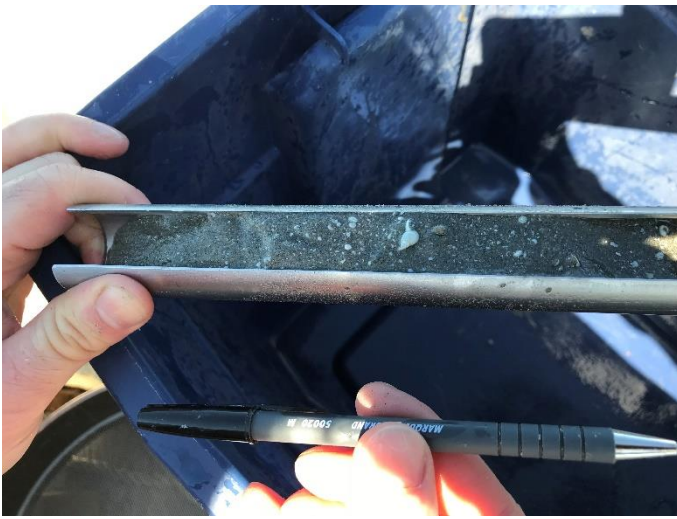
Birch Bay Sample 5

Photo ID: IMG 0522  
Dominant material: Fine sand and silt  
Secondary material: Shells in thin upper silty layer  
Top size: N/A  
Description: Material extracted from bed using hand auger.

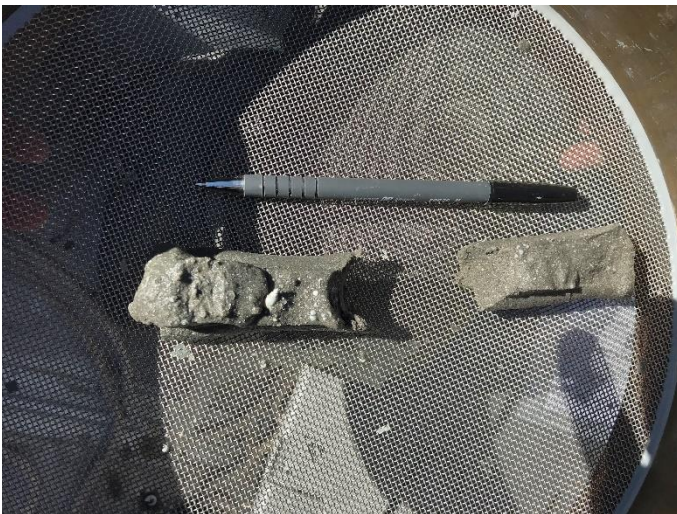
Photo ID: IMG 0523  
Dominant material: Fine sand and silt  
Secondary material: Shells in thin upper silty layer  
Top size: N/A  
Description: Material extracted from bed shown on a sieve plate. Pen for scale points to the top of the core.

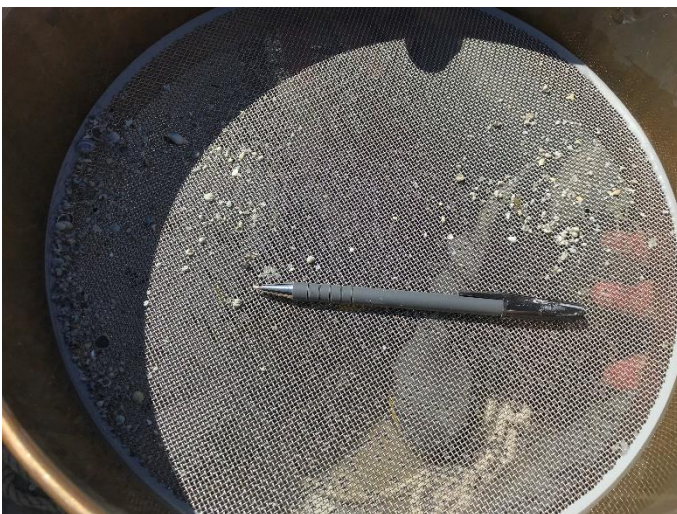
Photo ID: IMG 0525  
Dominant material: Fine sand and silt  
Secondary material: Shells in thin upper silty layer  
Top size: N/A  
Description: Material extracted from bed shown washed through a 1.18 mm sieve plate.

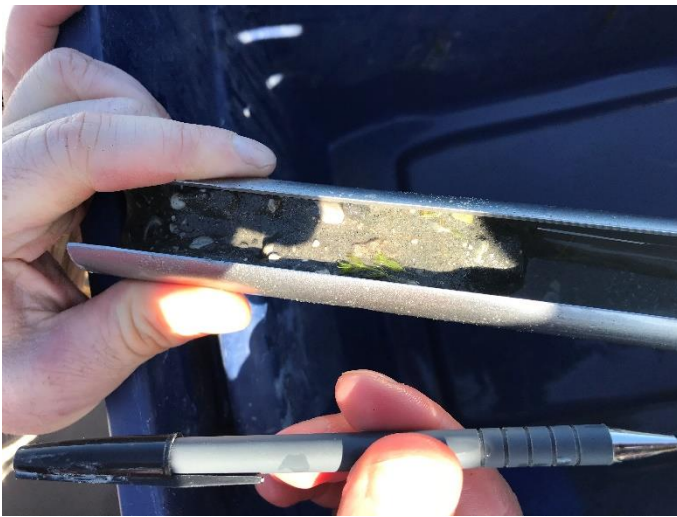
Birch Bay Sample 6

Photo ID: IMG 0527  
 Dominant material: Gravelly sand  
 Secondary material: N/A  
 Top size: 2.5 cm  
 Description: Material extracted from bed using hand auger.

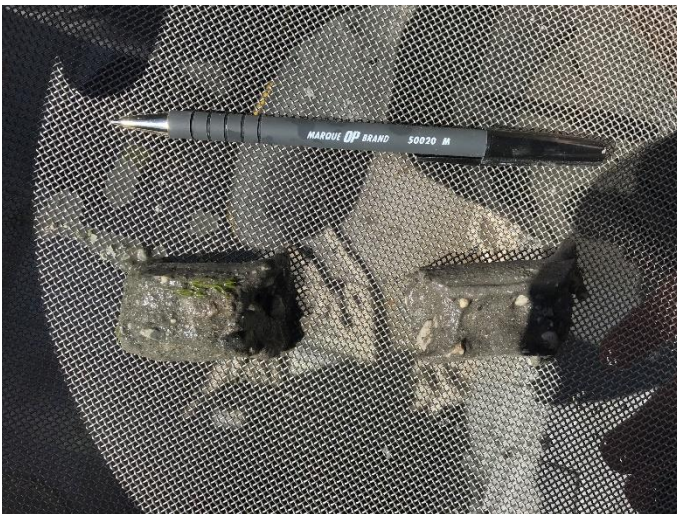
Photo ID: IMG 0528  
 Dominant material: Gravelly sand  
 Secondary material: N/A  
 Top size: 2.5 cm  
 Description: Material extracted from bed shown on a sieve plate. Pen for scale points to the top of the core.

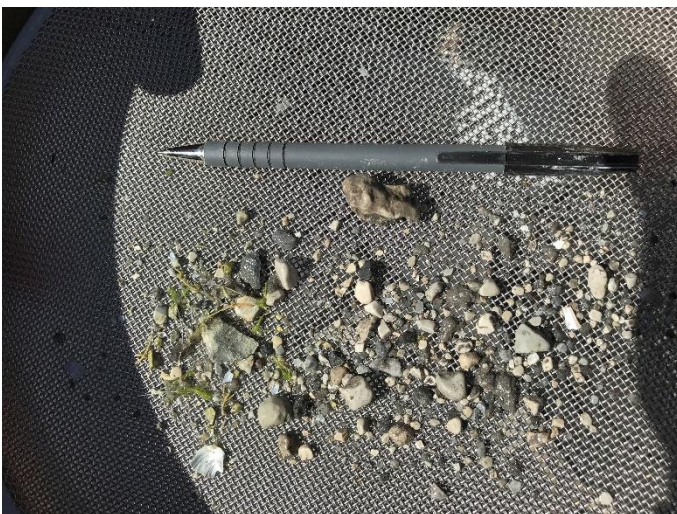
Photo ID: IMG 0529  
 Dominant material: Gravelly sand  
 Secondary material: N/A  
 Top size: 2.5 cm  
 Description: Material extracted from bed shown washed through a 1.18 mm sieve plate.

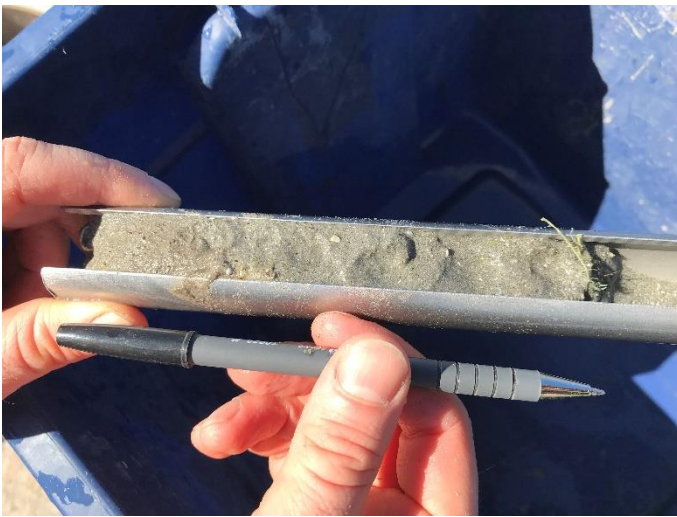
Birch Bay Sample 7

Photo ID: IMG 0531  
 Dominant material: Fine sand and silt  
 Secondary material: N/A  
 Top size: N/A  
 Description: Material extracted from bed using hand auger.

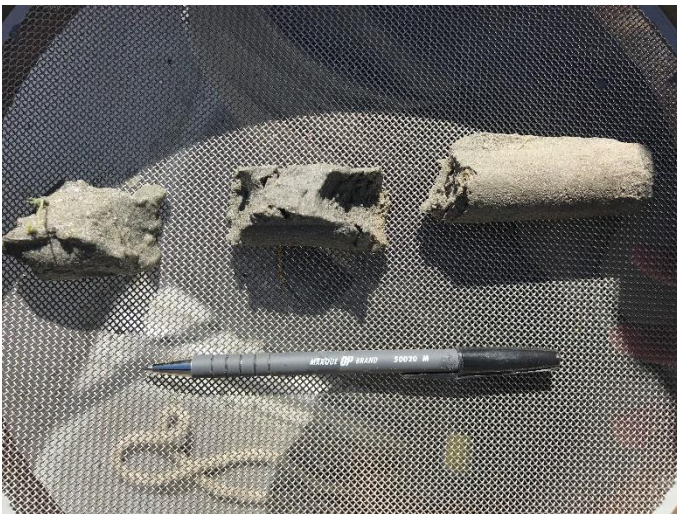
Photo ID: IMG 0532  
 Dominant material: Fine sand and silt  
 Secondary material: N/A  
 Top size: N/A  
 Description: Material extracted from bed shown on a sieve plate. Pen for scale points to the top of the core.

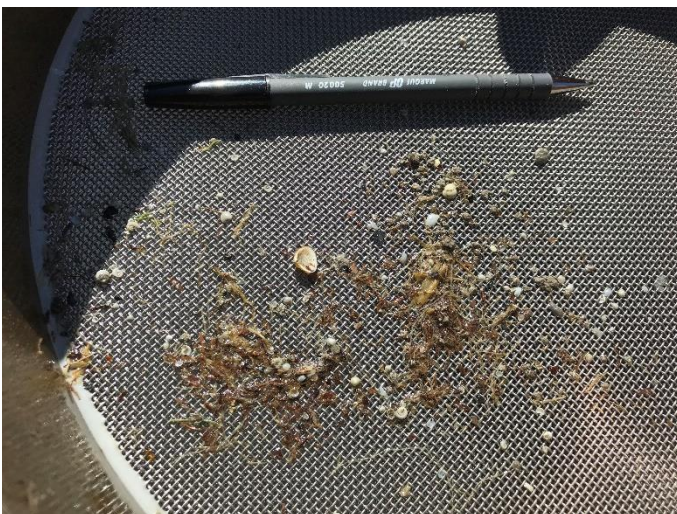
Photo ID: IMG 0533  
 Dominant material: Fine sand and silt  
 Secondary material: N/A  
 Top size: N/A  
 Description: Material extracted from bed shown washed through a 1.18 mm sieve plate.
