MANITOBA INFRASTRUCTURE

Lake Manitoba and Lake St. Martin Outlet Channels Analysis of Physical Impacts to Rivers within the Hydraulic System

Revision:
Final / Rev 0

KGS Group Project:
18-0300-005

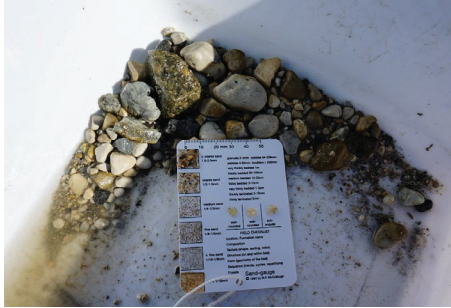
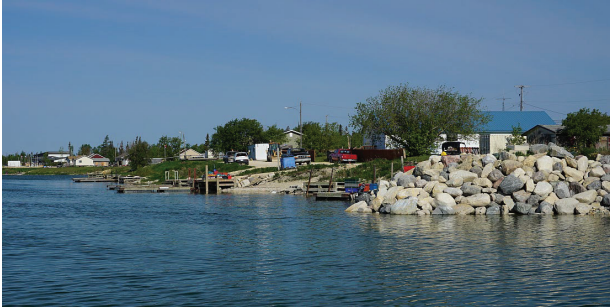
<p>Riverbank Description:</p>	<p>The banks of the river mouth have been armoured with large boulders (field stone) in select locations. The protection continues along the shoreline to the north. Upstream of the mouth the banks provide access to numerous boat docks.</p>
<p>Geology:</p>	<p>At the mouth of the river, unprotected sections of bank feature exposures of glacial till and signs of some erosion. Upstream of the river mouth, the banks were observed to be generally stable, with isolated areas of slumping and bank erosion. The bed of the river at the mouth featured a mix of sand, pebbles, cobbles, and boulders (see substrate sample photograph and sonar imaging).</p>
<p>Photographs: Sediment from bed of river at the mouth (left) and north bank of river (right).</p>	
<div style="display: flex; justify-content: space-around;">

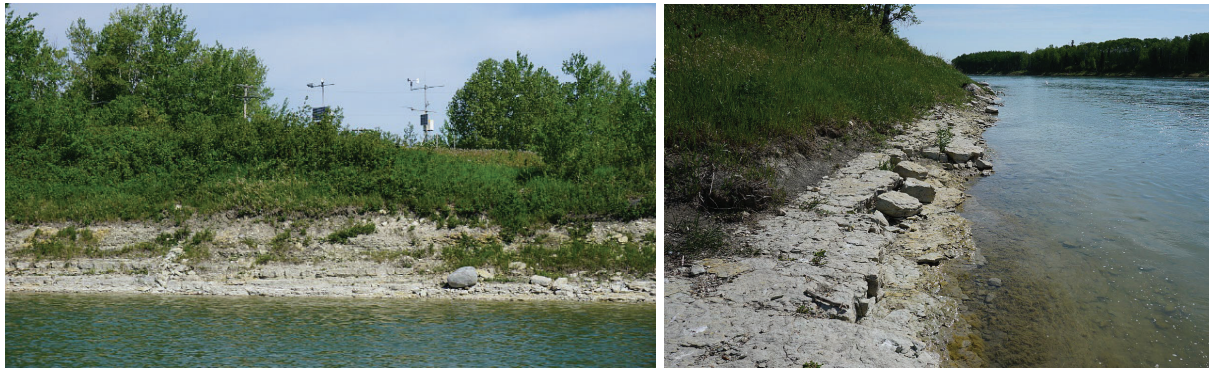
Photographs: North riverbank (left) and bedrock exposure at toe of bank (right).

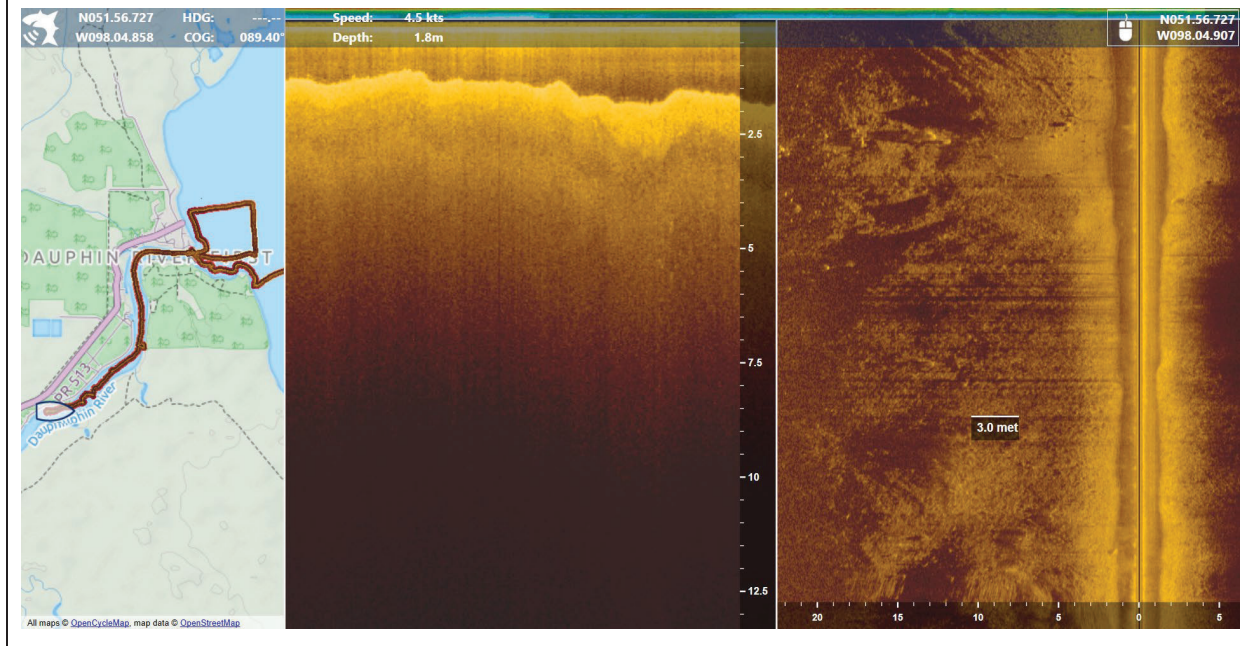
Sonar Imaging: Large scale bars and shoals captured in cross-section (left) and bottom image (right).

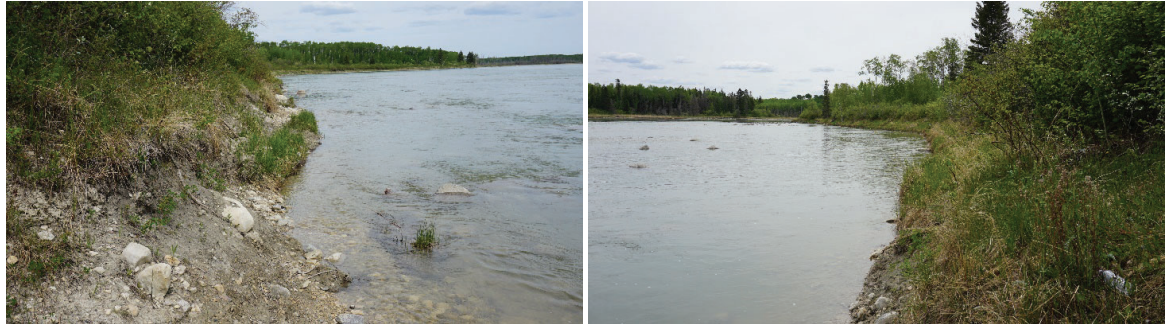
Riverbank Description:	Vegetated upper bank with eroding till exposed in a small erosion scarp in the toe of the bank. Vulnerable to undercutting during high river levels and strong currents. Large boulders visible in the river due to shallow depths. Stable during average and low water levels.
Geology:	Exposed glacial till in toe of banks features high cobble and boulder content.
Photographs: Minor toe erosion along west riverbanks looking downstream (left) and upstream (right).

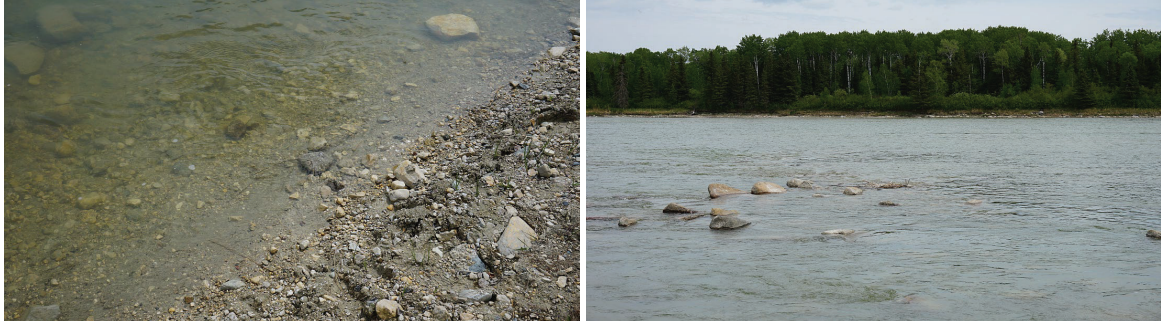
Soft glacial till at the waterline (left) and large boulders in shallow water close to the bank (right).

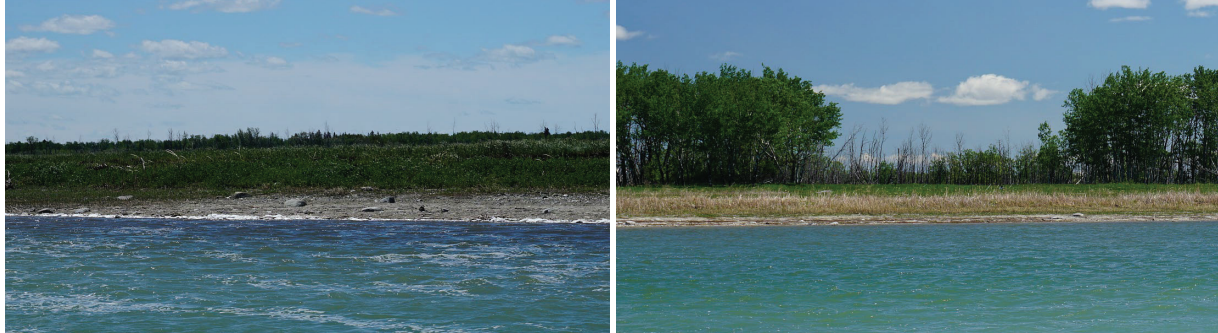
Riverbank Description:	Site F covers the channel that connects Lake Pineimuta to Lake St. Martin upstream of Fairford Road bridge. Riverbanks are low and generally stable.
Geology:	Glacial till with high concentration of cobbles and boulders.
Photographs: Stable vegetated riverbanks.

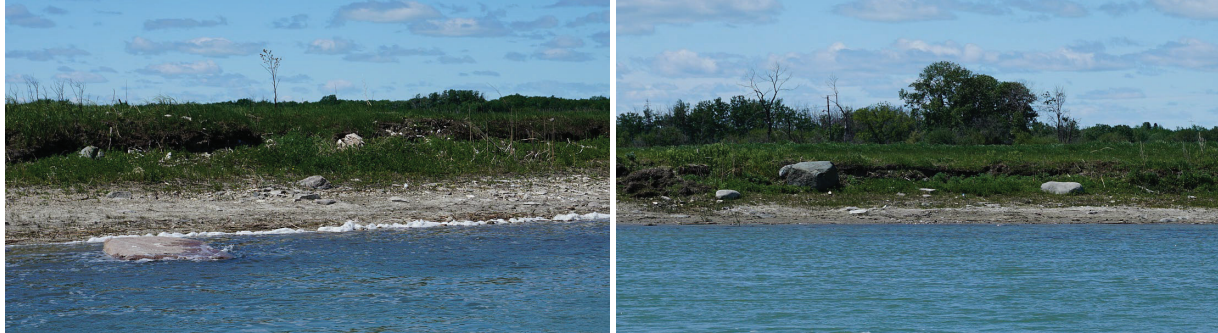
Some slumping of the riverbank, possibly triggered during high water events.

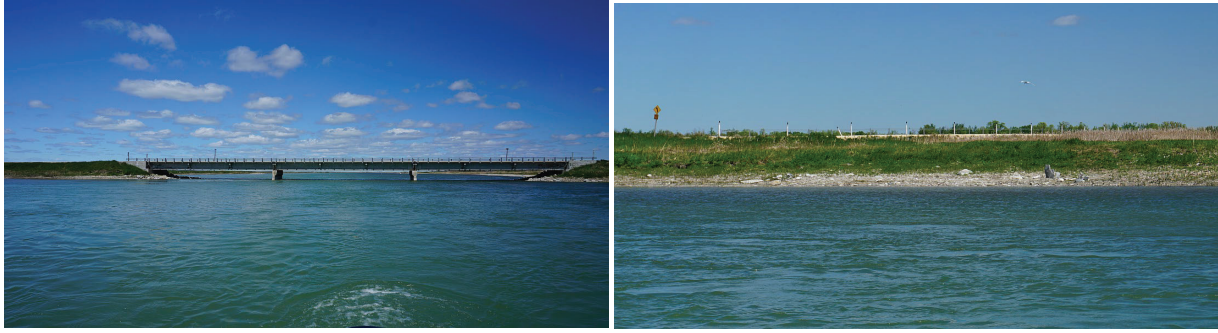
Riverbanks downstream of the bridge.

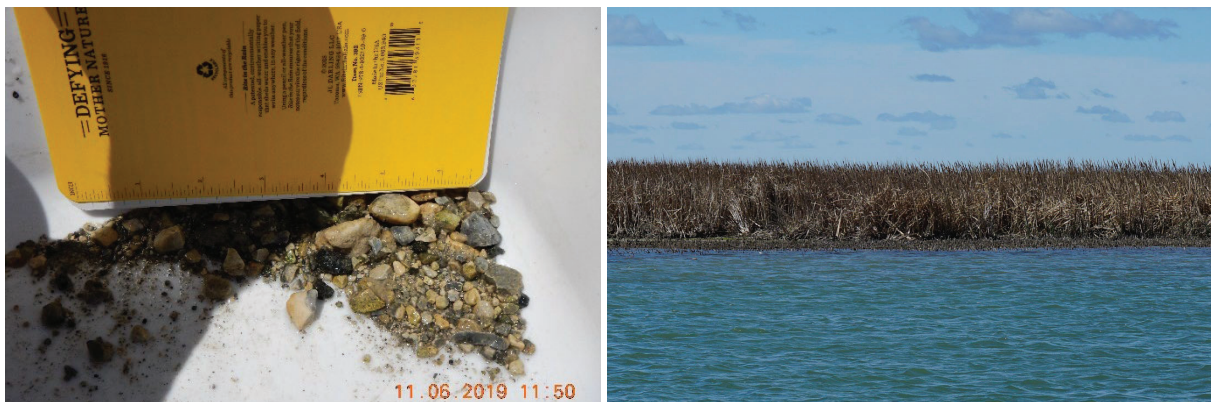
Photographs: River bottom sample at FR6 and typical picture of emergent vegetation along riverbanks.

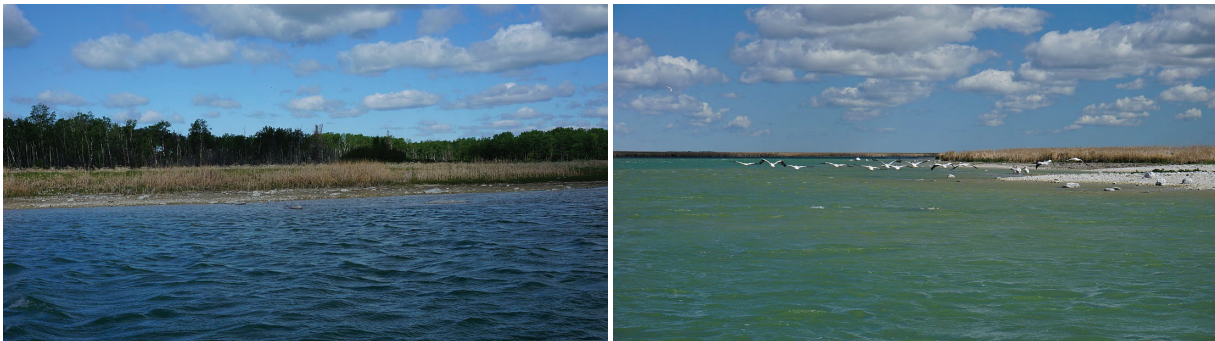
Photographs: Typical riverbanks at Site H (west bank, left, and east bank, right)

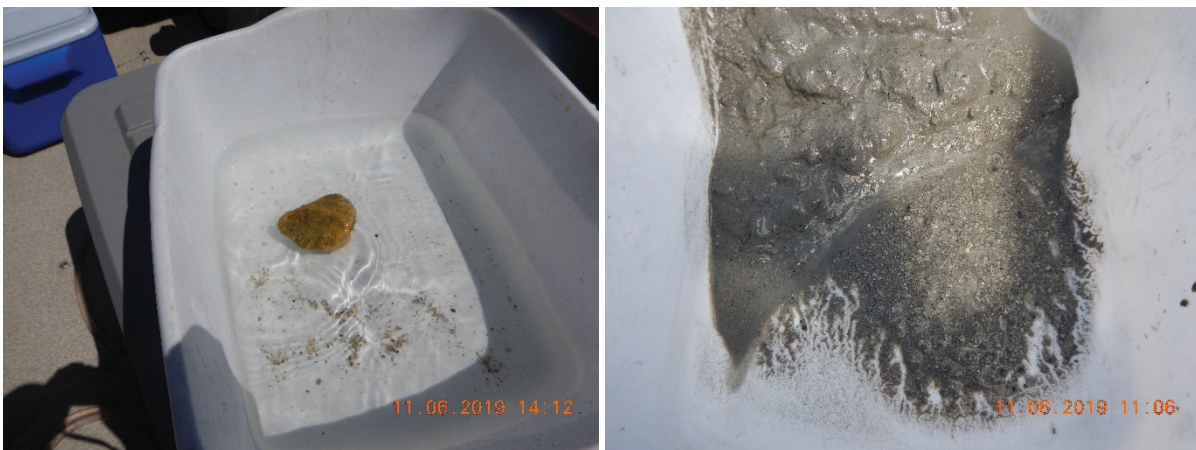
Ponar sample from FR14 (single cobble, left) and FR11 (silt sand, right)

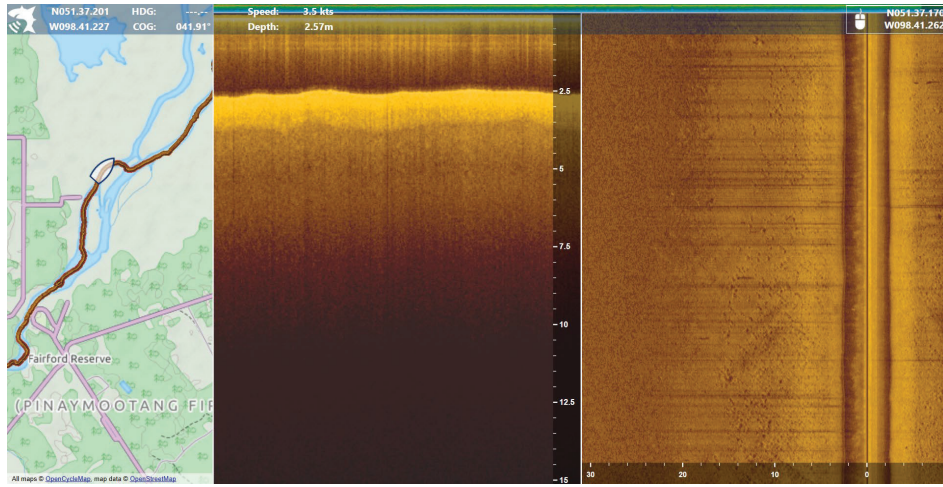
Sonar Imaging: Fine sediment bottom (sand, silt, clay).

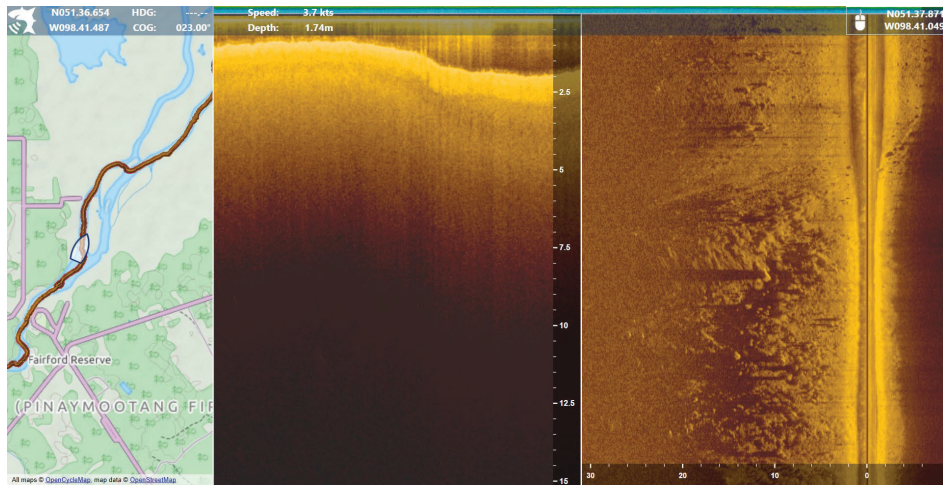
Transition from shallow cobble/boulder substrate to deeper region with fine sediment.

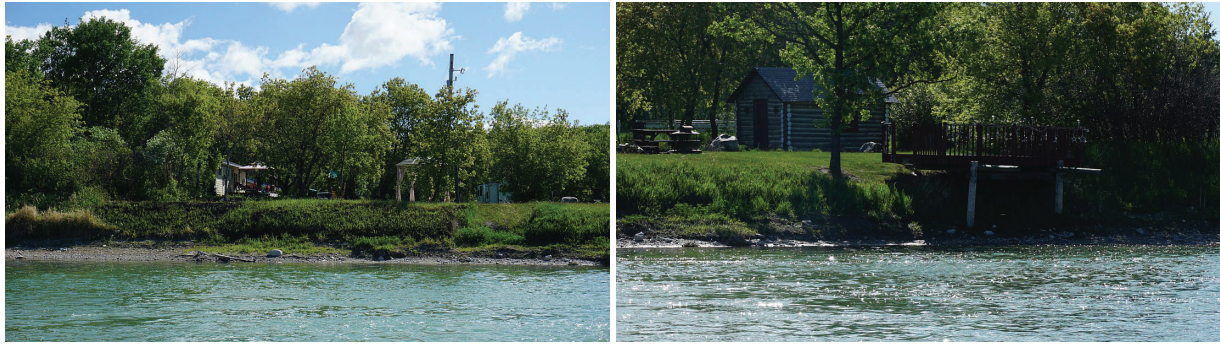
Riverbank Description:	Low bank at waters edge on east side of the river, with signs of instability and erosion, including slumps and exposed deck foundation.
Geology:	Glacial till with cobbles and boulders observed in the eroding riverbanks. Extensive lag deposit on the riverbed.
Photographs: Slump blocks along the riverbank (left) and exposed foundation of deck (right).

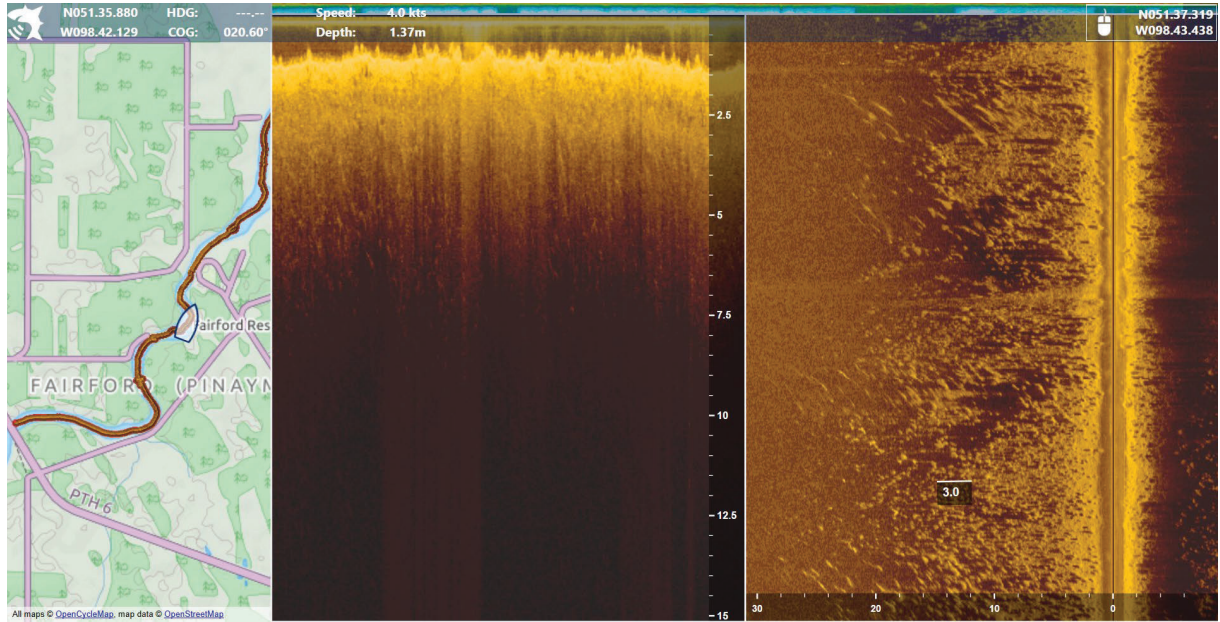
Sonar Imaging: Cobble boulder lag deposit covers the riverbed at Site I.

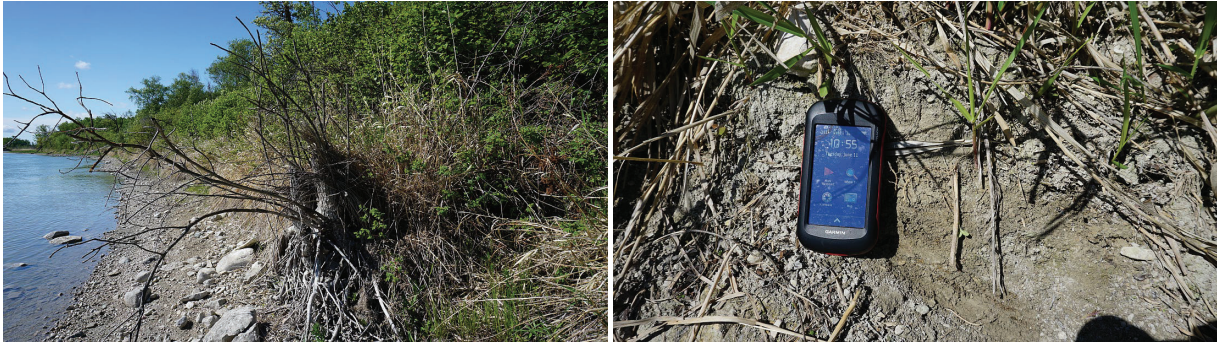
Riverbank Description:	Active erosion observed along the west bank of the river. Vulnerable to large flow events with a high water surface elevation and strong currents. See exposed roots of dead tree below. At low water levels, the banks are not impacted by erosion.
Geology:	Soft glacial till with high concentration of cobble exposed in the eroding bank.
Photographs: Eroding bank with exposed roots of dead tree (left) and soft till exposed in eroding bank (right).

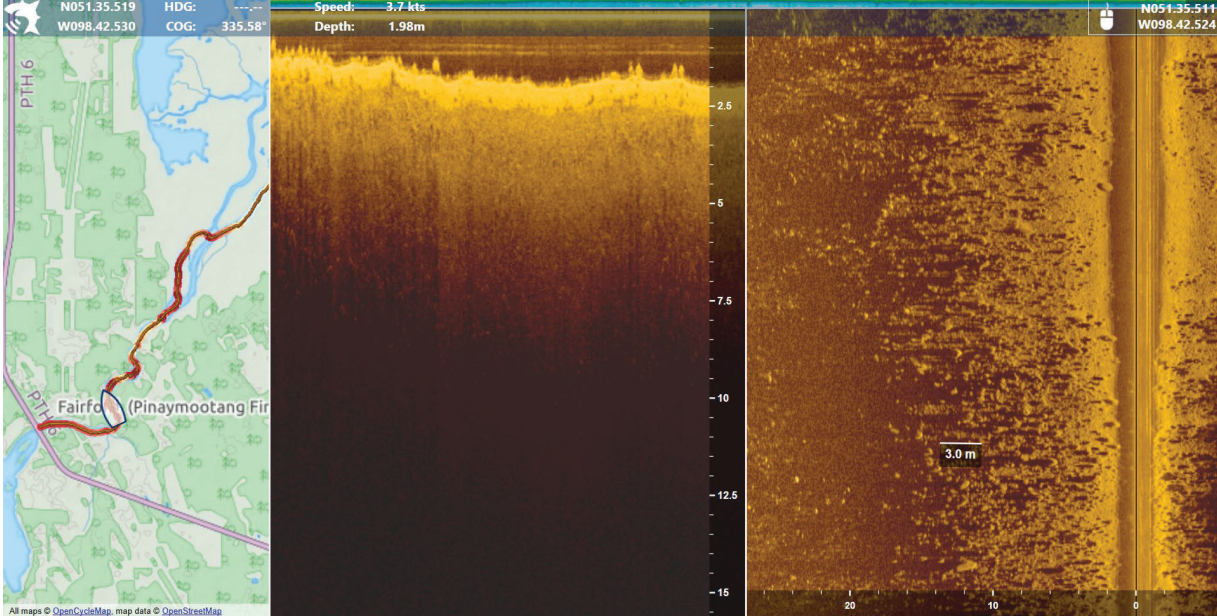
Sonar Imaging: Extensive cobble boulder lag on the riverbed.

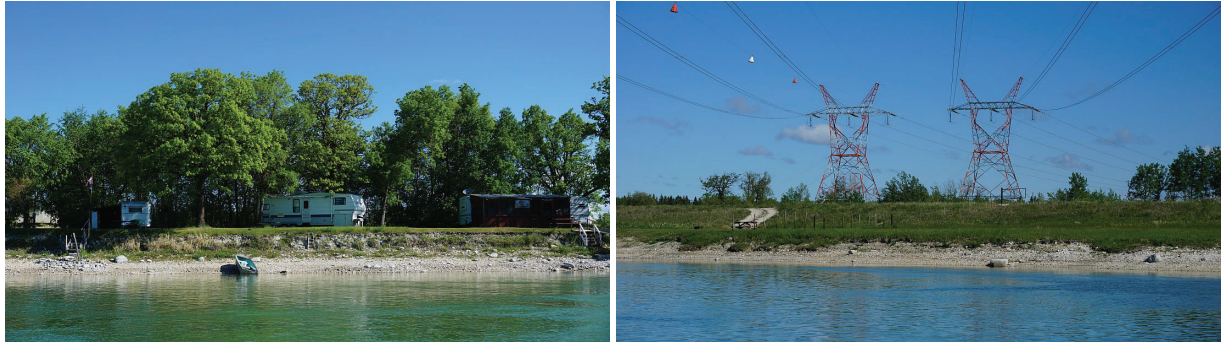
Riverbank Description:	The Site K riverbanks on the north shore are 2-3 m high, with the south side featuring a gentle slope without a bank. No sign of erosion on the south bank. Active erosion scarp along the entire north bank of Site K which is sensitive to water levels (only threatened at high water levels).
Geology:	Exposed glacial till in the eroding banks.
Photographs: Eroding north riverbank and cobble beach (left). Recreational vehicles parked above the bank. Sediment from river excavation in the 1960s stockpiled near the hydro towers in photo on right.

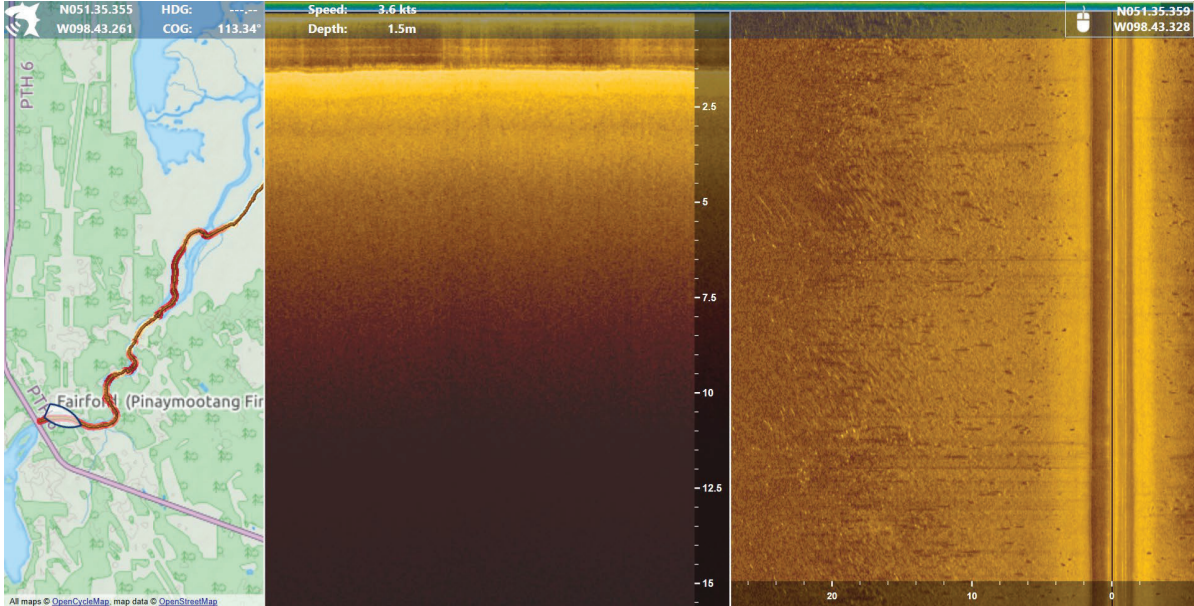
Sonar Imaging: Mixed bottom substrate with fine sediments and cobbles. The riverbed at Site K was extensively excavated in 1961 to increase the conveyance capacity of the river, so the bottom conditions are not natural.

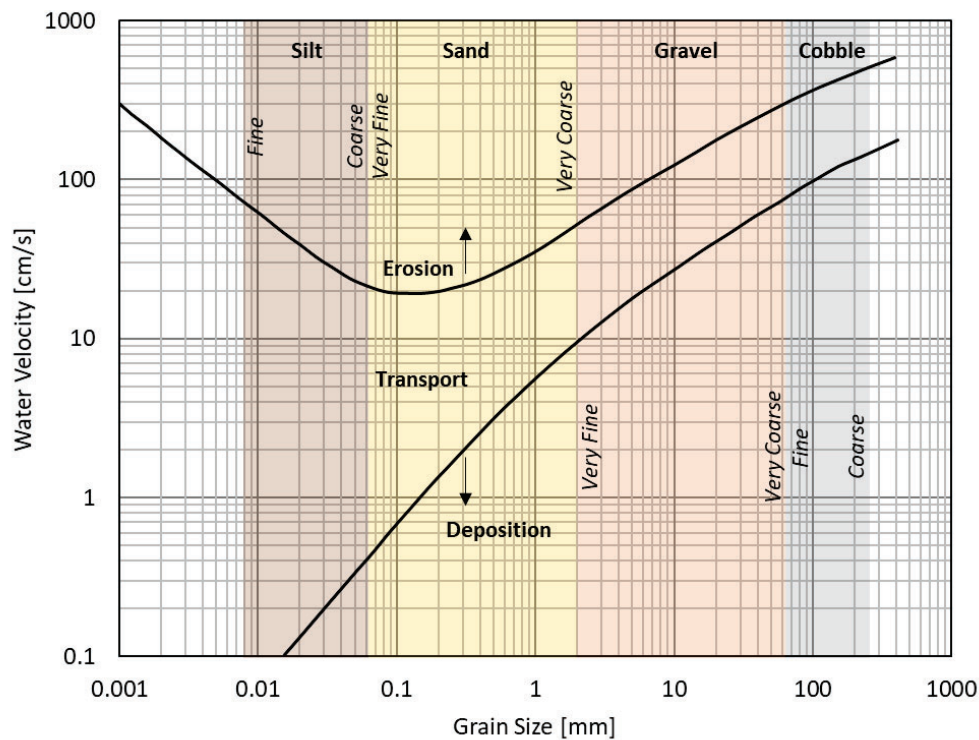
FIGURE 4: HJULSTROM CURVE

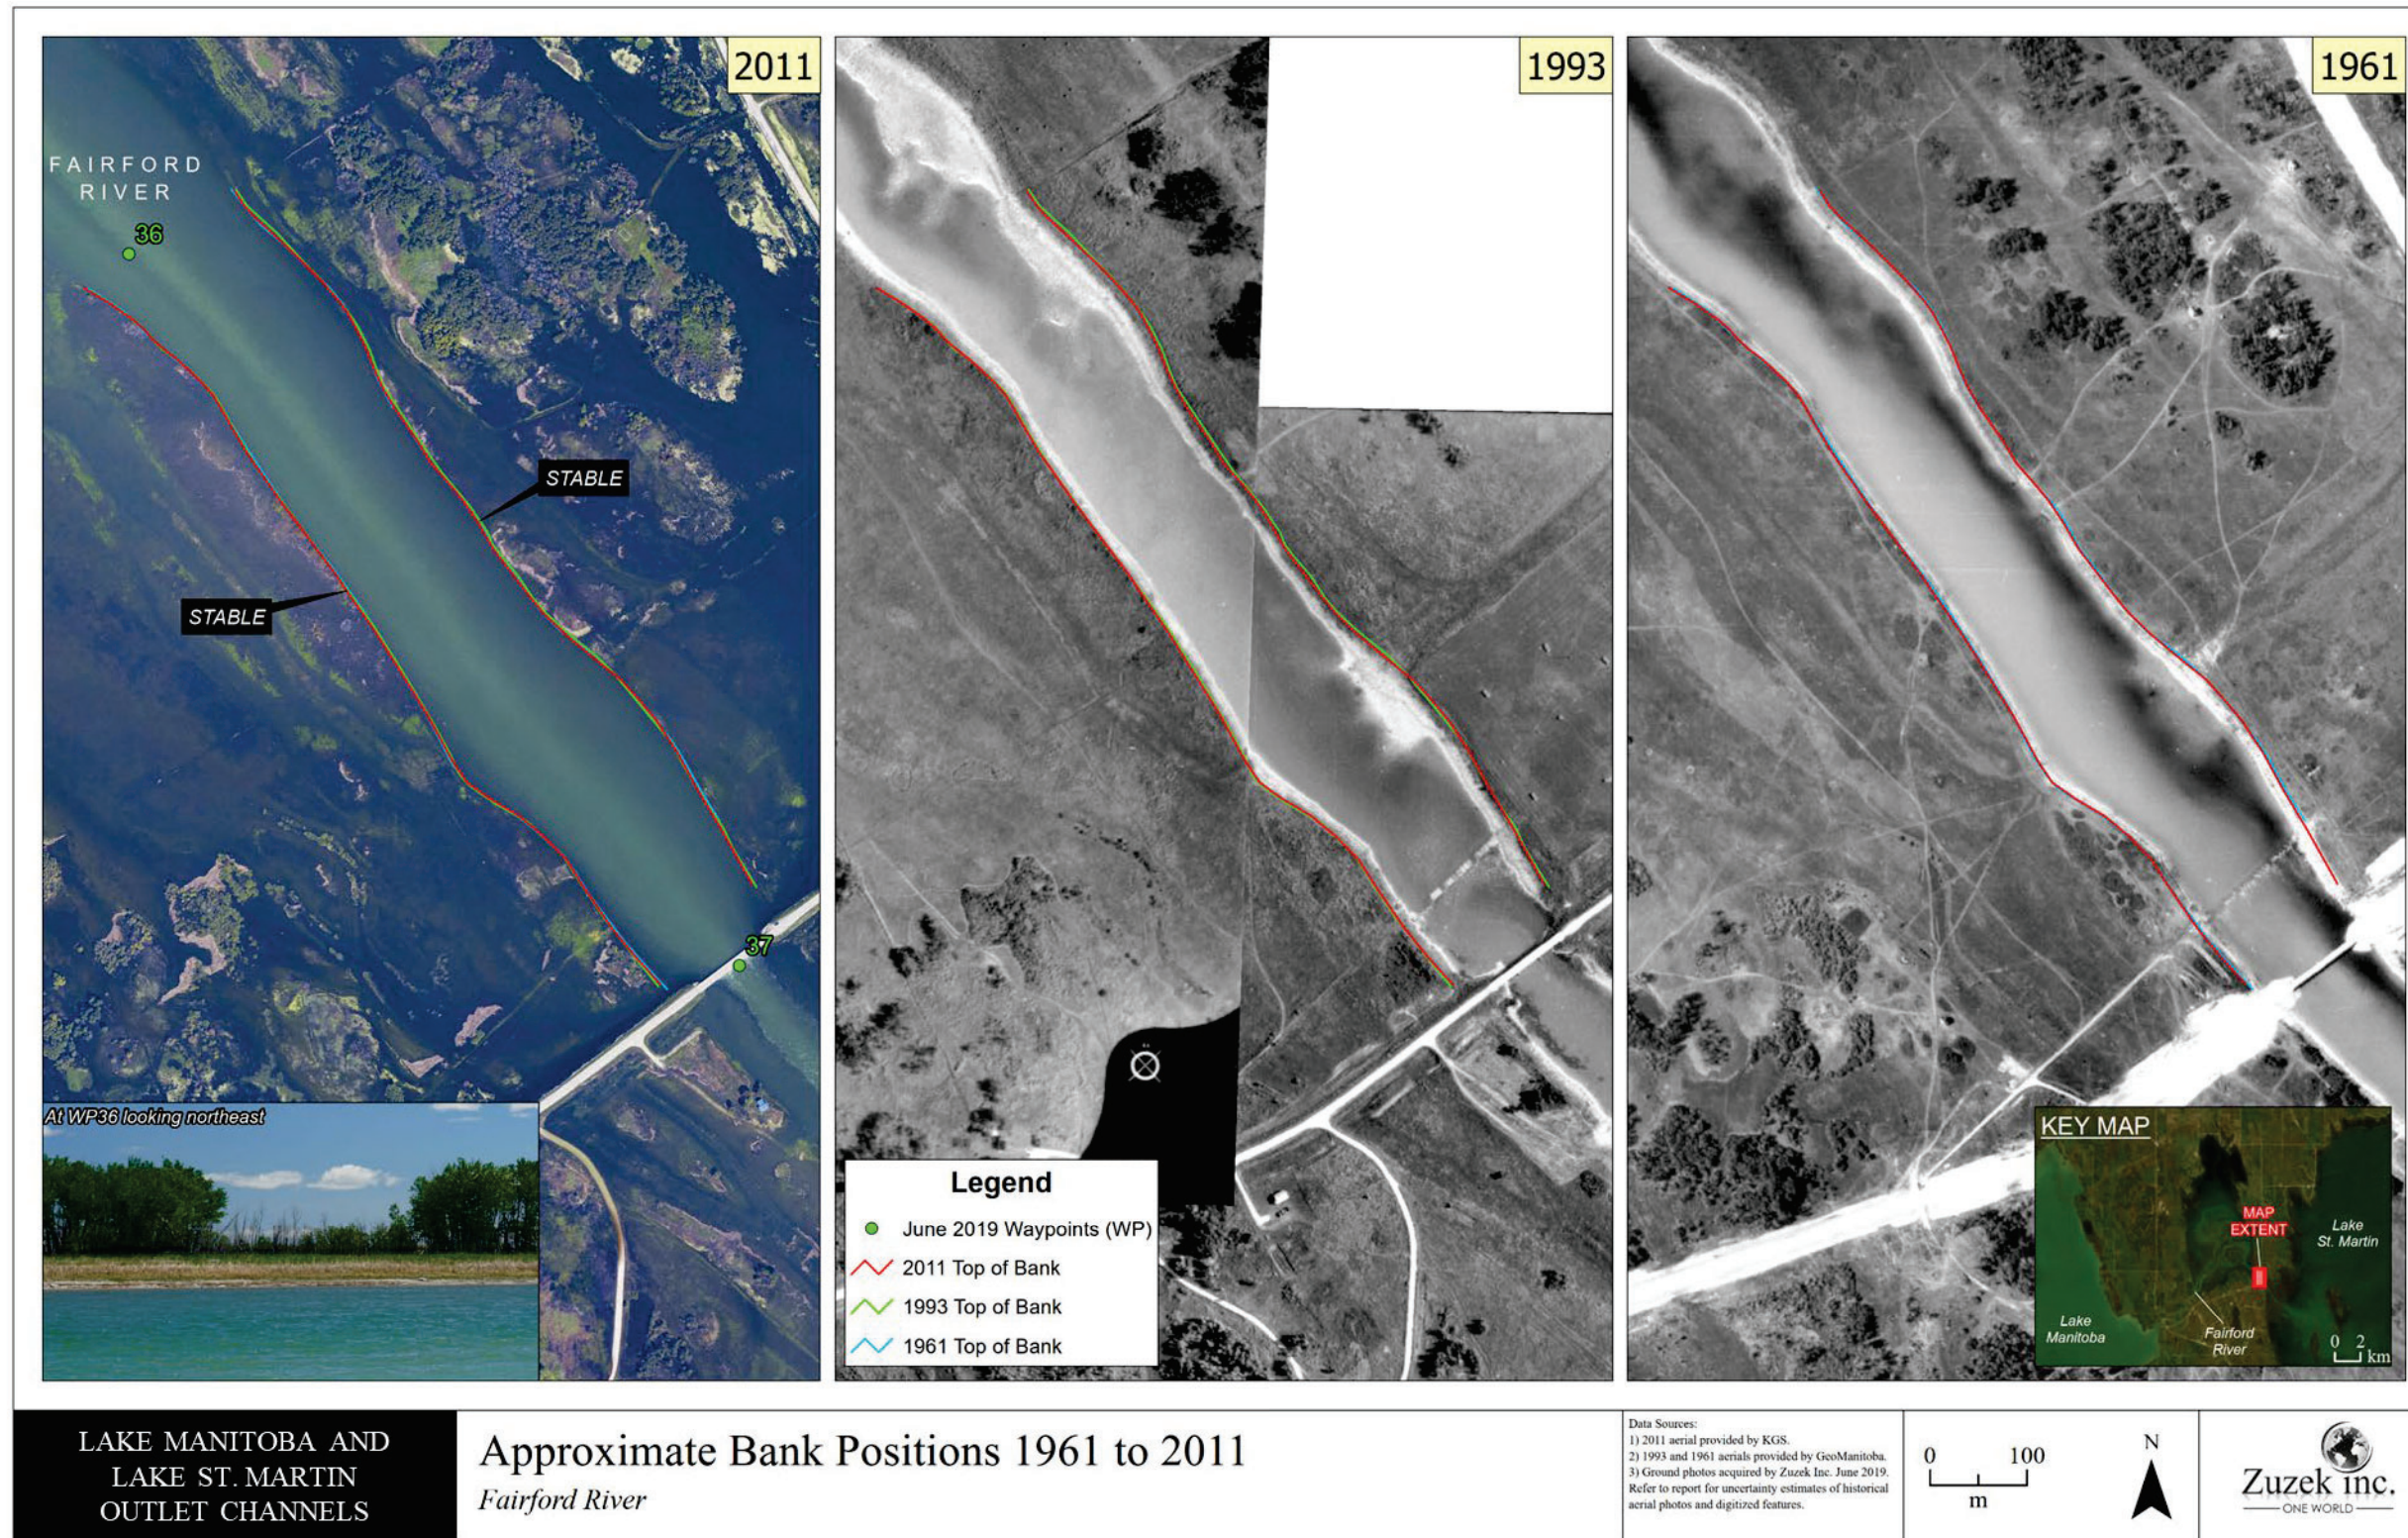
FIGURE 10: COMPARISON OF HISTORICAL POSITIONS OF RIVERBANKS AT SITE F – FR3

- **Site F – FR3** (Figure 10): The riverbanks have been stable from 1961 to 2011 at Site F, even with the extensive flooding that occurred in 2011. These findings are consistent with the site observations noted in Table 6.
- **Site G – FR6** (Figure 11): The north bank of the river has been stable for 50 years, as seen in Figure 11. The south bank has eroded 4.5 m (0.25 m/yr), but this could be attributed to the flooding in 2011. Overall, the delta tributaries have been very stable over the last 50 years.
- **Site H – FR12** (Figure 12): The Fairford River splits into two channels at Site H as it enters the delta. The 1961 to 2011 waterline comparison indicated the banks of the river have been very stable over the last 50 years.

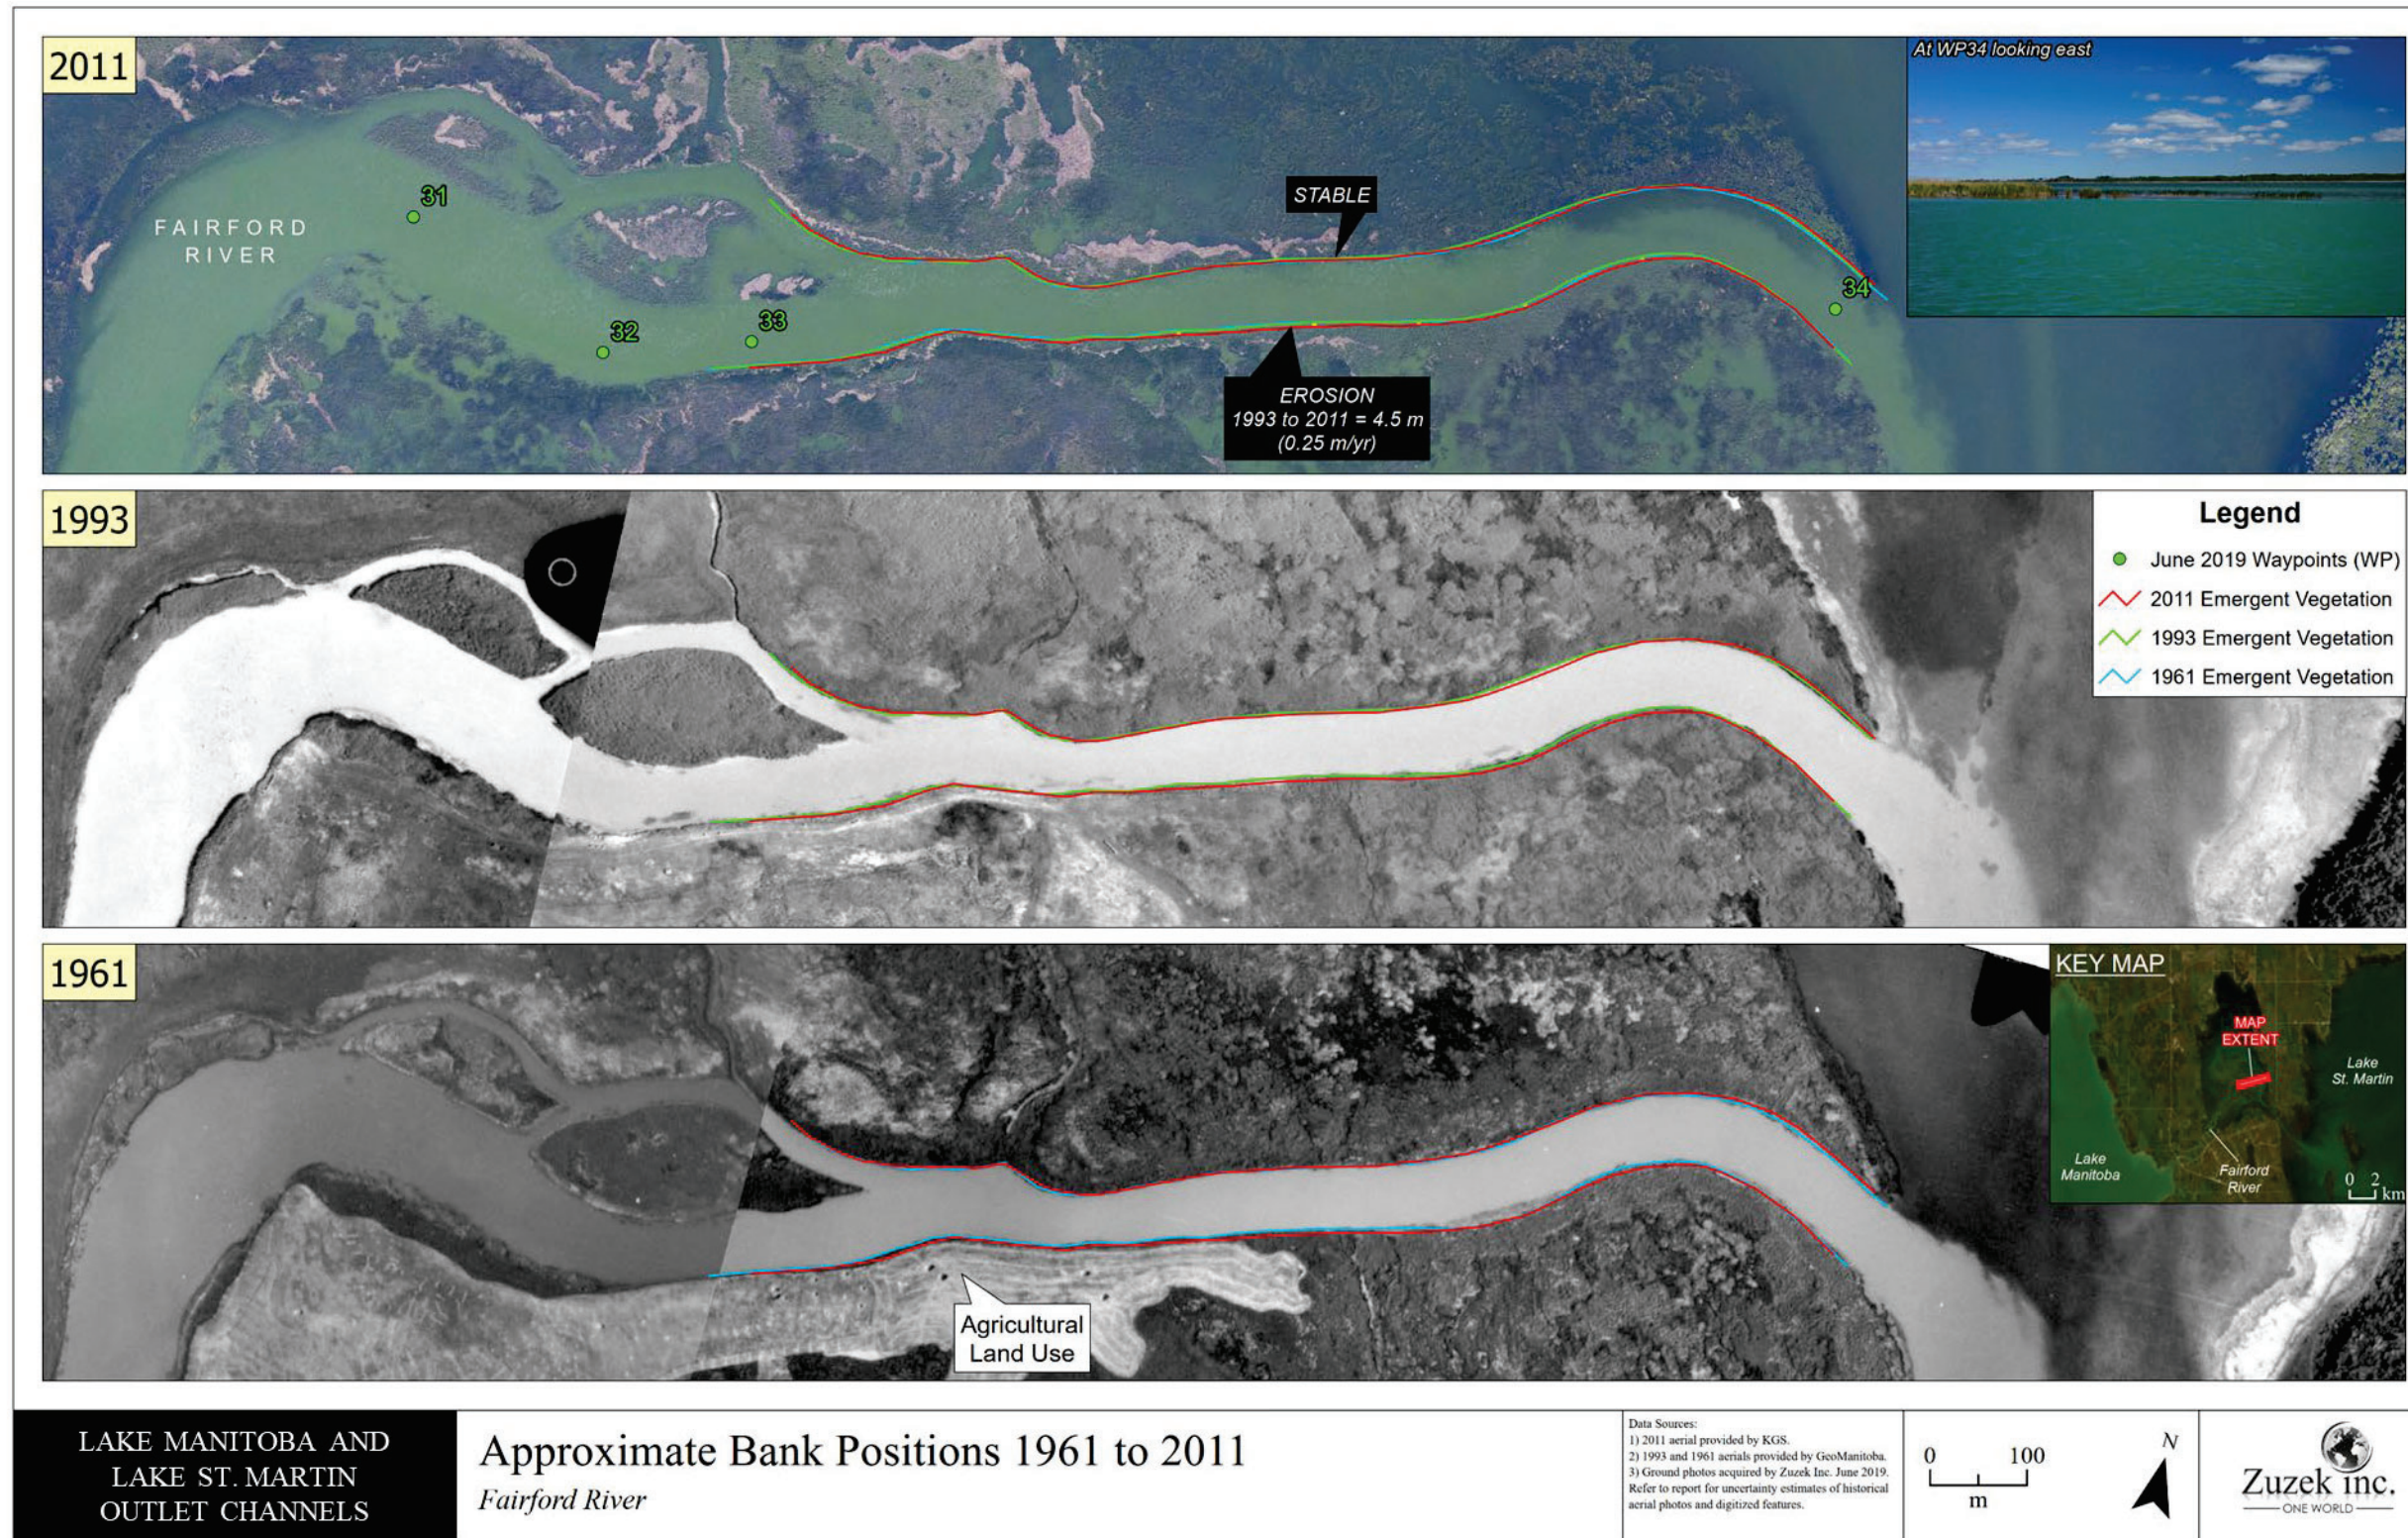
FIGURE 11: COMPARISON OF HISTORICAL POSITIONS OF RIVERBANKS AT SITE G – FR6

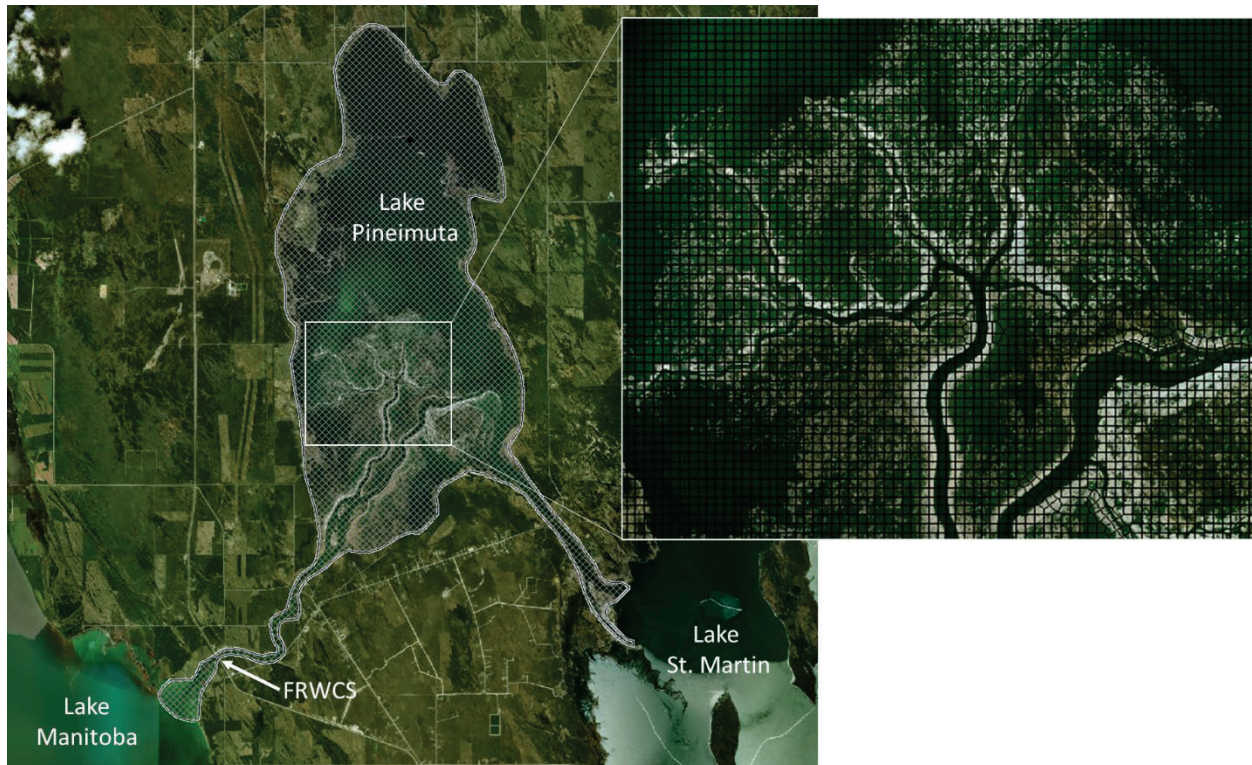
FIGURE 29: EXTENT OF MODEL ALONG FAIRFORD RIVER

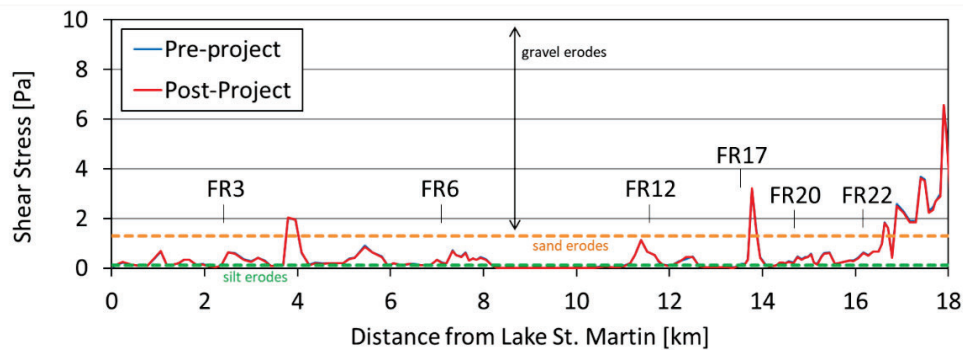
FIGURE 34: SHEAR STRESS ALONG MAIN CHANNEL OF FAIRFORD RIVER – SUMMER FLOWS AT 10TH PERCENTILE

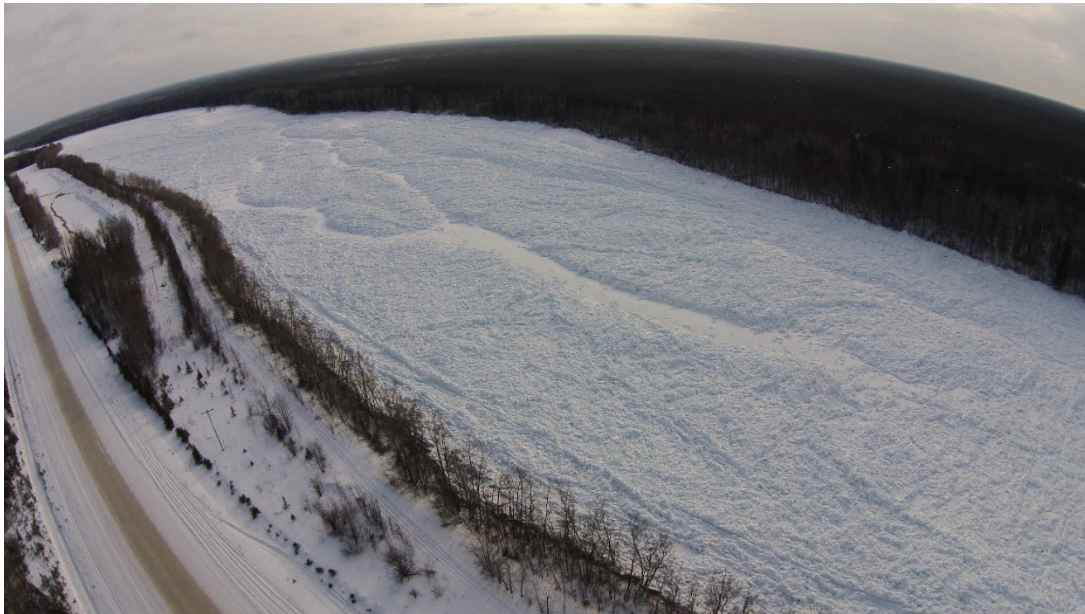
FIGURE 43: CONSOLIDATED ICE COVER ON THE LOWER DAUPHIN RIVER

Approximately 11 km from Lake Winnipeg, the river gradient increases abruptly. The fast-moving water in this reach limits the extent of border ice growth and frazil pans are transported downstream with the flow to Lake Winnipeg. A smooth, thermal ice cover grows in Lake Winnipeg early in the winter. Incoming frazil pans and slush can be swept under the lake ice cover or may juxtapose against the lake ice cover depending on the hydraulic conditions at the outlet. Typically, during high flows, the frazil pans are swept under the lake ice cover and are transported further into the lake where they are eventually deposited as velocities decline. This forms a hanging ice dam, and causes the upstream water levels to gradually increase. Eventually, the increase in water level allow incoming frazil pans to accumulate (“juxtapose”) against the lake ice cover, and the leading edge of the cover begins to progress upstream. Due to the high gradient of the lower reach, the ice cover typically experiences several “consolidation” events as it advances upstream. This refers to the collapse and mechanical thickening of the ice cover in response to the external forces of gravity and water shear which grow as the ice cover lengthens. The thickness and roughness of the consolidated cover can raise water levels by several metres (as much as 3-5 m in some areas). A photograph of a rough, consolidated ice cover on the lower Dauphin River is shown in Figure 43.

Once an ice cover forms, open water leads typically develop as the flowing water melts and erodes the ice along the preferential flow paths. Evidence of this process is shown in Figure 43, where an open lead developed in the centre of the river and subsequently formed a smooth thermal ice cover. As air temperatures rise in the spring, open water leads form and grow in size as the ice cover decays and melts.

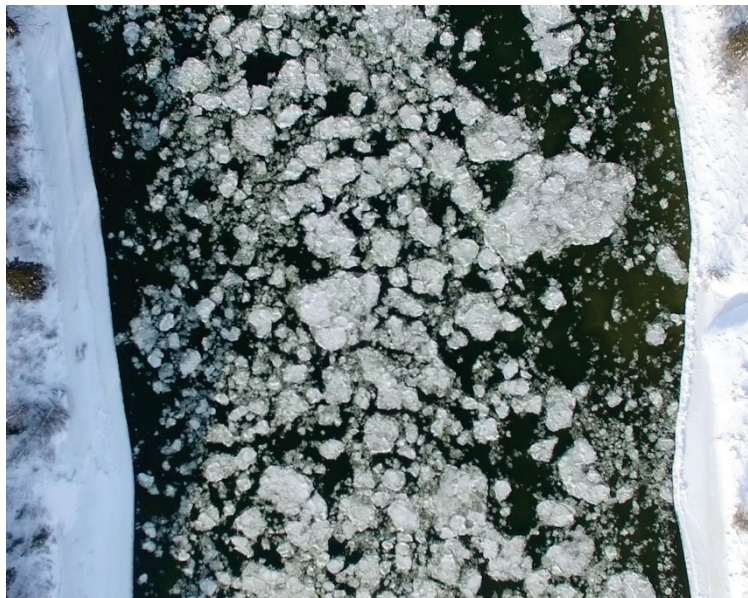
FIGURE 44: LARGE ICE RAFTS IN THE UPPER DAUPHIN RIVER

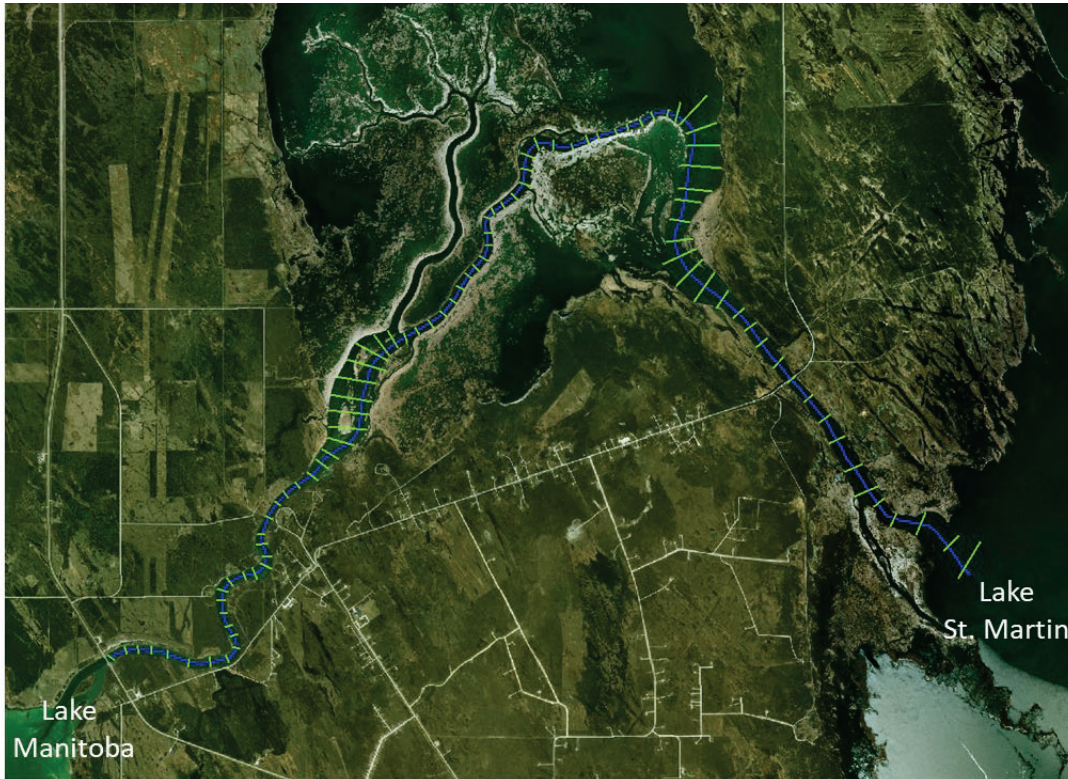
FIGURE 53: CROSS SECTIONS IN THE VARY-ICE MODEL OF THE FAIRFORD RIVER
