MANITOBA INFRASTRUCTURE

Lake Manitoba and Lake St. Martin Outlet Channels Analysis of Physical Impacts to Rivers within the Hydraulic System

Revision:
Final / Rev 0

KGS Group Project:
18-0300-005

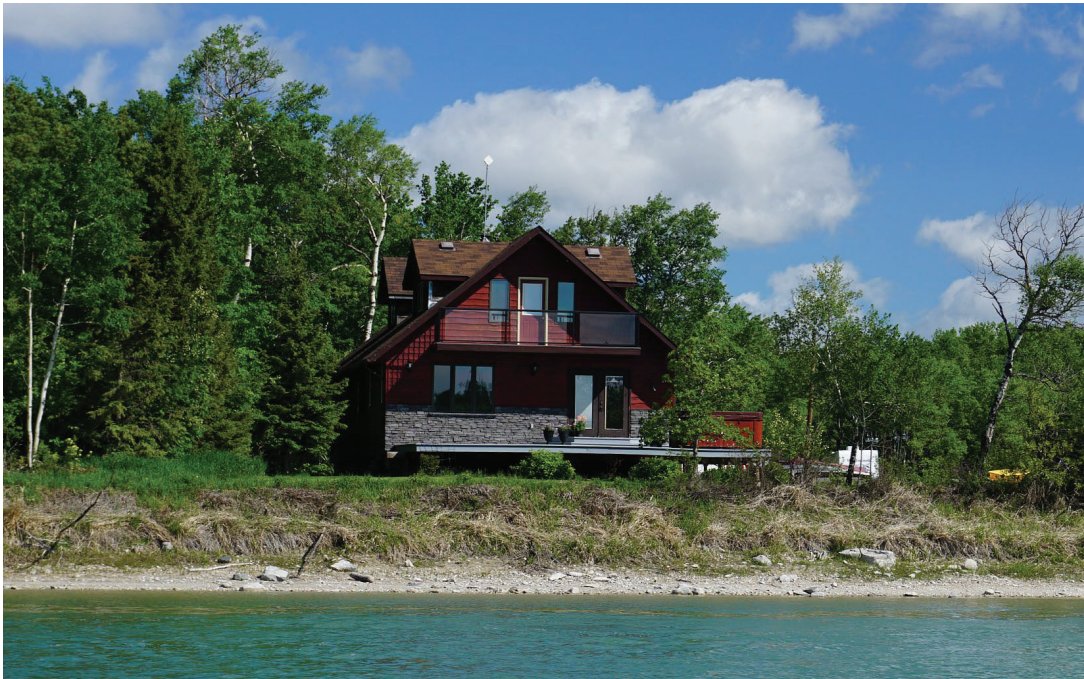
**FIGURE 56: ERODING RIVERBANK IN FRONT OF HOME (DOWNSTREAM
OF SITE J), JUNE 11, 2019**
