# Rook I Project

Annex IX: Heritage Resources Impact Assessment and Cover  
Letter

**Subject:** Heritage Resources Impact Assessment Update: NexGen Energy Ltd. Rook I Project, Patterson Lake

**NexGen Energy Ltd.  
Rook I  
Heritage Resources Impact Assessment  
Permit No. 18-068**

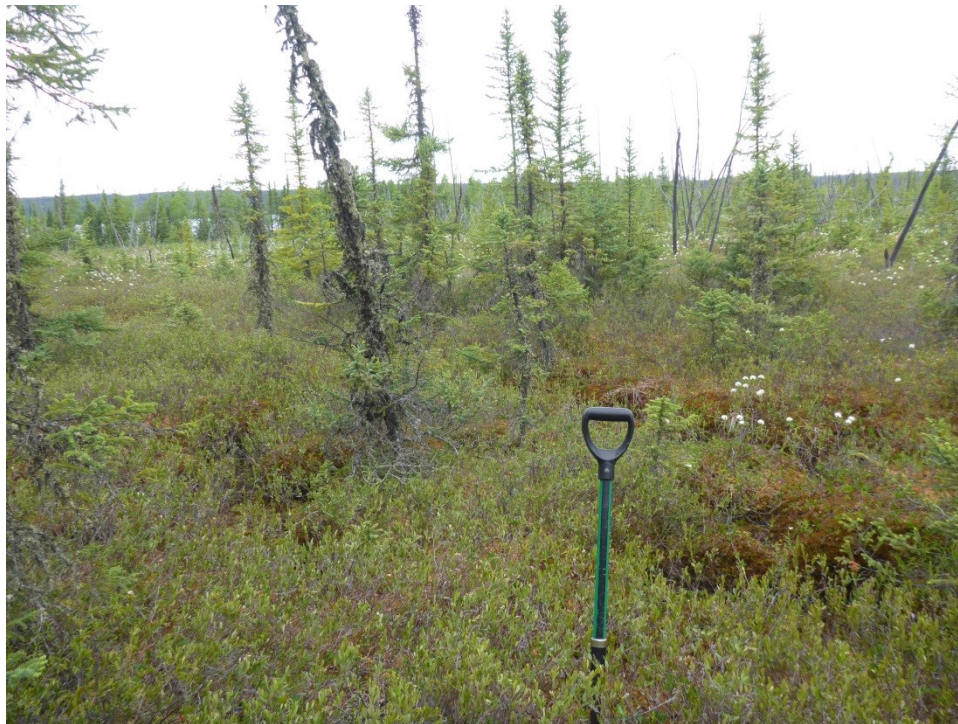
Photo 1. View north from PK04 of low-lying boggy terrain (June 19<sup>th</sup>, 2018)

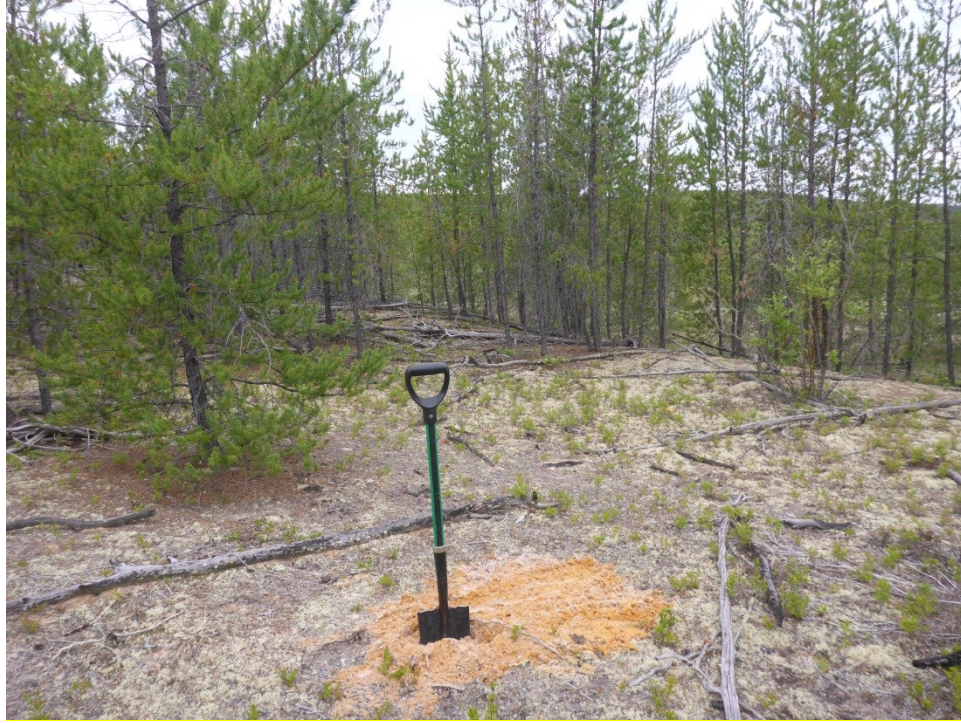
Photo 2. View west from shovel probe K031 of well-drained, level terrain in Area 1 (June 19<sup>th</sup>, 2018).

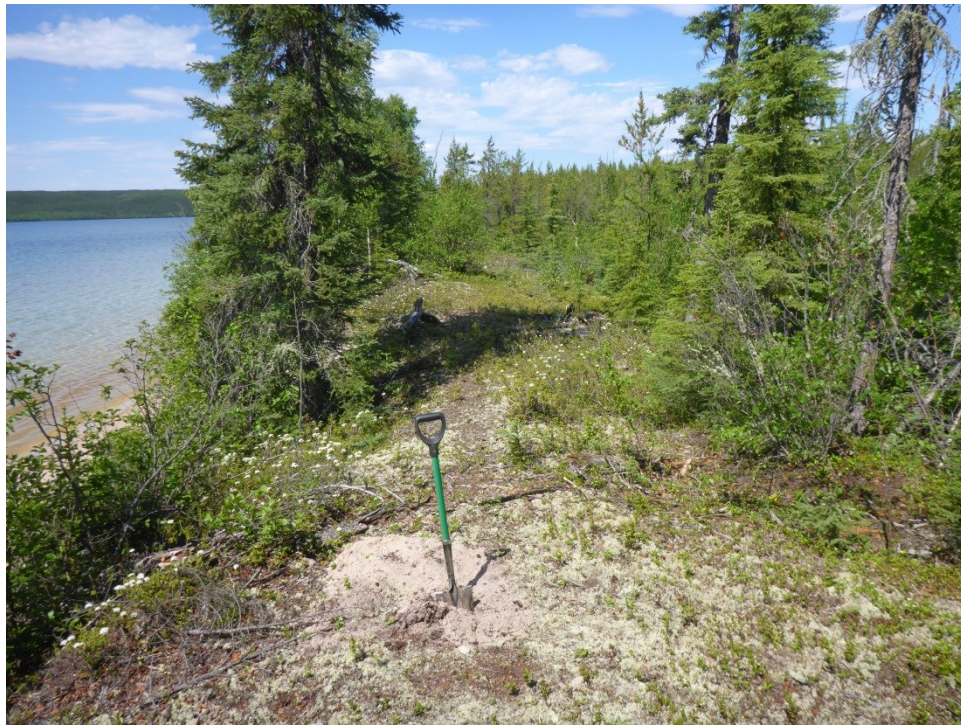
Photo 3. View north from shovel probe K019 along well-drained lake rampart along Patterson Lake (June 19<sup>th</sup>, 2018).

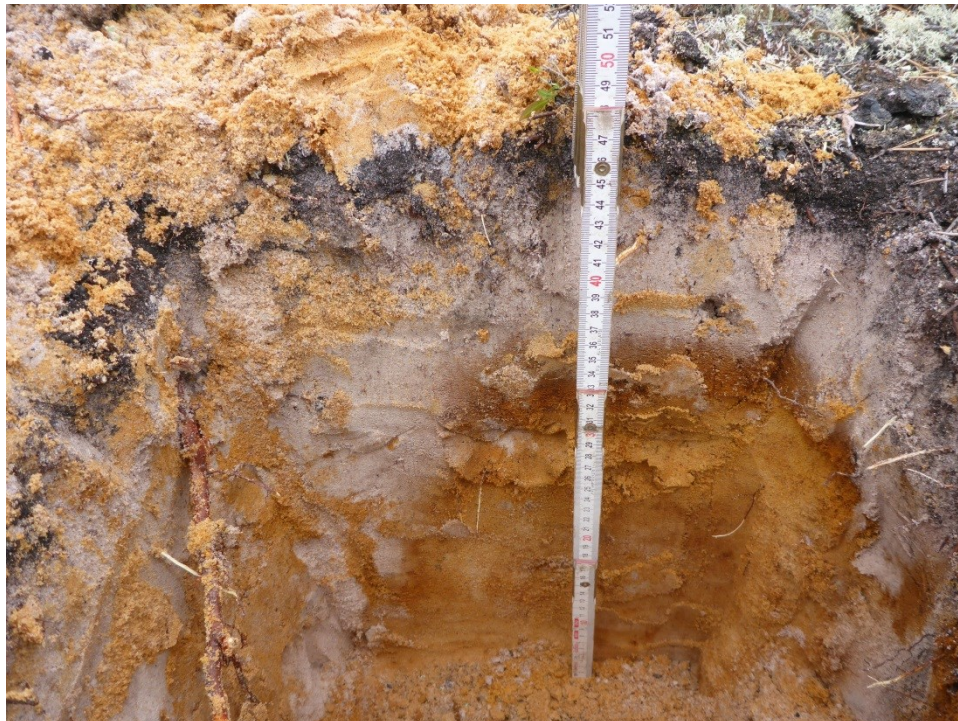
Shovel probes were judgmentally excavated in areas considered to have the greatest heritage potential (i.e., well-drained and level areas suitable for a camp site or activity area). Shovel probe stratigraphy was consistent across the area and consisted of a sand matrix as typified by shovel probe K031 (Photo 4; Figure 4):

- 0 cm to 4 cm organic duff;
- 4 cm to 14/30 cm tan sand; and
- 14/30 cm to 50 cm orange sand.

Photo 4. Stratigraphy of shovel probe K031 (July 19<sup>th</sup>, 2018).

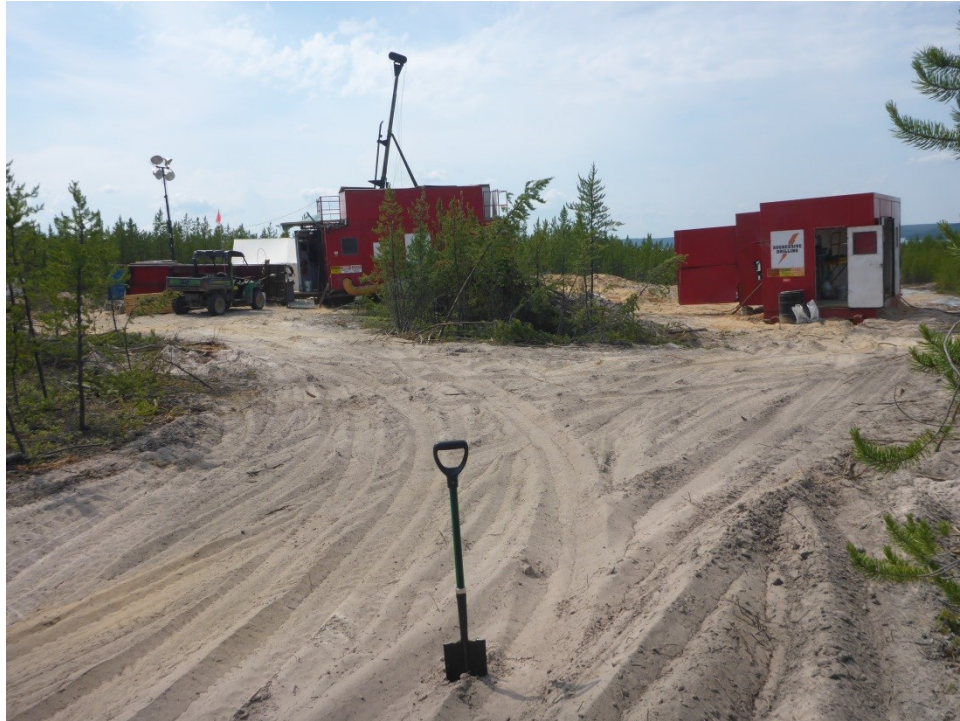
Large portions of the project area were impacted by previous exploration infrastructure, including trails, pump stations, a helicopter pad, wood waste storage, and drill areas. It appeared that levelling activities had occurred and that fill might have been brought in to build up trails through low-lying areas. Many of the areas that contained drilling equipment were located on higher, well-drained areas (Photo 5; Figure 4).

Photo 5. View southwest from PK40 of a high heritage potential area subject to disturbance from drilling and trail developments (June 22<sup>nd</sup>, 2018).

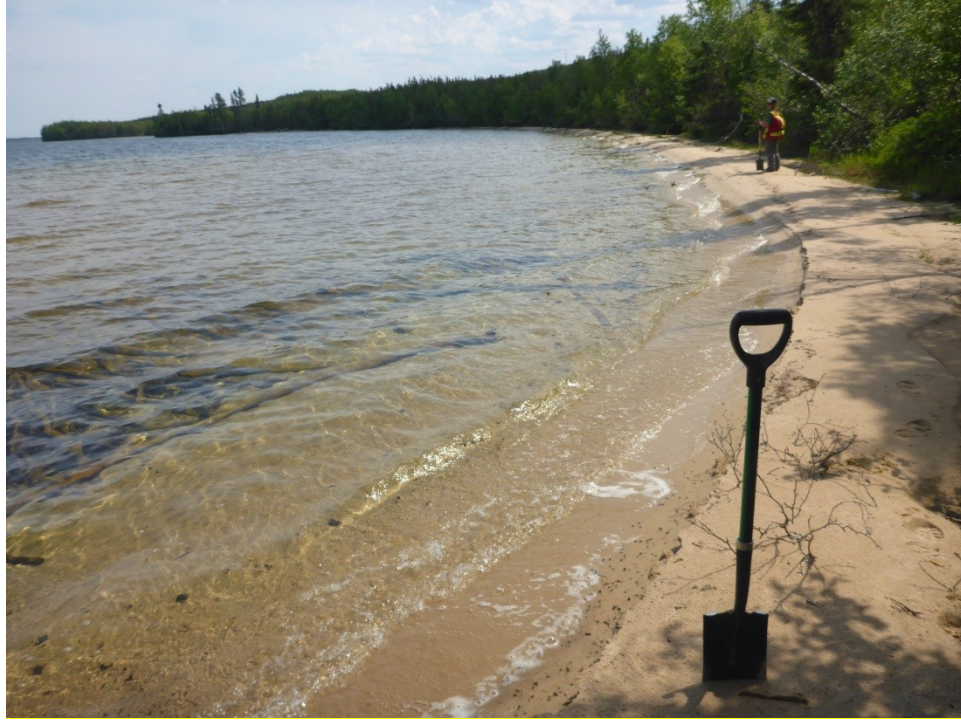
Surface visibility was good to excellent throughout the project area. Surface surveys were conducted along the beach and cut banks (Photo 6; Figure 4). No surface features or cultural materials were discovered in conflict with Area 1.

Photo 6. View east from PK25 of the beach along Patterson Lake in Area 1 (June 21<sup>st</sup>, 2018).

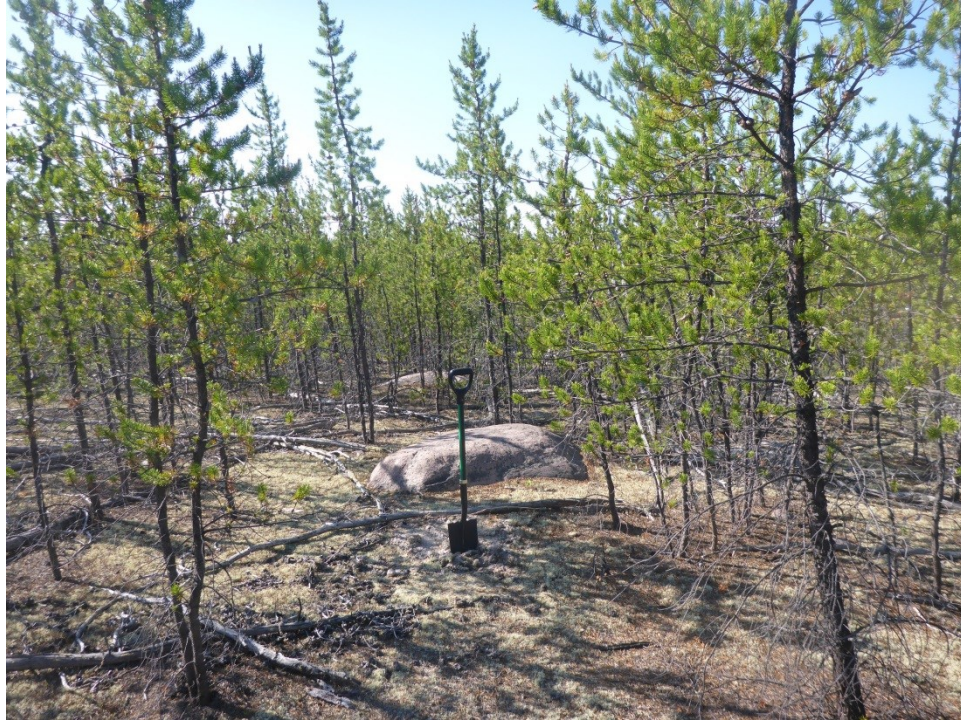
Photo 7. View south from shovel probe K039 of terrain in Area 2 (June 20<sup>th</sup>, 2018).

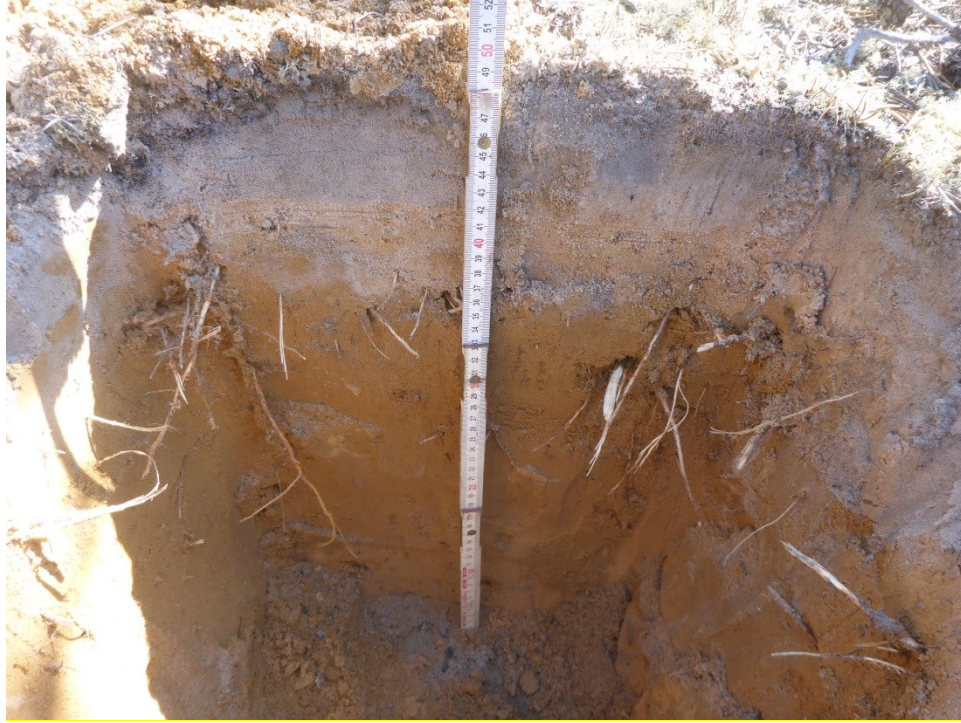
Shovel probes were judgmentally excavated in areas considered to have the greatest heritage potential (i.e., well-drained and level areas suitable for a camp site or activity area). In total, 75 shovel probes were excavated in Area 2. Shovel probe stratigraphy was consistent across the area and comprised a sand matrix as typified by shovel probe K040 (Photo 8; Figure 5):

- 0 cm to 15 cm tan sand; and
- 15 cm to 50 cm orange sand with some cobbles at the bottom.

Photo 8. Stratigraphy of shovel probe K040 (June 20<sup>th</sup>, 2018).

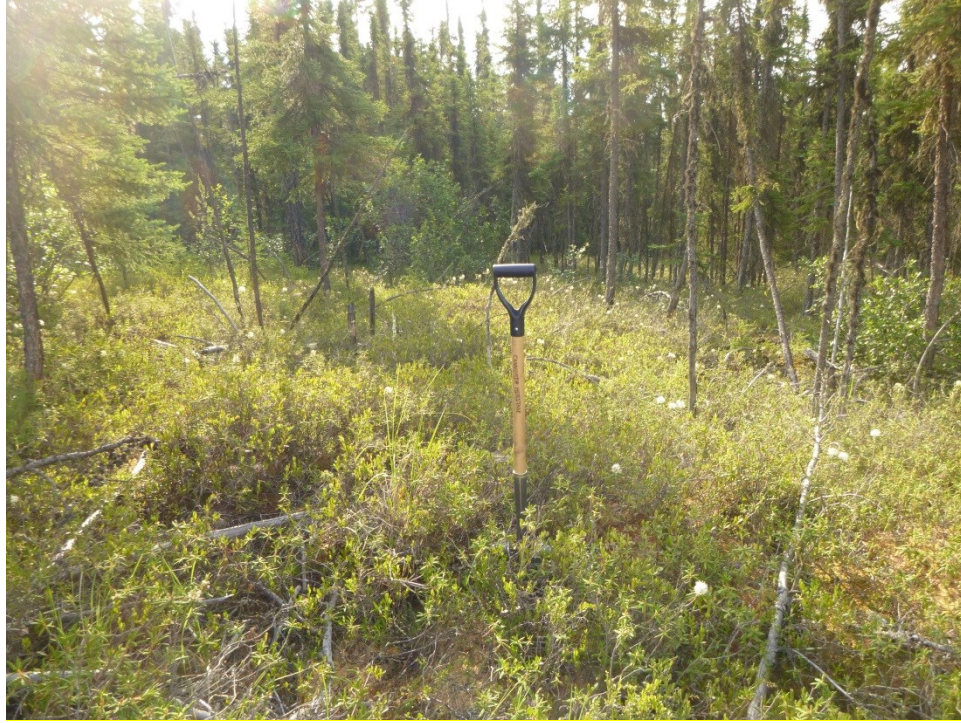
Photo 9. View east from PJ 40 of low-lying, boggy terrain in Area 3 (June 22<sup>nd</sup>, 2018).

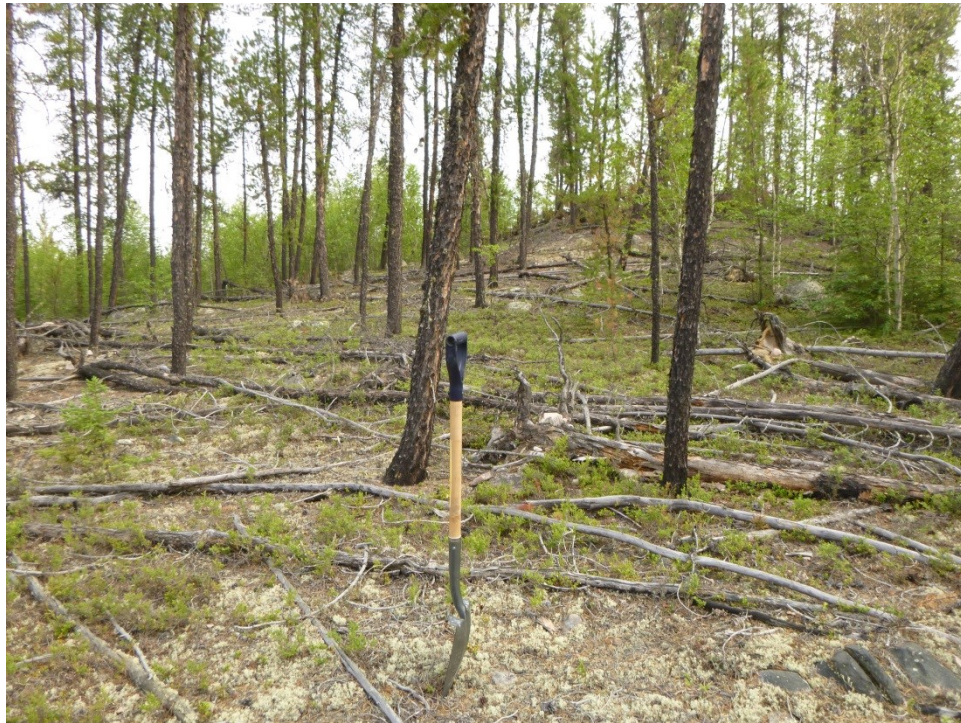
Photo 10. View north from shovel probe J111 along a small drumlin in Area 3 (June 22<sup>nd</sup>, 2018).

Area 3 was assessed using a combination of pedestrian reconnaissance, post-impact survey, and the excavation of 20 shovel probes. Shovel probes were judgmentally excavated in areas considered to have the greatest heritage potential (i.e., well-drained and level areas suitable for a camp site or activity area). In general, the terrain in Area 3 would be categorized as moderate to poor heritage potential. The highest heritage potential in Area 3 consisted of a small drumlin feature (Photo 10; Figure 5). Shovel probe stratigraphy along the drumlins consisted of a sand matrix and is summarized below:

- 0 cm to 5 cm tan sand; and
- 5 cm to 15 cm tan sand with large cobbles.

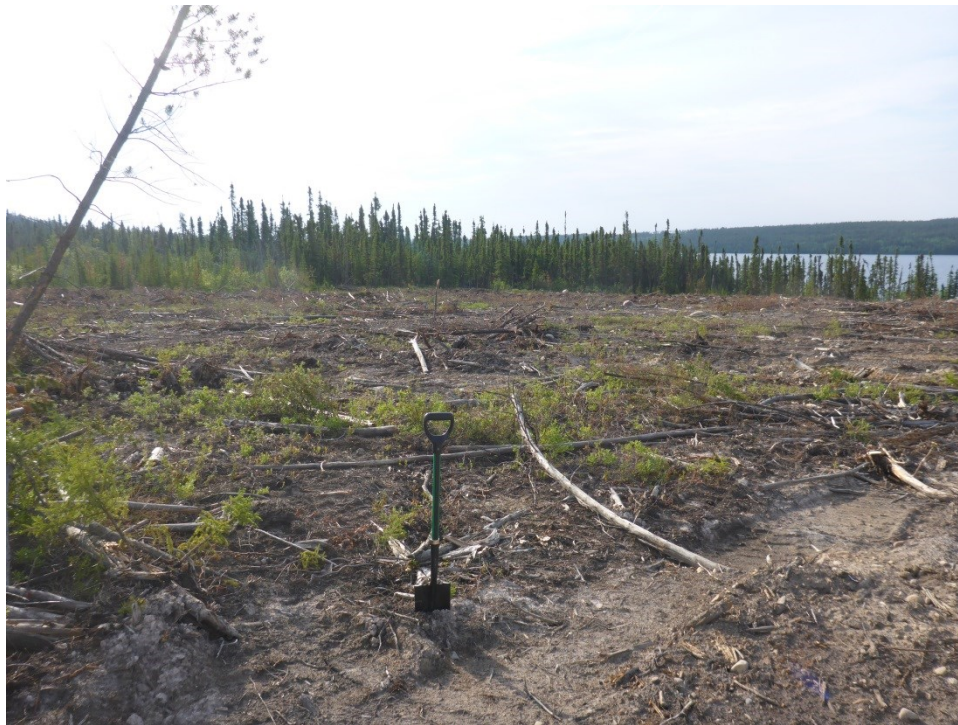
Large portions of Area 3 had been cleared, and post-impact surveys were conducted in these areas (Photo 11; Figure 5). Surface visibility was moderate throughout the project area. No surface features or cultural materials were identified in conflict with Area 3.

Photo 11. View east from PK30 of the proposed camp area that has been disturbed by clearing activities (June 22<sup>nd</sup>, 2018).
