# Rook I Project

Annex IV.3: Geomorphology Characterization Report

# GEOMORPHOLOGY CHARACTERIZATION REPORT FOR THE ROOK I PROJECT

**WSP Canada Inc.**

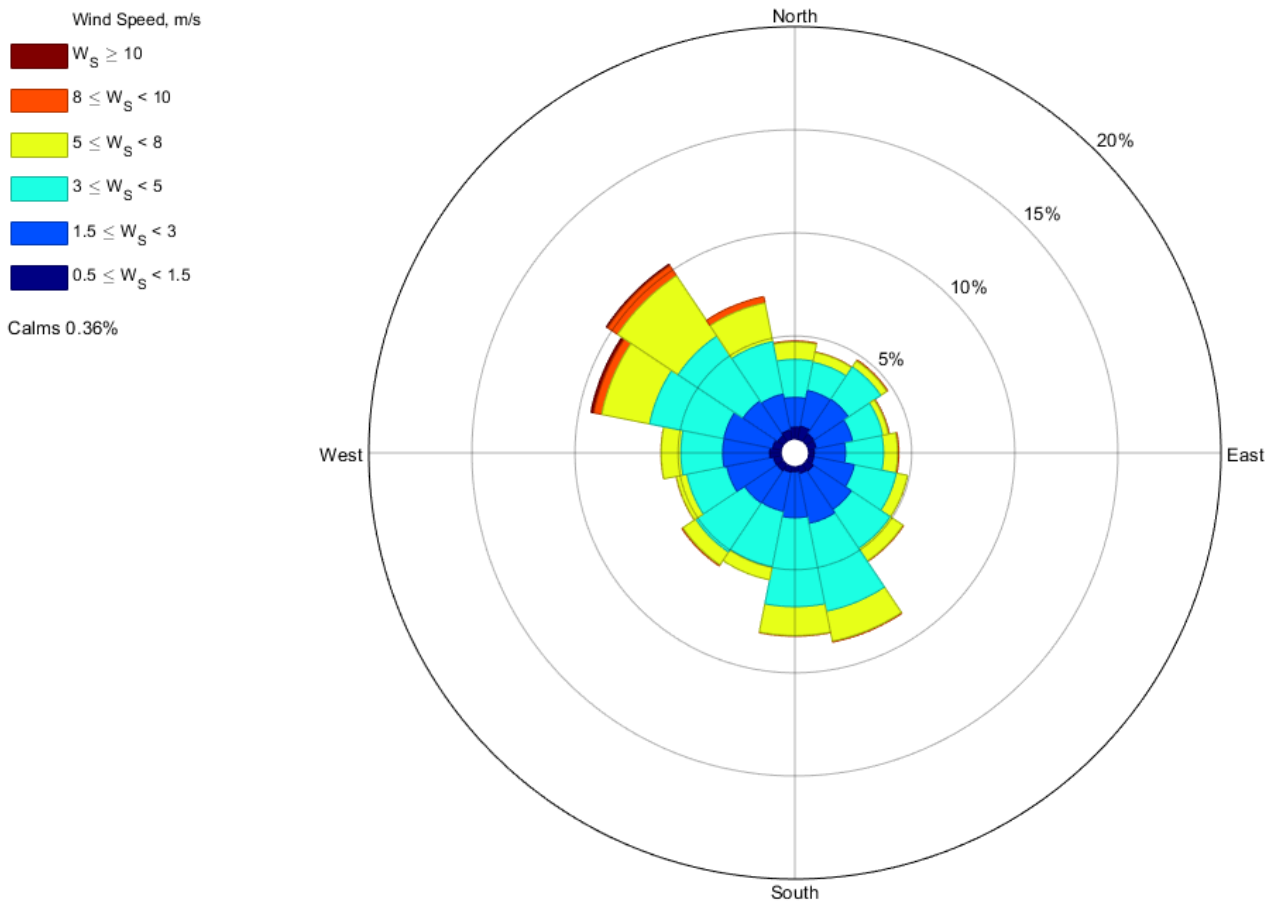
**Figure 5: Rook I Meteorological Station Wind Rose for the Open-Water Period, May 2016 to October 2020**

Figure 5 presents the directions and the wind class frequency distribution measured during the period with available climate data. Prevailing winds were from the northwest and west-northwest as well as the south-southeast and south directions (Figure 5). Higher winds exceeding 5 m/s occurred 25% of the time and were most frequently from the west-northwest to north-northwest. The available wind data were sufficient to characterize the general range of wind speed and directions for the site.

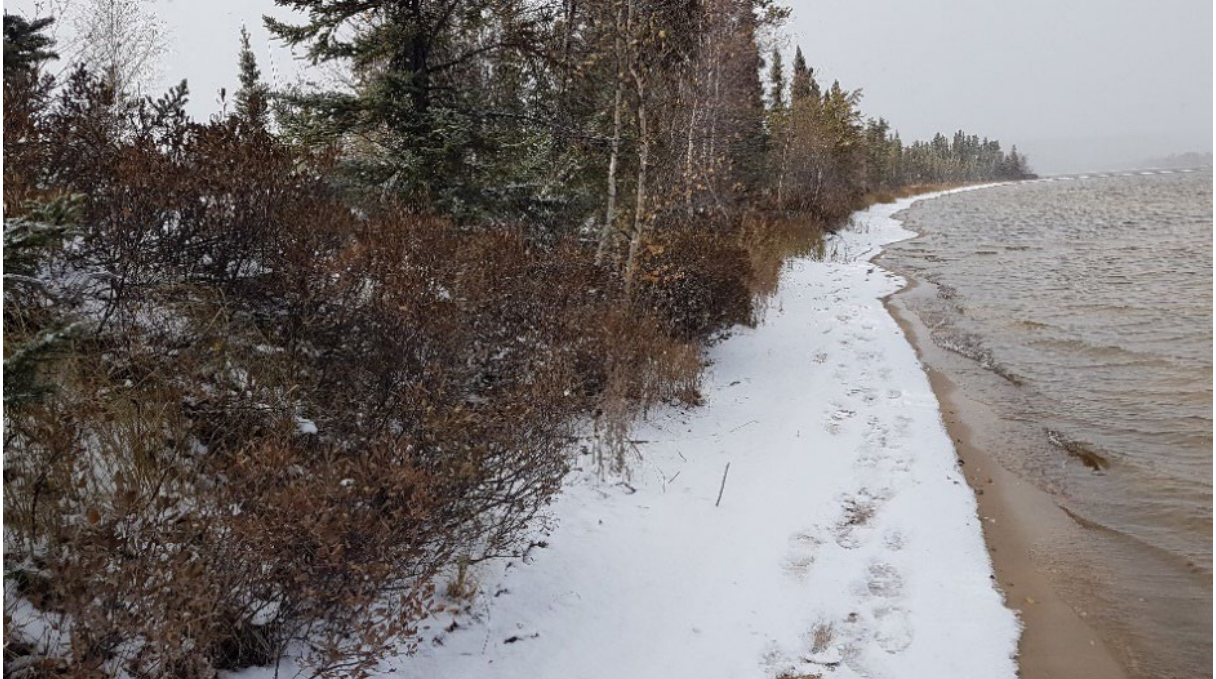
**Figure 8: Typical Photograph of the Shoreline at Site 1**

Site Number	Location	Site Description
Site 1	Southern shoreline of the North Arm at the narrows (Figure 8)	Site 1 is located along a sandy spit-like shoreline between the western and eastern basins of the North Arm. The shoreline is composed of a sand beach varying in width from approximately 1.5 m on the lakeward end of the spit, widening to 6 m shoreward. Elevated shoreline berms of sediments and organics were observed along the shoreline and were interpreted to be ice-thrust features. The height of the berms was measured at approximately 2 m above the top of bank. The bank height was measured at approximately 0.5 m to 0.7 m above the water level (498.510 masl) at the time of visit on 29 September 2018. The shoreline banks were steep (i.e., >45°) along the entire investigated shoreline section.
Site 2	Northeast shoreline of the South Arm (Figure 9)	Site 2 shoreline is composed of a mix of large cobble and boulder materials overlain with organic soils and a forest with mainly black spruce. Elevated shoreline berms were not observed at this location. The bank height was measured at approximately 0.5 m above the water level (498.510 masl) at the time of visit on 29 September 2018. The shoreline banks have a gentle slope (i.e., <25°) along the investigated shoreline section.

Note: Universal Transverse Mercator 12V 603680 E 63943657 N facing northwest.

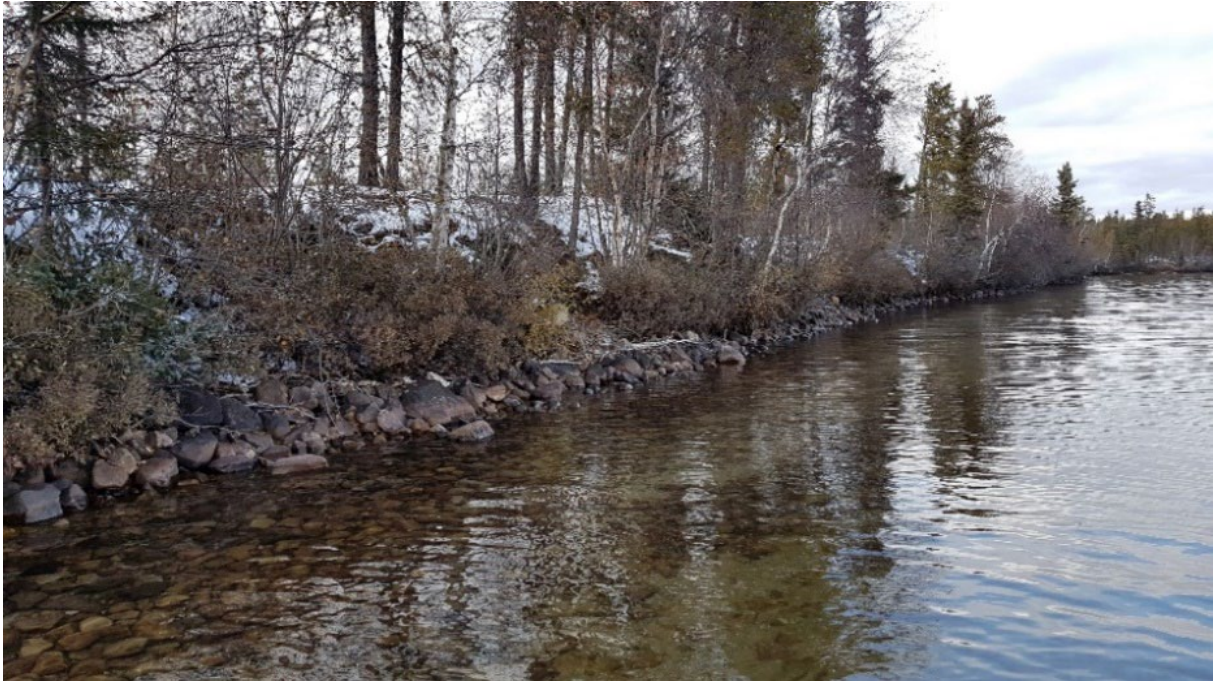
**Figure 9: Typical Photograph of the Shoreline at Site 2**

Note: Universal Transverse Mercator 12V 597619 E 6389251 N facing northwest.

Site 2 was classed as having a Moderate erosion susceptibility. Site 2 is located near the active hydrometric station on Patterson Lake, CR-WB-MS-02, and is also near the existing exploration camp. The fetch length at Site 2 is approximately 0.9 km. The shores were armoured with large cobbles and boulders, and the banks were interpreted as stable (i.e., no erosion signs). The shoreline banks are covered by mature pine trees. No signs of other shoreline processes were observed.

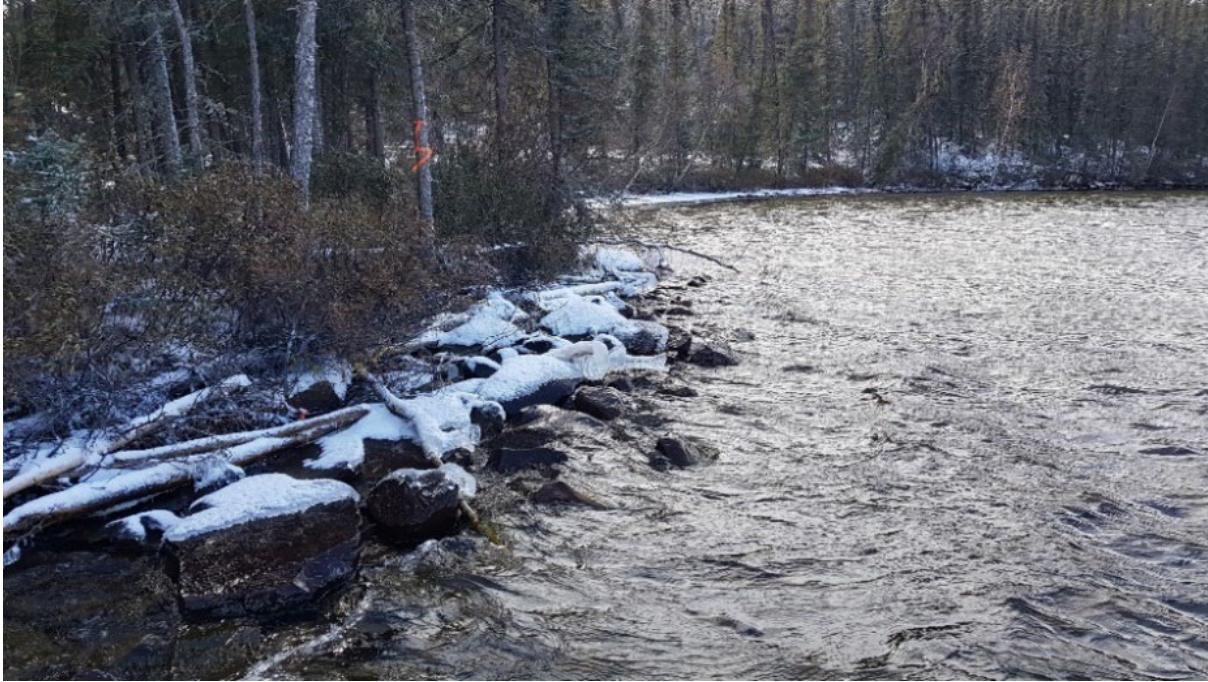
**Figure 10: Typical Photograph of the Shoreline at Site 3**

Site 3	Western shoreline of the South Arm (Figure 10)	Site 3 shoreline is composed of a mix of cobble and boulder materials overlain with organic soils and a forest with mainly conifers. Elevated shoreline berms were observed and measured to be approximately 3 m above the water level at the time of visit. These are interpreted to be ice-thrust features. The bank height was measured at approximately 0.5 m to 1.0 m above the water level (498.571 masl) on 1 October 2018. The shoreline banks are steep (i.e., >45°) along the investigated shoreline section.

Note: Universal Transverse Mercator 12V 604460 E 6394250 N facing east.

Site 3 was classed as having a High erosion susceptibility. Site 3 is located on the western shoreline of the Patterson Lake – South Arm near the site of a former hydrometric station that was used for the monitoring of lake water levels. The fetch length at Site 3 is approximately 8 km. At this location, a large ice-thrust berm, approximately 3 m high, was interpreted from observations of mounded sediment and organic material along the shoreline. The berm forms the edge of the lake. Bank erosion and bank failures were also observed along this section of shoreline. The main shoreline processes at this location were attributed to thermal erosion (i.e., ice-push berms) where lake ice is the dominant factor. The bank materials were observed to be large cobble and boulders.

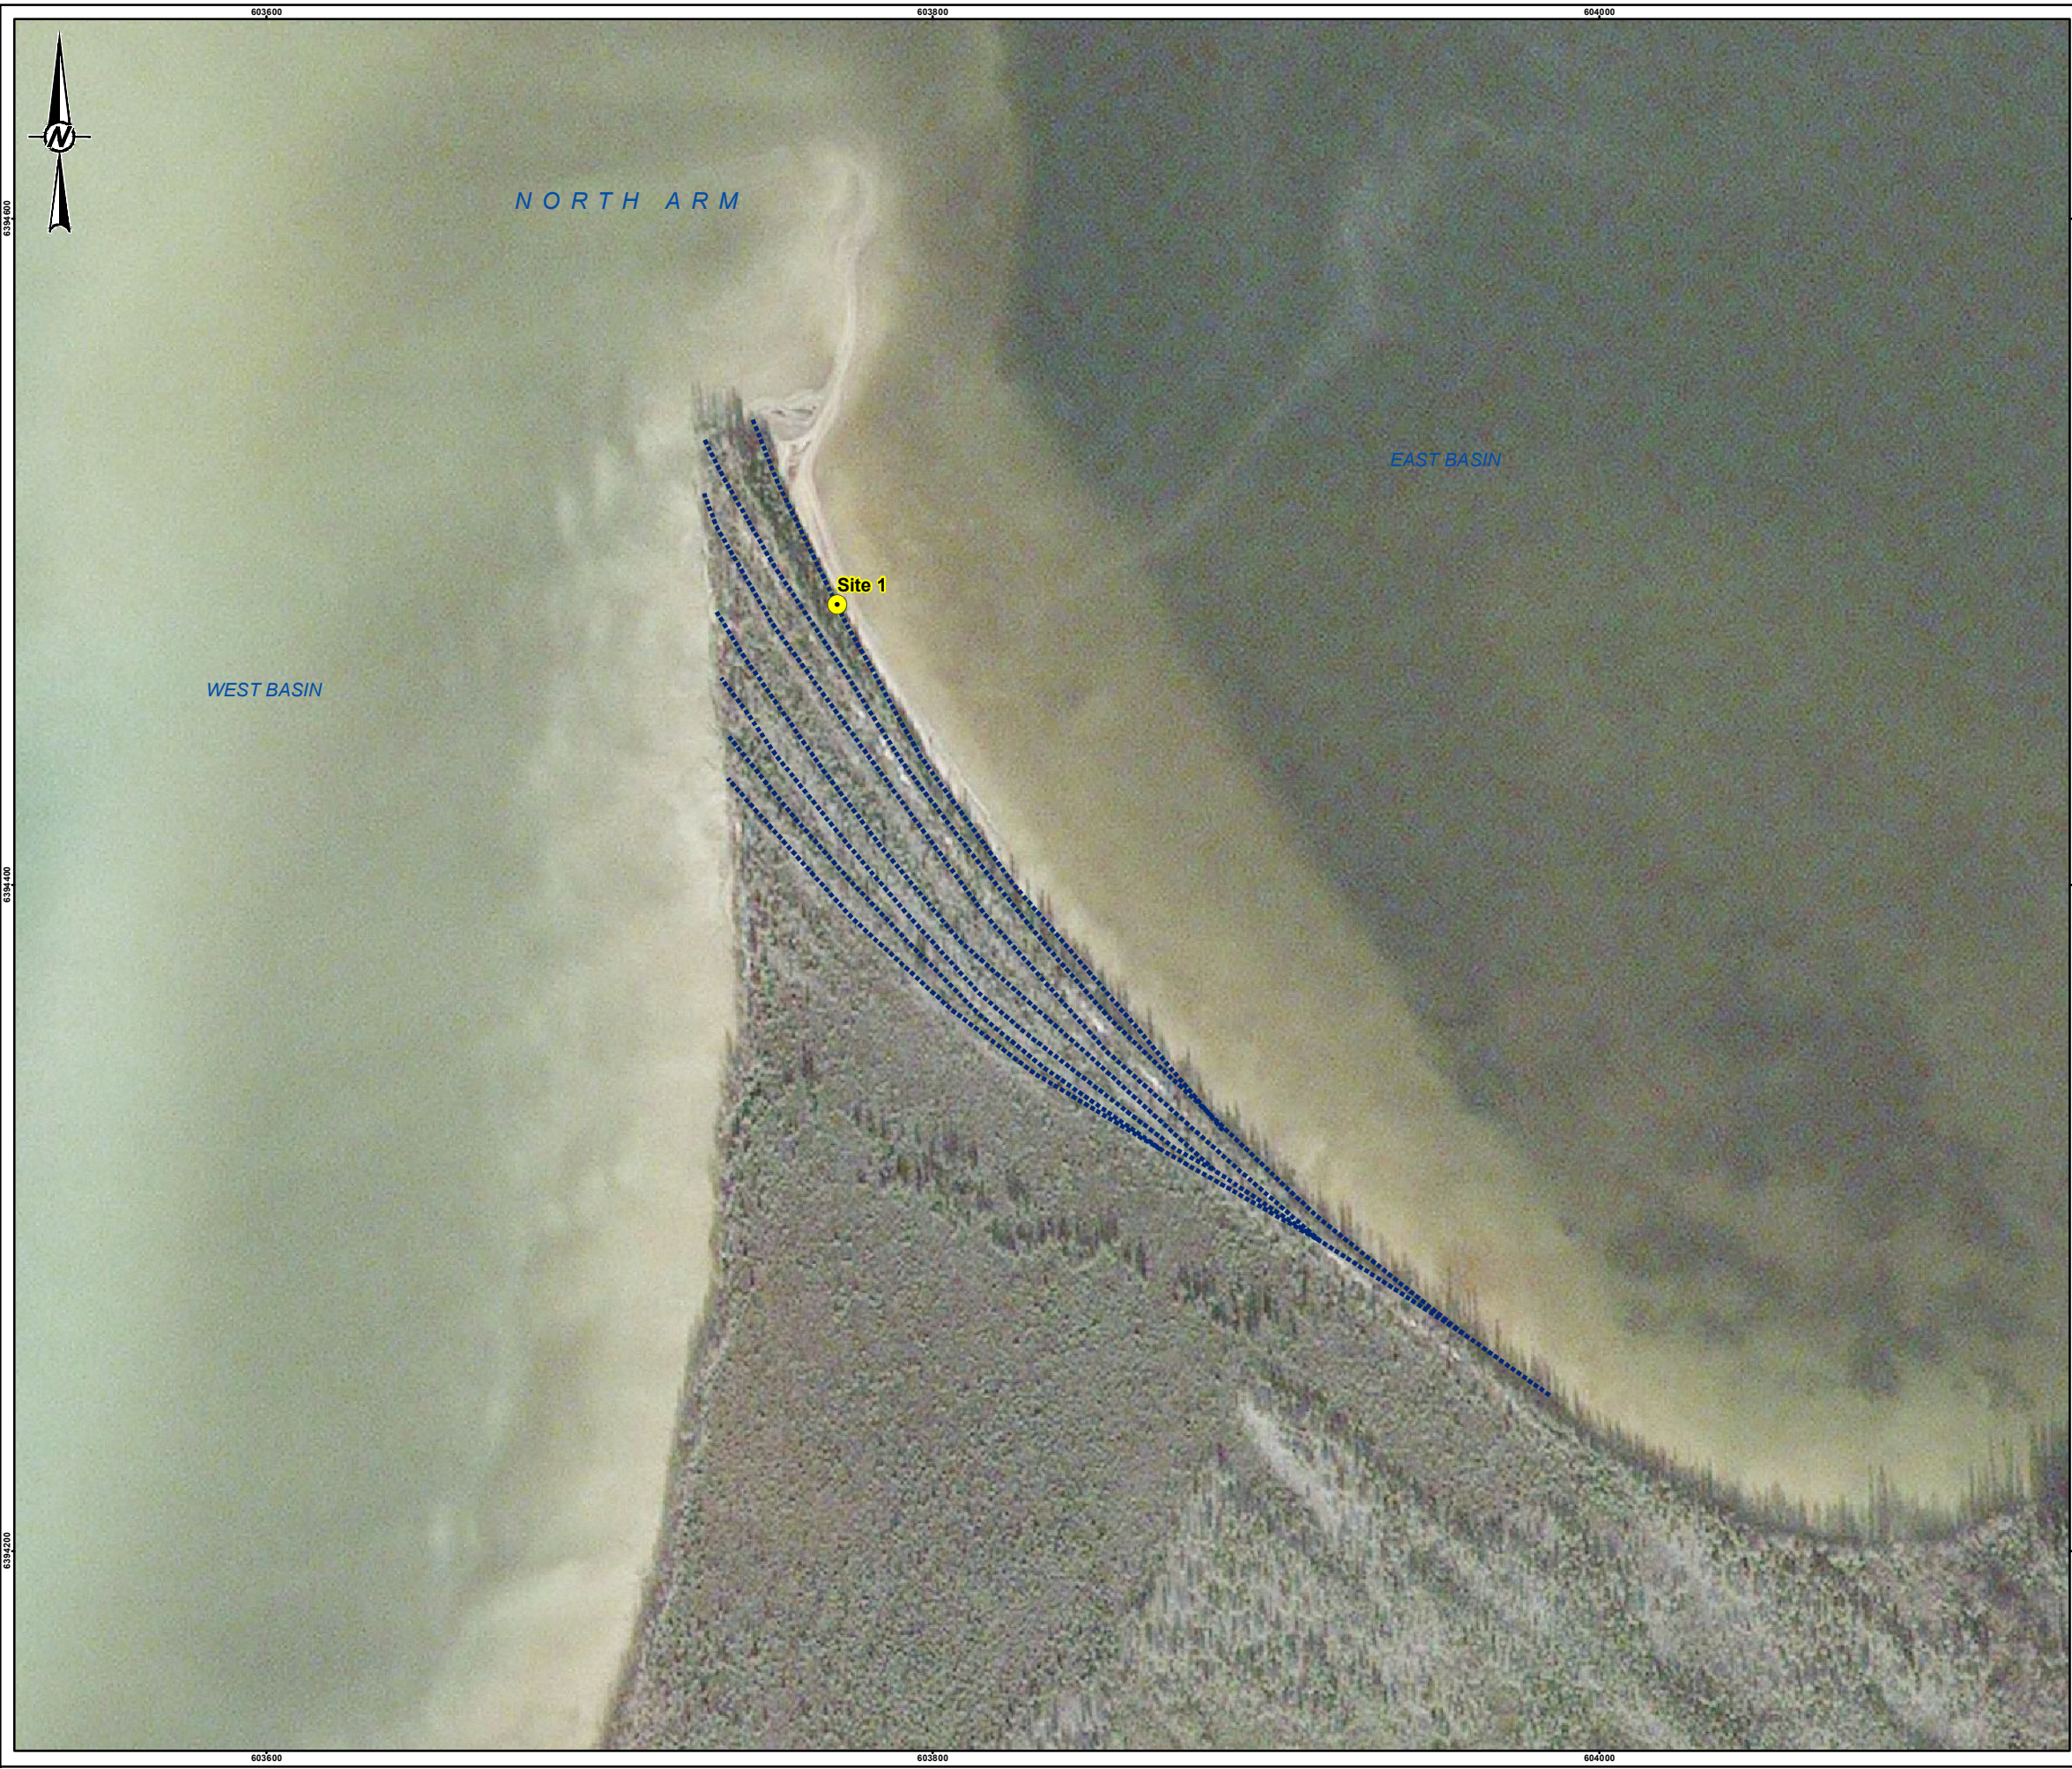
The results of the Patterson Lake shoreline delineation are presented in Figure 12. The variability in Patterson Lake shoreline exposure, surficial geology, landform, and geometry are shown in the complexity and variety of shoreline types inferred in the delineation. Relatively long wind fetches (i.e., over 3 km) are typical for most of the shoreline. These characteristic fetch lengths, combined with the observed shoreline landform (i.e., profile) and surficial materials, are expected to be the main indicator of shoreline susceptibility to erosion, recognizing that shoreline sections with similar erosion potential are expected to exhibit similar responses to changes in the hydrological regime of the lake. To that end, the areas most susceptible to erosion due to wave action are shorelines composed of sand with long wind fetches, especially with exposure to the directions with the most intense winds including the south and northwest. The shoreline classification in Figure 12 indicates such shorelines can be found on the end of the peninsula separating the North Arm – West Basin and South Arm as well as on the north shore of the North Arm – East Basin. The shoreline classification mapping was verified during subsequent hydrometric field investigations in 2019 and 2020 when shoreline landforms were visually checked for ground truthing at randomized locations on the Patterson Lake shoreline.

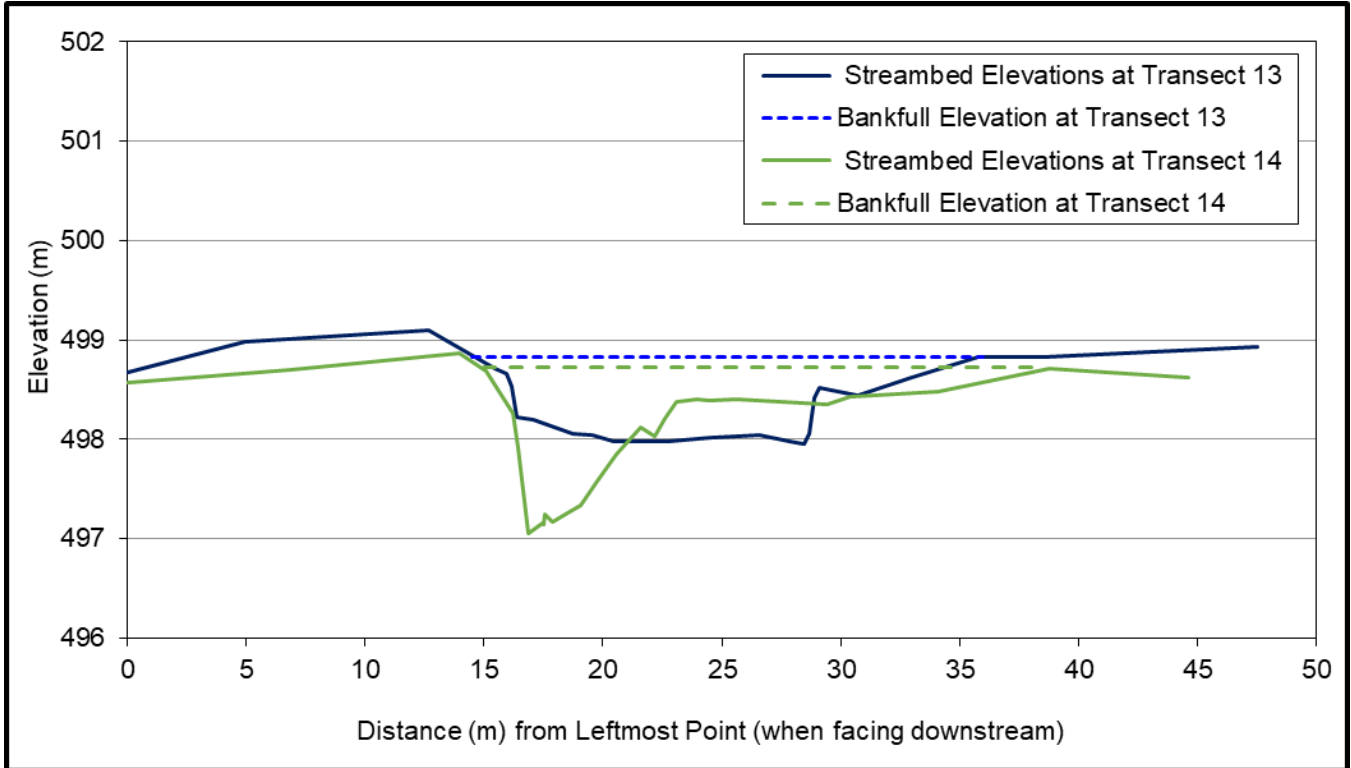
**Figure 14: Channel Cross-Section Comparison, Clearwater River below Patterson Lake**

Ongoing bank erosion was observed on the outside bend for most channel meanders and was confirmed by channel geometry cross-section measurements (Appendix C) and vegetation observations such as mature trees leaning over the channel, or already fallen in the channel. A typical channel-transects comparison example in Figure 14 shows the differences in bank slope and maximum bank full depth between a transect measured in a straight portion of the channel (i.e., Transect 13), and a transect measured at a meander (i.e., Transect 14). The maximum bank full depth is approximately double in the meander section.

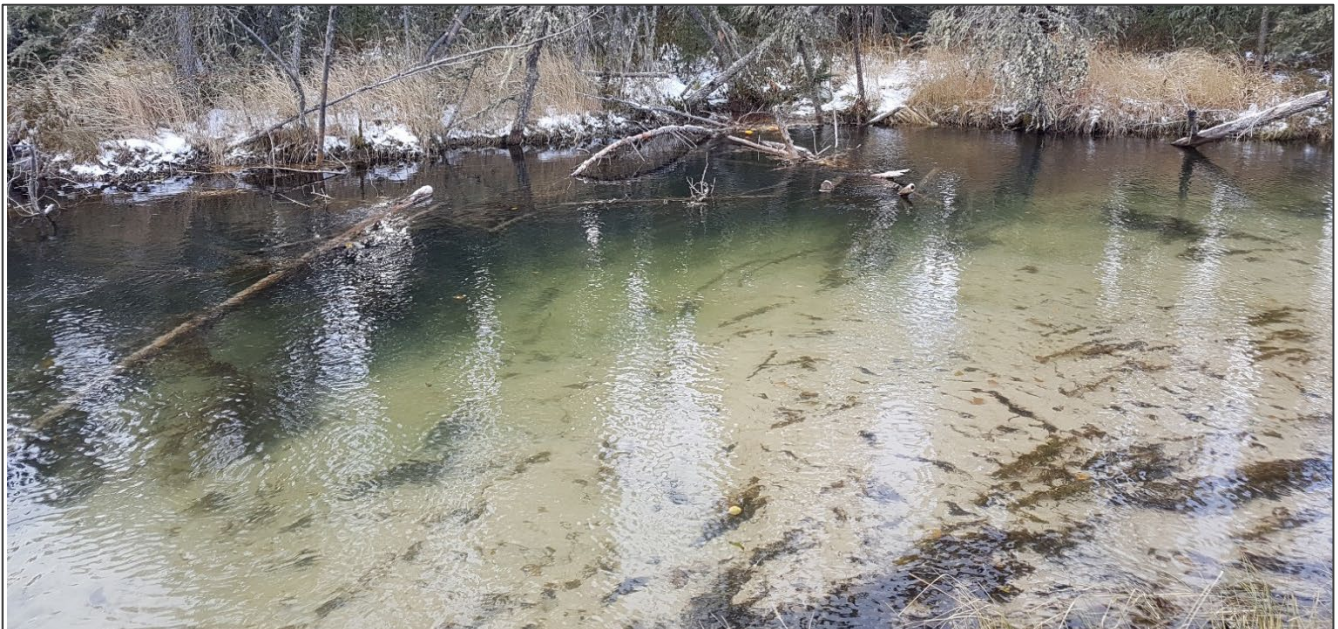
**Figure 15: Typical Bank Erosion on Outside of Meander with Trees Leaning over the Channel**

Where trees were observed to have fallen from the bank, they were observed to typically remain attached to the bank (Figure 15) and have the potential to promote local scour during high flow periods in the spring.

Note: Universal Transverse Mercator 12V 605322 E 6390403 N. View is from south to north, taken on 3 October 2018.

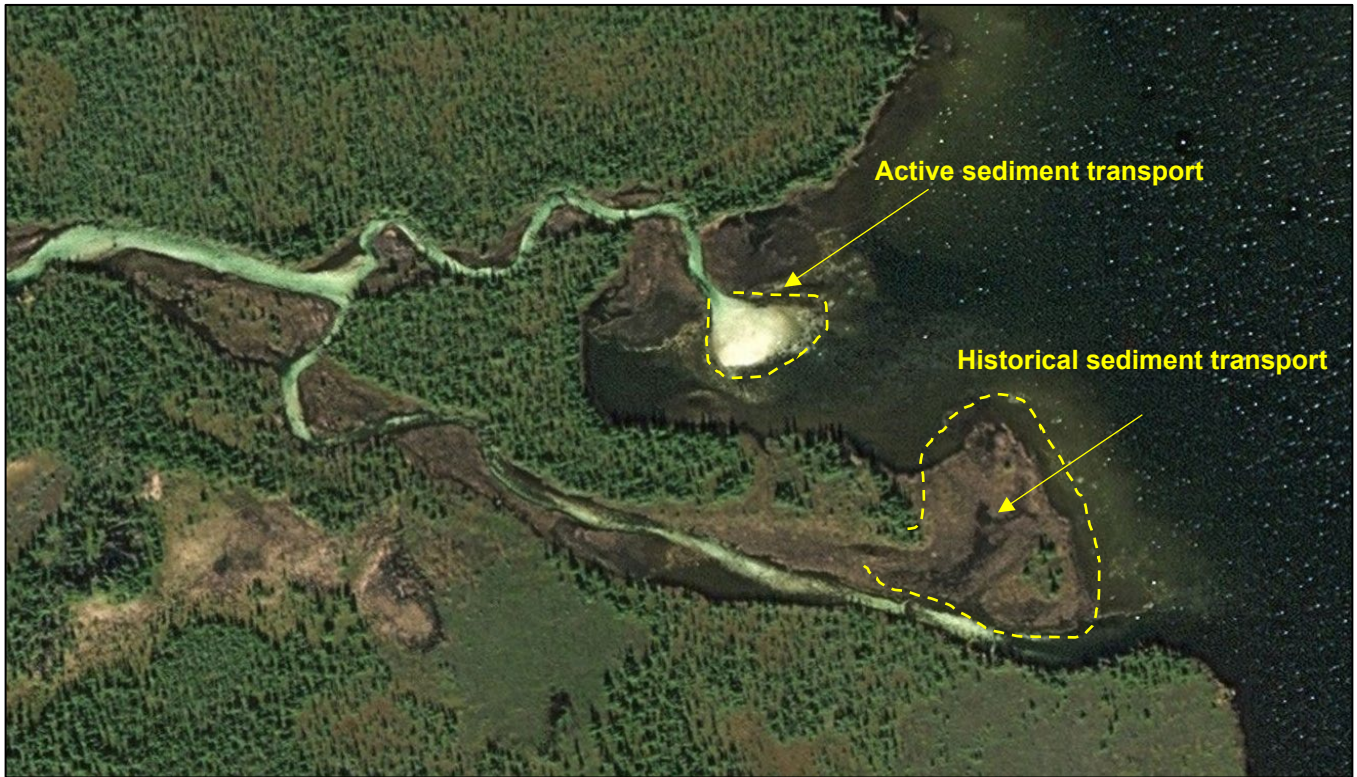
Figure 16: Patterson Lake Channel Outflow (Clearwater River below Patterson Lake) into Forrest Lake

Overall, the Clearwater River below Patterson Lake is susceptible to bank erosion (with soils and organics materials on its banks) and has active sediment transport (mostly sand-size materials) indicated by the active delta at its mouth.

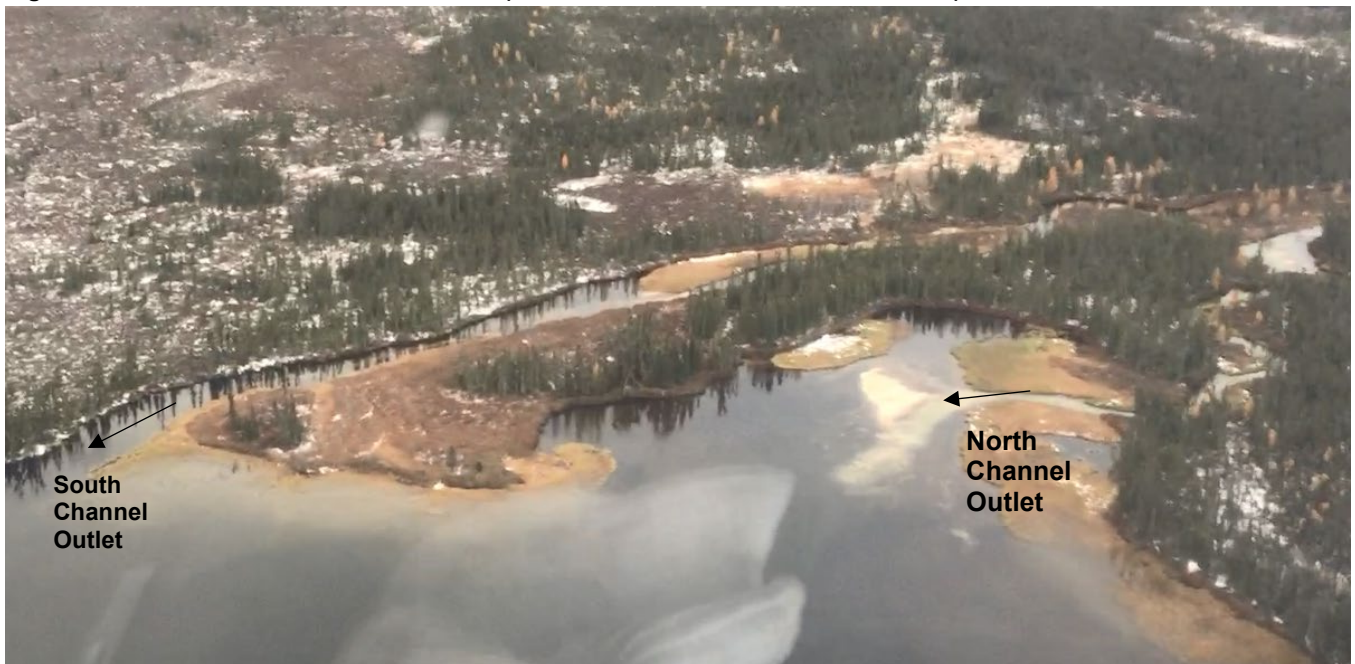
Figure 17: Patterson Lake Channel Outflow (Clearwater River below Patterson Lake) into Forrest Lake

Note: View is from east to west, the photo was taken from helicopter on 1 October 2019.
