# Rook I Project

Annex V.2: Overwintering Fish Habitat Report

# **OVERWINTERING FISH HABITAT FIELD PROGRAM RESULTS SUMMARY REPORT FOR THE ROOK I PROJECT**

**Golder Associates Ltd.**

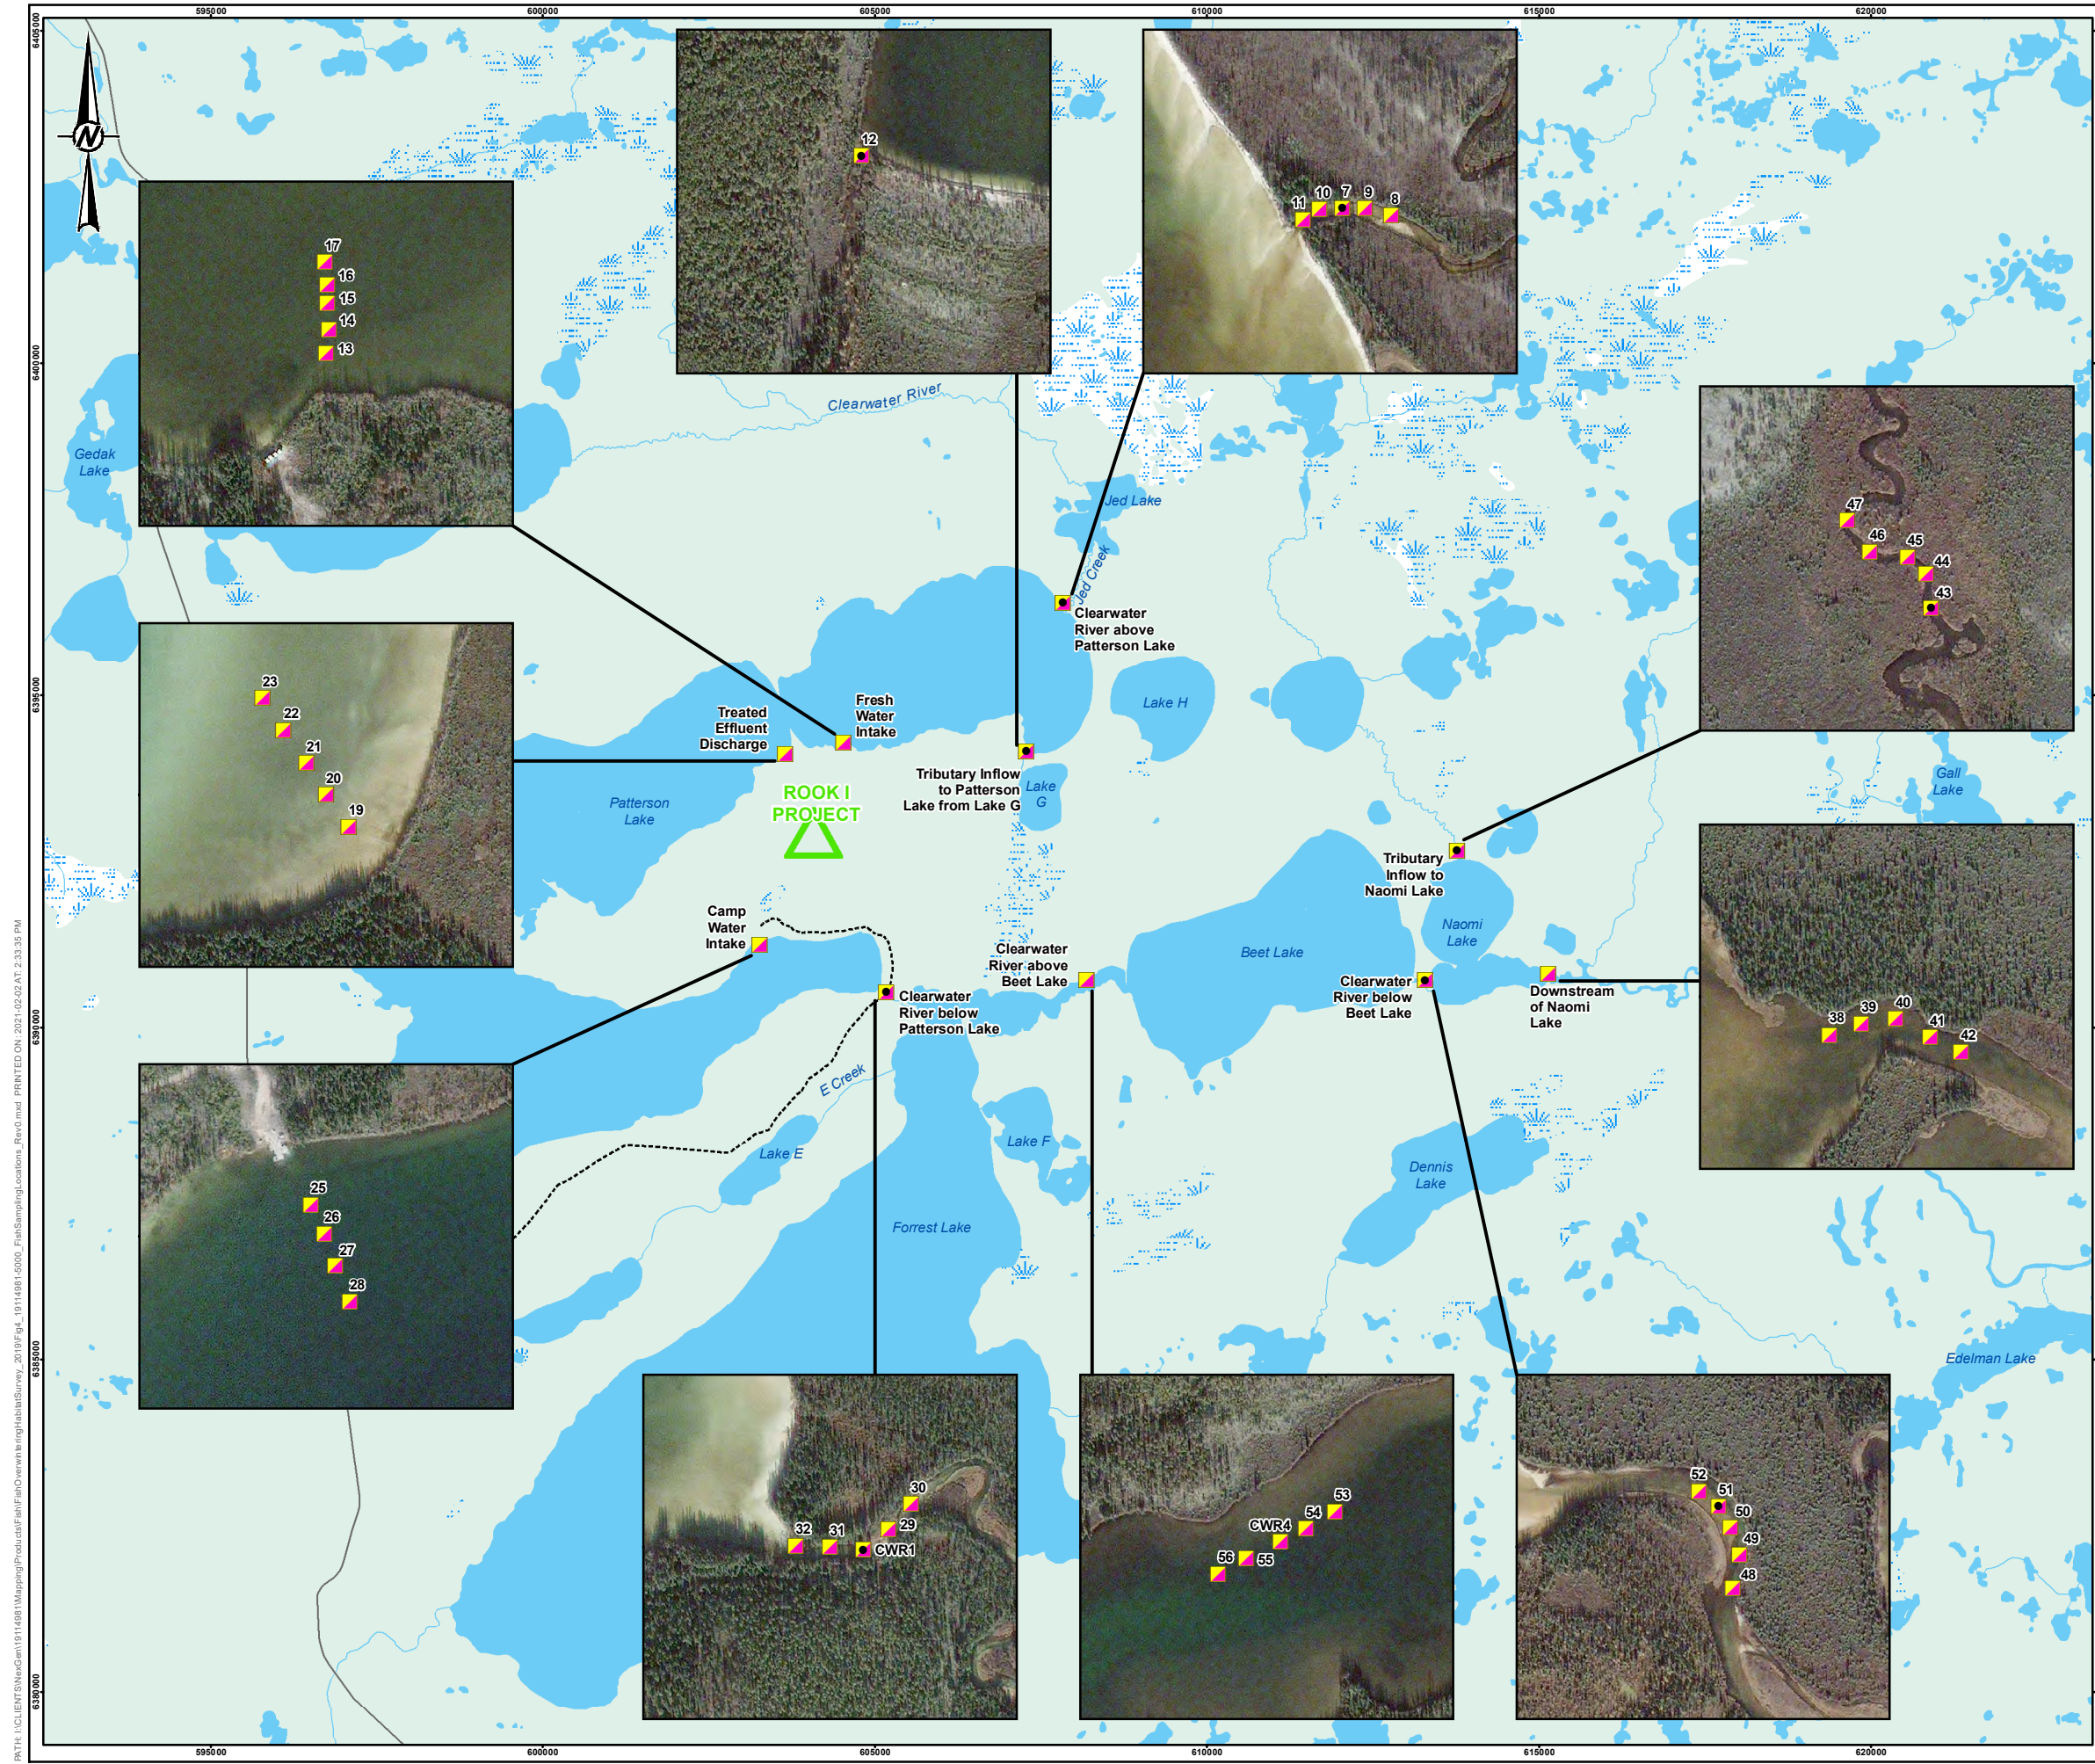
PROJECT NO. 19114981      PHASE 5000      REV. 0      FIGURE 4

TITLE  
**OVERWINTERING FISH HABITAT SAMPLING LOCATIONS**

Ten sites were surveyed in 2019, which included three sites on Patterson Lake and seven sites on surrounding watercourses that could be potentially affected by the Project (Table 1; Figure 4). Each of the sites surveyed overlapped with habitat transects assessed by CanNorth during the 2018 and 2019 open-water fish and fish habitat baseline sampling (Annex V.1).

The watercourse sites included five sites on the Clearwater River mainstem and two sites on tributaries of the Clearwater River (Table 1). Watercourse sites were selected based on a desktop review of satellite imagery, and to overlap with fish habitat sampling transects completed by CanNorth (Annex V.1). Specific sampling locations were determined in the field based on the approach described in Section 4.2.2.2.

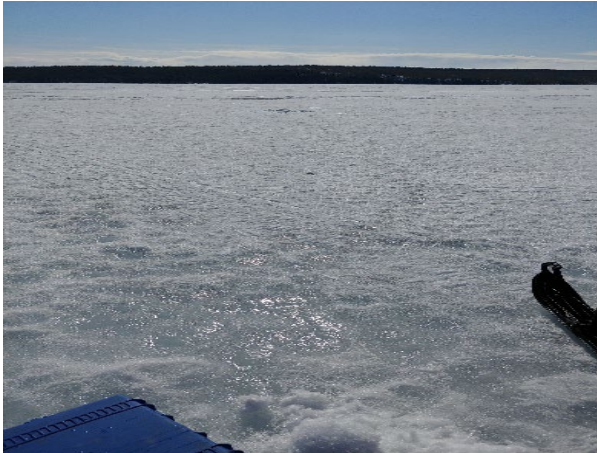
**Photo 1: View looking away from shore at the Camp Freshwater Intake site.**

Under-ice water depths at the Camp Freshwater Intake site (Appendix A) ranged from 0.20 m to 0.80 m across the five sampled stations (Table 2). Ice thickness was similar at the five stations, averaging 0.73 m. The water temperature at the ice-water interface averaged 0.8°C. The water was well oxygenated, with surface DO concentrations ranging from 13.2 mg/L to 14.4 mg/L (Table 2); all measurements were within guideline values. The pH of the water was slightly acidic to neutral. The conductivity of the water at the ice-water interface was highest at the station nearest to shore (60.7 microsiemens per centimetre [ $\mu\text{S}/\text{cm}$ ]) and generally decreased with distance from shore. At the profile station, water temperature and DO were lower at the ice-water interface (0.6°C and 13.7 mg/L, respectively) and higher near the lake bottom (1.1°C and 13.9 mg/L, respectively). Overall, the surveyed area of Patterson Lake in the vicinity of the camp water intake location would provide suitable overwintering habitat for large-bodied fish and forage fish.

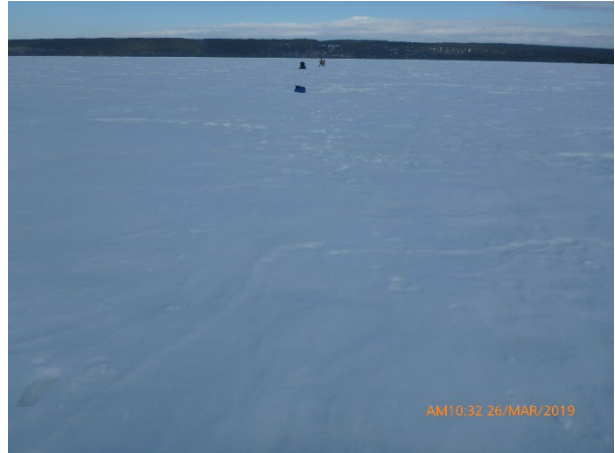
**Photo 2: View away from shore at the Treated Effluent Discharge site, from Station 19.**

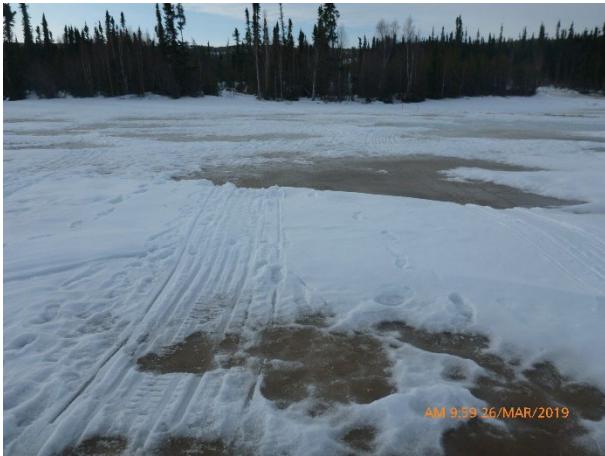
**Photo 3: View looking towards shore at the Freshwater Intake at Mine/Mill site.**

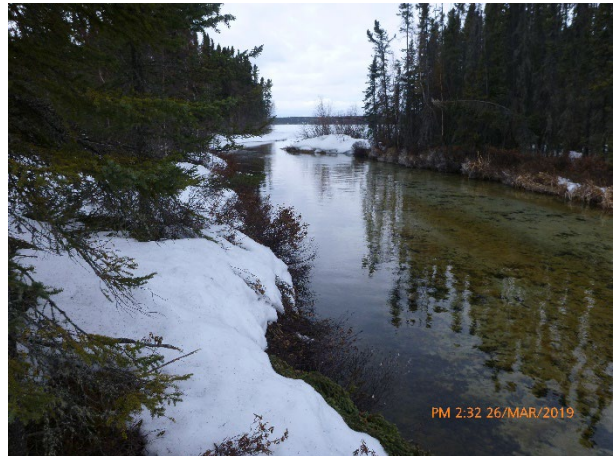
**Photo 4: View looking upstream at the Clearwater River below Patterson Lake site, from Station CWR1.**

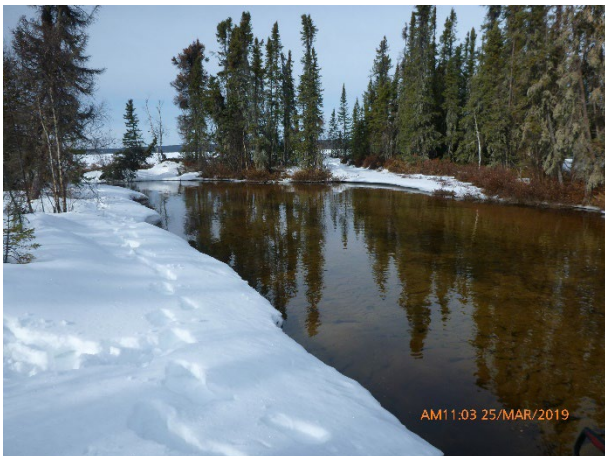
**Photo 5: View looking downstream at the Clearwater River above Patterson Lake site, from Station 7.**

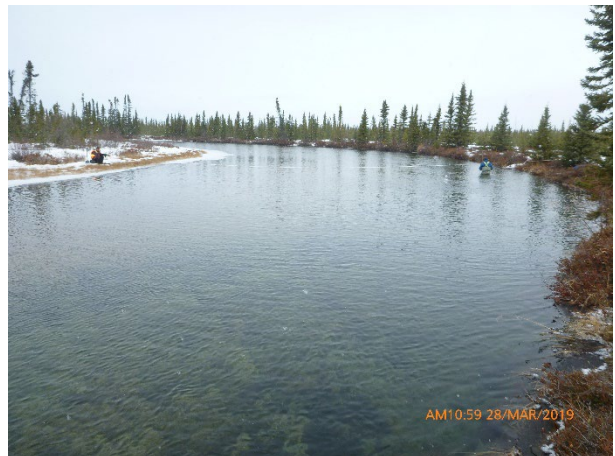
**Photo 6: View looking upstream at the Clearwater River below Beet Lake site, from Station 50.**

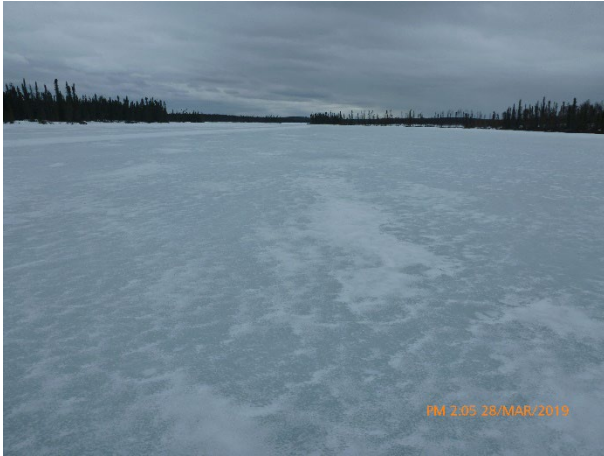
**Photo 7: View upstream at Clearwater River above Beet Lake site, station CWR4.**

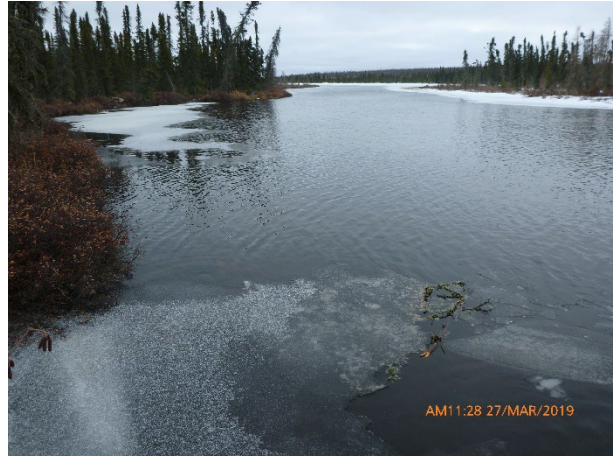
**Photo 8: View looking downstream at the Downstream of Naomi Lake site, from Station 39.**

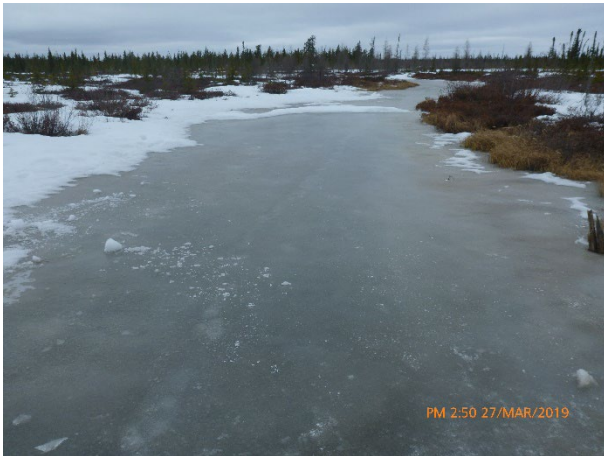
**Photo 9: View looking upstream at the Tributary Inflow to Naomi Lake site, from Station 43.**

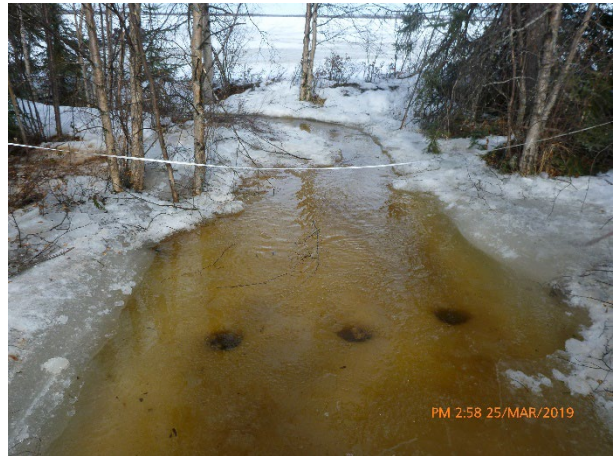
**Photo 10: View looking downstream at the Tributary Inflow to Patterson Lake from Lake G site, from Station 12.**
