Wheeler River Project

Final Environmental
Impact Statement

**2011 – 2019 BASELINE
HYDROLOGY SUMMARY
REPORT - WHEELER RIVER
PROJECT, DENISON MINES**

Ref. 19-2589
25 March 2020

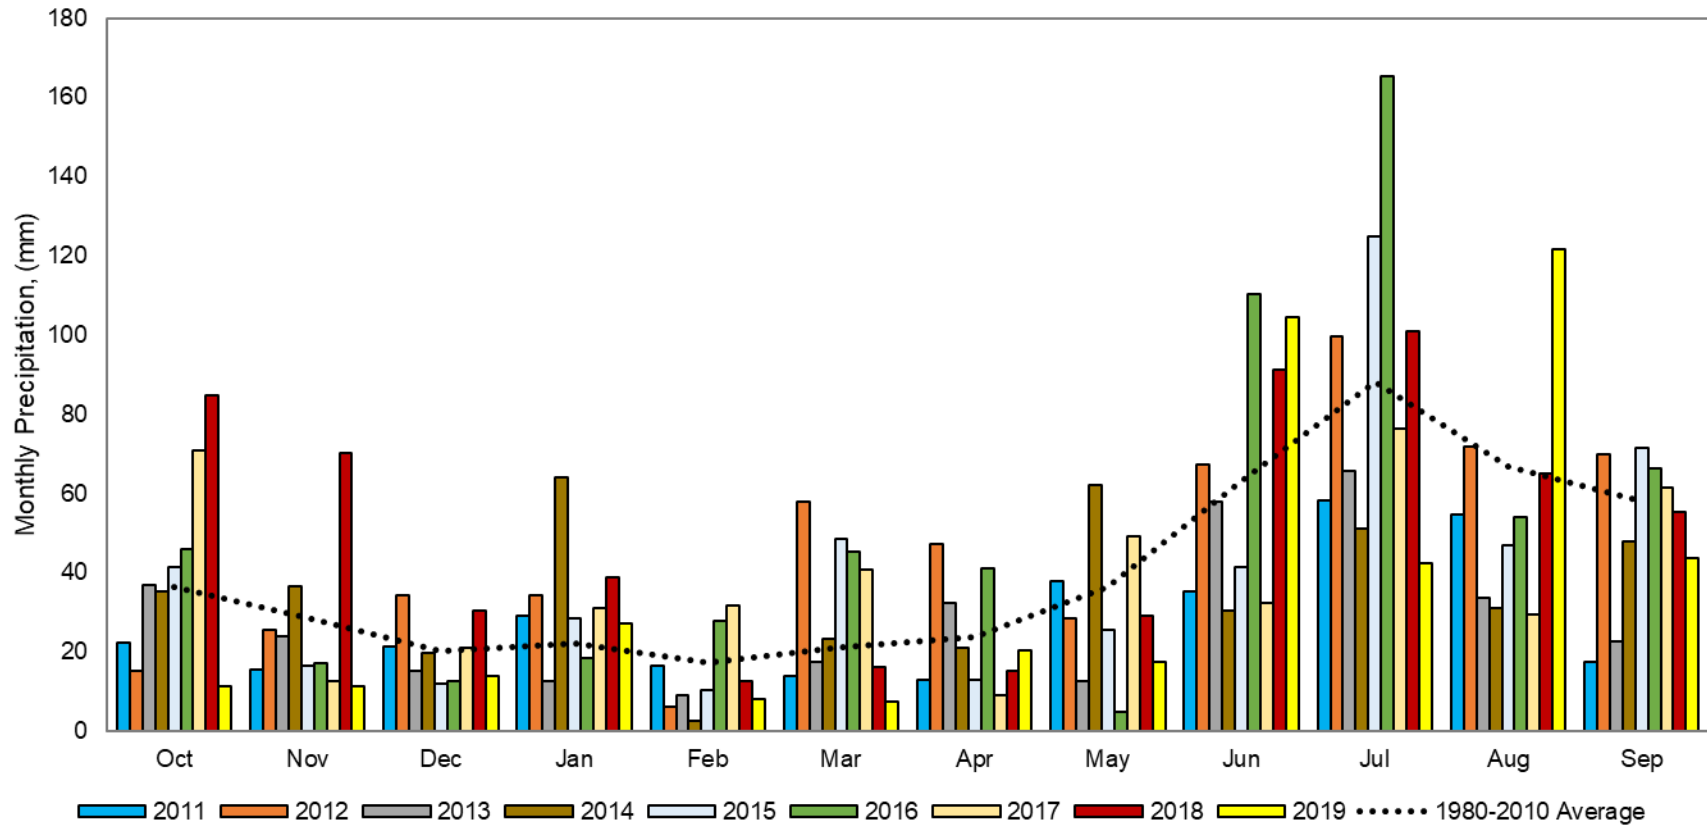
Figure 1-2: Key Lake Monthly Precipitation for Hydrological Years between 2011-2019 (ECCC, 2019).

Precipitation is the primary input of surface water and as such, it provides important context for observed flow characteristics. **Figure 1-2** presents the precipitation record for the period 2011 through 2019, as well as historical averages for comparison. The data are presented on the basis of hydrological years that run from October 1 of one year to September 30 of the following year.

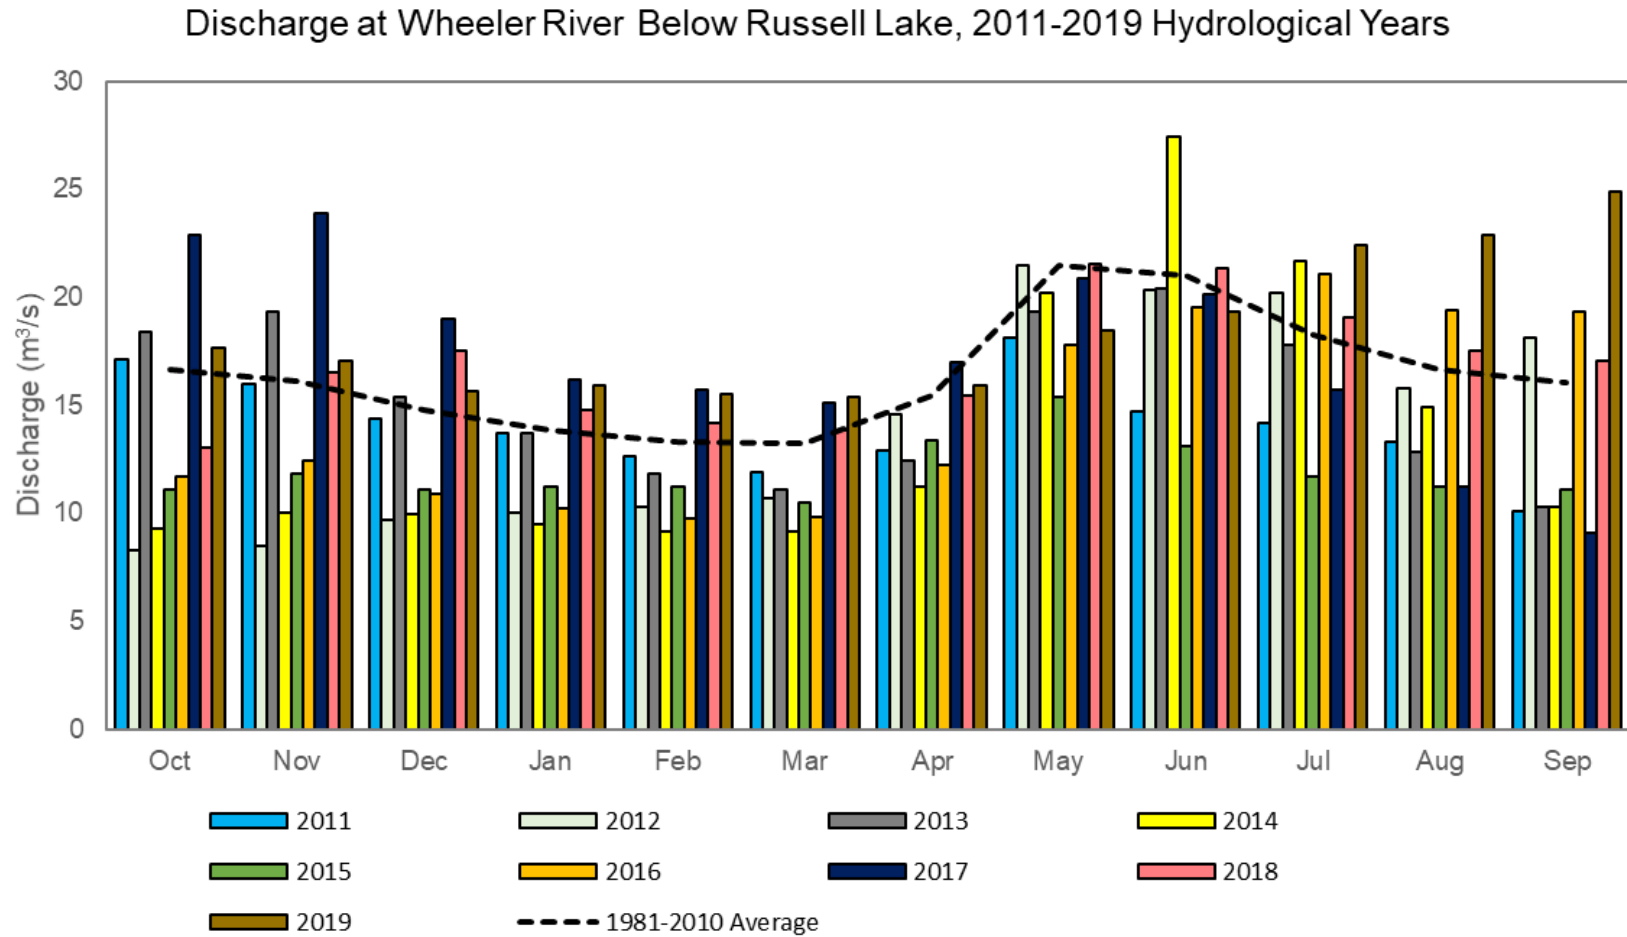
Figure 1-3: Wheeler River mean monthly discharge for the hydrological years between 2011 and 2019. (WSC 2019a, b).

The mean monthly discharge rates at the Wheeler River for the period 2011 through 2019 are presented in **Figure 1-3**. Data corresponding to the period 1981 through 2010 are also presented in **Figure 1-3** for comparison. The data are presented on the basis of hydrological years that run from October 1 of one year to September 30 of the following year. It is noted that only provisional data are available for 2018 and 2019.

- During the first six months of the 2018 hydrological year, discharge in the Wheeler River was slightly above the historical average level, possibly corresponds to the high precipitation in the first quarter 2018 (50% above the historical average). From April through June, the discharge rate was similar to the historical average level, and slightly above average between July and September.

- During the 2019 hydrological year, despite the low precipitation in the first six months, the Wheeler River discharge was slightly above the historical average. The river discharge slowly decreased during the winter months, similar to the temporal trend in previous years. The discharge started to increase in May during the spring freshet and reached a peak of 24.9 m³/s in September. The increased discharge over the summer and early fall corresponded to the high precipitation in June and August, which was more than 1.5 and 2 times, respectively, compared to the historical average.

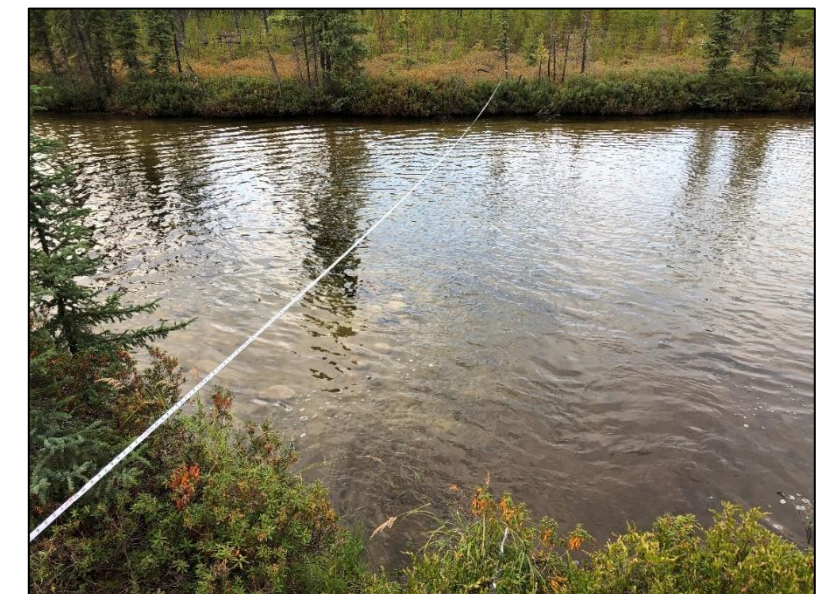
SA-10 cross section, Aug 2019

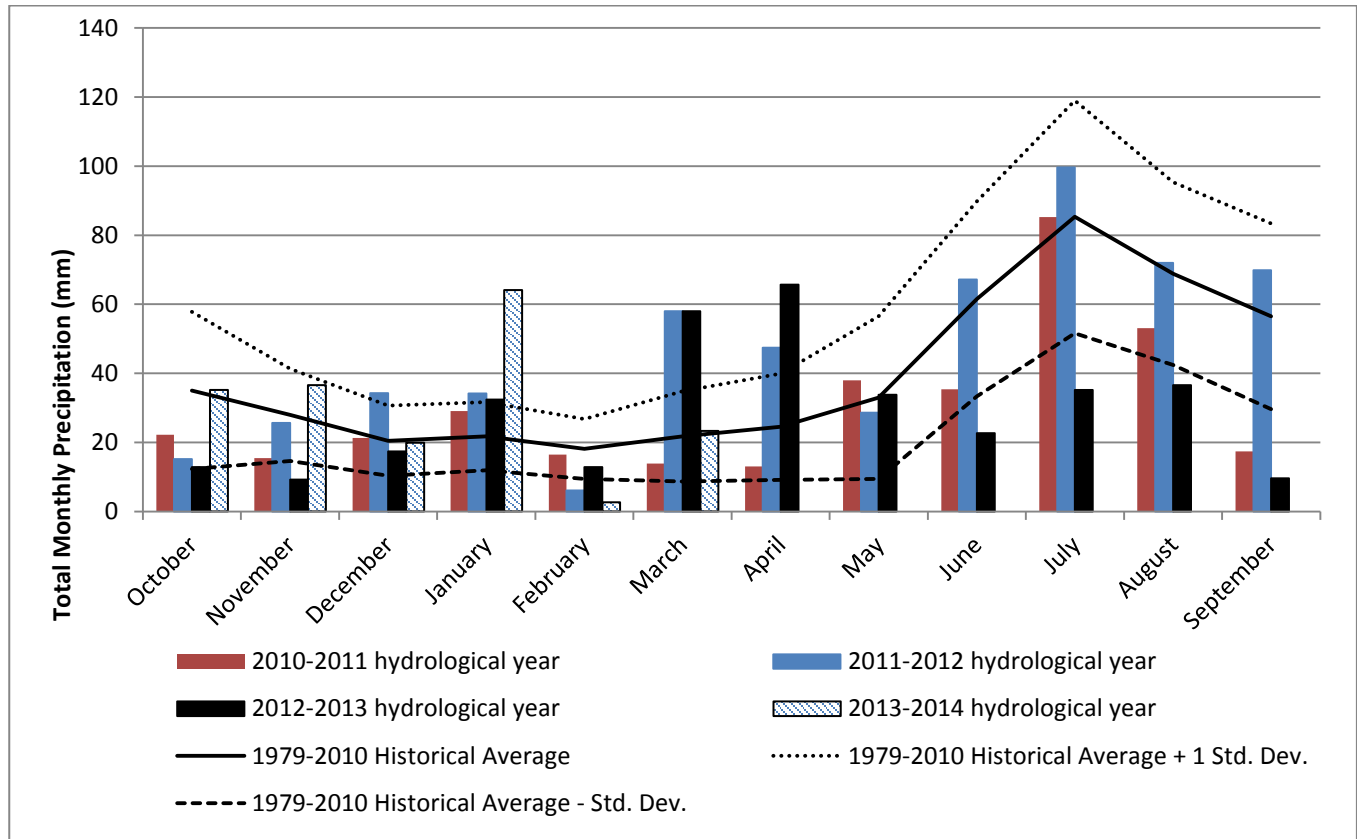
Figure 1: Key Lake Total Precipitation for Hydrological Years between 2010 and 2013 (EC 2013)

Precipitation during the 2010-2011 hydrological year was less than average during all months except January, May and July when precipitation was above average (January) or near average (May and July). The low precipitation throughout most of the winter would contribute to a smaller snowpack and a reduced spring freshet. Low summer and early fall precipitation would contribute to lower than normal flows during these periods.

Precipitation during the 2011-2012 hydrological year was generally near the 1979-2010 historical average. While cumulative precipitation from October to March was within 20% of the historical average, precipitation in March and April was more than twice the historical average. Near normal values were observed throughout the rest of the summer and early fall; the generally high precipitation rates in June through September could result in secondary peak flow events in summer and early fall.

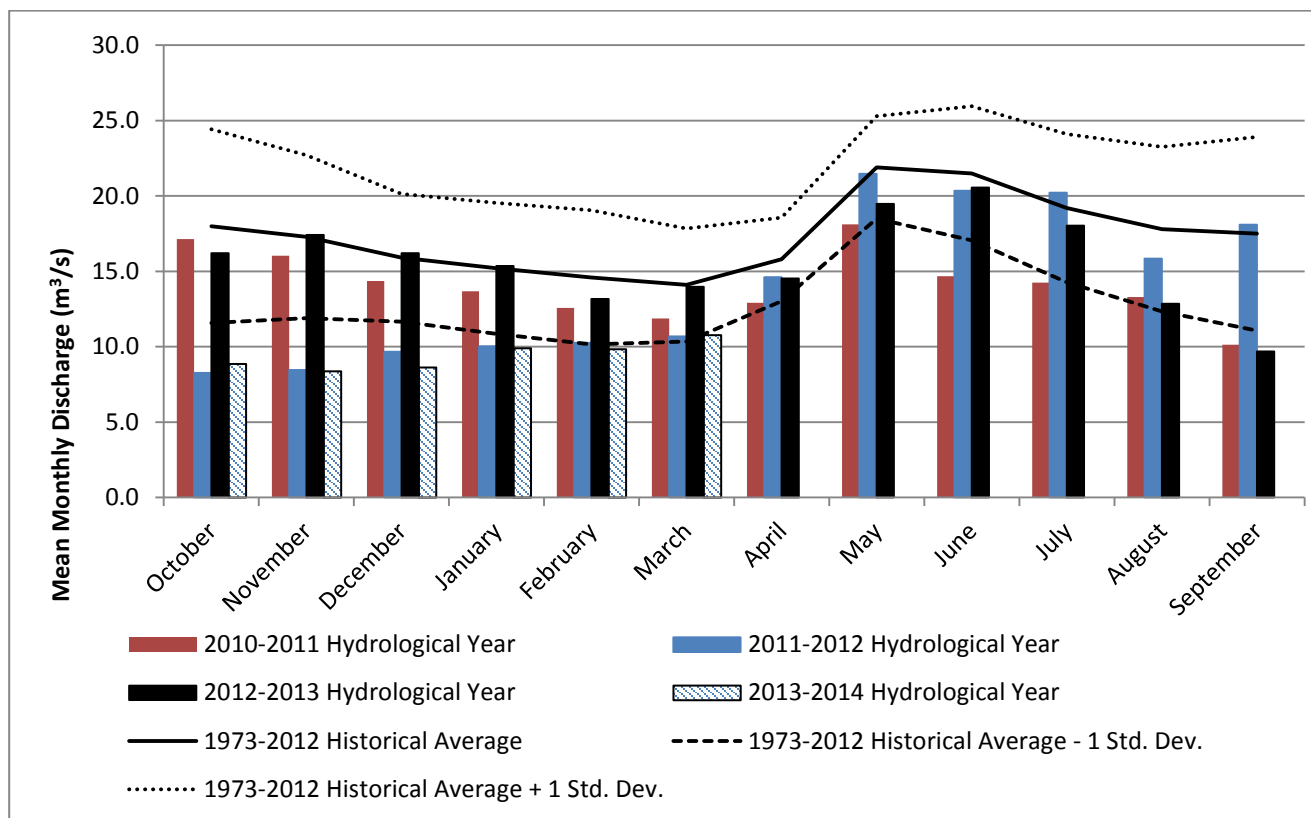
Figure 2: Wheeler River Mean Monthly Discharge for the Hydrological Years Between 2010 and 2013 (WSC 2013, 2014).

The mean monthly discharge rates at the Wheeler River for the hydrological years (October 1 to September 30) of 2010-2011 and 2011-2012 (WSC 2014a) as well as 2012-2013 and 2013-2014 (WSC 2014b) are presented in Figure 2.

Although only provisional data that are subject to revision are available for 2012-2013 and 2013-2014 (Figure 2) these flow rates provide important context to the corresponding flow rates observed near the Project.

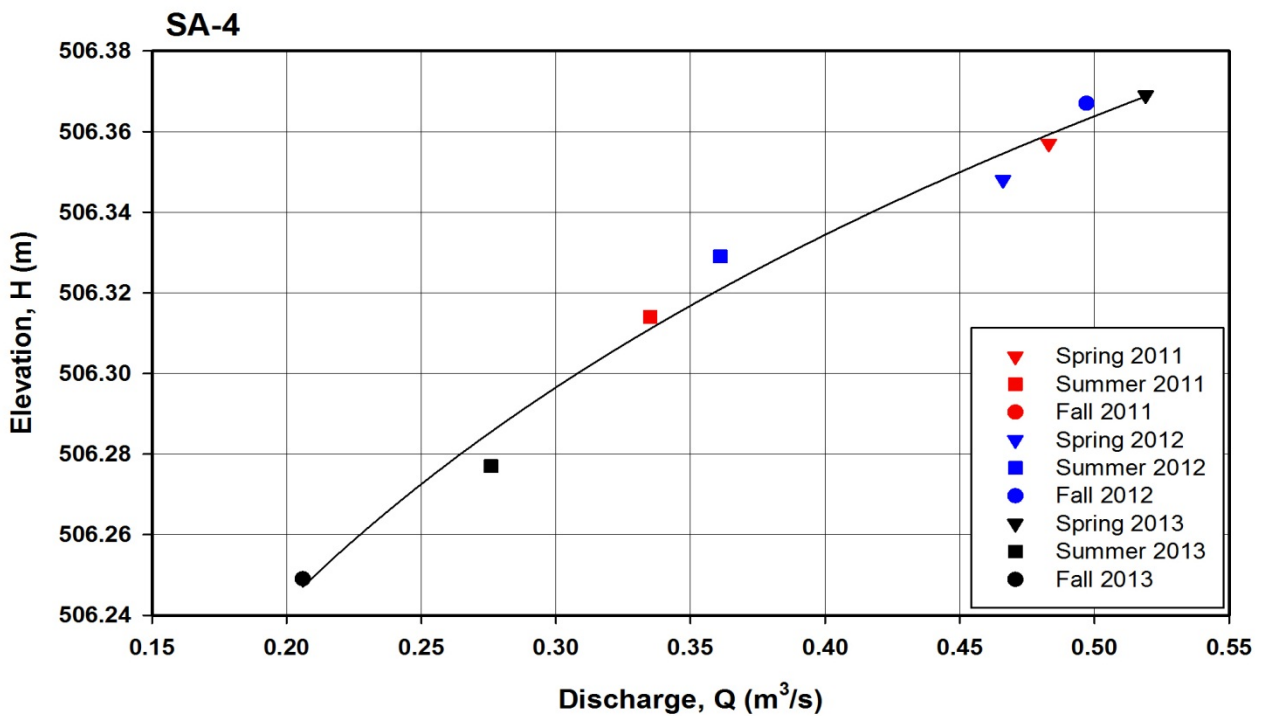
Figure C4: Relationship between Water Surface Elevation, H (m), and Discharge, Q (m³/s), at Streamflow Station SA-4.

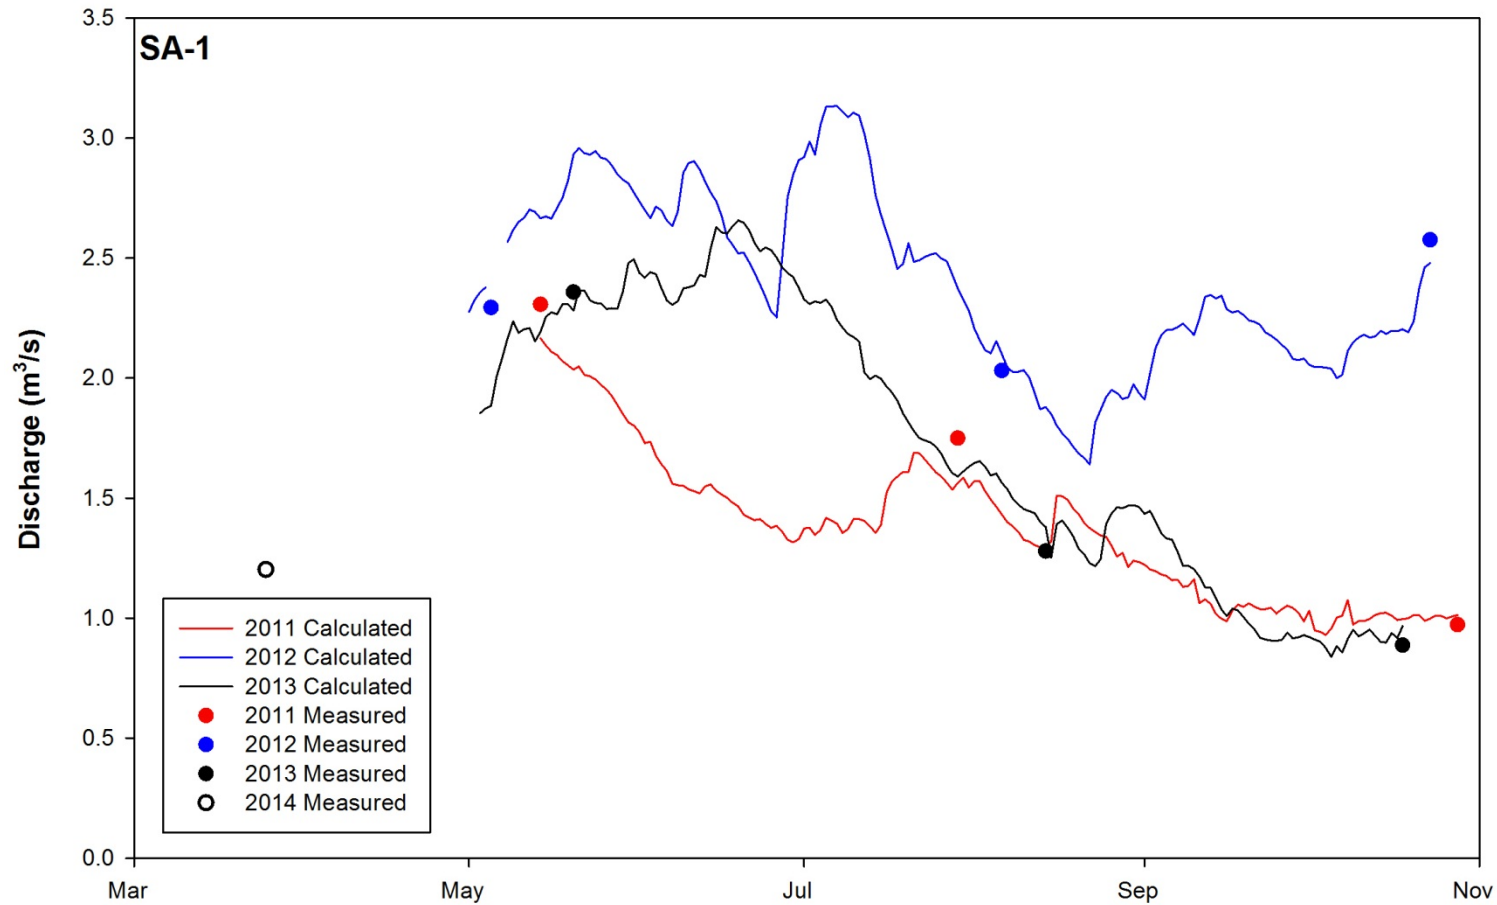
Figure D1: Measured and Calculated Discharge, Q (m^3/s), for Stream Monitoring Station SA-1.

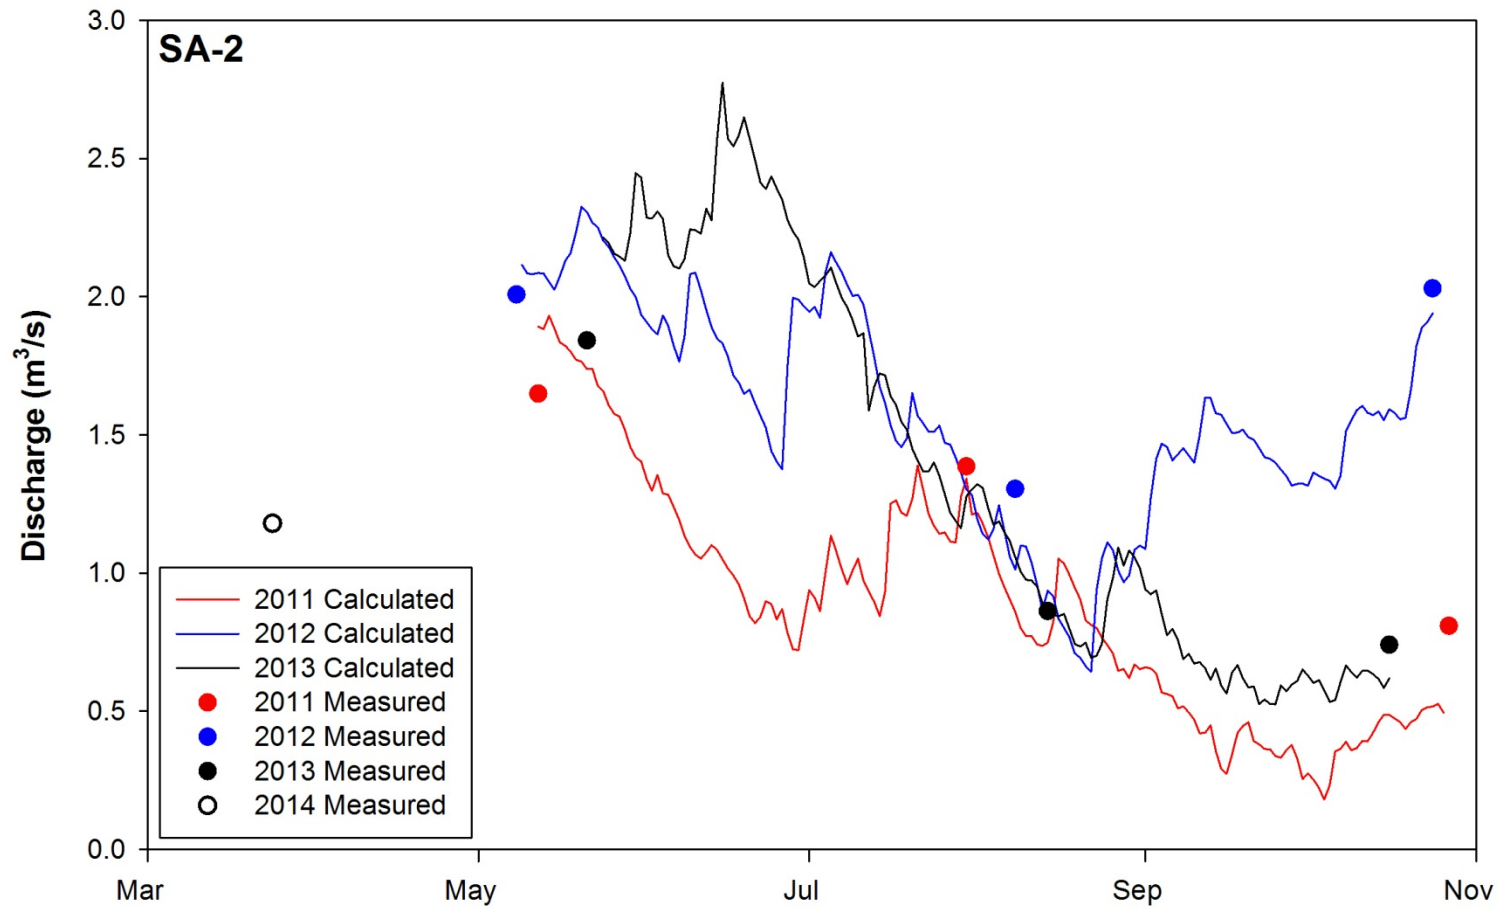
Figure D2: Measured and Calculated Discharge, Q (m^3/s), for Stream Monitoring Station SA-2.

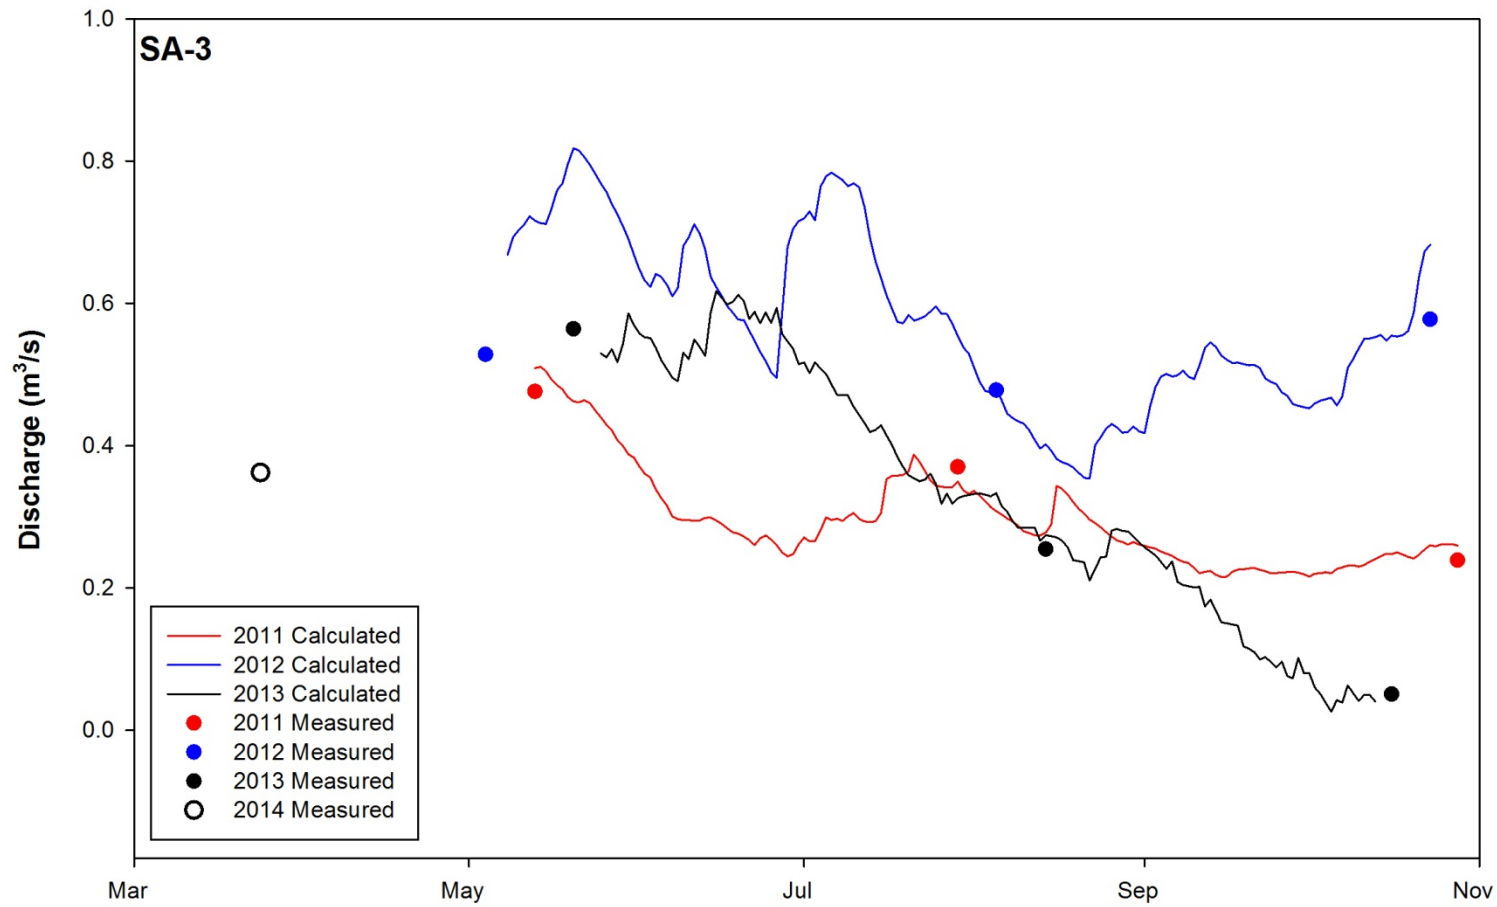
Figure D3: Measured and Calculated Discharge, Q (m^3/s), for Stream Monitoring Station SA-3.

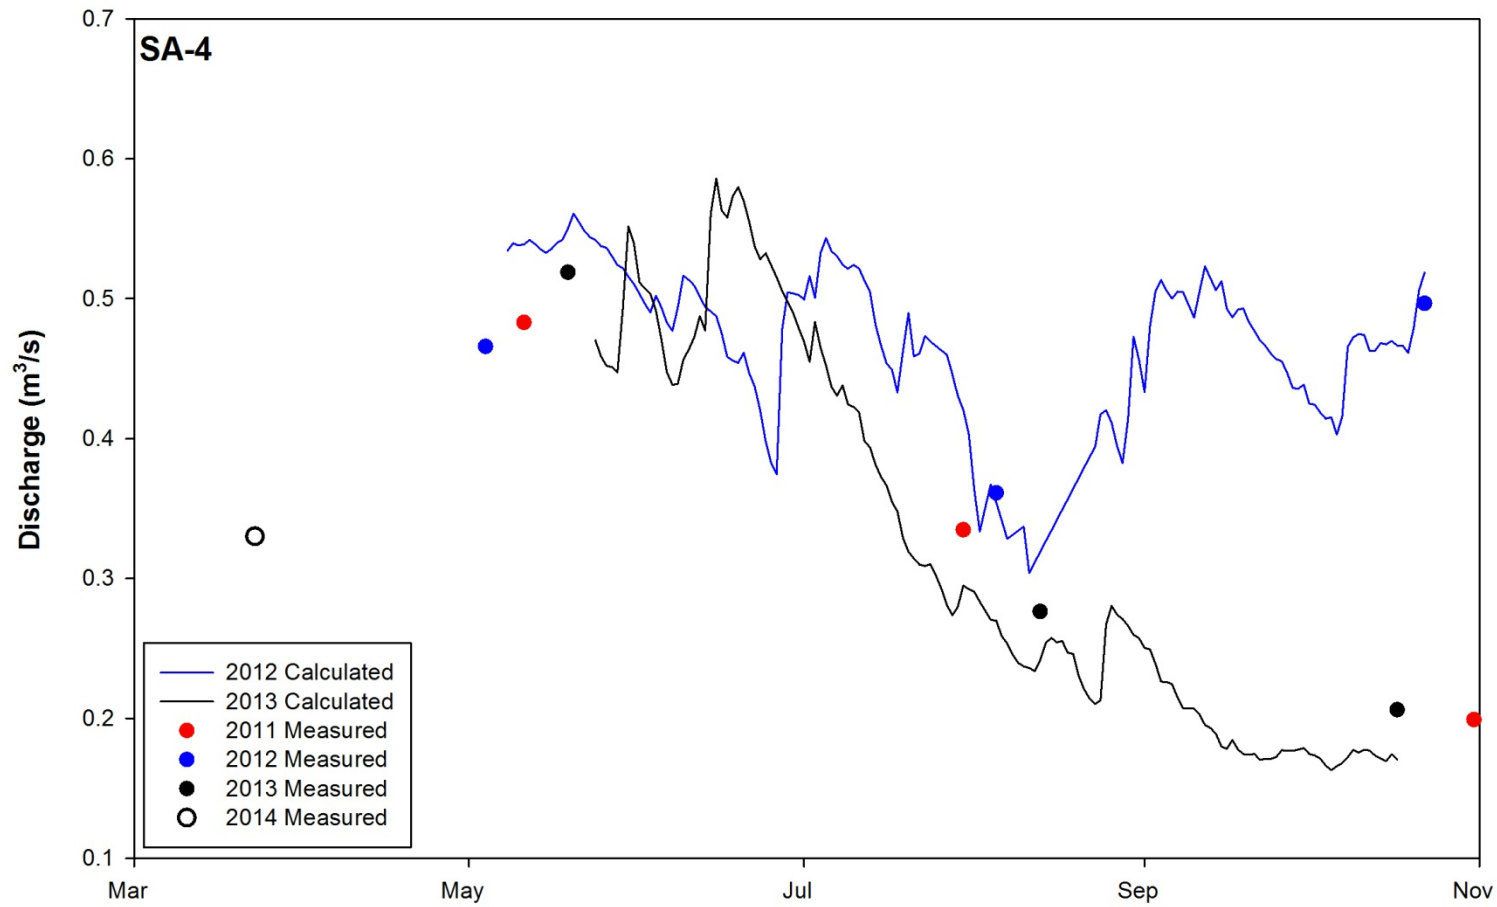
Figure D4: Measured and Calculated Discharge, Q (m^3/s), for Stream Monitoring Station SA-4.

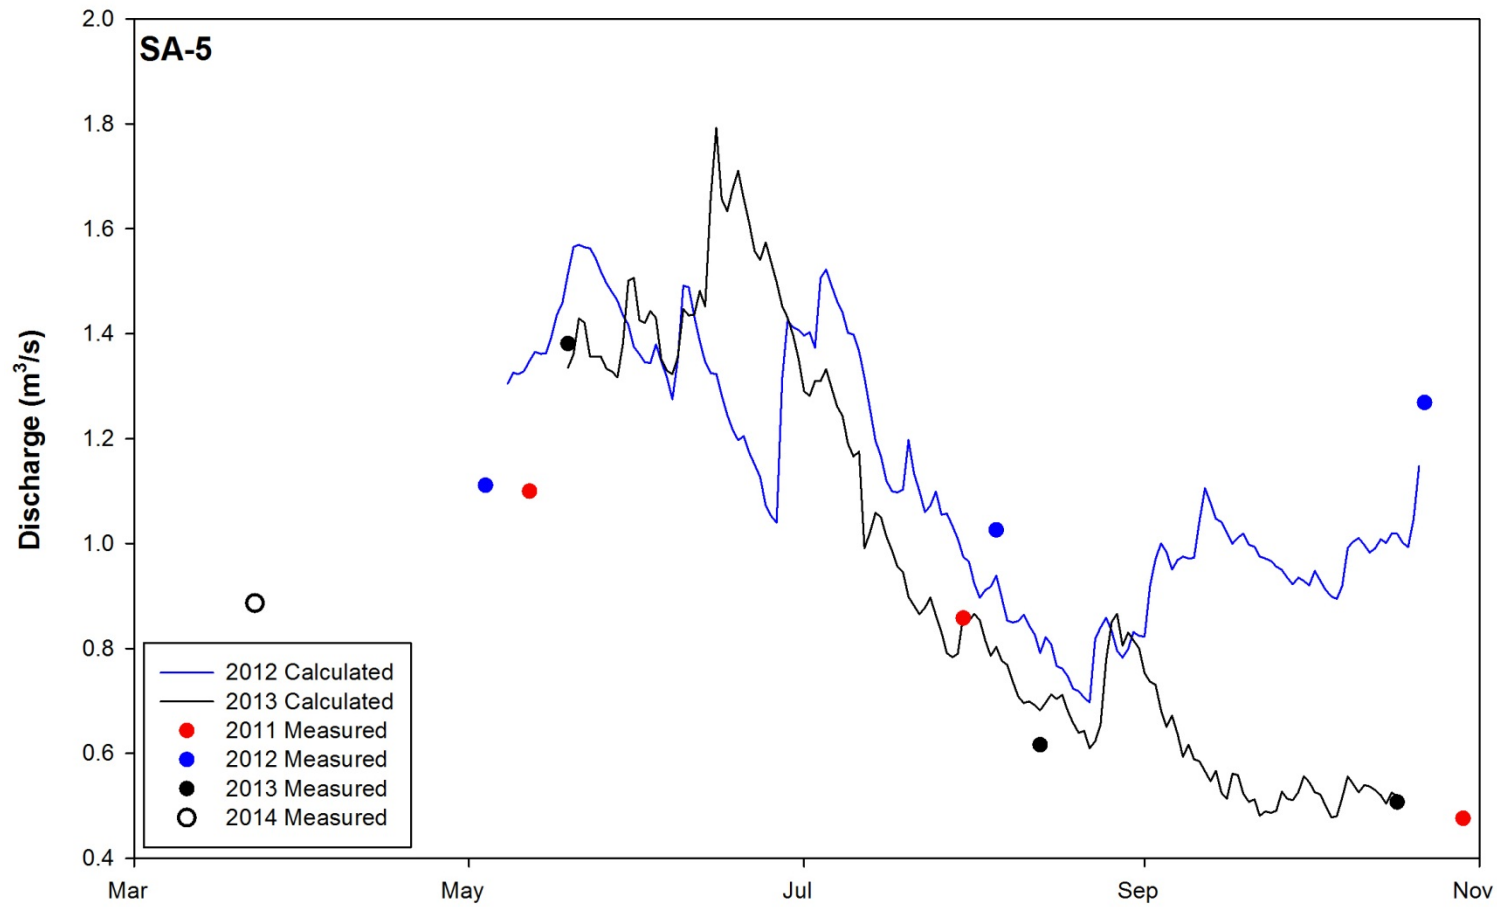
Figure D5: Measured and Calculated Discharge, Q (m^3/s), for Stream Monitoring Station SA-5.

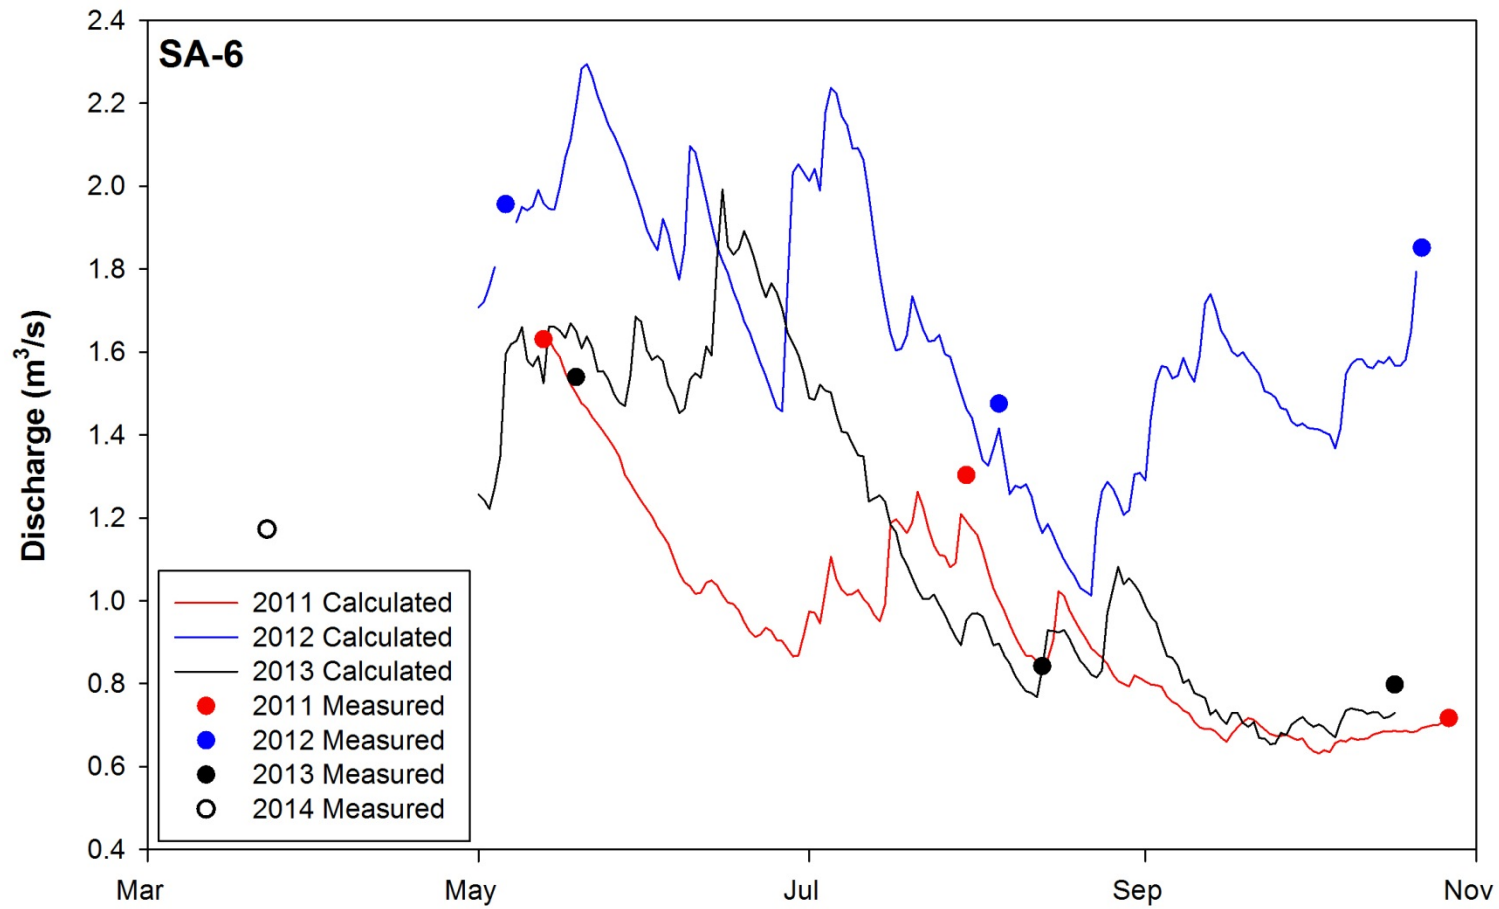
Figure D6: Measured and Calculated Discharge, Q (m^3/s), for Stream Monitoring Station SA-6.

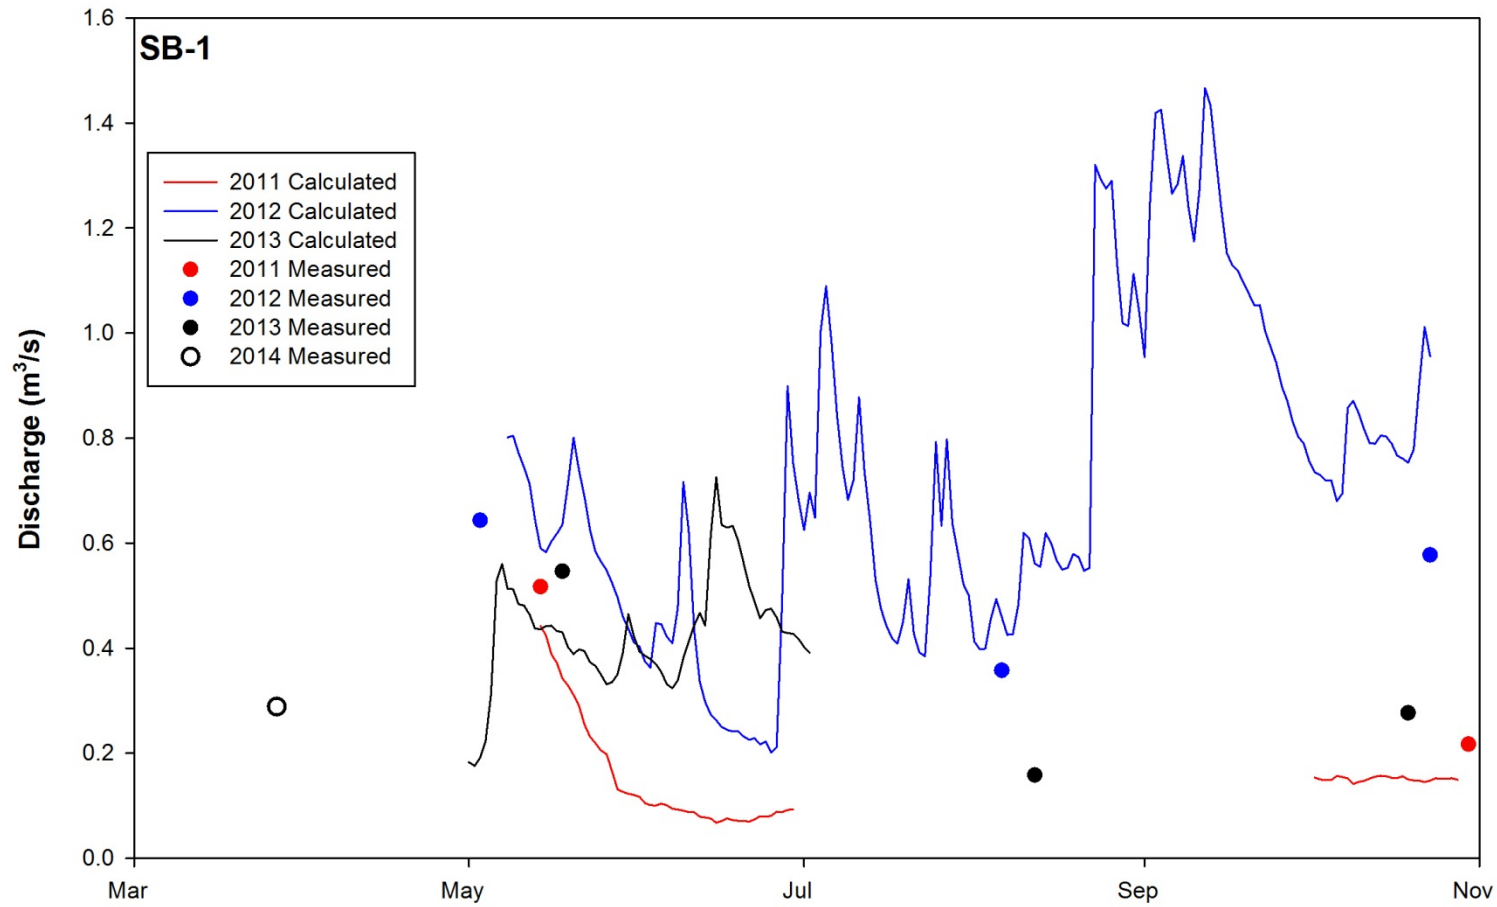
Figure D7: Measured and Calculated Discharge, Q (m^3/s), for Stream Monitoring Station SB-1.

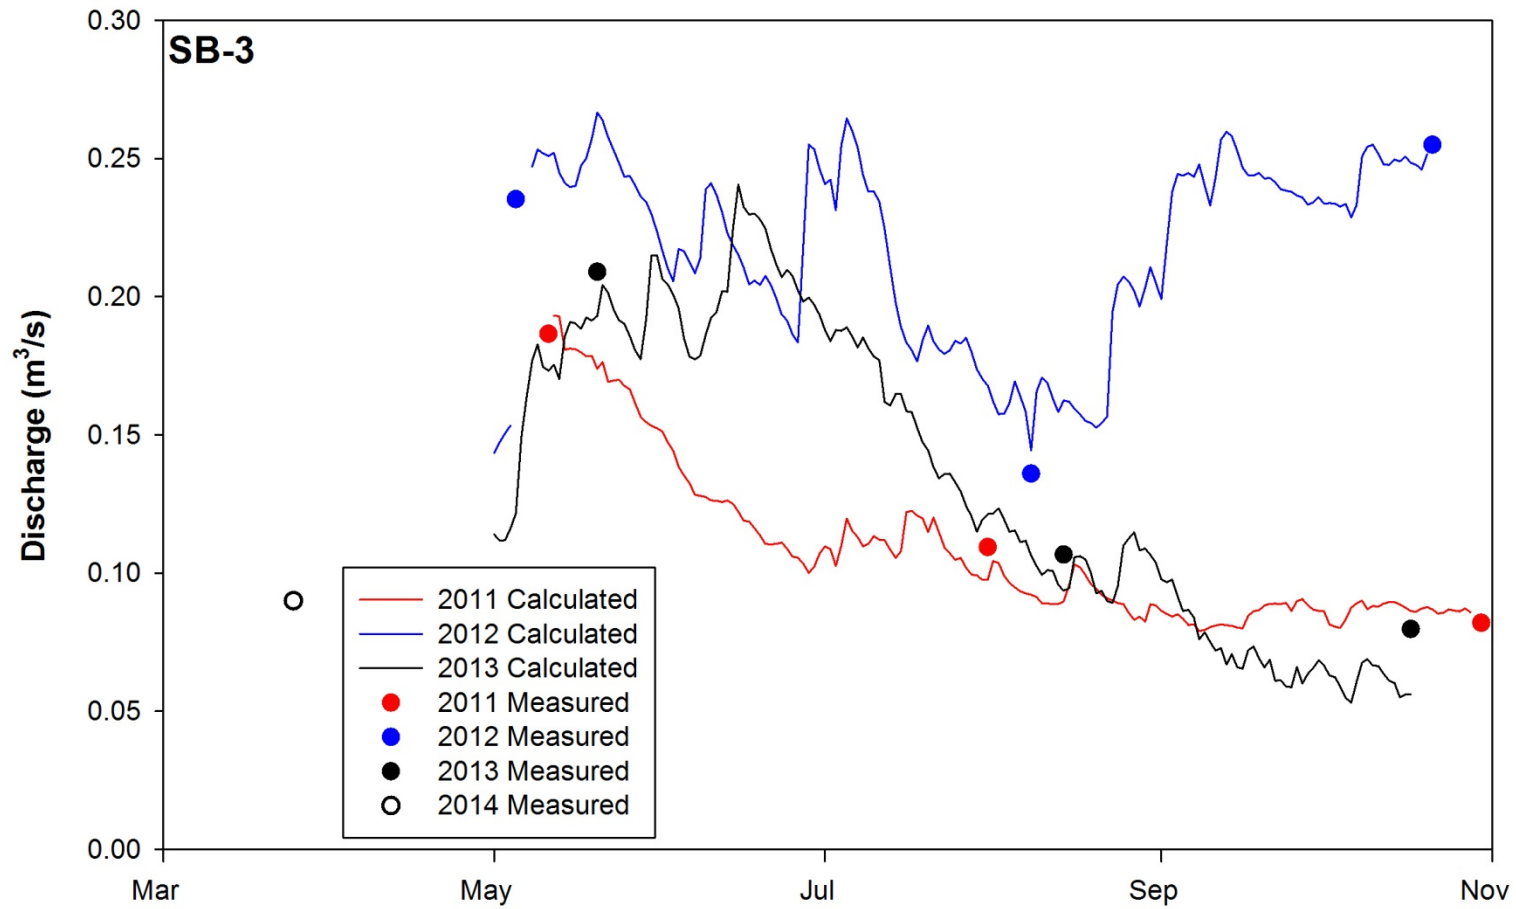
Figure D8: Measured and Calculated Discharge, Q (m^3/s), for Stream Monitoring Station SB-3.

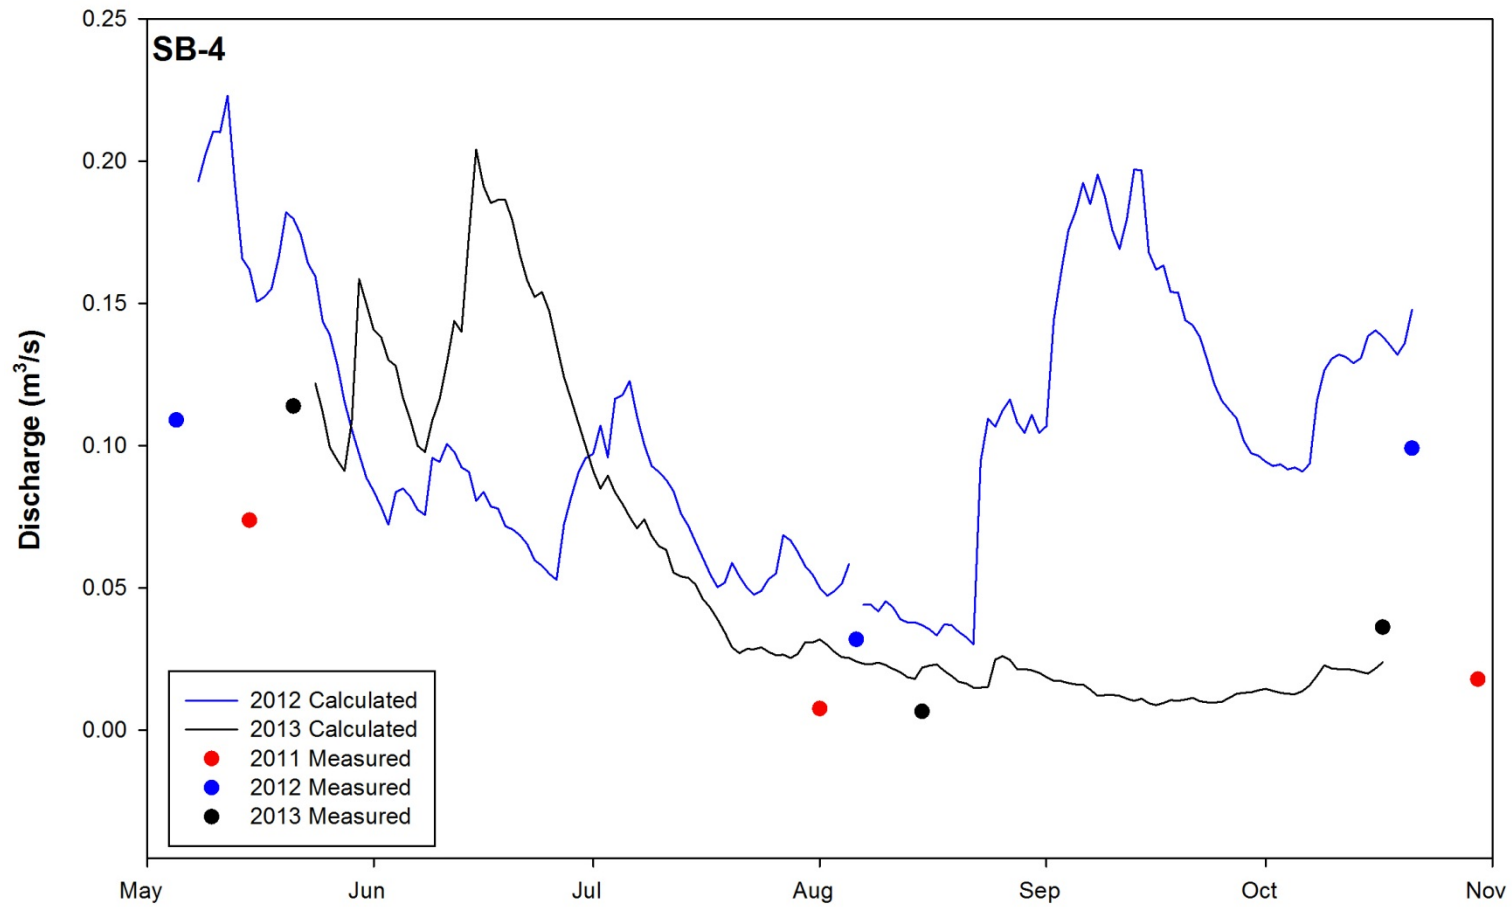
Figure D9: Measured and Calculated Discharge, Q (m^3/s), for Stream Monitoring Station SB-4.

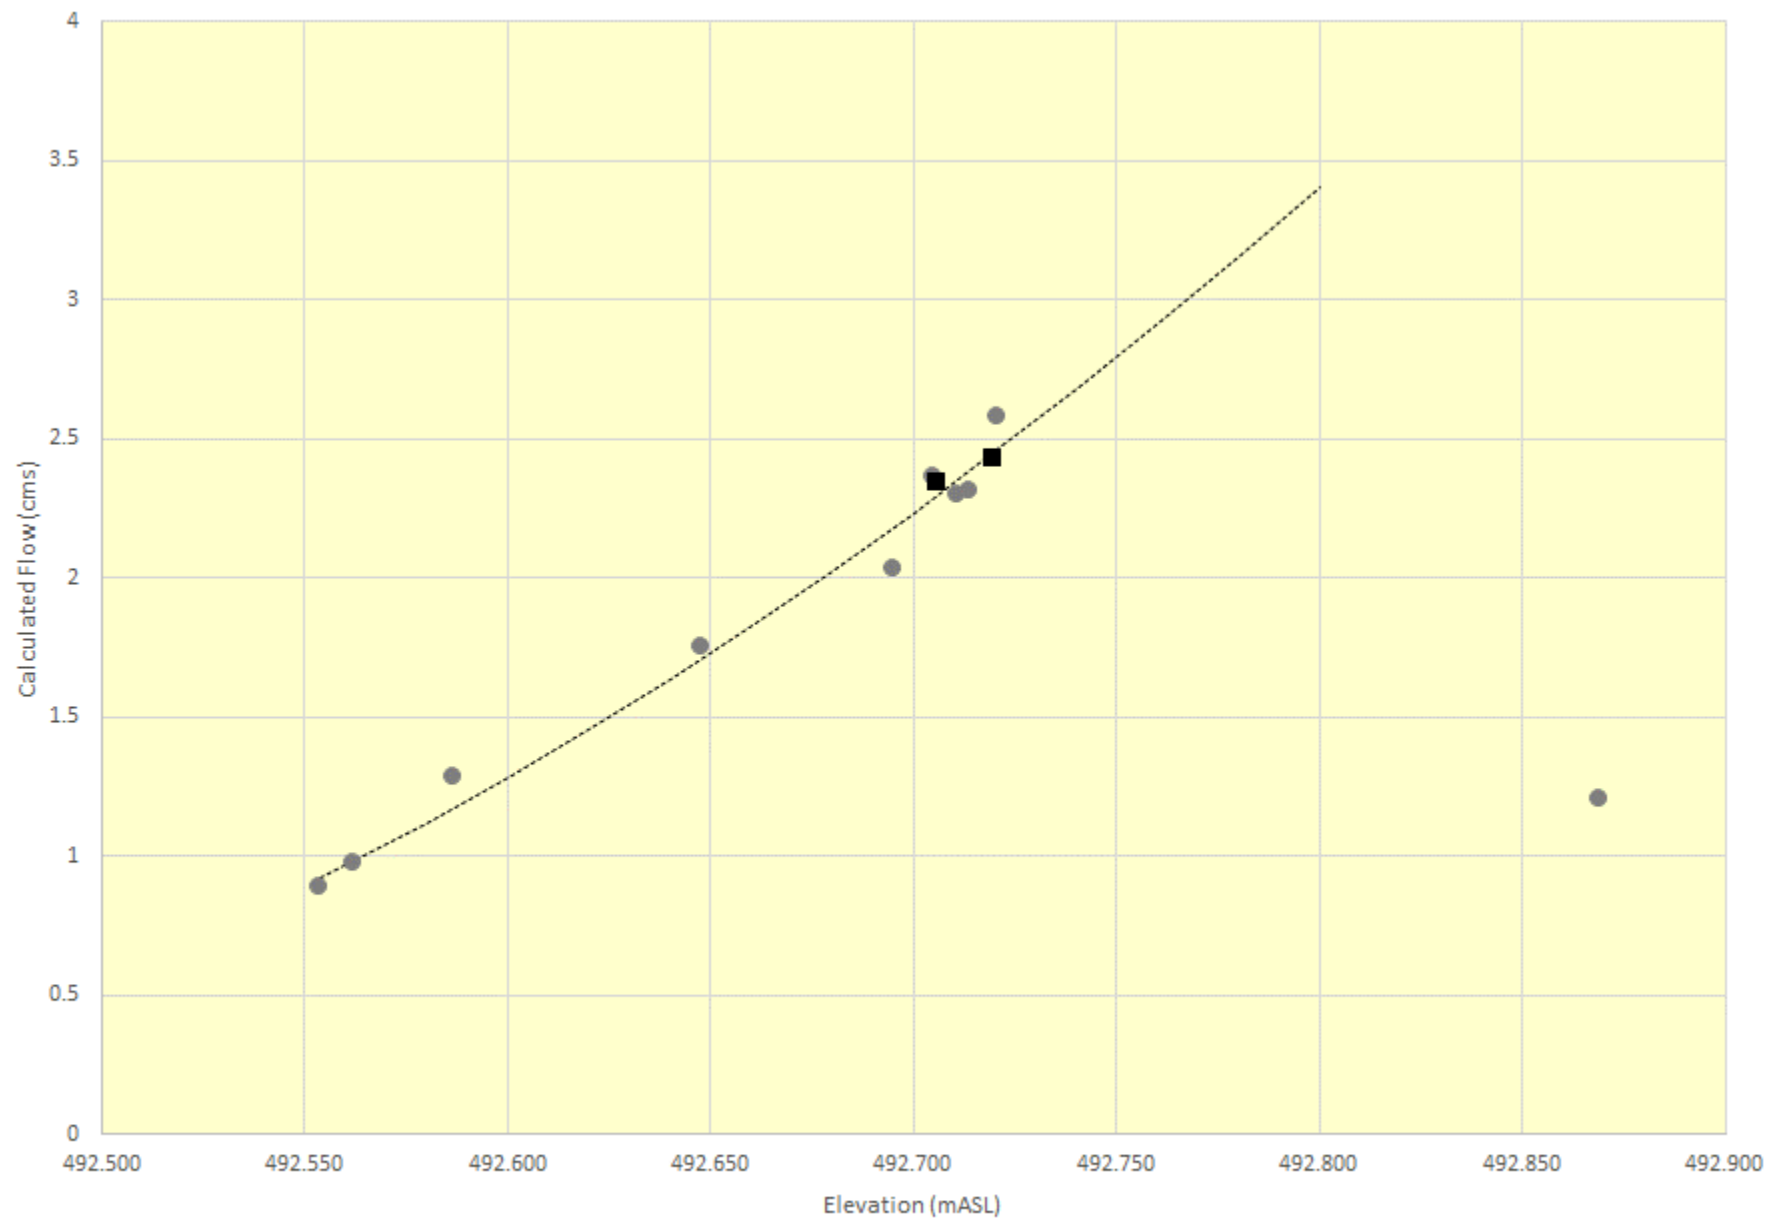
SA1 – MANUAL FLOW MEASUREMENTS AND RATING CURVE
