Wheeler River Project

Final Environmental
Impact Statement

**2011 – 2019 BASELINE
HYDROLOGY SUMMARY
REPORT - WHEELER RIVER
PROJECT, DENISON MINES**

Ref. 19-2589
25 March 2020

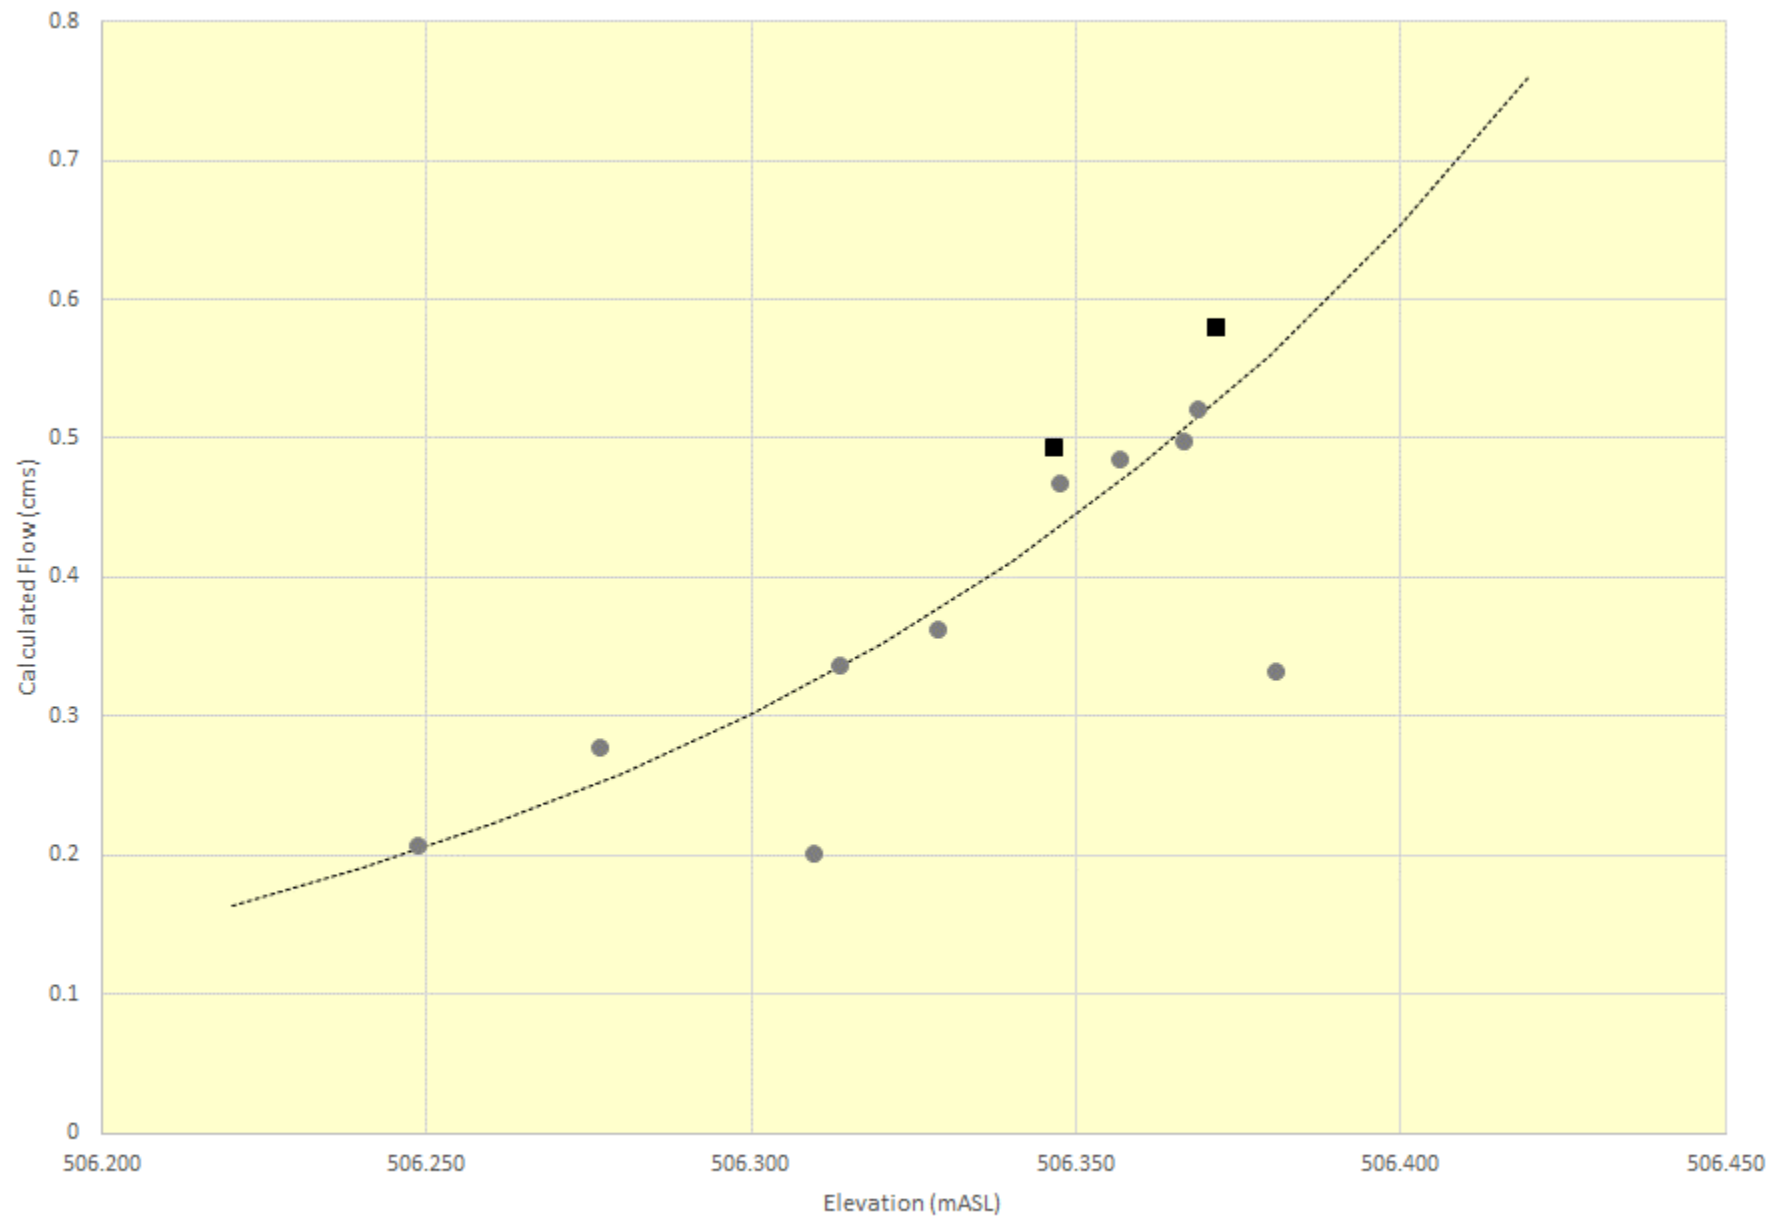
SA4 – MANUAL FLOW MEASUREMENTS AND RATING CURVE

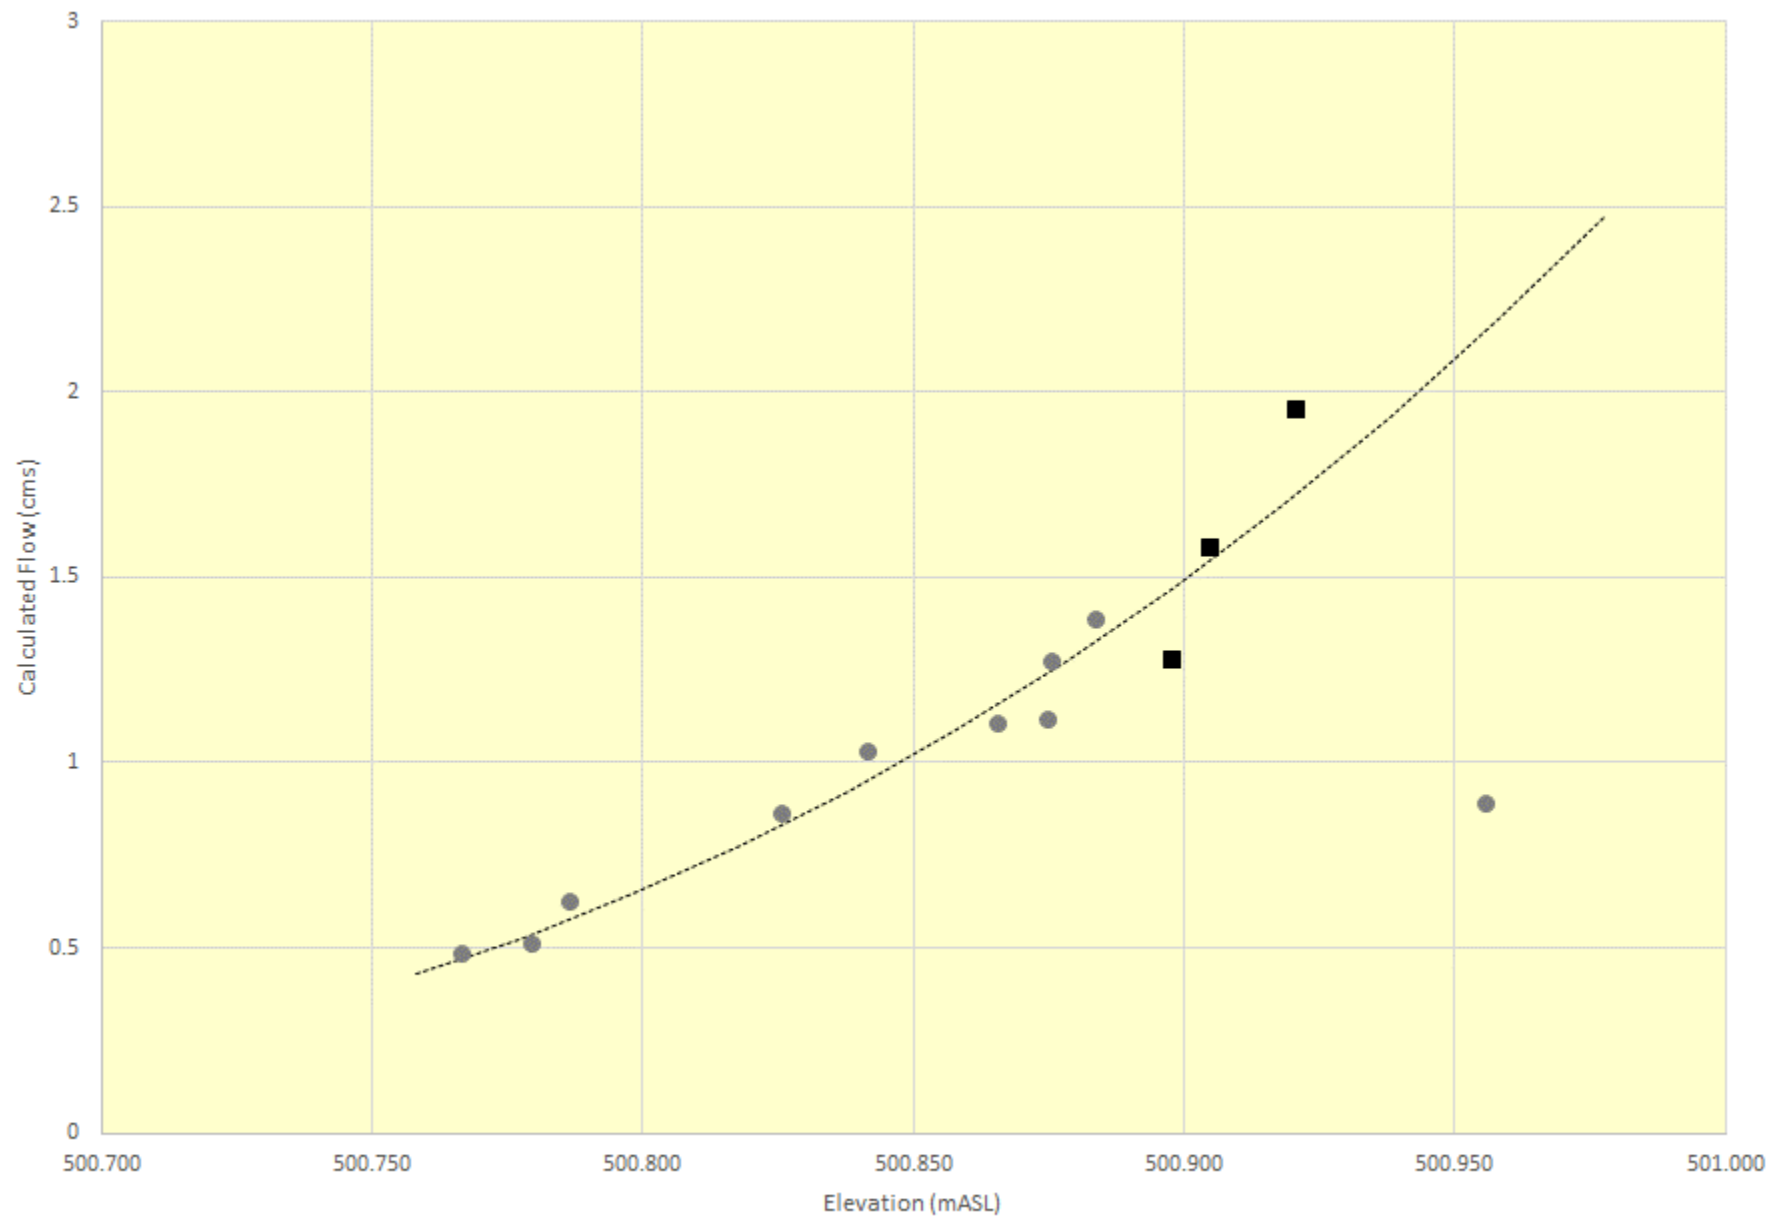
SA5 – ADJUSTED MANUAL FLOW MEASUREMENTS AND ADJUSTED RATING CURVE

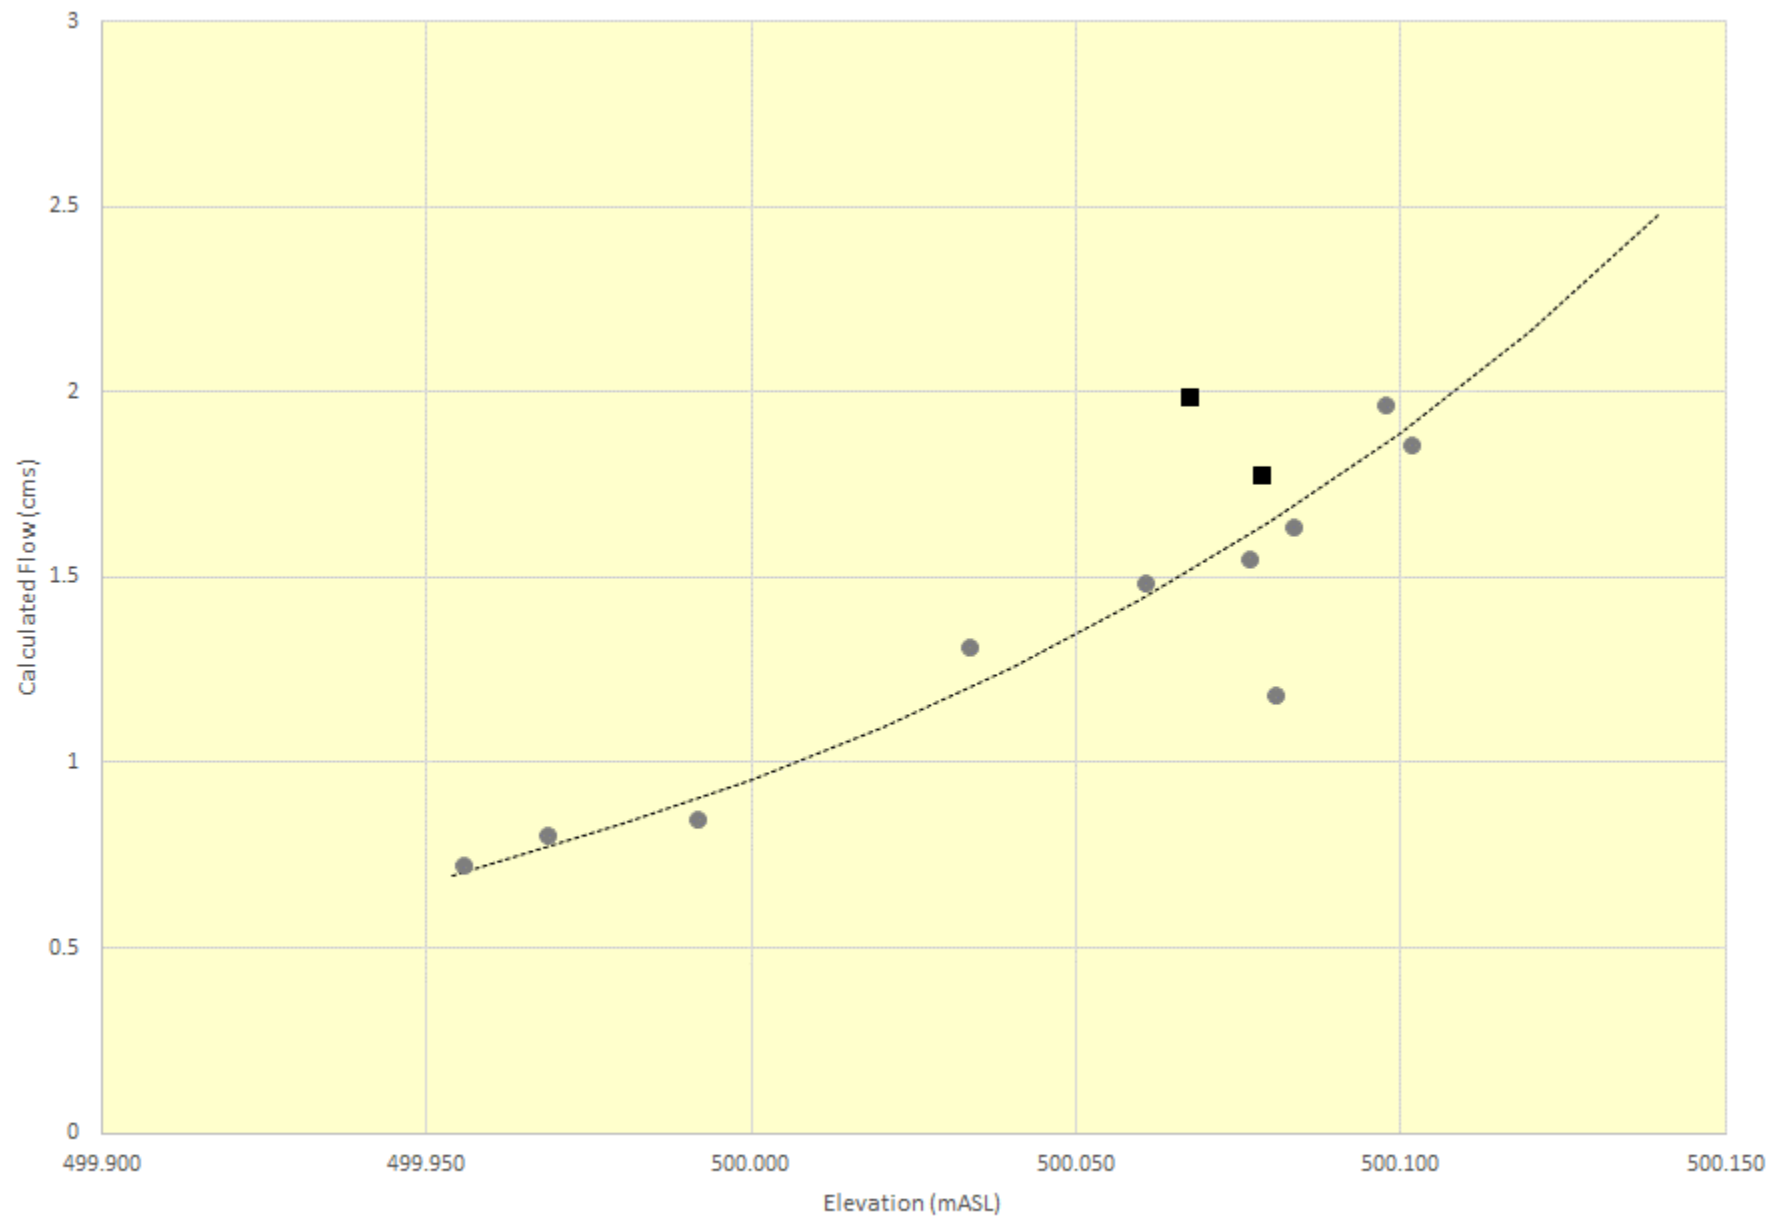
SA6 – MANUAL FLOW MEASUREMENTS AND RATING CURVE

muskeg, shrubs and black spruce. The continuous monitoring station was installed approximately halfway between LA-6 and LA-5 and is currently active. The cross-section has a width of approximately 14 m. Manual stream measurements at SA-6 have yielded a fair stage-discharge relationship. The level data logger was replaced in 2019 due to battery life.

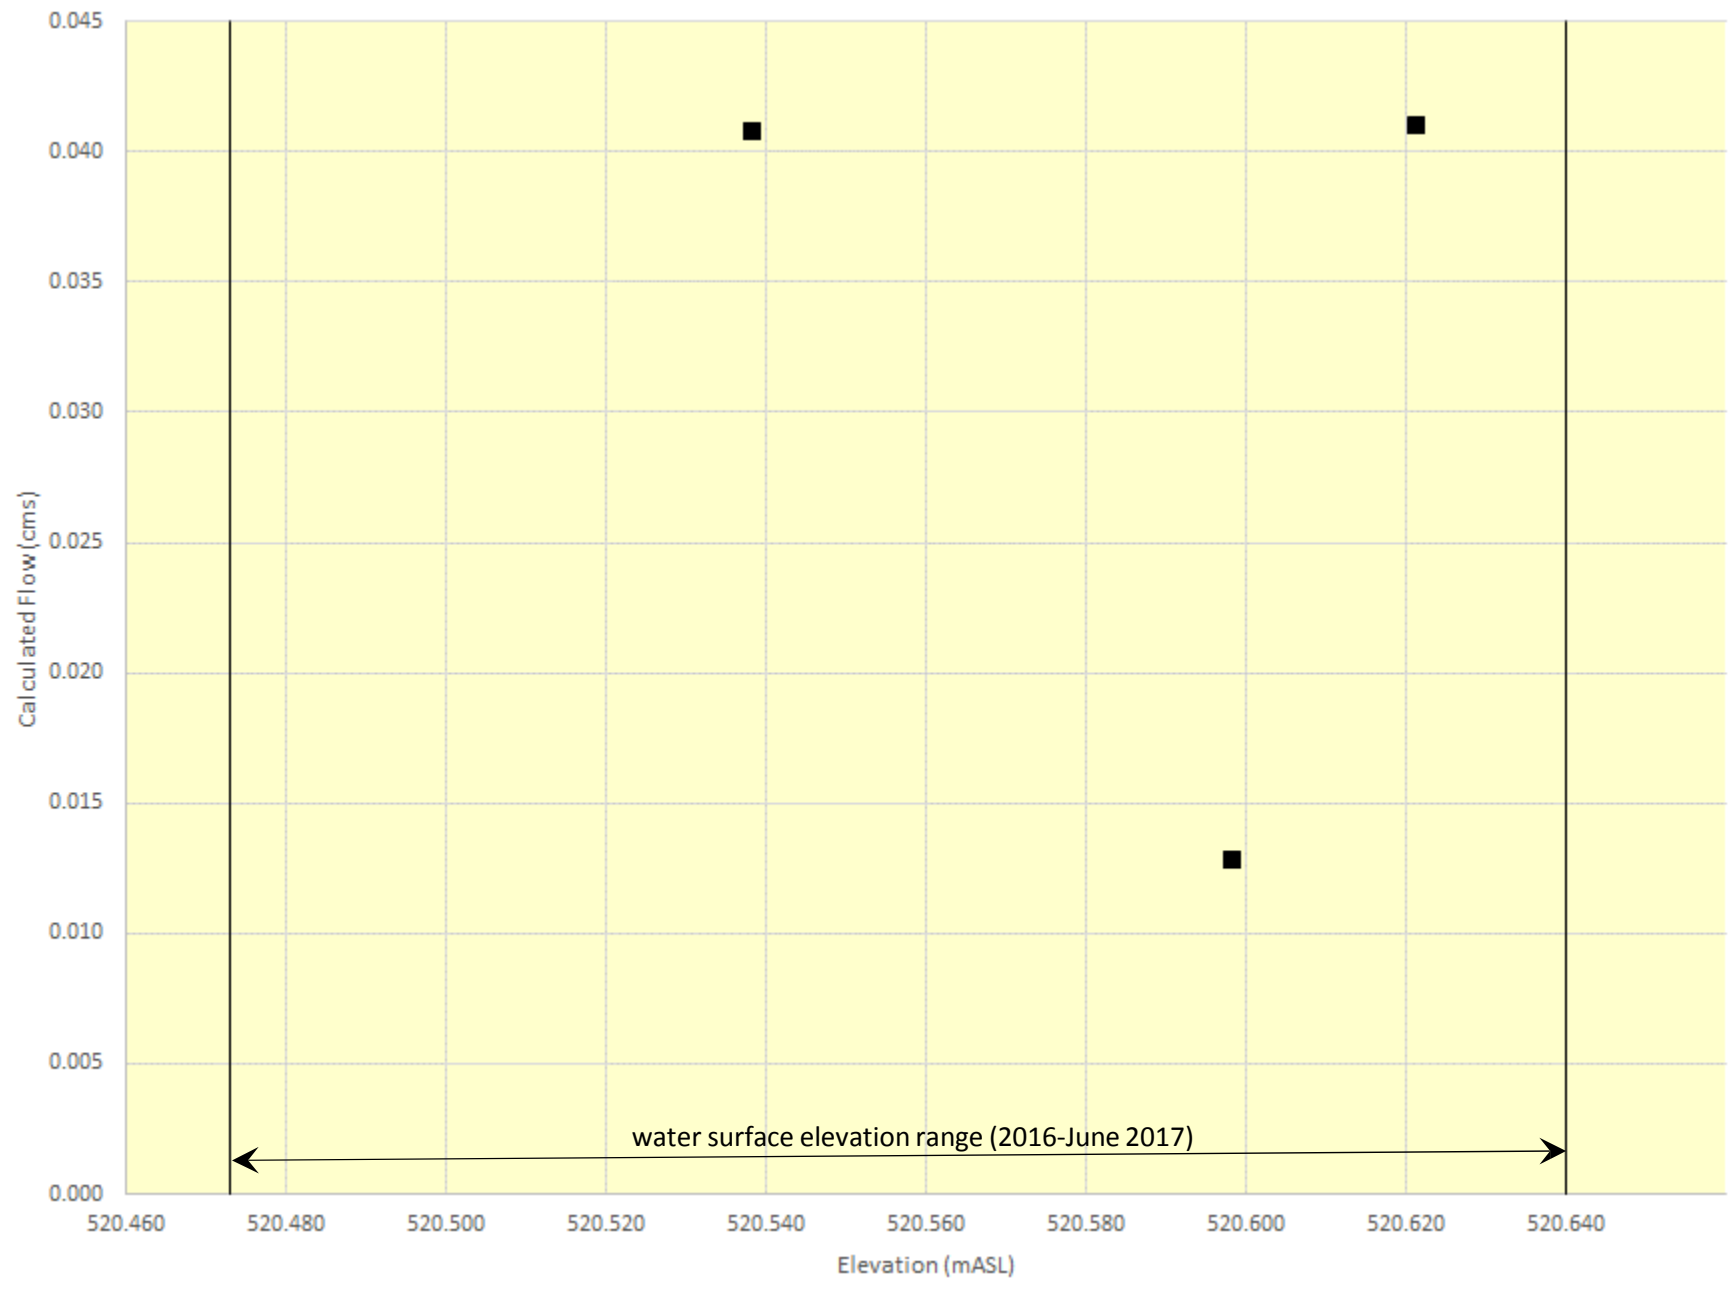
SA8 – MANUAL FLOW MEASUREMENTS

Streamflow station SA-8 is located in an inlet channel at the northwestern end of Kratchkowsky Lake. It is a meandering, narrow sandy bottom stream with deep banks. Some areas of the bank are undercut. The continuous monitoring station was installed in a relatively straight, faster flowing section of the channel immediately upstream of the lake in September 2016. In 2019, it was noted that this station is subject to backwater effects owing to its proximity to the lake, and therefore the station was moved upstream ([Appendix E](#)). A rating curve has yet to be established for this station – more manual measurements that include high and low flow events are needed to establish a reliable elevation-discharge relationship.

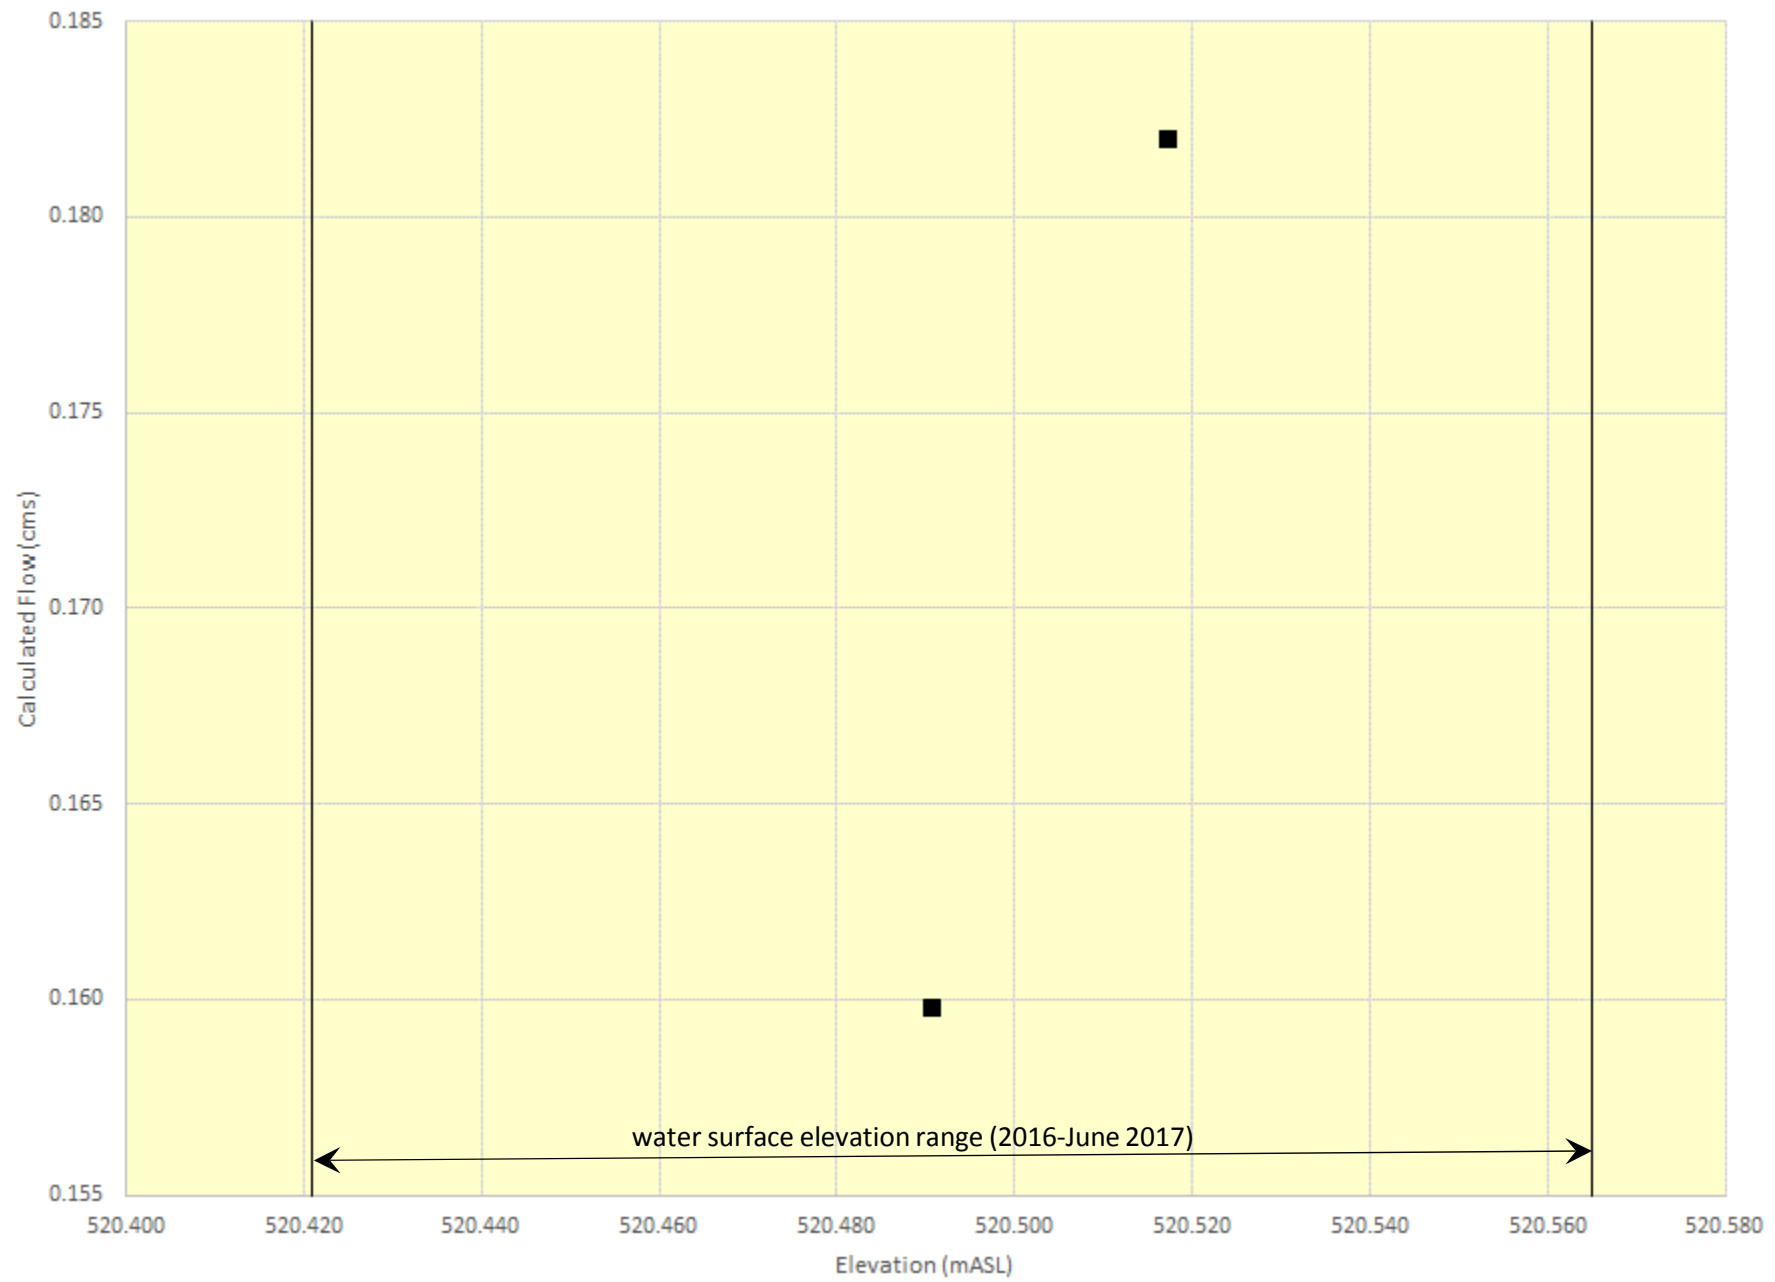
SA9 – MANUAL FLOW MEASUREMENTS

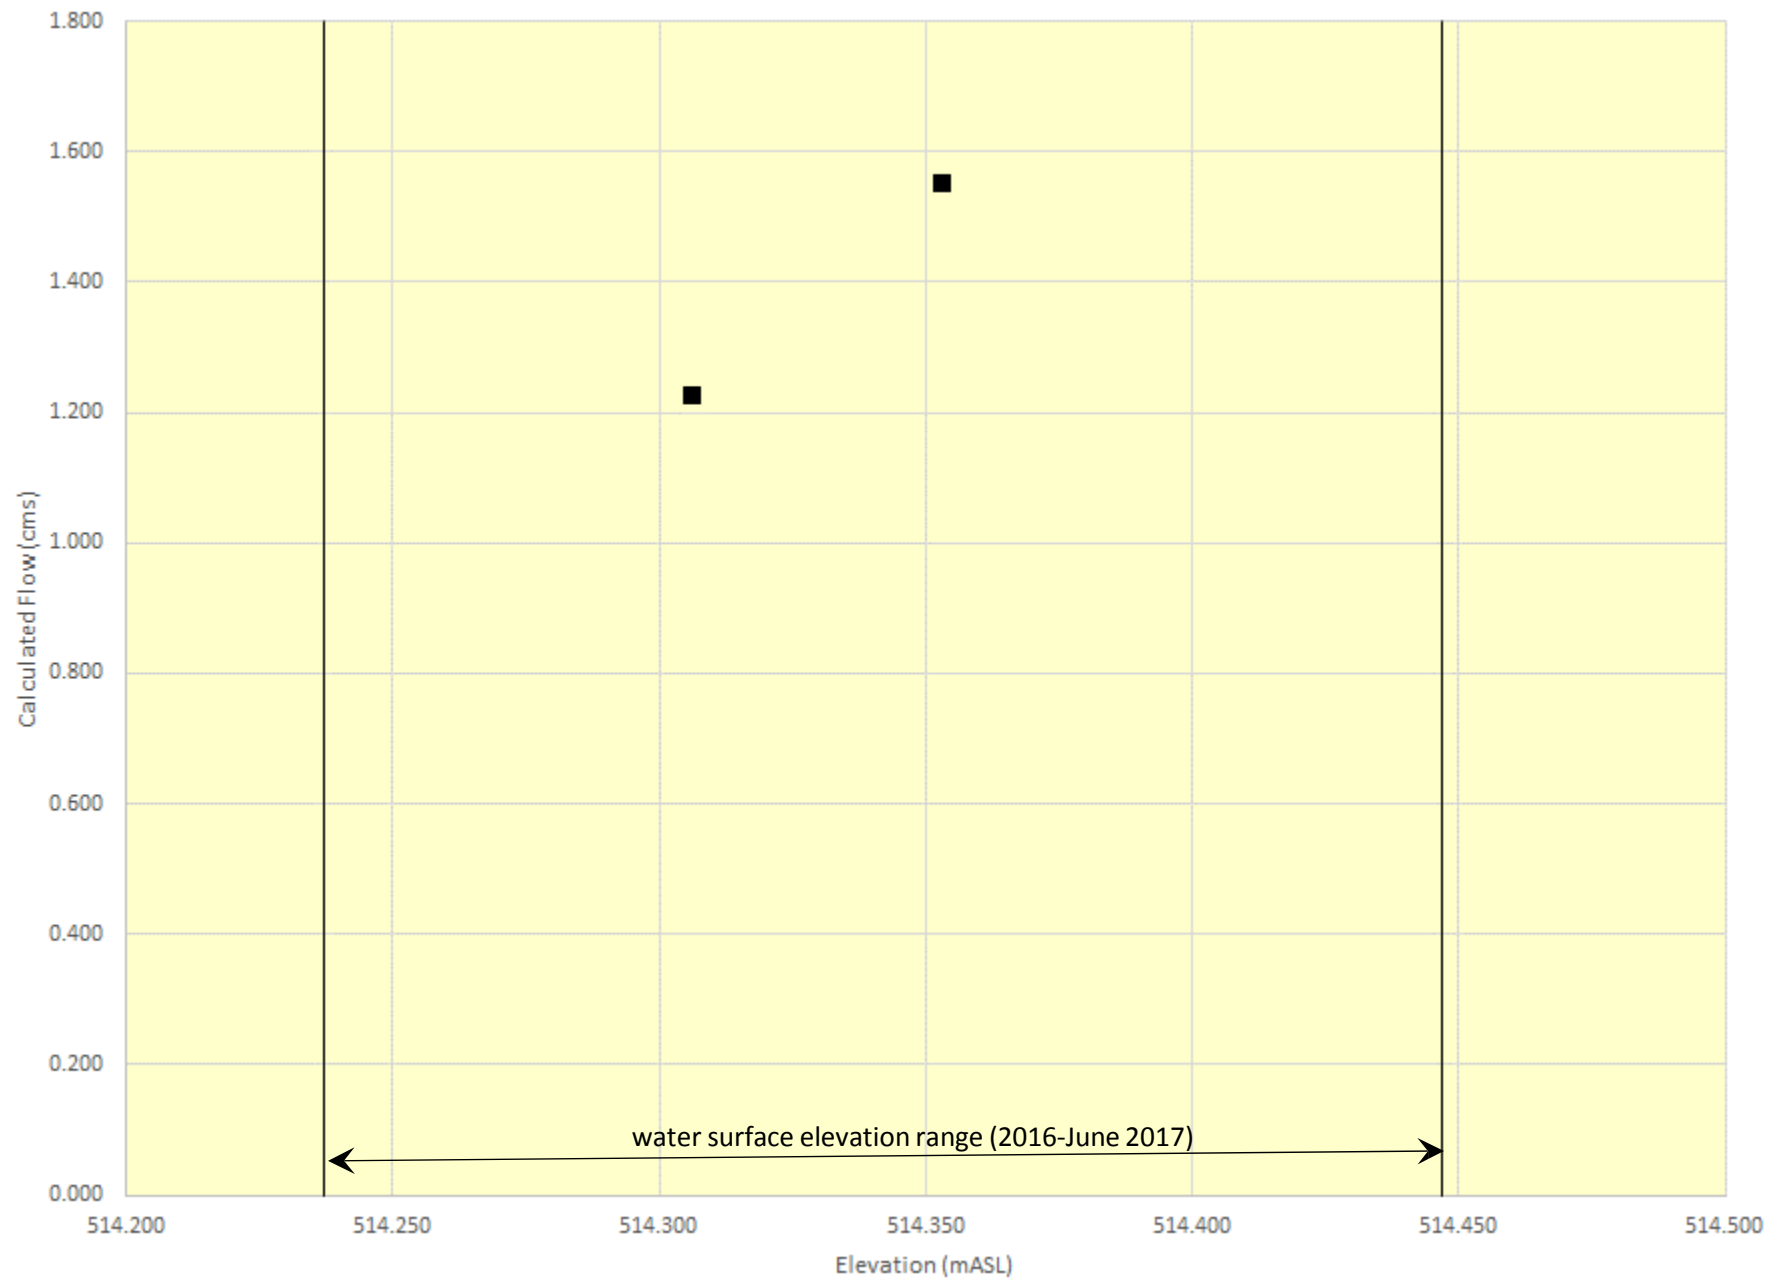
SA10 – MANUAL FLOW MEASUREMENTS

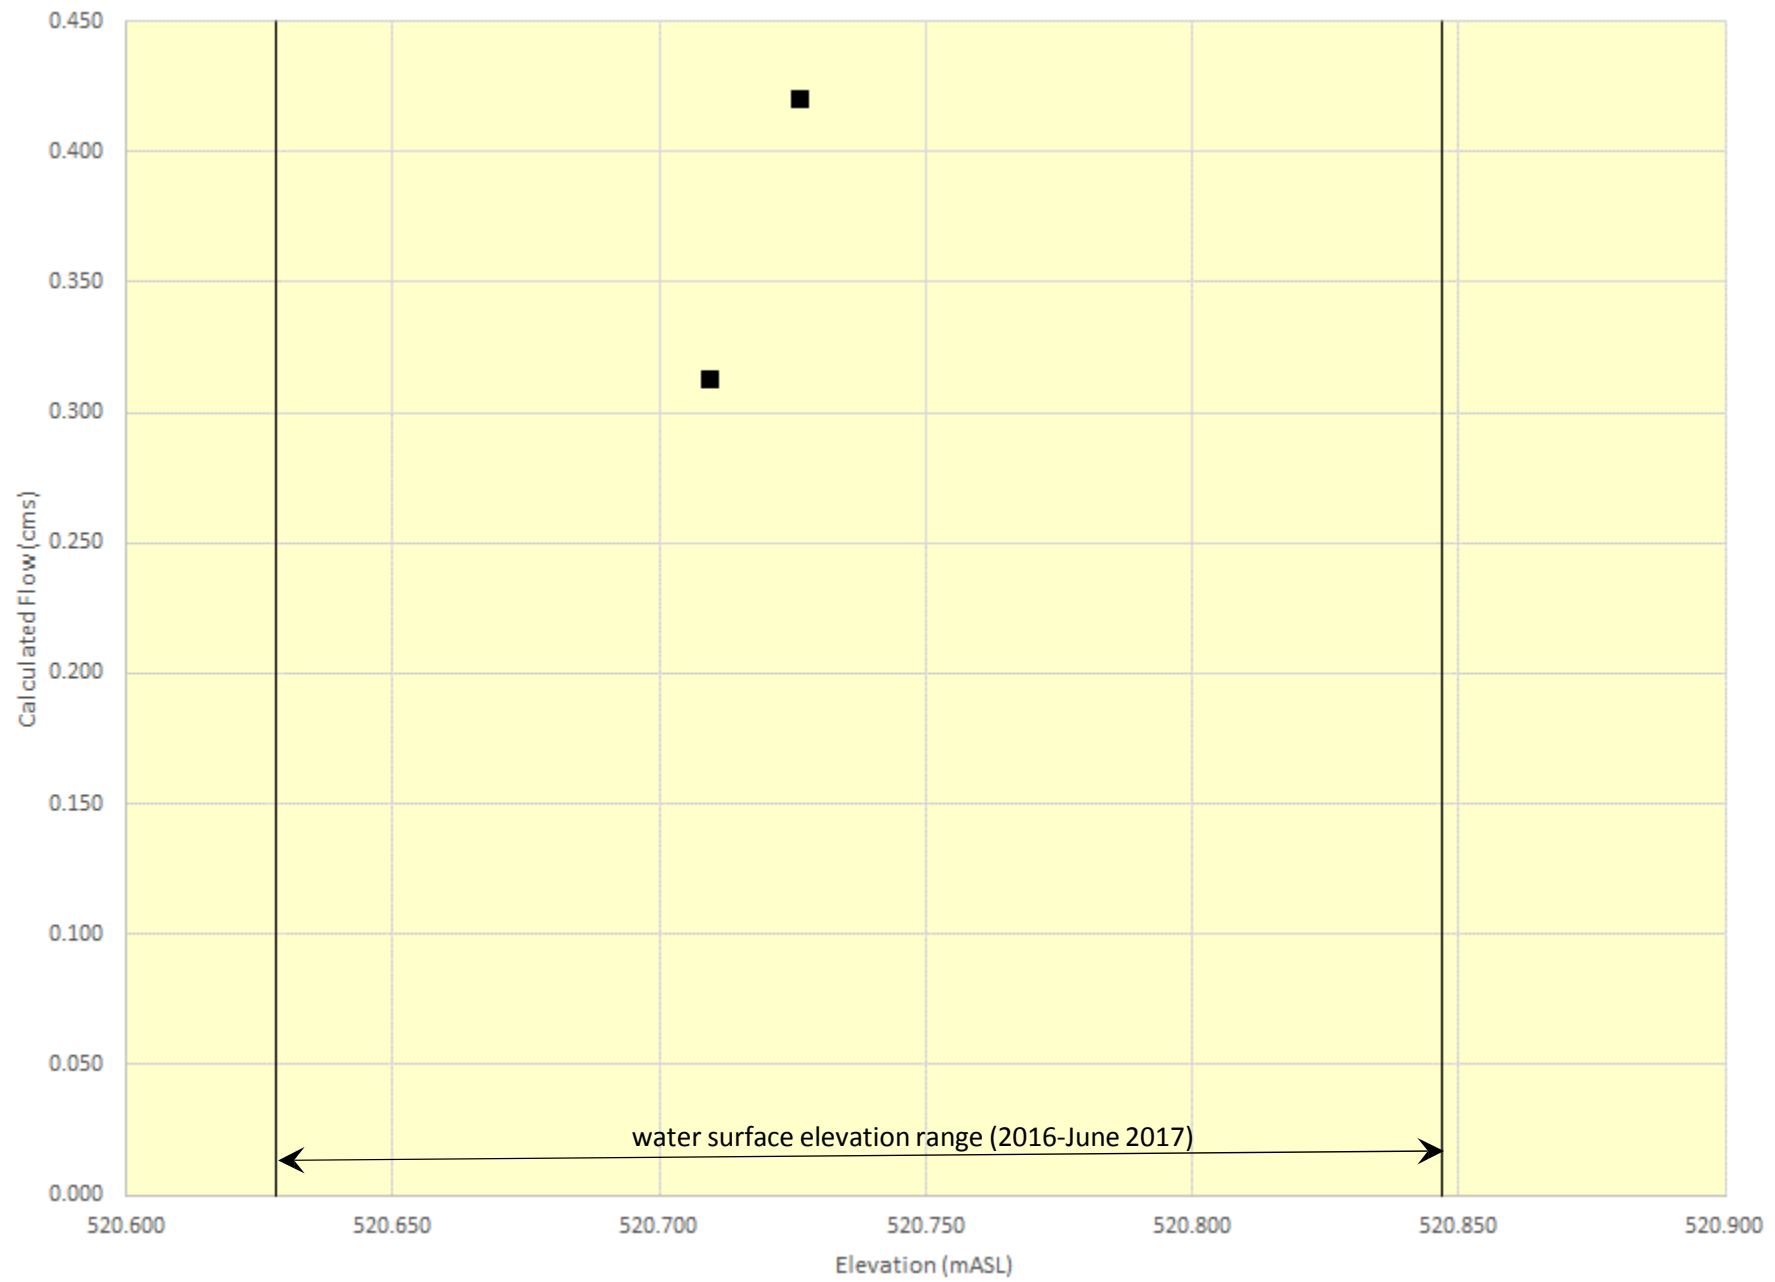
SA11 – MANUAL FLOW MEASUREMENTS

SA-11 is located at the northern-most inlet to Kratchkowsky Lake, and serves as a replacement station for SA-7. The stream substrate is comprised primarily of gravel and cobbles. The stream channel here is braided, though the monitoring station was located in an unbraided section immediately upstream of the lake. A level data logger was installed in September 2016, and is still recording continuous water level data. A preliminary stage and discharge relationship was developed in 2019 ([Appendix E](#)).

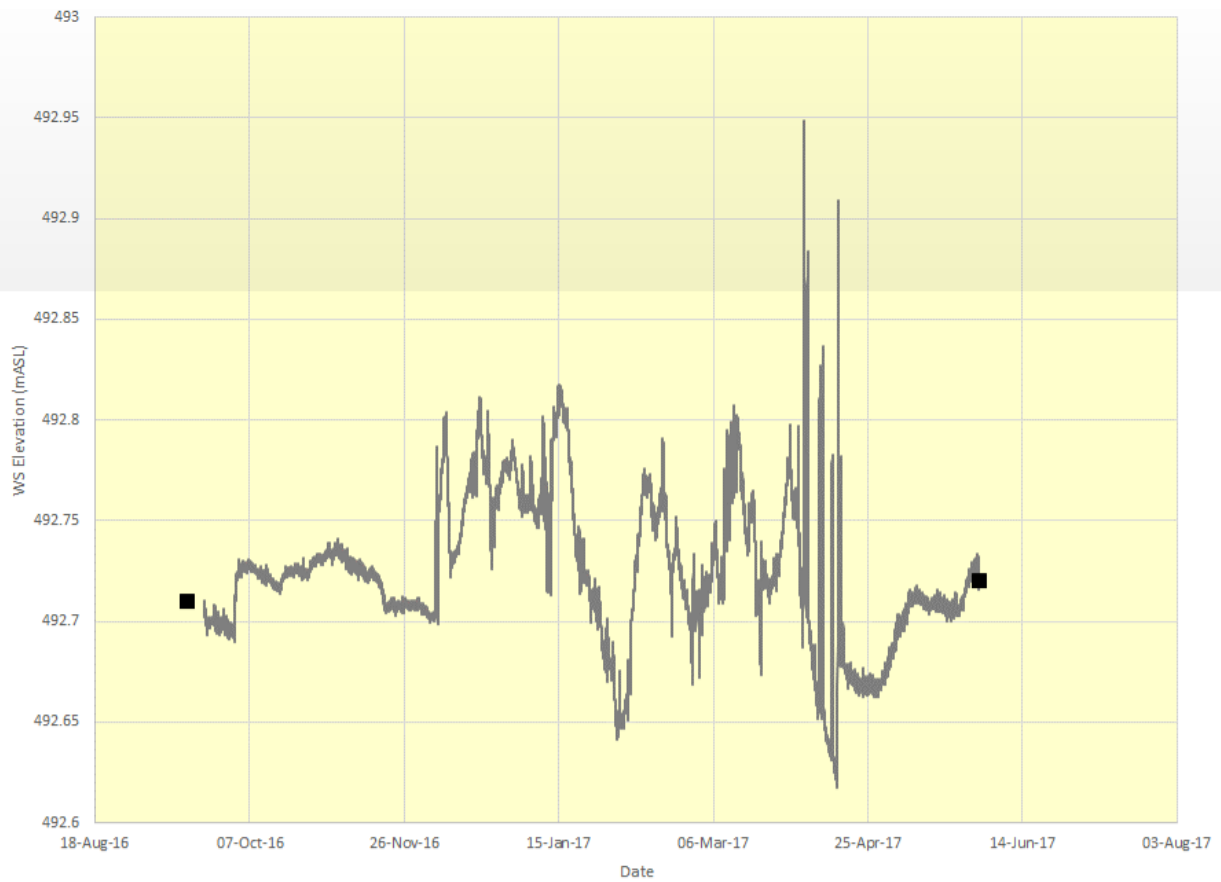
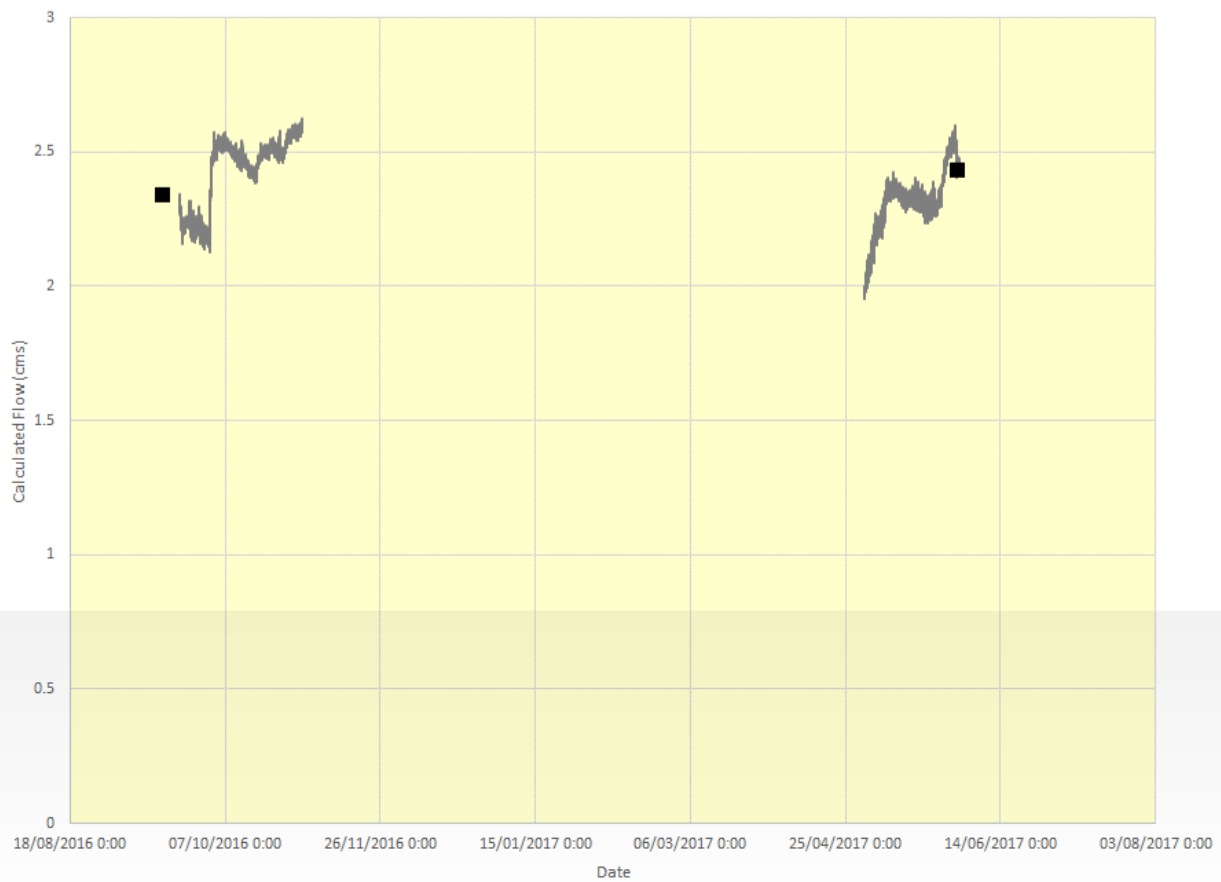
SA1 – Elevation and Discharge (September 2016 to June 2017)

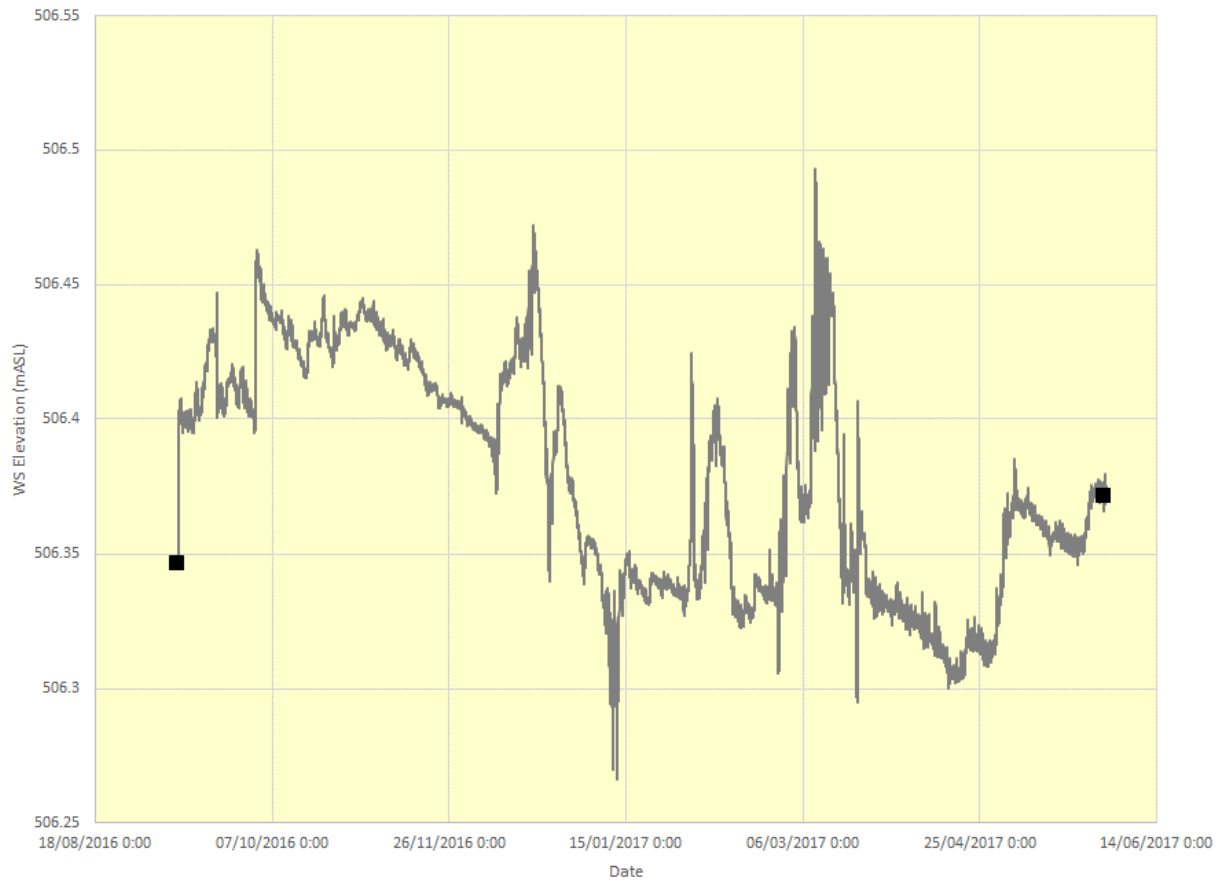
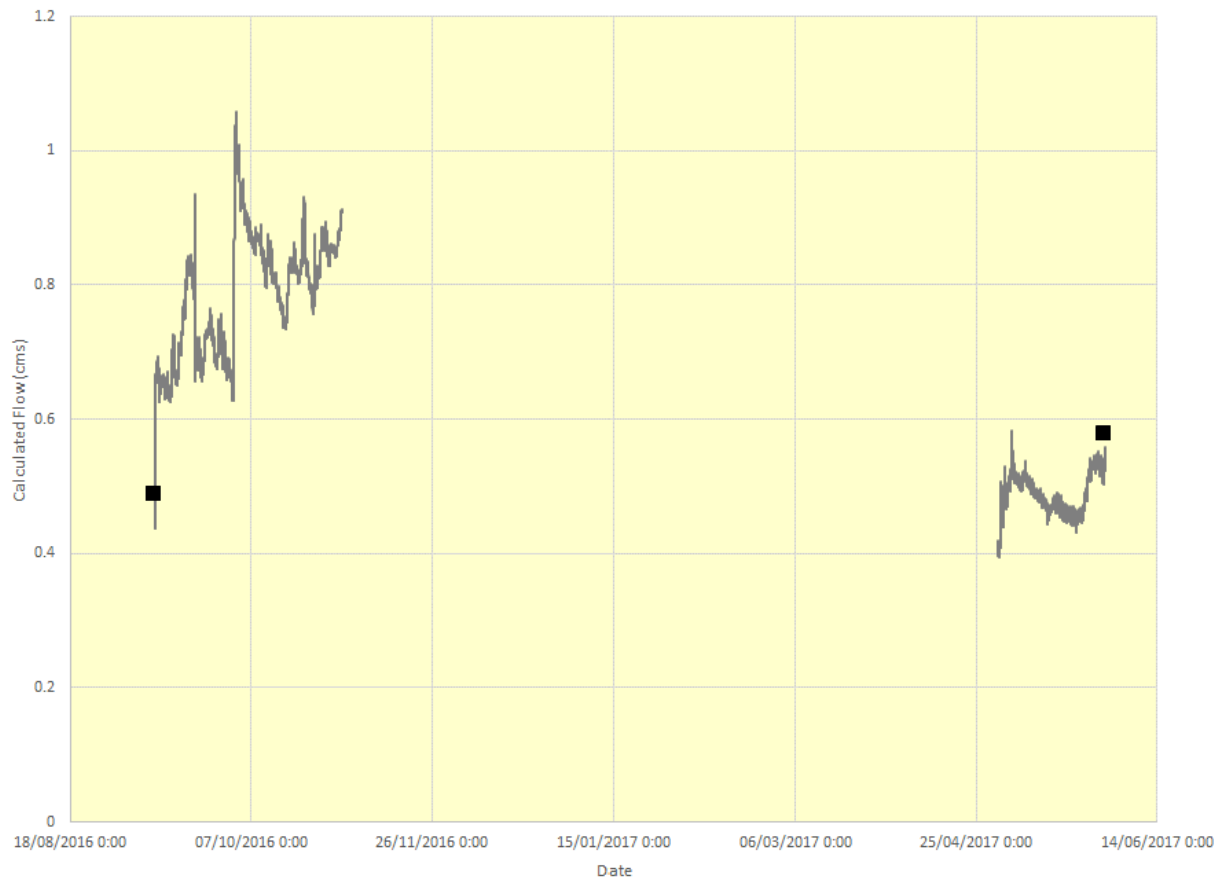
SA4 – Elevation and Discharge (September 2016 to June 2017)

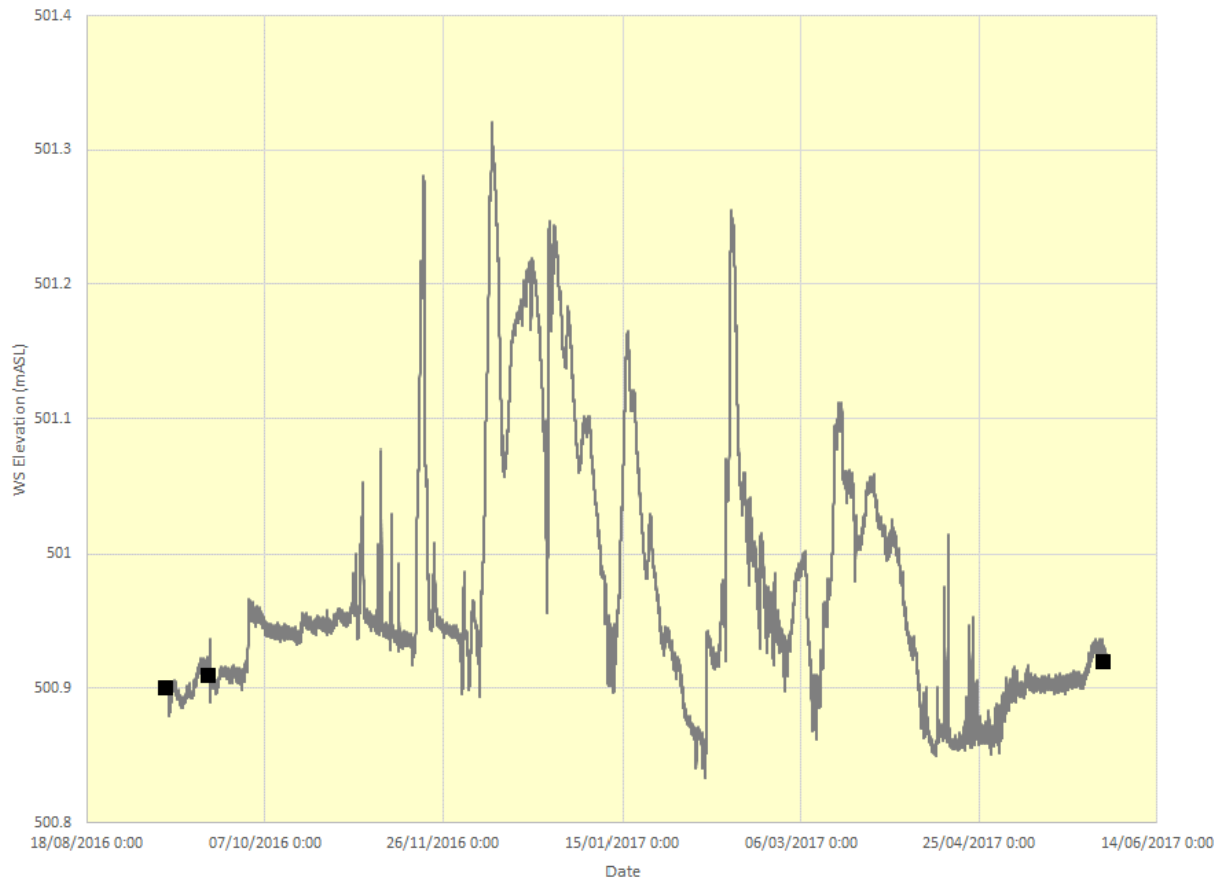
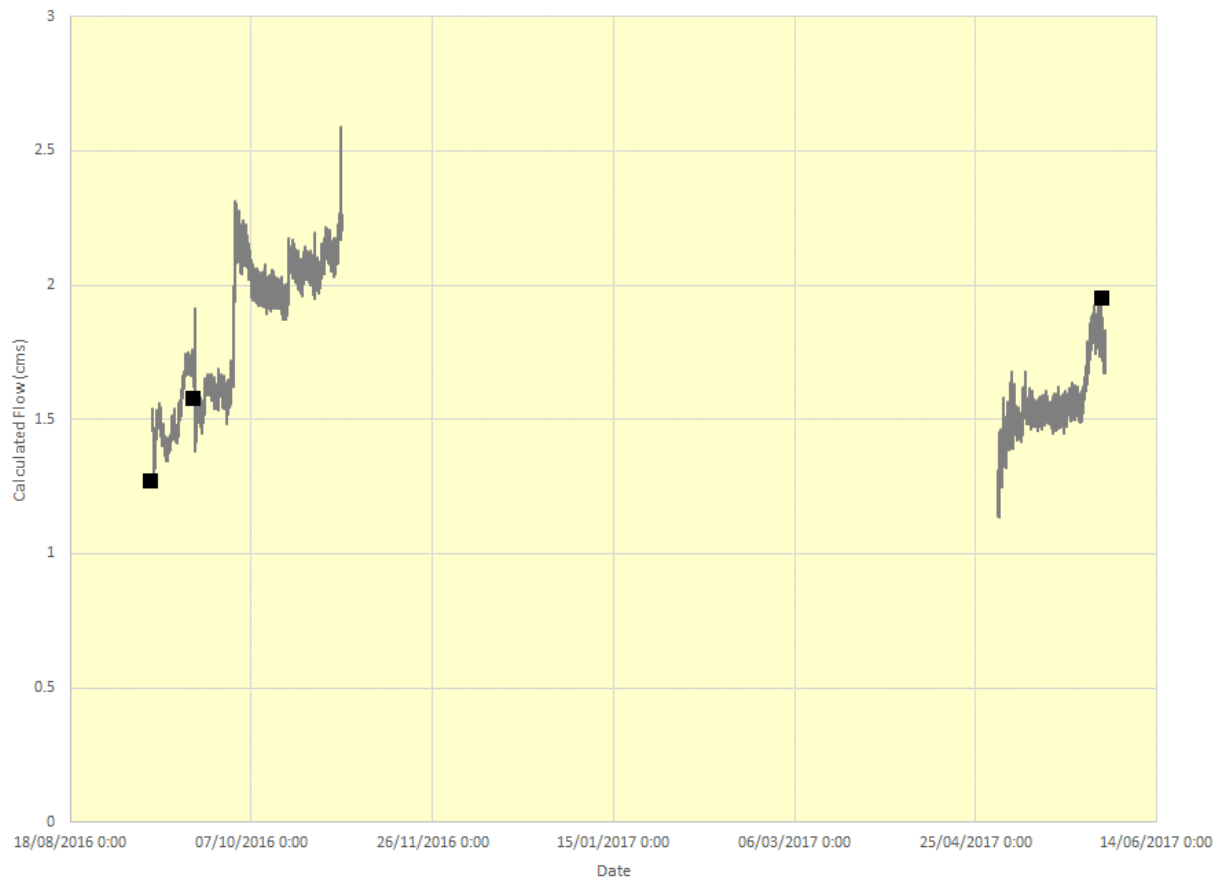
SA5 – Elevation and Discharge (September 2016 to June 2017)
