Wheeler River Project

Final Environmental
Impact Statement

**2011 – 2019 BASELINE
HYDROLOGY SUMMARY
REPORT - WHEELER RIVER
PROJECT, DENISON MINES**

Ref. 19-2589
25 March 2020

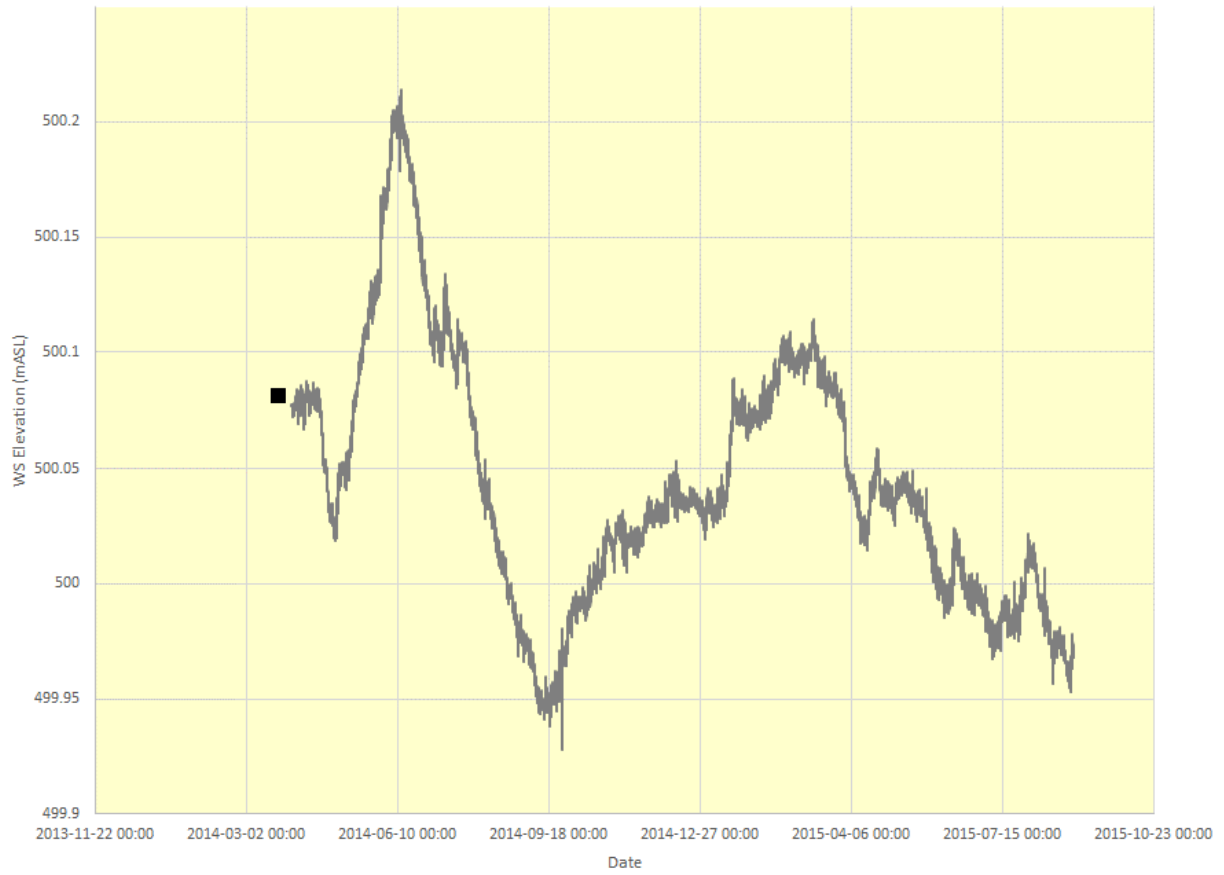
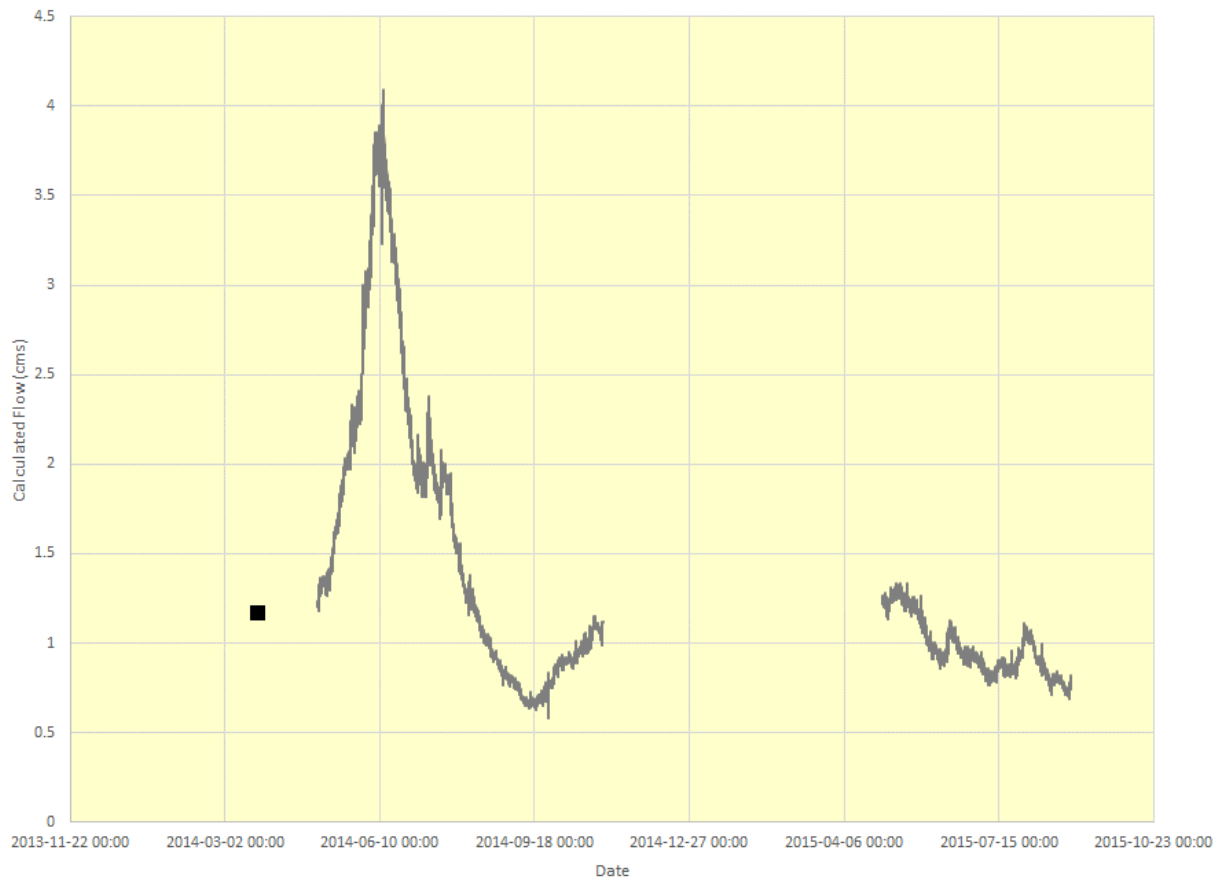
SA6 – Elevation and Discharge (March 2014 to August 2015)

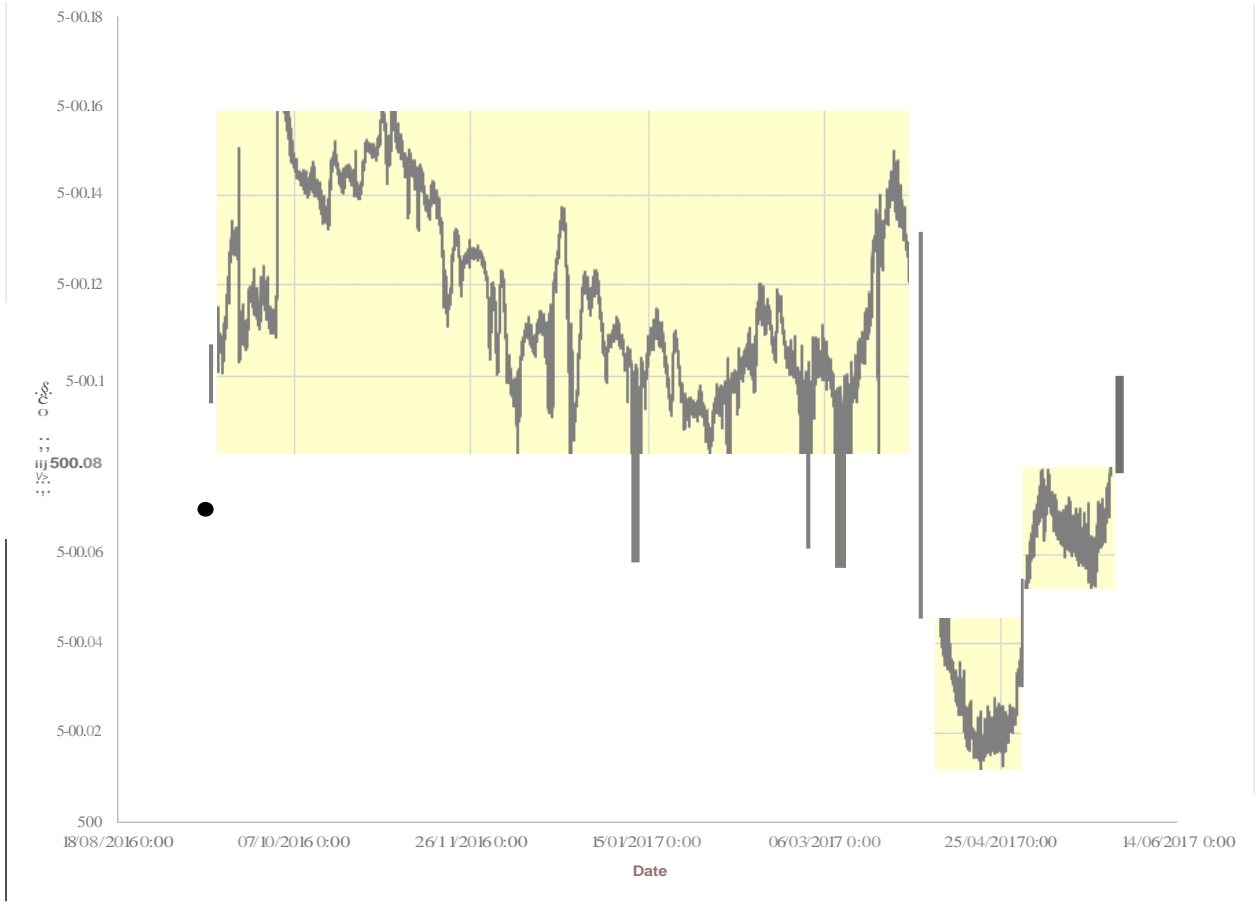
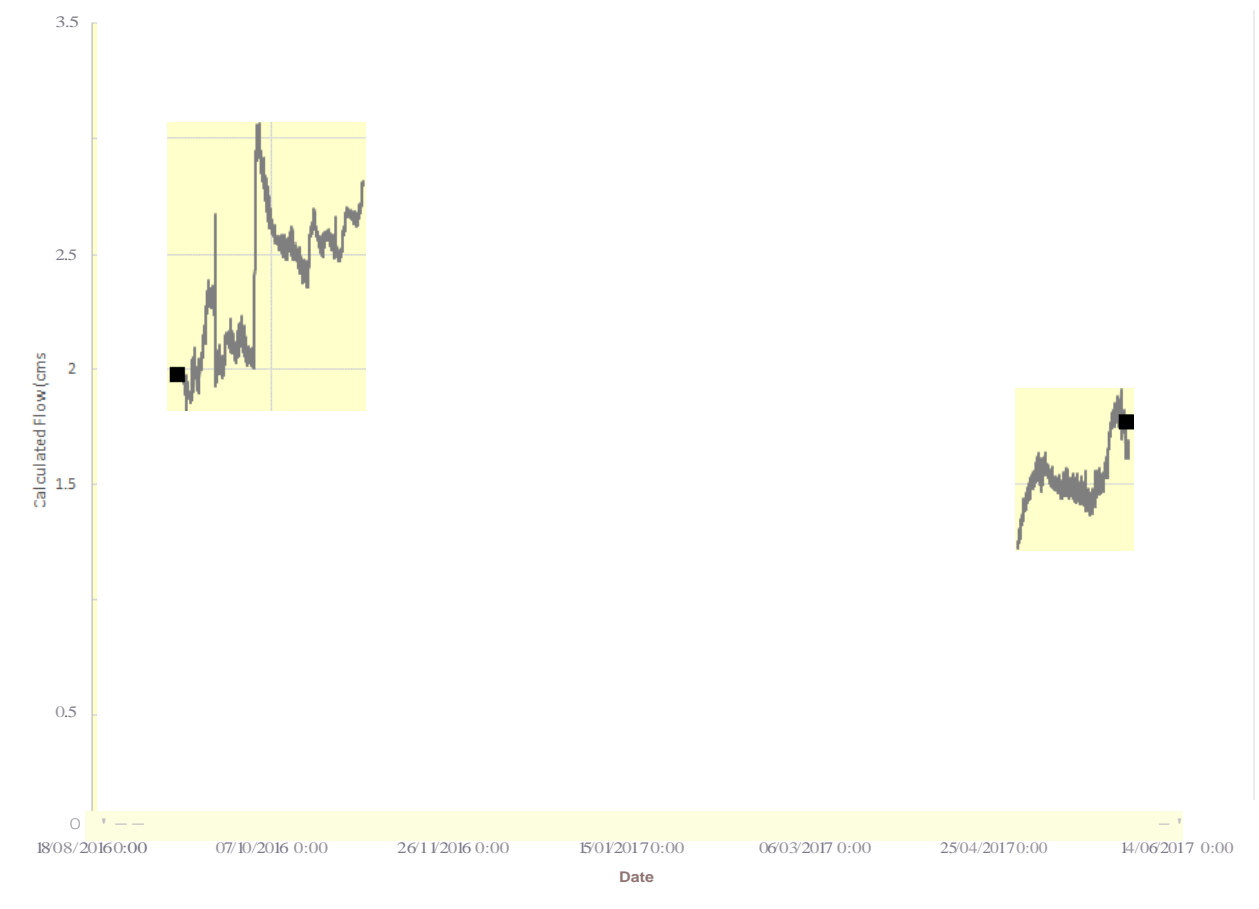
SA6 - Elevation and Discharge (September 2016 to June 2017)

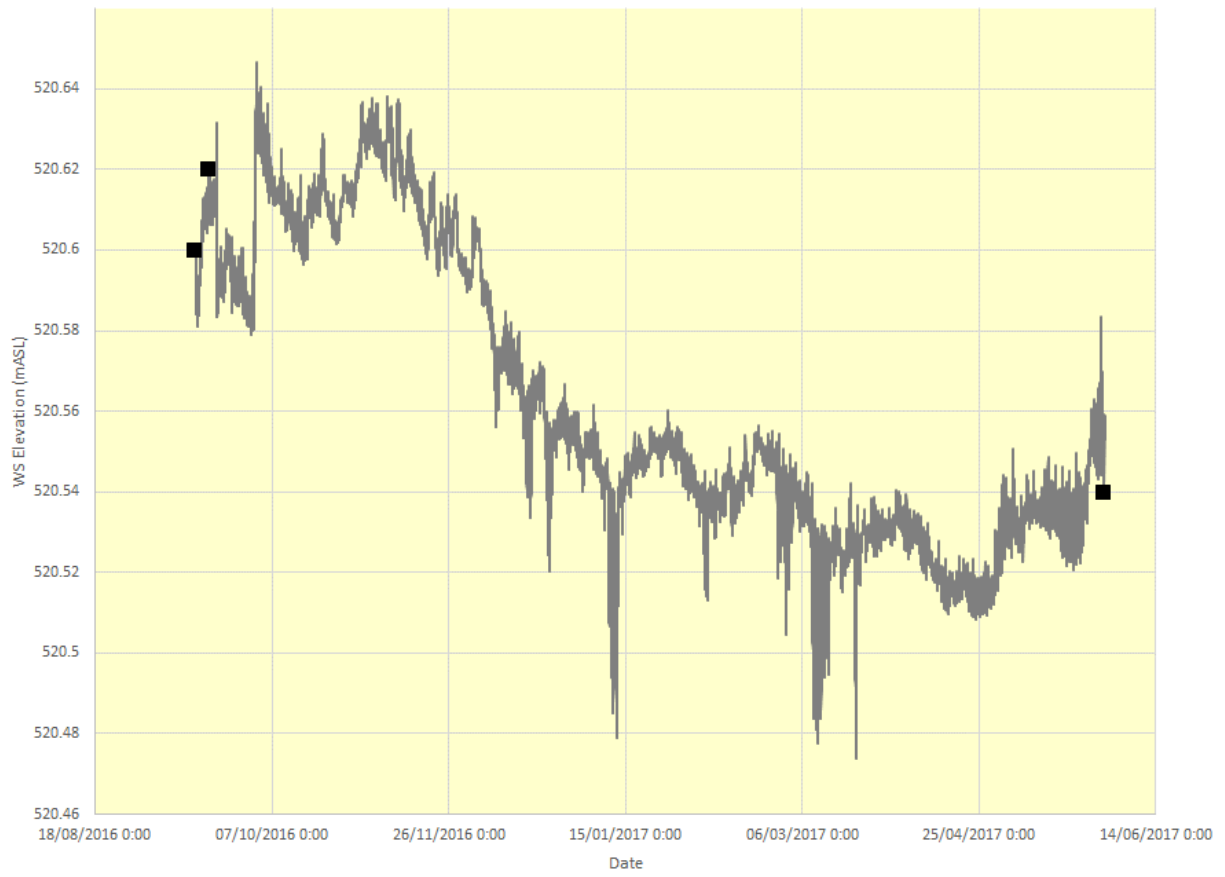
SA8 – Elevation (September 2016 to June 2017)

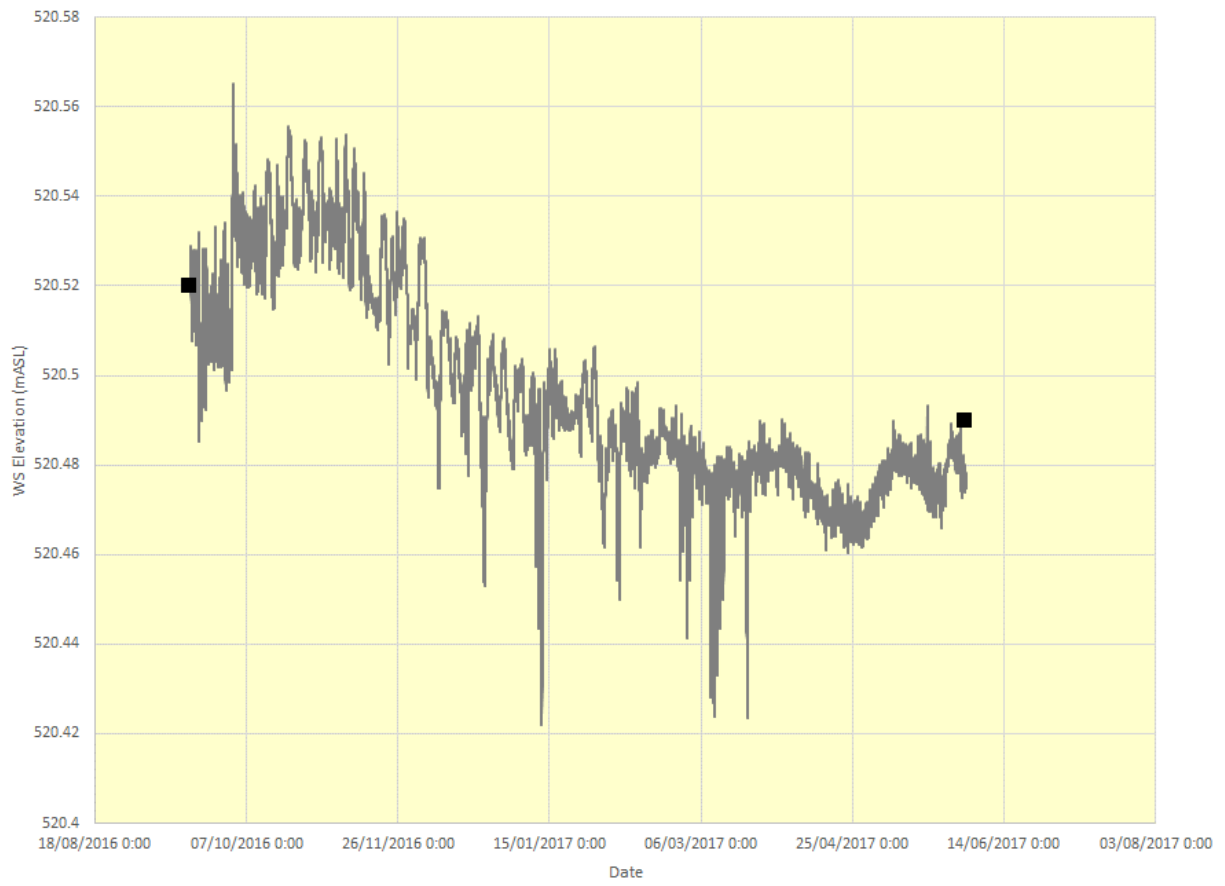
SA9 – Elevation (September 2016 to June 2017)

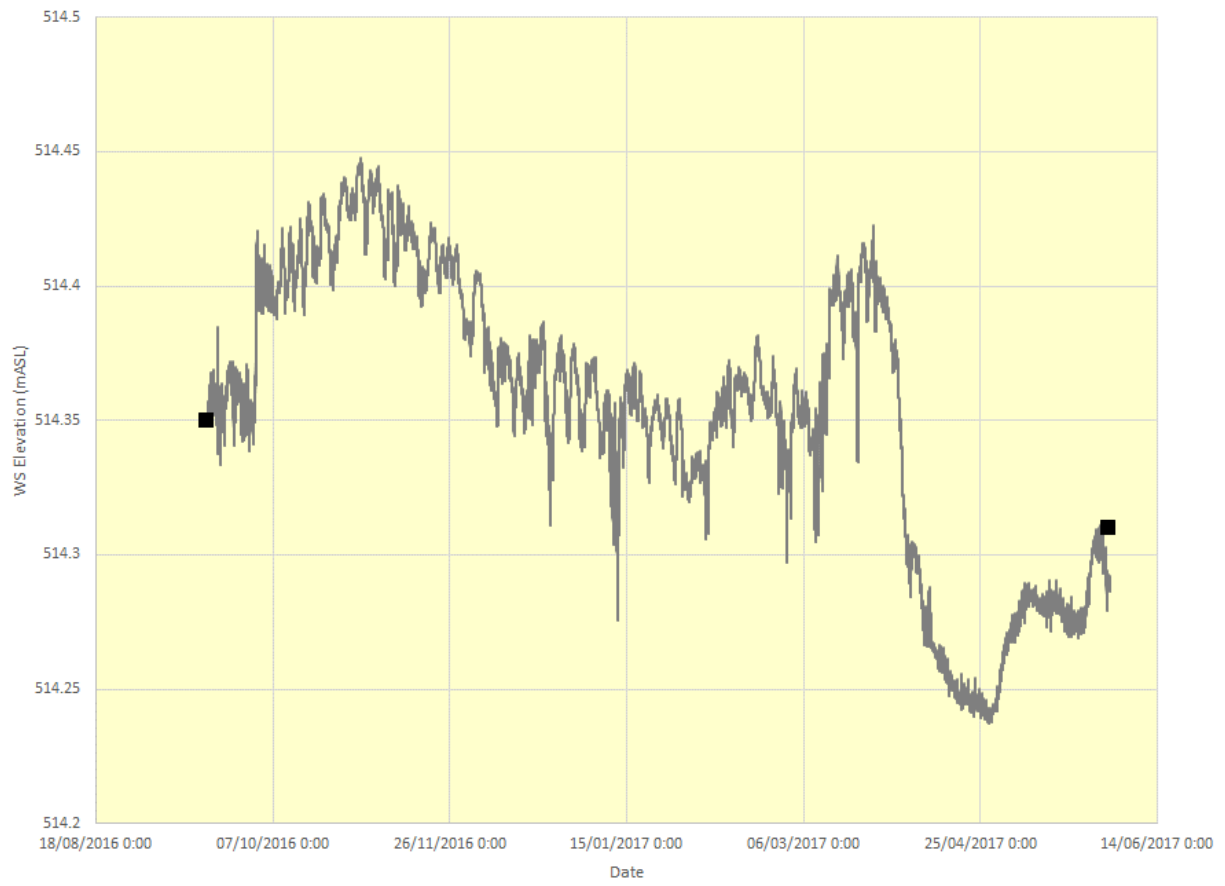
SA10 – Elevation (September 2016 to June 2017)

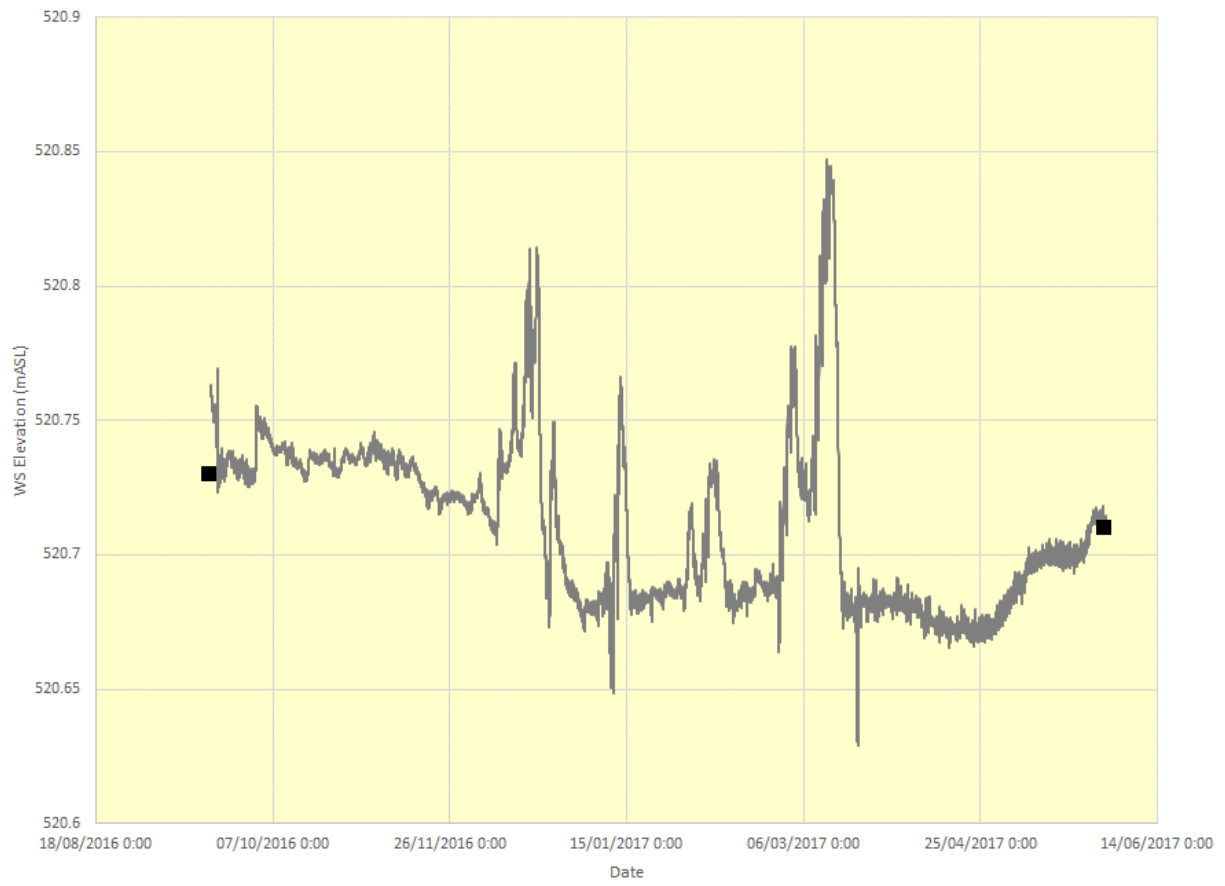
SA11 - Elevation (September 2016 to June 2017)

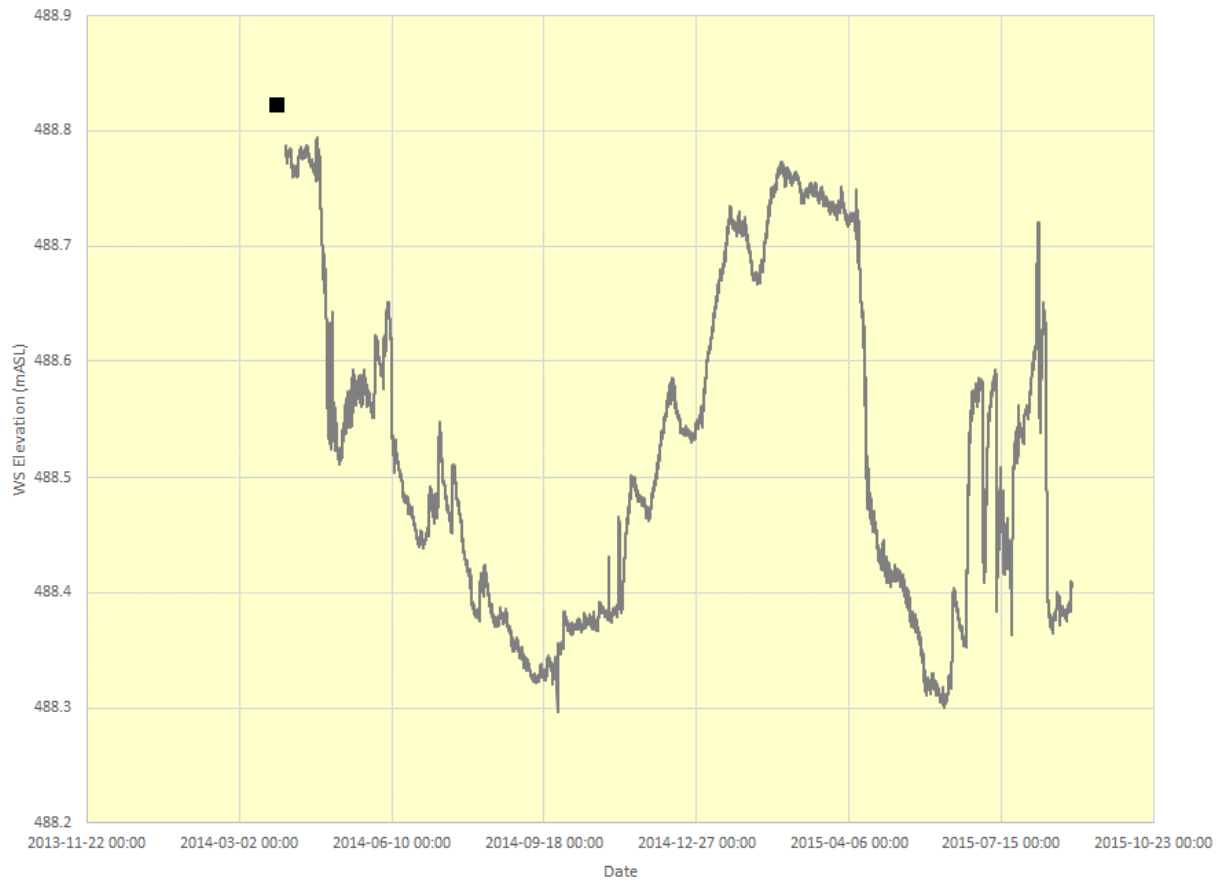
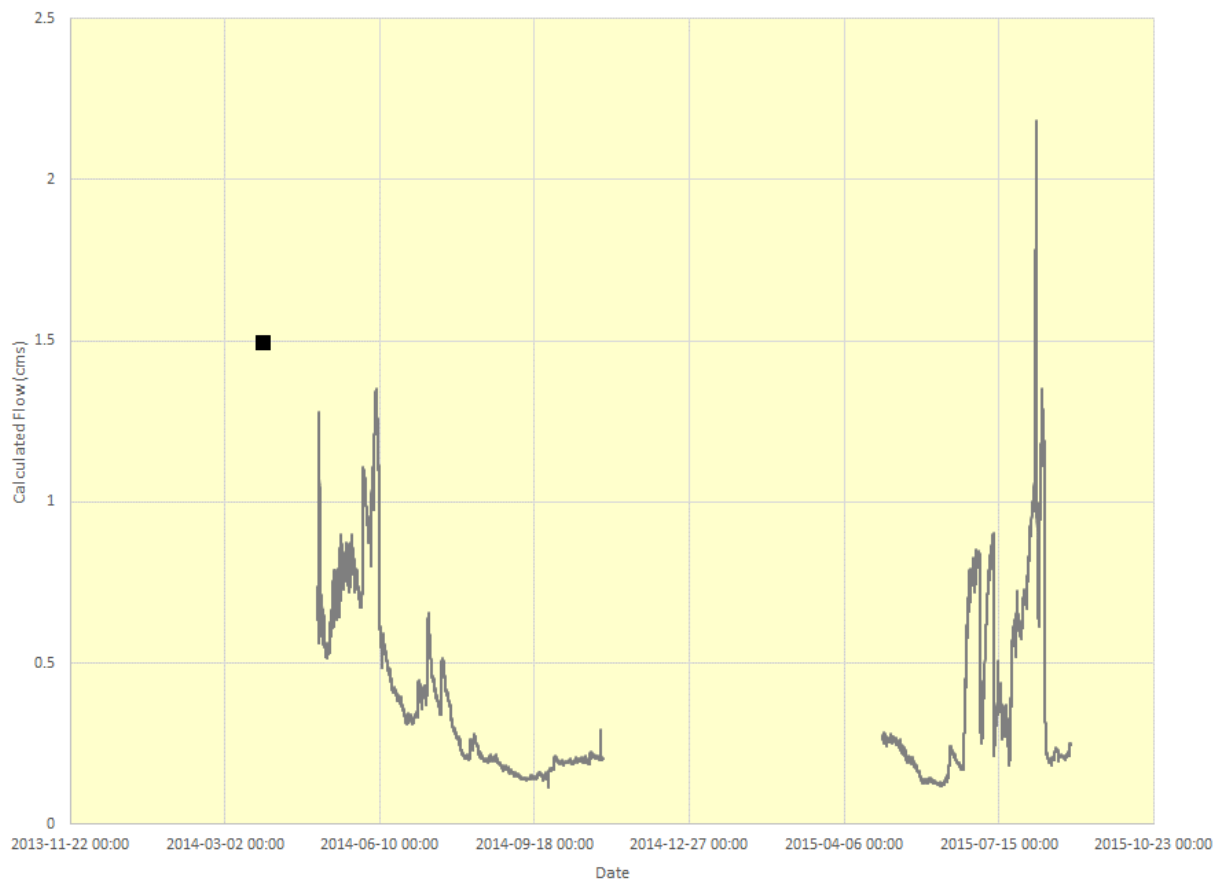
SB1 – Elevation and Discharge (March 2014 to August 2015)

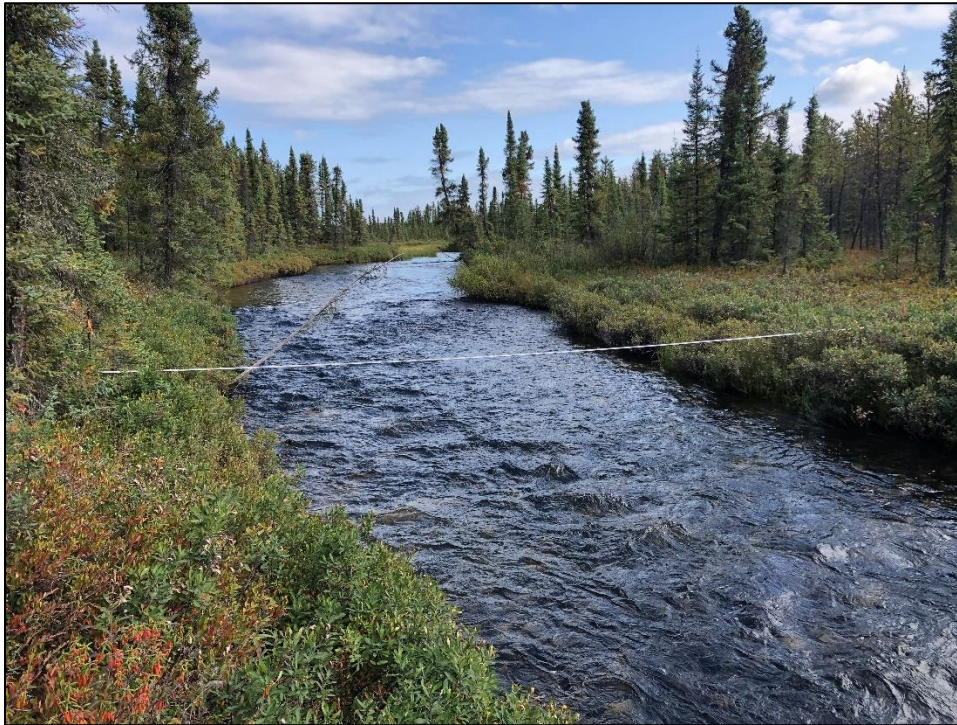
### SA-6 (Outflow from LA-6)

SA-6 is the outflow from LA-6 and is equipped with a stage recording datalogger. The sensor and sensor housing at this location were replaced in August. Stage and discharge data for SA-6 are presented in Table 6 and the rating curve is shown as Figure 6. The cross-section is shown in Photo 11 for the July field program and Photo 12 is from the August field program.
