APPENDIX D: HYDROLOGICAL BASELINE DATA REPORT PALMER ENVIRONMENTAL

AMBERSHAW PROJECT SITE

HYDROLOGICAL BASELINE DATA REPORT ADVANCED EXPLORATION PERMIT

PALMER ENVIRONMENTAL CONSULTING GROUP INC.

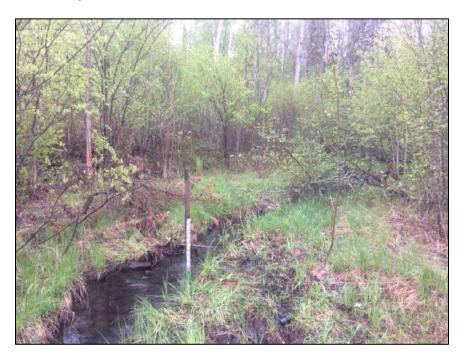
The stream at H1 is contained within a low gradient channel section with low vegetative cover. At the hydrometric station, the channel is approximately 1.5 m wide. The staff gauge and pressure transducer PVC pipe are attached to an 8-cm wide steel channel iron embedded in the channel. The levelogger is suspended within the PVC and protected from dynamic movements by the perforated PVC. The substrate consists of sands, gravels and boulders. The stream flow is confined for most of the 500 m reach with braided segments of the stream to the north of H1 and near the northern outlet to Bending Lake. The stream has been modified with the addition of a culvert beneath Bending Lake Road 10 m to the north of H1, and the northern terminus of the stream towards Bending Lake has been altered due construction of a boat launch near Bending Lake.

Photo 5-1. H1 Hydrometric Station – upstream

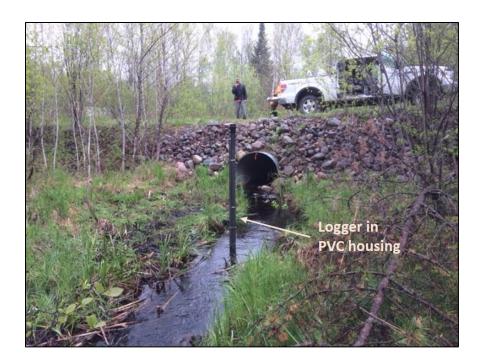
Photo 5-2. H1 Hydrometric Station – downstream

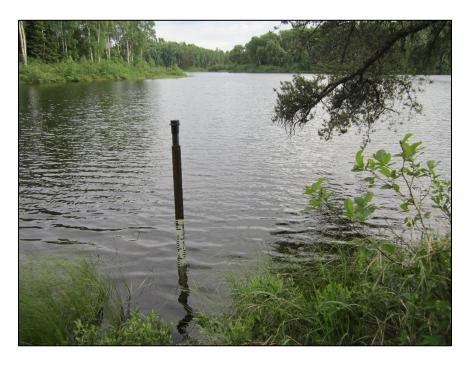
Hydrometric station H2 is located on shores of Page Lake, approximately 400 m upstream of H1 (**Figure 4-1**). The station has been monitored since May 2017. **Photo 5-3** shows a view of the Page Lake water level gauge. H2 is installed roughly 1 m from the shore of Page Lake at a depth of 0.40 m. The staff gauge and pressure transducer PVC pipe are attached to an 8-cm wide steel channel iron embedded in lake sediments along the shore. The pressure transducer is suspended within the PVC and protect from

Photo 5-3. H2 Lake Hydrometric Station

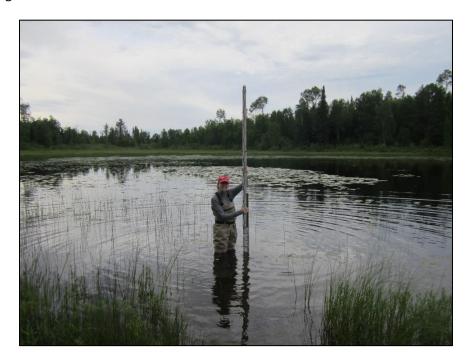
Hydrometric station H3 is located on the shores of Bending Lake near the outlet of Page Creek, roughly 400 m downstream of H1. The station was monitored between May 2017 and May 2018. **Photo 5-4** shows a view of the Bending Lake water level gauge. H3 is installed roughly 3 m from the shores of Bending Lake at a depth of 0.50 m. The station is equipped with a staff gauge fastened to an 8-cm wide steel channel iron embedded in lake sediments along the shore. The lake floor substrate consists of fine sediments, organics and boulders.

Photo 5-4. H3 Lake Water Elevation Station

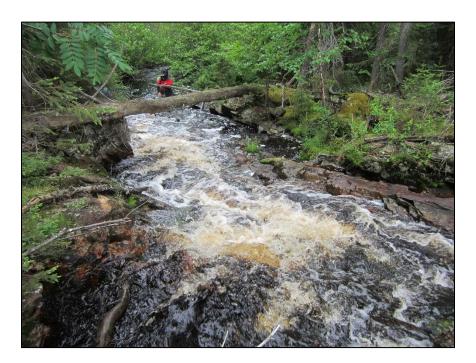
The creek at H4 is contained within a medium gradient channel section with bedrock banks on both sides and vegetated banks where lower gradients are observed. The stream flow is confined in a valley setting and is not braided along its length. At the hydrometric station, the channel is approximately 3 m wide with a maximum depth of 0.5 m. The pressure transducer PVC pipe is attached to an 8-cm wide steel channel iron fastened to bank bedrock in the channel. The pressure transducer is suspended within the

Photo 5-5. H4 Hydrometric Station – facing downstream

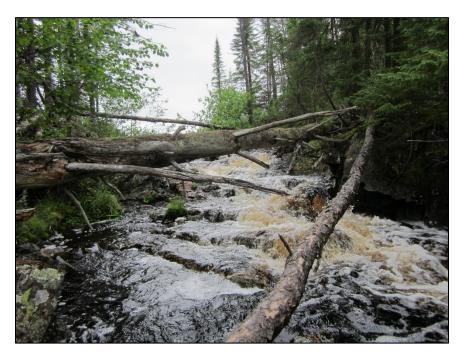
Photo 5-6. H4 Hydrometric Station – facing upstream

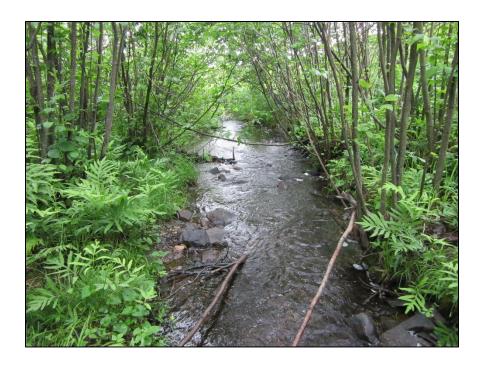
The stream at H5 is contained within a low gradient channel section with low vegetative banks. At the hydrometric station, the channel is approximately 0.7 m wide and maximum depth of 0.05 m. The staff gauge and pressure transducer PVC pipe are attached to an 8-cm wide steel channel iron embedded in the channel pool below the road culvert. The pressure transducer is suspended within the PVC and protected from dynamic movements by the perforated PVC. The substrate consists of sands, gravels and boulders. The stream flows are confined for most of the 200-m reach south of the highway culvert before the outlet to a marshy wetland unit. The stream has been modified with the addition of a culverts beneath Highway 622, approximately 2 m to the east of H5.

Photo 5-7. H5 Hydrometric station facing downstream

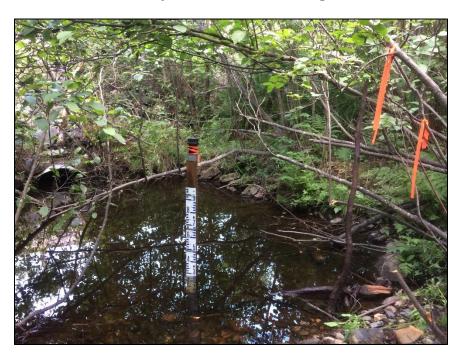
Photo 5-8. H5 Hydrometric station facing upstream
