Crawford Nickel Project: Soils and Terrain Baseline Report

September 30, 2024

Canada Nickel Company

Stantec Consulting Ltd.

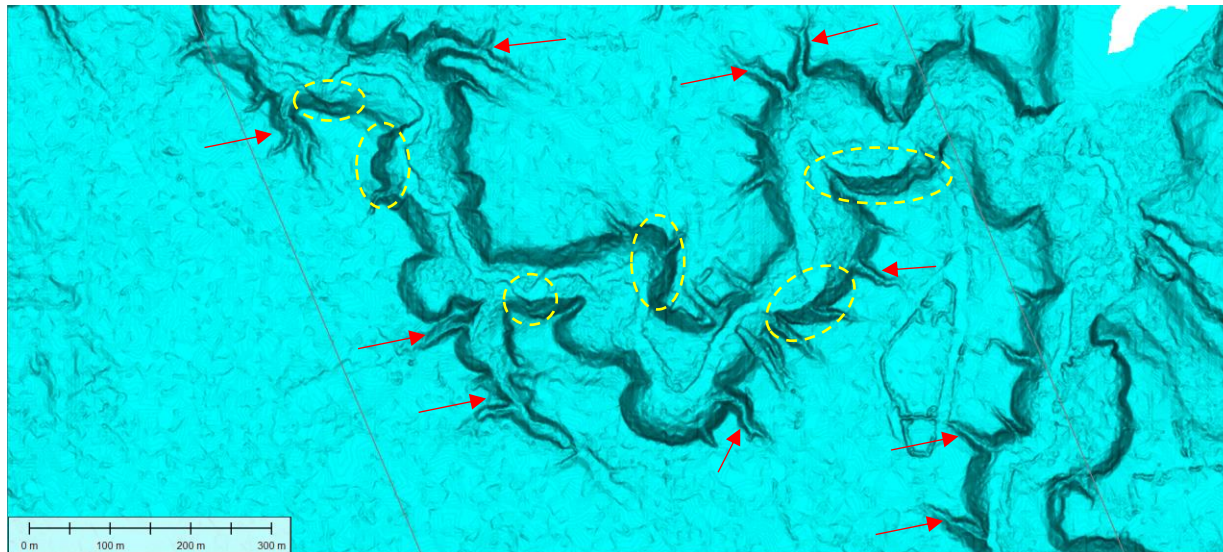
Figure 3 Bare-earth LiDAR hillshade view of erosion and gullying occurring along Jocko Creek.

On the above figure, the LSA/RSA footprint is displayed in black, examples of areas where the stream channel is in contact with the edge of the floodplain in yellow. Example of gullies having developed in the glaciolacustrine clays above from the floodplain are shown in red.

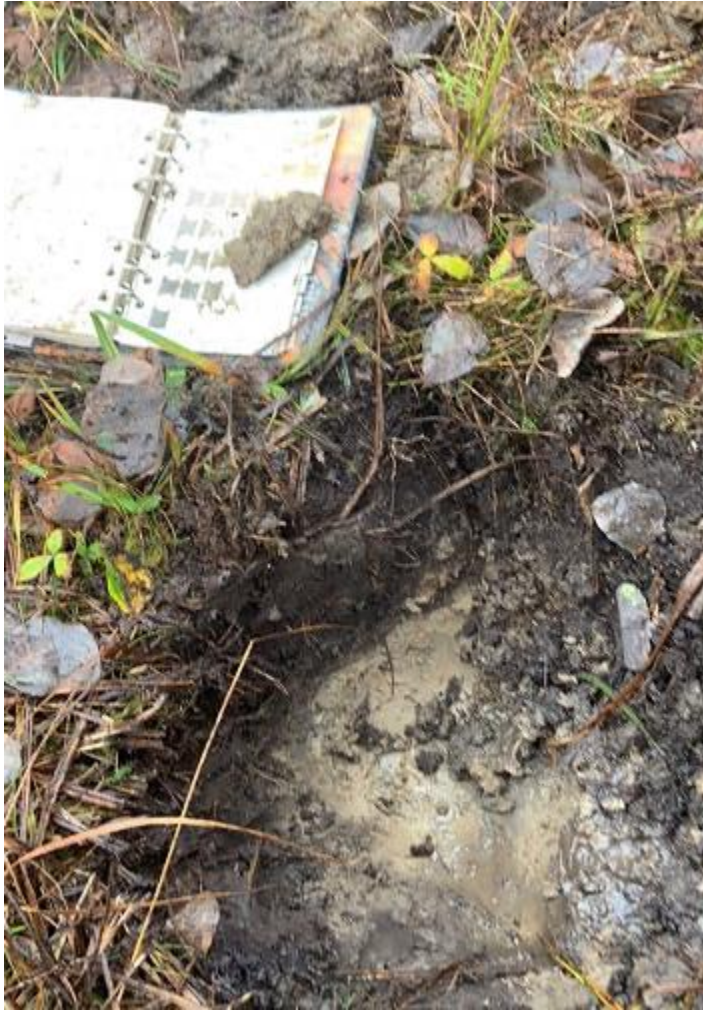
Photo 1: Site CSS 104 – Humic Luvisol on Glaciolacustrine Material

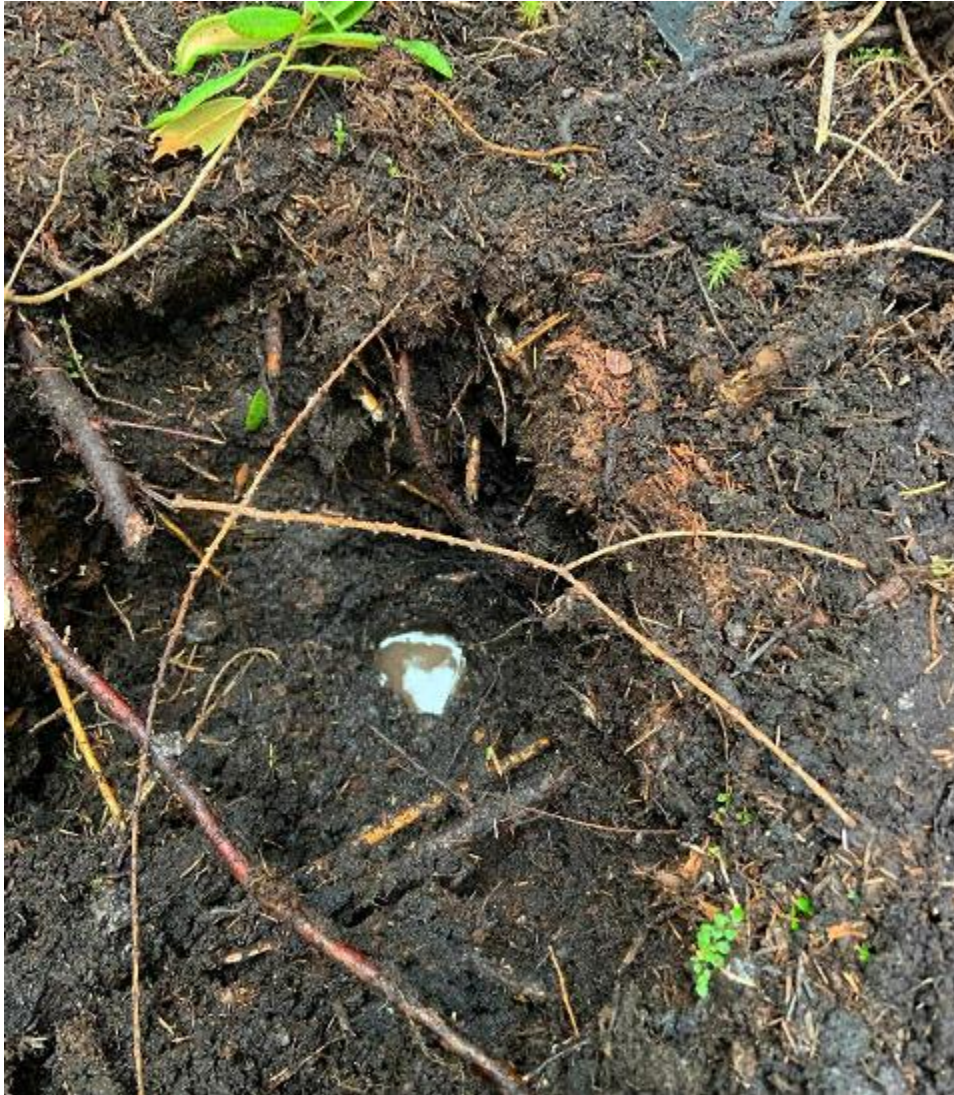
Photo 2: Site CSS 001 – peaty Orthic Gleysol on Glaciolacustrine Parent Material

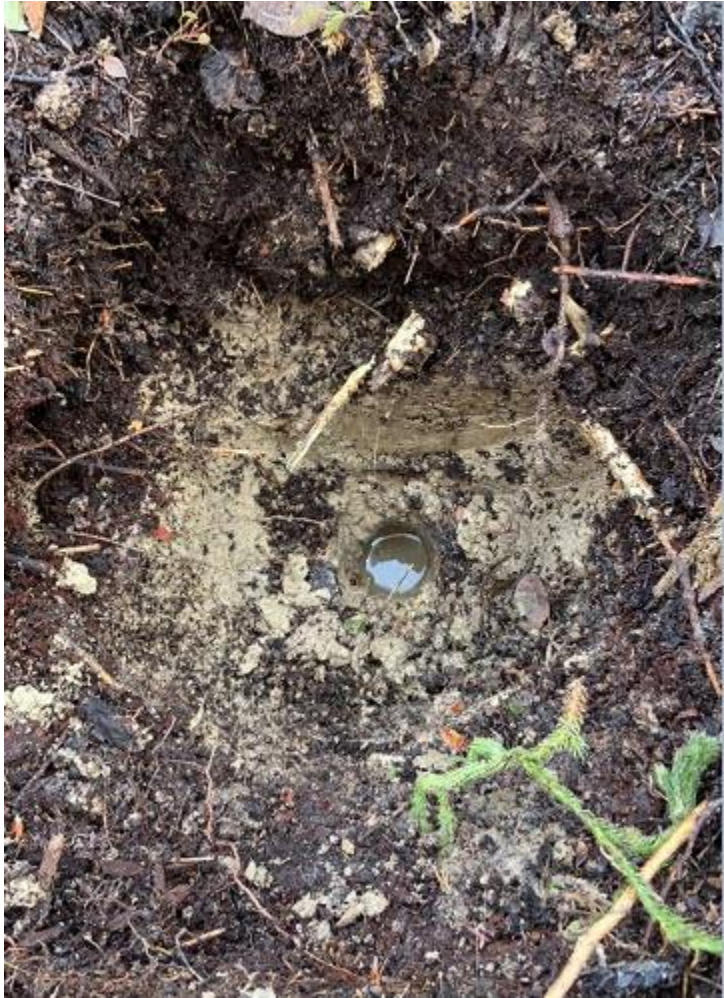
Photo 3: Site CSS 43 – Gleyed Gray Luvisol on Lacustro-till

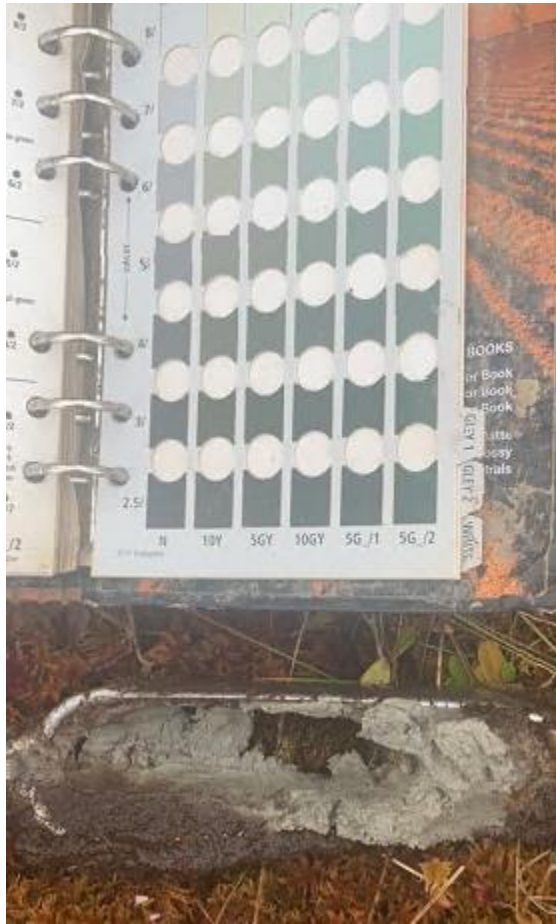
Photo 4: Site CSS 37 – Cg horizon on Mesic Fibrisol

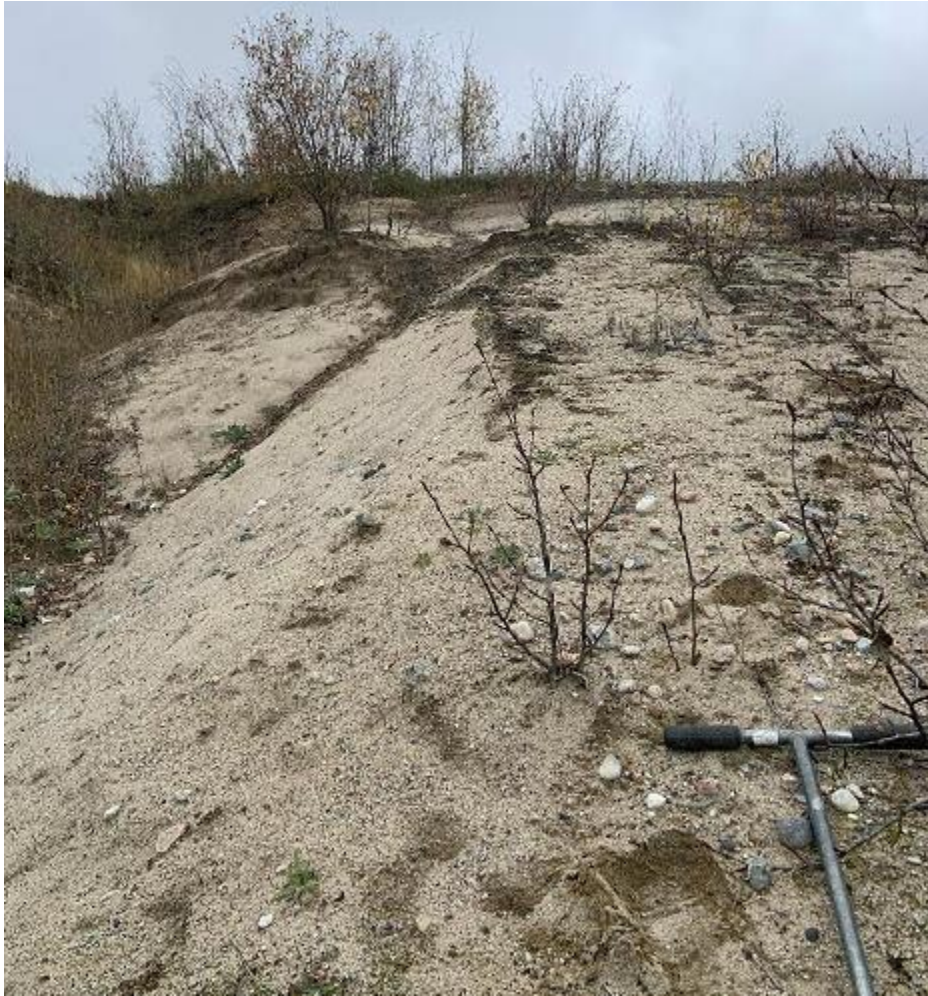
Photo 5: Glaciofluvial deposit on former aggregate quarry

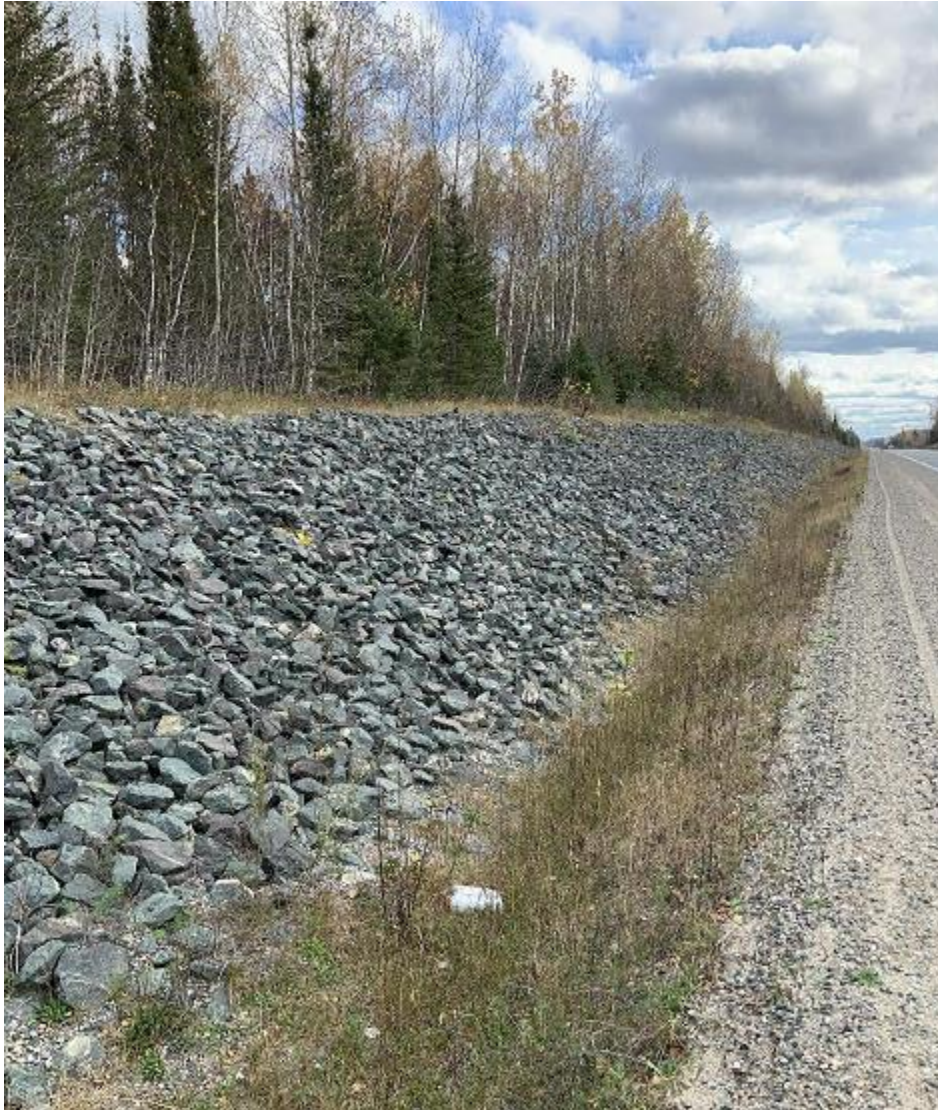
Photo 6: Erosion armouring/protection on cut slope along Highway 655.

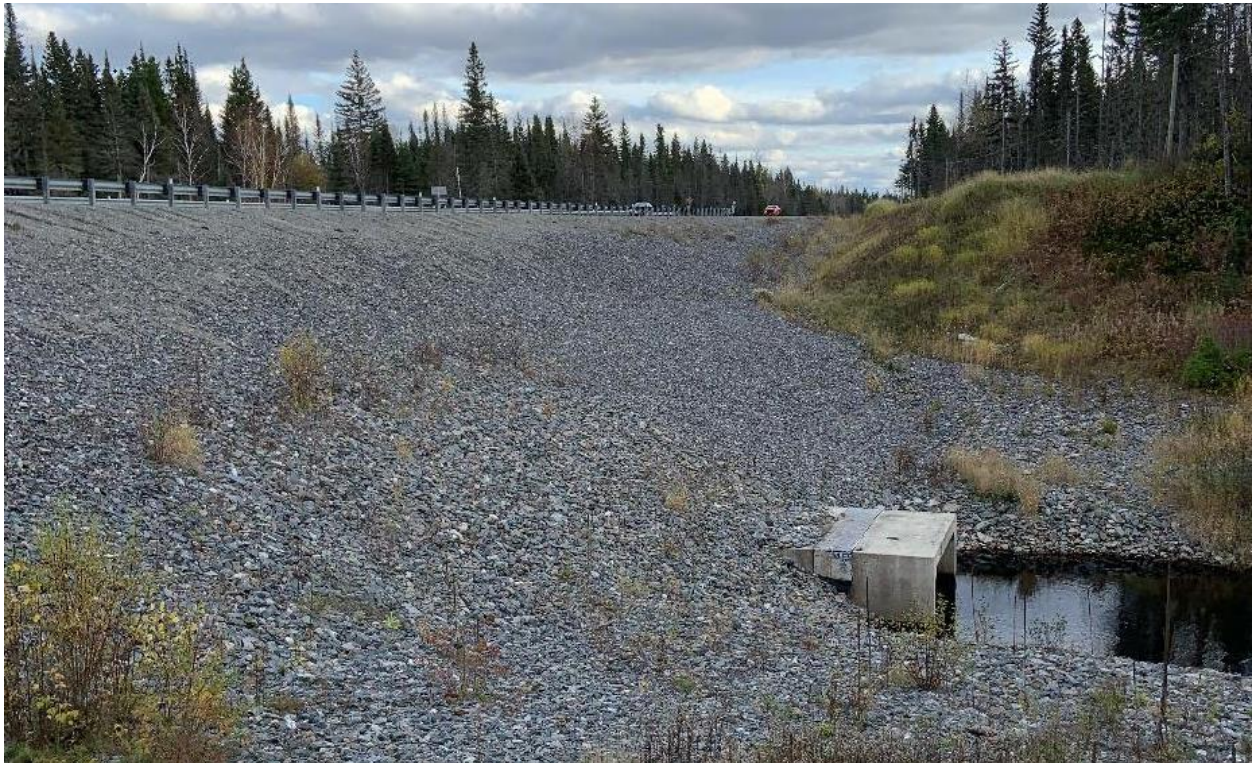
Photo 7: Erosion armouring/protection on fill slope to Jocko Creek
