APPENDIX 9-F KSM PROJECT TERRAIN STABILITY FIELD ASSESSMENT OF THE PROPOSED COULTER CREEK, TEIGEN CREEK AND TUNNEL SPUR ACCESS ROADS

KSM PROJECT

TERRAIN STABILITY FIELD ASSESSMENT OF THE PROPOSED COULTER CREEK, TEIGEN CREEK, AND TUNNEL SPUR ACCESS ROADS

Project No. 0638-005

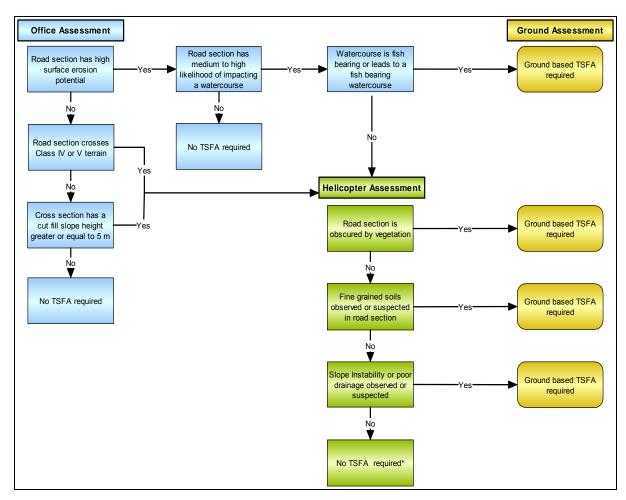
Figure 2. Flow Chart Describing Logic for Selecting Road Sections for Ground Based TSFA.

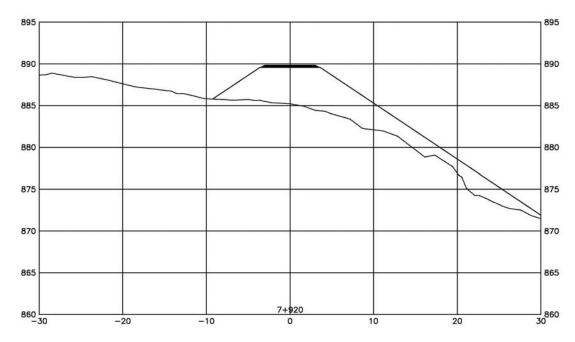
Figure 3 and Figure 4 are examples of typical road sections flagged, and not flagged, for TSFA, respectively. The road section in Figure 3 (Coulter Creek KP 7+920; June 18, 2010 alignment) is at least an 18 m high soil fill on a moderate slope. Figure 4 (Coulter Creek KP 21+300; June 18, 2010 alignment) is a 4-5 m high fill slope that is buttressed at the toe by a concave break in slope.

Figure 3. Example of a Proposed Road Section that was Flagged for Field Review

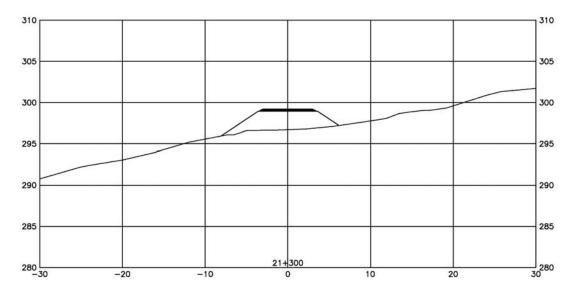
Figure 4. Example of a Proposed Road Section that was not Flagged for Field Review

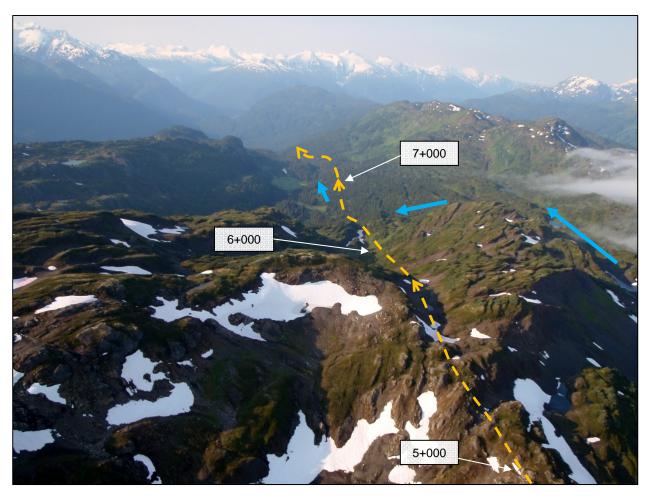
Photograph 2 Coulter Creek Access Road – Looking upchain (south) along Coulter Creek towards the Unuk River Valley from KP 5+000.

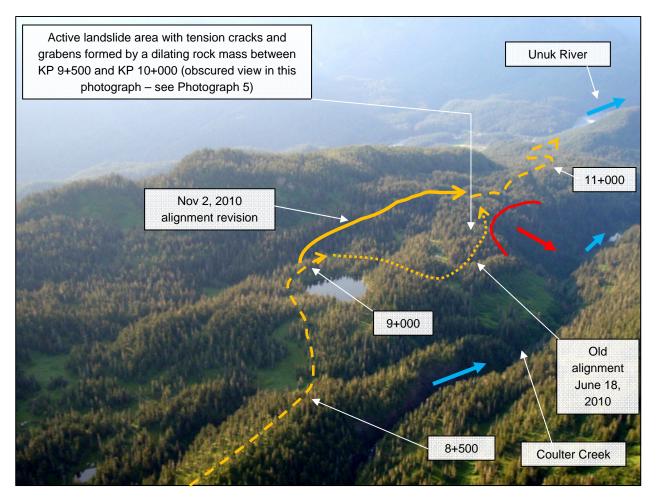
Photograph 4 Coulter Creek Access Road – Looking upchain (south) along Coulter Creek towards the Unuk River Valley from about KP 8+000. The dotted orange line marks the approximate location of the June 18, 2010 alignment and the solid orange line marks the approximate location of the updated November 2, 2010 alignment. The revised alignment avoids the active landslide area (see Photograph 5).

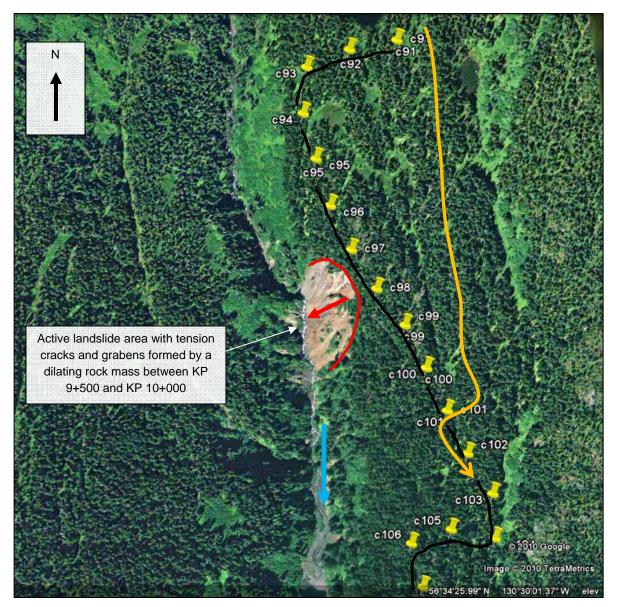
9.77	9.94	0.17 51-53	-	Ground	476	Cv	Colluvium	IV	М	LP	LS	Low	w	R"s-Rb	32/25	Colluvium/Rock/Active Landslide Area	A and B	Many pistol-butt conifers and evidence of recent slope deformation. A 5-10 m wide tension crack, vertically offset 3-5 m, at least 50 m long, is interpreted as a backscarp to a larger rock slope failure.

9.68	9.77	0.09 49-50	-	Ground	479	Cv/Rs-VR"s	Colluvium and Rock			LP	LS	Low	w	R"s-Rb	32/25	Colluvium/Rock/Active Landslide Area	A and B	Many pistol-butt conifers and evidence of recent slope deformation. A 5-10 m wide tension crack, vertically offset 3-5 m, at least 50 m long, is interpreted as a backscarp to a larger rock slope failure.

Photograph 5 Coulter Creek Access Road – Orthophoto of active landslides identified in BGC (2010a) on the left bank of Coulter Creek. Tension cracks, grabens and evidence of fresh deformation was observed in the field. Yellow pins mark the June 18, 2010 alignment centreline – c93 refers to Coulter Creek KP 9+300. BGC recommended re-routing around the active landslide area by realigning road between about KP 9+000 and KP 10+300. The solid orange line marks the approximate location of the November 2, 2010 updated road alignment (McElhanney 2010b).

- Coulter Creek KP 9+000 to KP 10+300 active landslide area.
- Coulter Creek KP 30+320 to KP 30+600 inactive or dormant landslide area.
- Teigen Creek KP 8+300 active landslide area.

BGC understands McElhanney modified the road alignment in these sections in the updated November 2, 2010 road alignments (McElhanney 2010b).

Avoid the Potential Slop	e Instability
А	Consider re-routing around slope instability.
Landslide Area - Coulter	Creek Access Road KP 9+500 - KP 10+000 (June 18, 2010 KP's)
В	Consider re-routing around active landslide area by re-aligning road between KP 9+000 and KP 10+300 (consider moving road centreline approximately 250 m east). November 2, 2010 alignment centreline moved approximately 250 m eastward to avoid this hazard.
Avoid Large Fill Slopes	
С	Consider re-routing alignment to avoid large fill sections.
Inactive Landslide Area	Coulter Creek Access Road KP 30+320 - KP 30+600) (June 18, 2010 KP's)
D	Confirm construction plan with QRP before crossing this dormant or inactive landslide area. Ensure the road prism is constructed of fill across the dormant or inactive landslide area. Do not cut into the slope. Ensure adequate and efficient slope drainage. Monitor slope for movement as specified by a QRP.

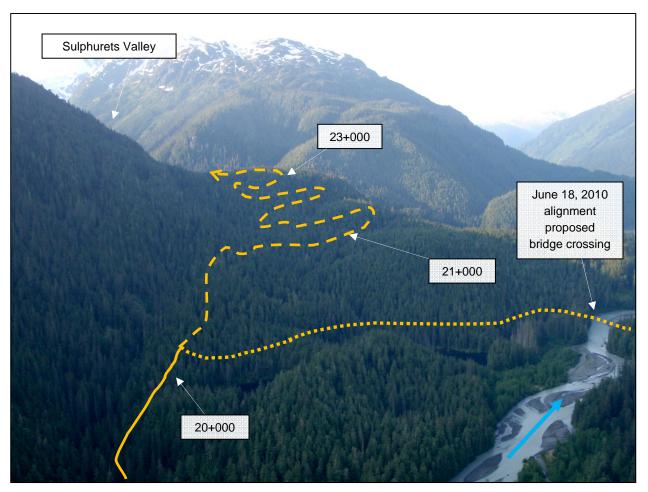
Photograph 9 Coulter Creek Access Road – Looking upchain (southeast) from the Unuk River towards Sulphurets Creek Valley. The proposed access road ascends through a series of switchbacks into Sulphurets Valley. The solid orange line marks the approximate location of the November 2, 2010 updated road alignment (McElhanney 2010b). The November 2, 2010 road alignment bridge crossing is slightly upstream of the bottom right section of this photograph – and so not shown on this photograph.

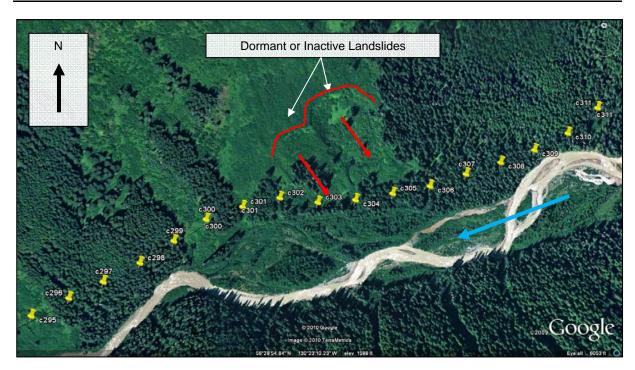
29.69	30.06	0.37				774	Cv//Rsk	Colluvium and Rock						w					
30.06	30.29	0.23				804	Сс	Colluvium						w-m					
30.29	31.13	0.83	-	-	Helicopter	843	Mw Ru	Rock and Till	П	М	-	-	-	m-w	-	-	Remnant Landslide	D	BGC (2010) identified KP 30+320 to KP 30+600 as a Road Hazard Segment (Remnant Rotational Slope Failure or Earth Flow). BGC (2010) identified KP 30+600 to KP 31+900 as a Potential Road Hazard Segment (Flooding).

Photograph 13 Coulter Creek Access Road – Orthophoto of dormant or inactive landslides identified in BGC (2010a). Yellow pins mark the June 18, 2010 alignment centreline – c304 refers to Coulter Creek KP 30+400. Fill only road construction (over landing) is recommended between KP 29+300 and KP 29+700 (June 18, 2010 alignment KP 30+200 to KP 30+600) and confirmation of the construction plan with a QRP is recommended before crossing this dormant or inactive landslide area. Do not cut into the slope between KP 29+300 and KP 29+700 (November 2, 2010; McElhanney 2010b) and ensure effective slope drainage. Monitor slope for movement during construction as directed by a QRP.

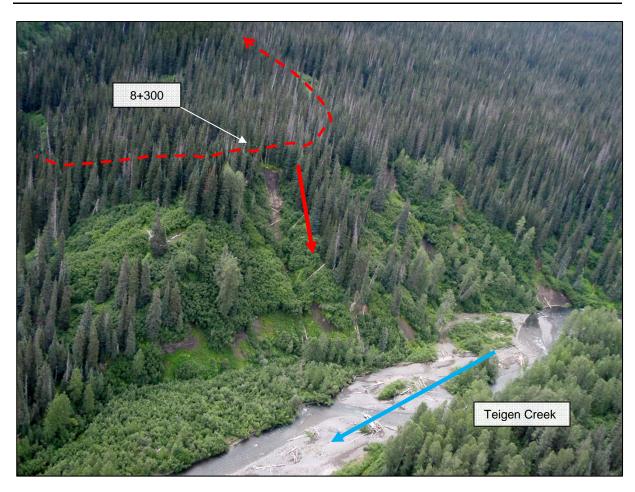
Photograph 18 Teigen Creek Access Road – Looking towards KP 8+300 and an active landslide area (left of solid red line in photograph) below road grade approximately 10 m from the flagged road alignment. Moving road centreline approximately 25 – 50 m to the southeast is recommended.
