APPENDIX 9-G KSM PROJECT TERRAIN STABILITY FIELD ASSESSMENT OF THE PROPOSED TREATY CREEK, NORTH TREATY AND TUNNEL ADIT ACCESS ROADS

SEABRIDGE GOLD INC.

TERRAIN STABILITY FIELD ASSESSMENT OF THE PROPOSED TREATY CREEK, NORTH TREATY AND TUNNEL ADIT ACCESS ROADS

DOCUMENT NO: KSM 12-31 BGC: e-copy

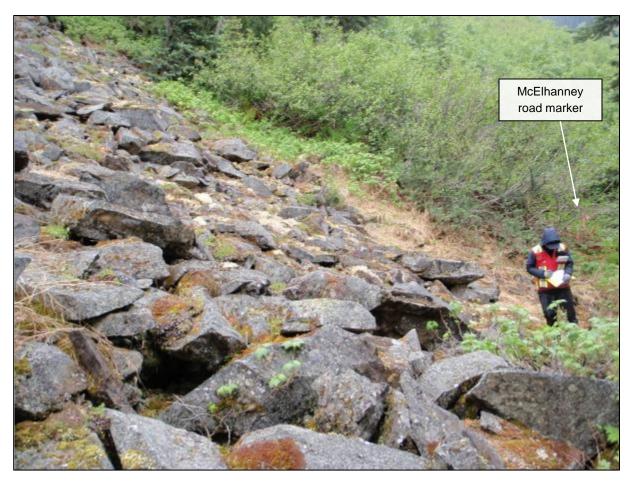
Photograph 11 Treaty Creek Access Road – Looking downchain (east) towards Km 25+420 where the road traverses below a talus slope. Moss covered angular boulders between 1 m and 2 m diameter.

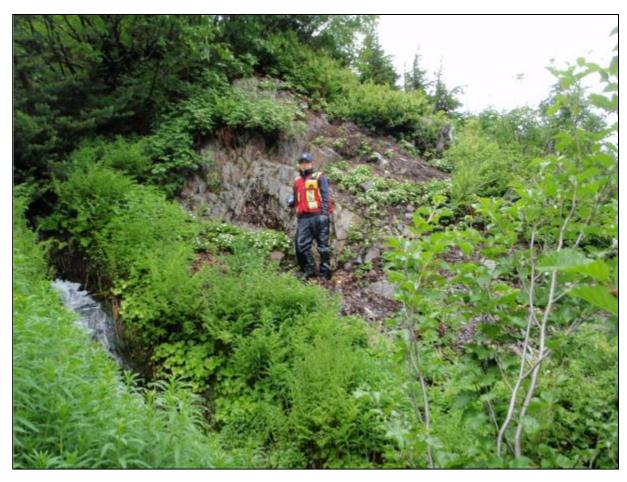
Photograph 17 Treaty Creek Access Road – Looking downchain (east) from left river bank approximately 7 m upslope of Km 26+200 towards an exposure of slightly weathered (W2), weak to medium strong (R2 to R3), sandstone and siltstone.

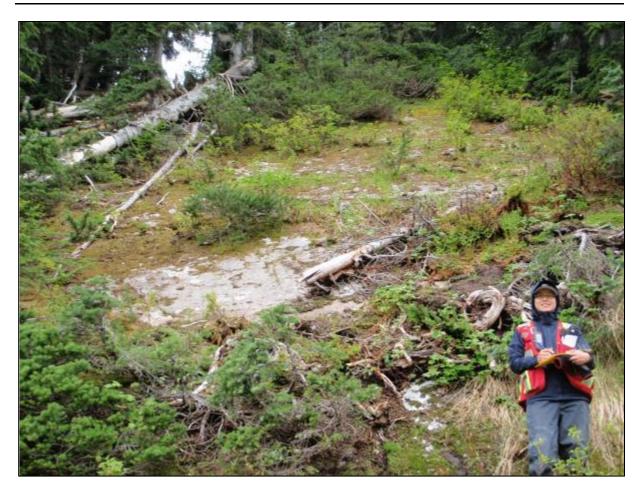
Photograph 23 North Treaty Upper Access Road – Looking upslope approximately 15 m from Km 2+400 of the North Treaty Upper access road towards a bedrock exposure. The bedrock is a slightly weathered (W2), medium strong (R3) sandstone with a highly persistent joint set that strikes sub parallel to the proposed road centerline (dip/dip direction is 44/043 degrees with joint persistence >18 m).

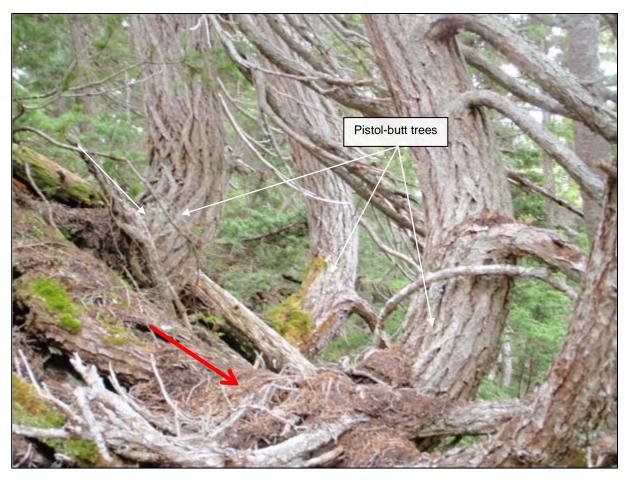
Photograph 25 North Treaty Lower Access Road – Looking cross slope (north) from Km 8+880 of the North Treaty Lower access road at pistol-butt trees on a steep slope (downslope angle - 45°). Red arrow illustrates the direction of soil creep towards the stream downslope.

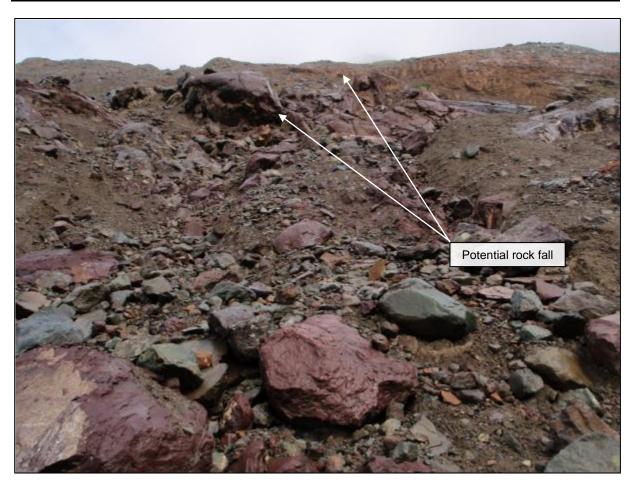
Photograph 31 Tunnel Adit & Tunnel Adit Spur Access Roads – Looking upslope (north) from the Tunnel Adit at Km 2+200 towards rock fall hazards upslope (boulders up to 3 m diameter).
