**APPENDIX 9-H
PRELIMINARY GEOTECHNICAL ASSESSMENT OF
THE SNOWFIELD LANDSLIDE**

Project No.: 0638-013-31

Document No.: KSM12-27

Re: Preliminary Geotechnical Assessment of the Snowfield Landslide

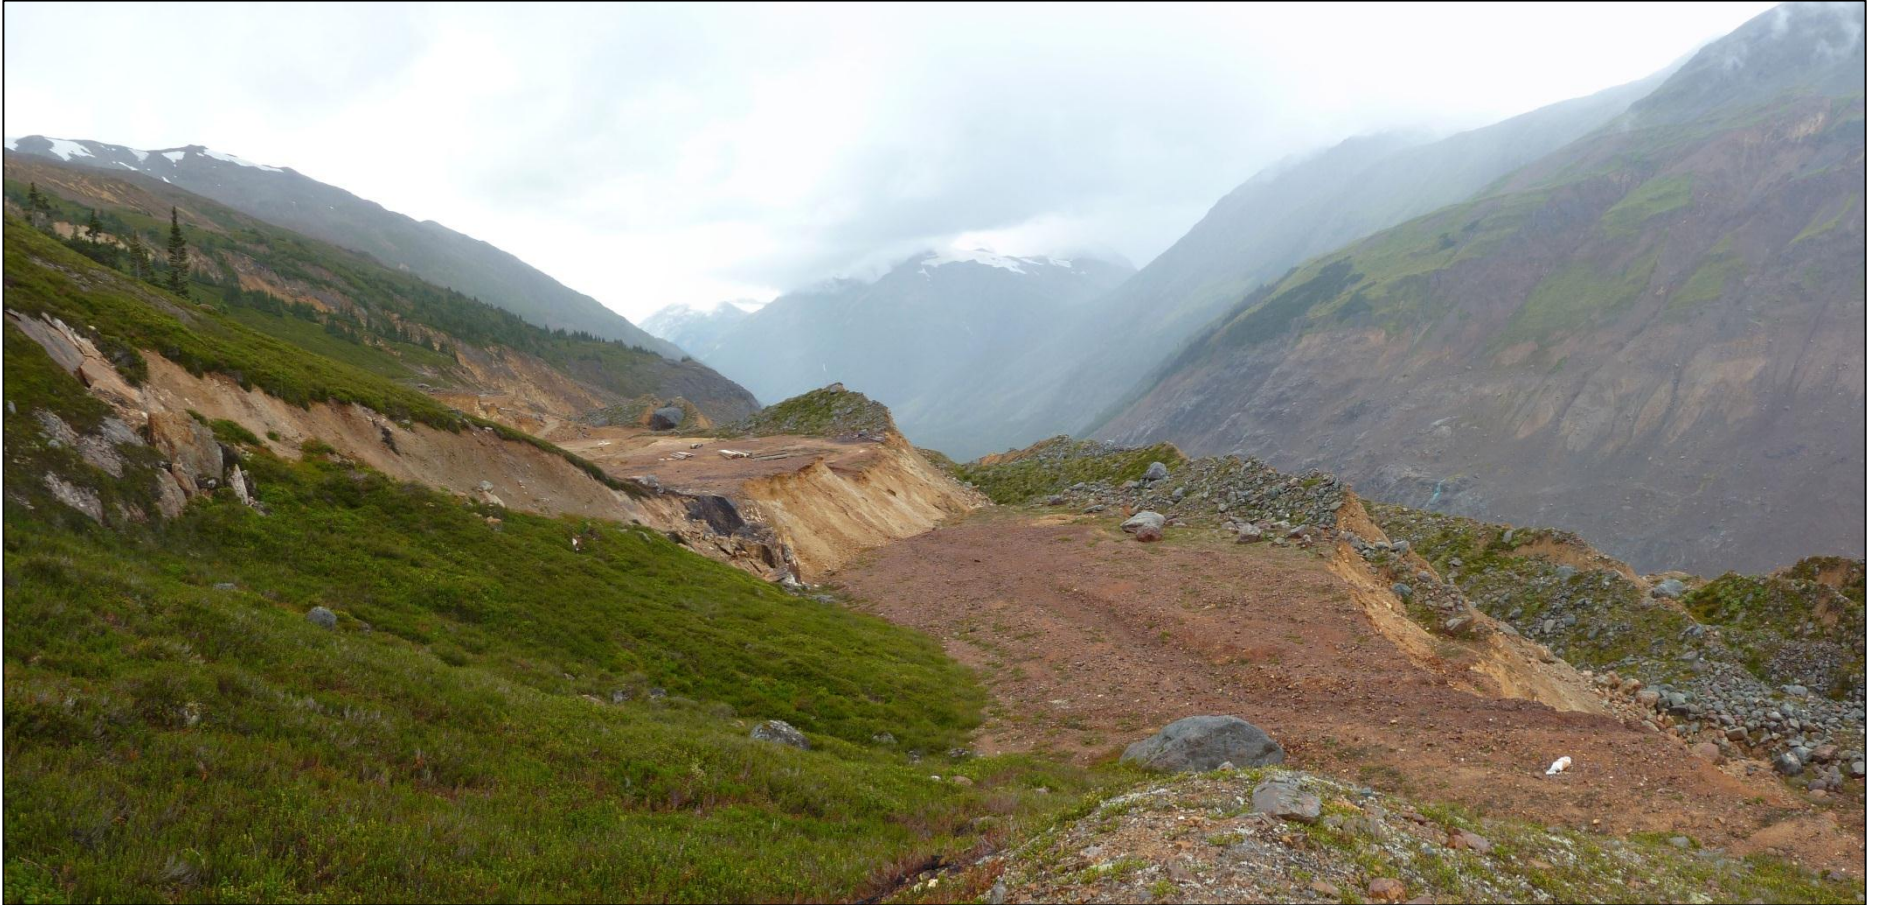
BGC ENGINEERING INC. AN APPLIED EARTH SCIENCES COMPANY	REPORT TITLE: PRELIMINARY GEOTECHNICAL ASSESSMENT OF THE SNOWFIELD LANDSLIDE	
	FIGURE TITLE: FRESH SCARP DEVELOPMENT	
CLIENT: SEABRIDGE GOLD INC.	PROJECT No.: 0638-013-31	FIGURE No.: 2

Several landforms typical of large landslides are observed within the limits of the Snowfield Landslide. Up-hill facing or “obsequent” scarps are found between the toe of the slope and 1,140 mASL elevation. Down-hill facing or “normal” scarps (Figure 2) and tension cracks are found between elevations 1,140 mASL and 1,420 mASL. On the basis of the distribution of these landforms, the Snowfield Landslide has been divided into two zones (Drawing 1):

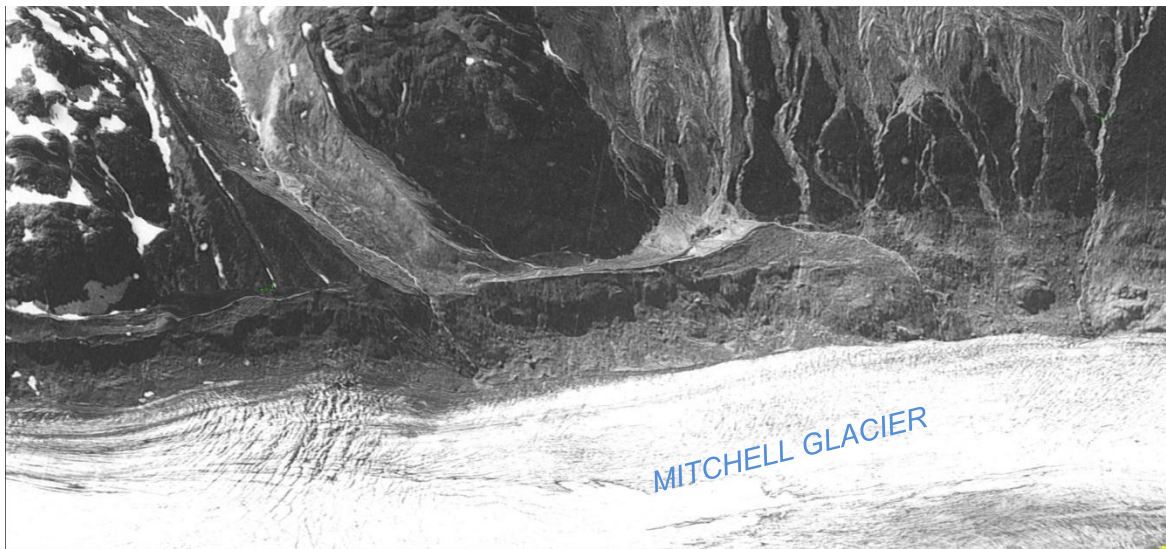
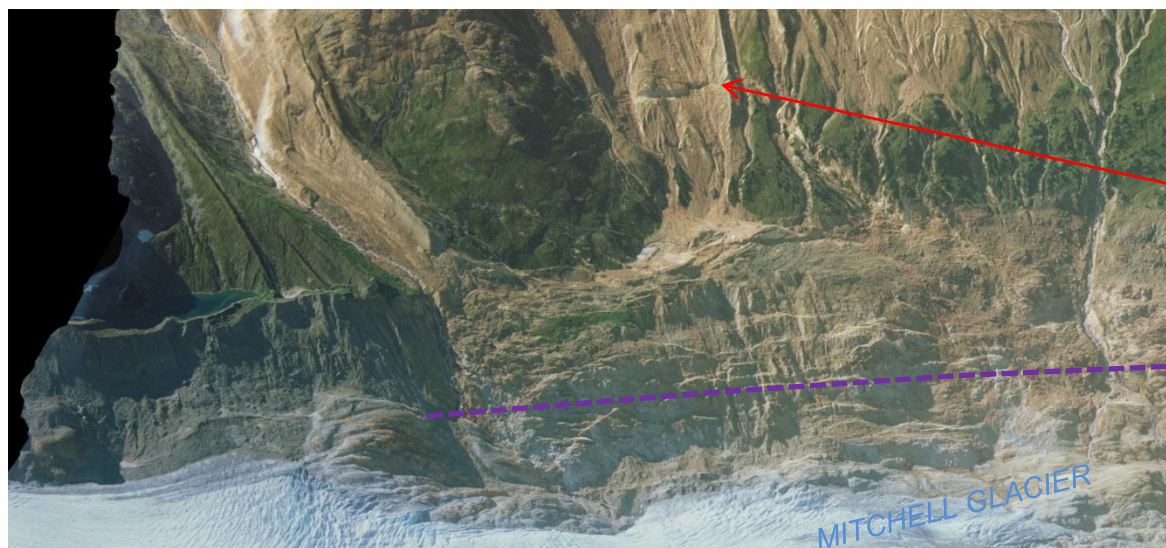
5

1956

1972

CRACKING

TOPPLING

APPROX.
1956 ICE LIMIT

2010

DEVELOPED
BACK SCARP

Landslide is currently located have been created from the available aerial photographs from 1956, 1972, and 2010 (Figure 5):

1. 1956 – No landforms indicative of the Snowfield Landslide are visible. Some sloughing of moraine material above the glacier surface may be occurring.
2. 1972 – Obsequent scarps are found at the northeast limit of the Snowfield Landslide; tension cracks are visible at the mid-slope bench.
3. 2010 – Obsequent scarps are well developed in lower slope of the landslide. Tension cracks define a back scarp at the southern limit of the unstable mass.

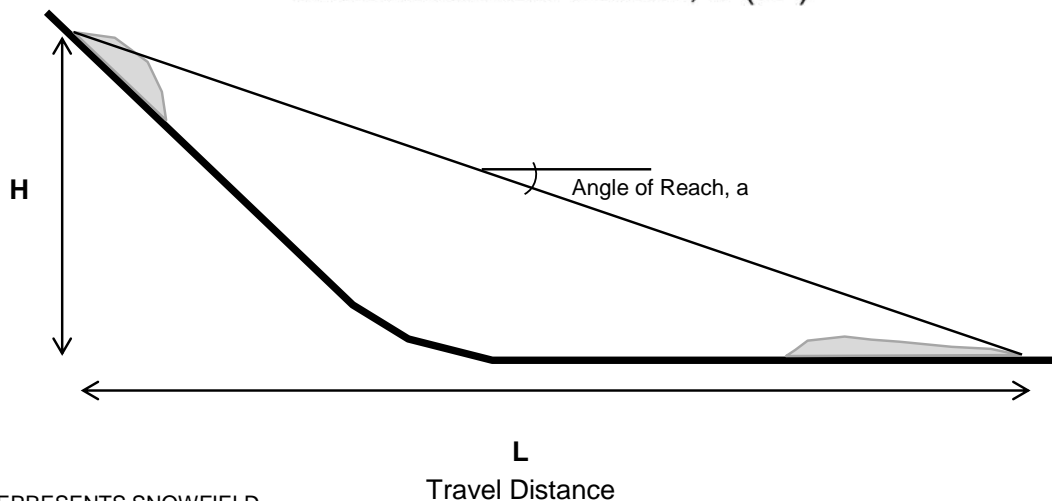
1. RED LINE REPRESENTS SNOWFIELD LANDSLIDE ESTIMATED VOLUME.

<p>BGC ENGINEERING INC. AN APPLIED EARTH SCIENCES COMPANY</p>	REPORT TITLE: PRELIMINARY GEOTECHNICAL ASSESSMENT OF THE SNOWFIELD LANDSLIDE	
	FIGURE TITLE: RUNOUT ANALYSIS USING VOLUME AND ANGLE OF REACH RELATIONSHIP	
CLIENT: SEABRIDGE GOLD INC.	PROJECT No.: 0638-013-31	FIGURE No.: 7

Li (1983) presents a plot that compares landslide volume to the angle of reach for 76 rock avalanches and an equation for the best fit lines through the data points. The expected angle of reach can be estimated for a given landslide volume from the best fit line. There is considerable scatter of the data points around this best fit line as a result of unique physical aspects of each case. To reduce this scatter, lines have been drawn that define the runout exceedance probability for the data set (Figure 7). The best fit line defines the 50% exceedance probability as it is drawn through the center of the data set, and half of the case studies traveled farther than indicated by the best fit. Similarly, 10% of the landslides included in the database ran out farther than would be estimated from the 10% exceedance probability line.

The travel path of Snowfield Landslide debris is uncertain. Initial displacement of the landslide may be perpendicular or oblique to the axis of Mitchell Valley. In the analysis it has been assumed that the initial landslide travel path will be oriented at a 60° angle to the valley axis; this is the most oblique travel direction that appears likely and maximizes the debris runout down Mitchell Valley, resulting in a more conservative result. Figure 8 illustrates the travel path used in the analysis and the travel distance for the 50% and 10% runout exceedance probability.
