2013 AQUATICS BASELINE: PINWOOD RIVER / HIGHWAY 600 CROSSING

**RAINY RIVER RESOURCES LTD.
RAINY RIVER PROJECT**

**FISH AND FISH HABITAT EXISTING CONDITIONS FOR
HIGHWAY 600 REALIGNMENT
TOWNSHIP OF CHAPPLE**

**October 2013
TC111504**

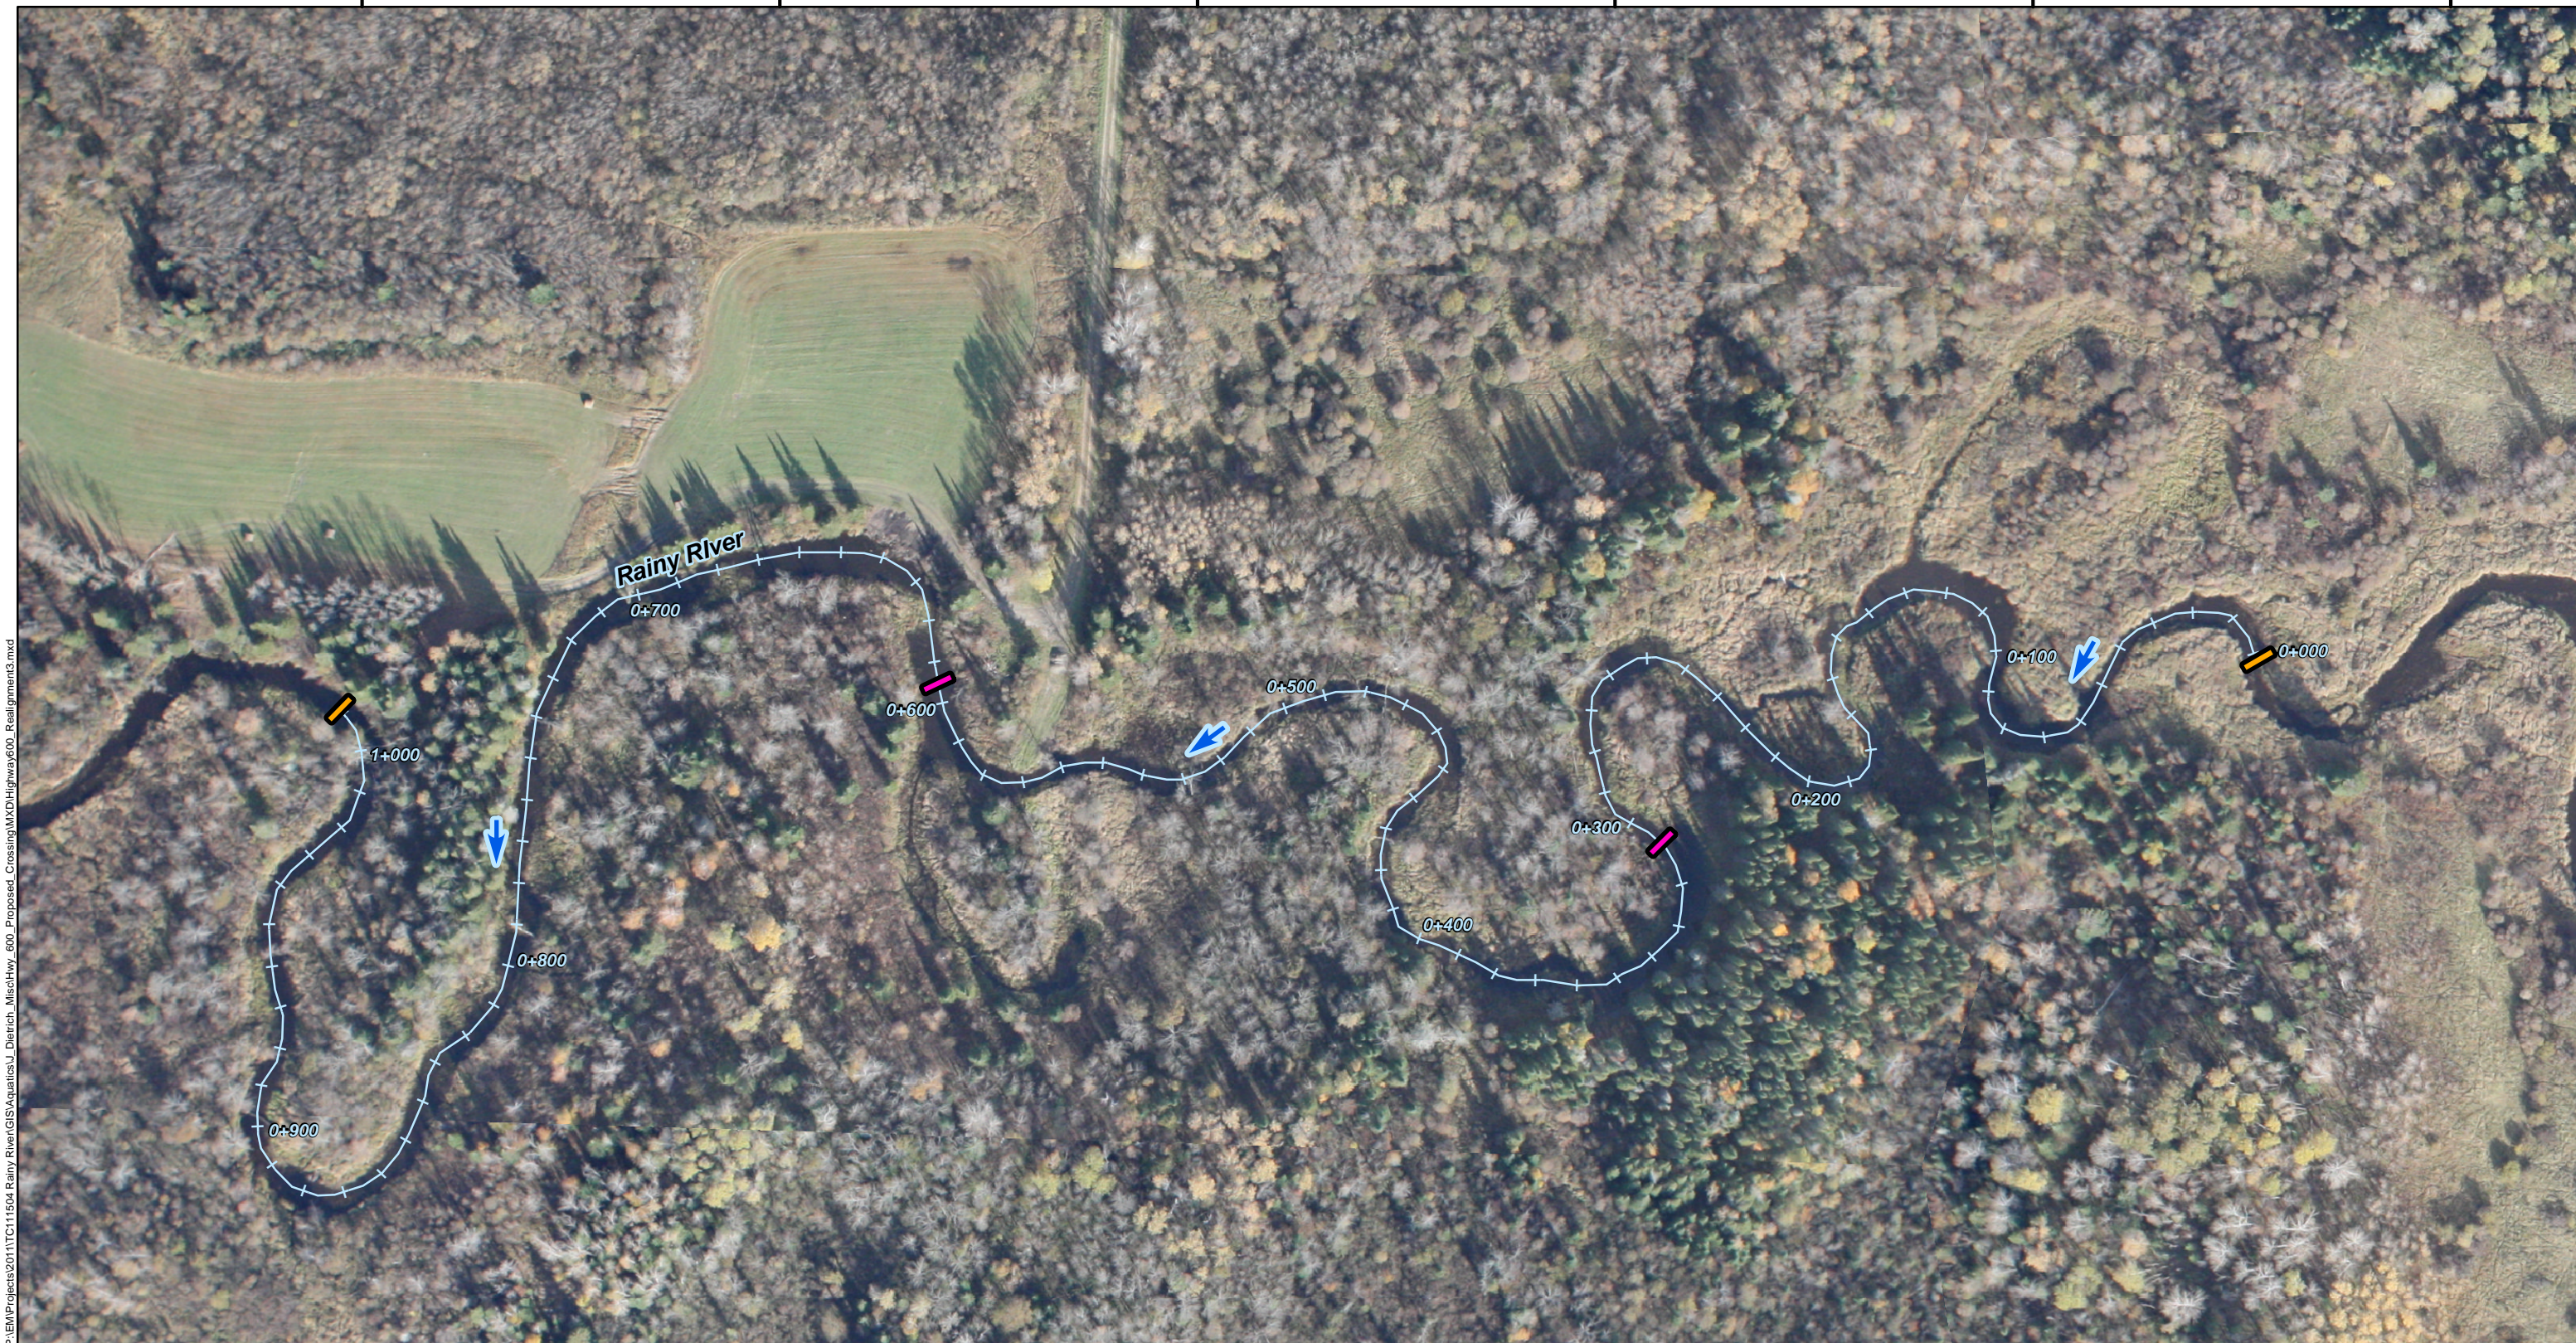
FIGURE: 1-3

**Location of Works for
Pinewood River Crossing**

Rainy River Resources Ltd. (RRR) has been exploring the Rainy River Project (RRP) situated on private lands in the Township of Chapple, approximately 65 kilometres (km) northwest of Fort Frances in northwestern Ontario (Figure 1-1). The RRP is a proposed 20,000 tonnes per day gold mine that would entail the realignment of approximately 11 km of gravel-surfaced Provincial Highway 600, south and west of the project site (Figure 1-2), in order to facilitate the development of the open pit and associated stockpiles. The Universal Transverse Mercator coordinates for the centroid of the proposed open pit are at 425660E, 5409700N (NAD 83 Zone 15). The RRP site and surrounding lands are dominantly privately held, with RRR holding a very large private land package. The approximate 11 km realignment follows a height of land and existing roadways and as a result requires only a single water crossing of the Pinewood River as shown in Figure 1-3.

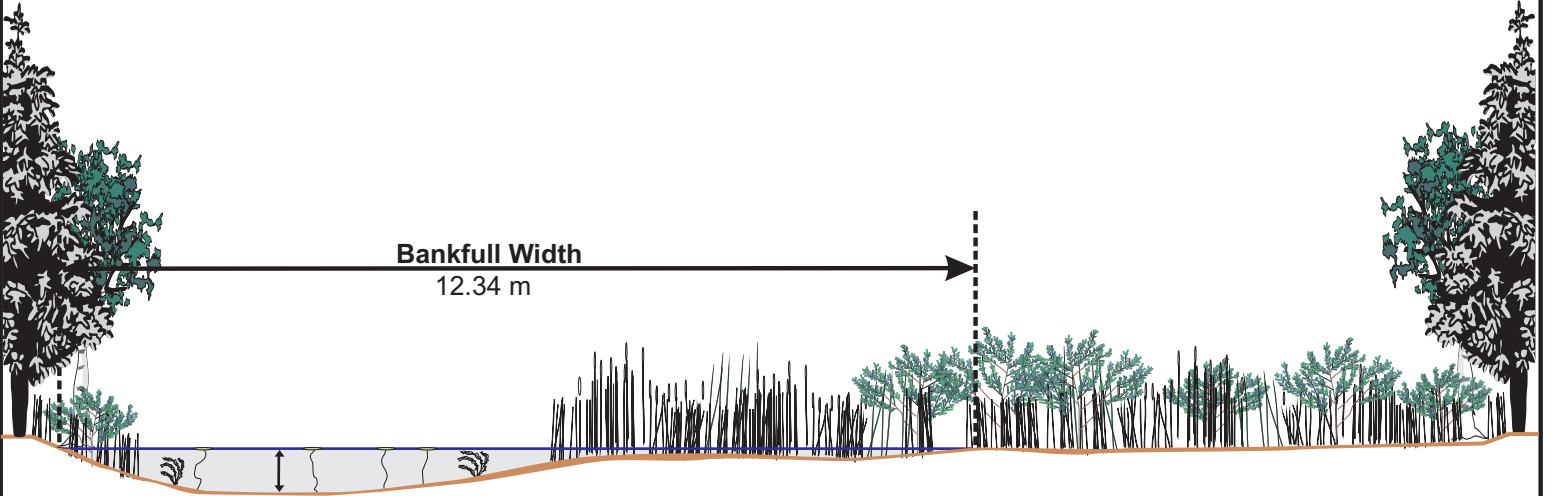
Pinewood River (0+000)

Bankfull Width
12.34 m

Bankfull Depths 0.83 m - 2.35 m

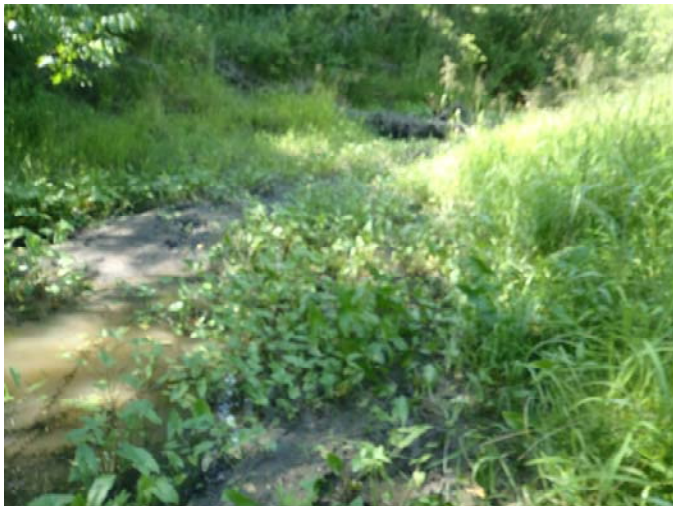
Photo 1: Intermittent back-channel at downstream of PIN-9 sampling location.

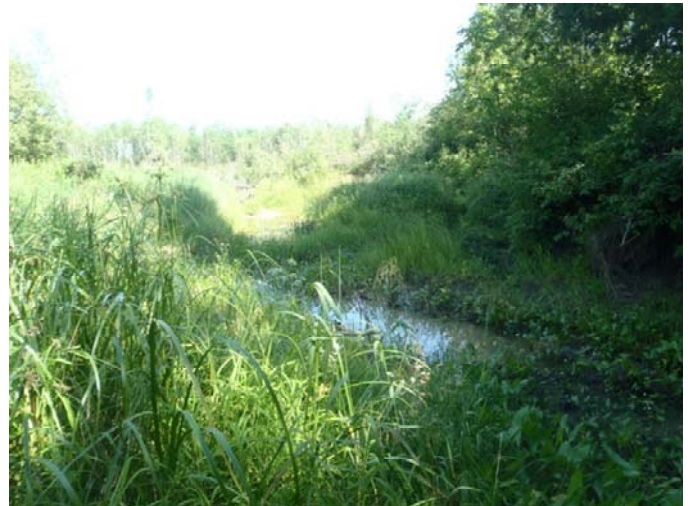
Photo 2: PIN-9 riparian vegetation (looking upstream) dominated by grasses.

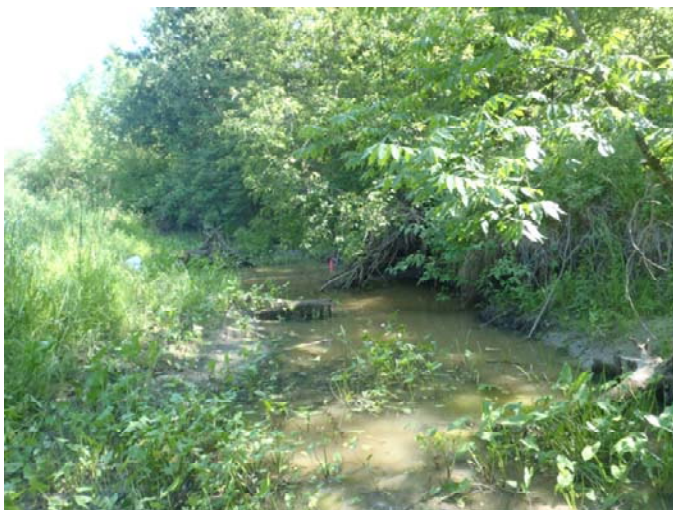
Photo 3: Pinewood River at PIN-9 exhibited high amounts of in-stream cover ($\approx 60\%$), undercut banks ($\approx 10\%$), debris ($\approx 25\%$ woody and $\approx 5\%$ organic) and vascular macrophytes ($\approx 20\%$).

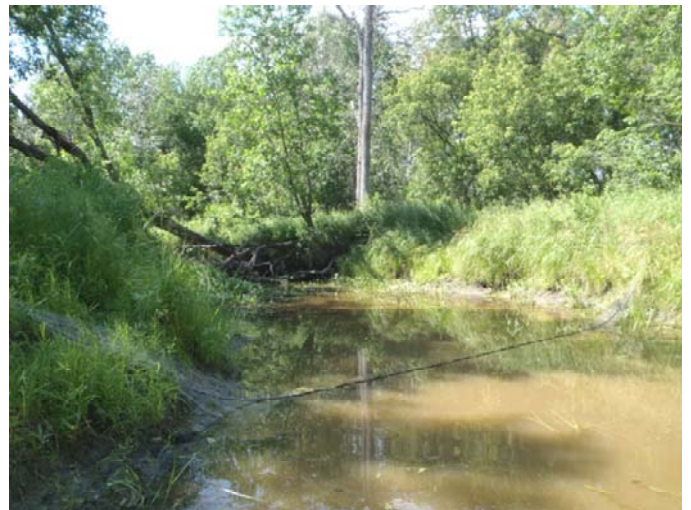
Photo 4: Gill net set across pool at PIN-9 during field reconnaissance (summer 2012).

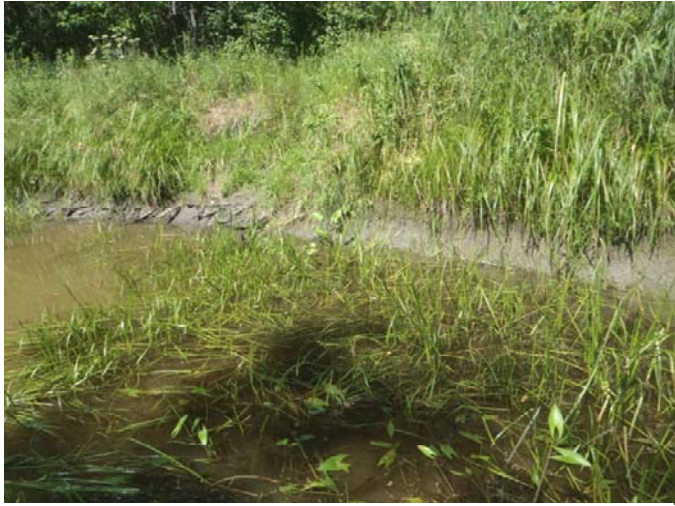
Photo 5: Aquatic vegetation 200 m downstream PIN-9 was dominated by coontail ($\approx 20\%$), floating pond lily ($\approx 10\%$) and arrowhead ($\approx 20\%$).

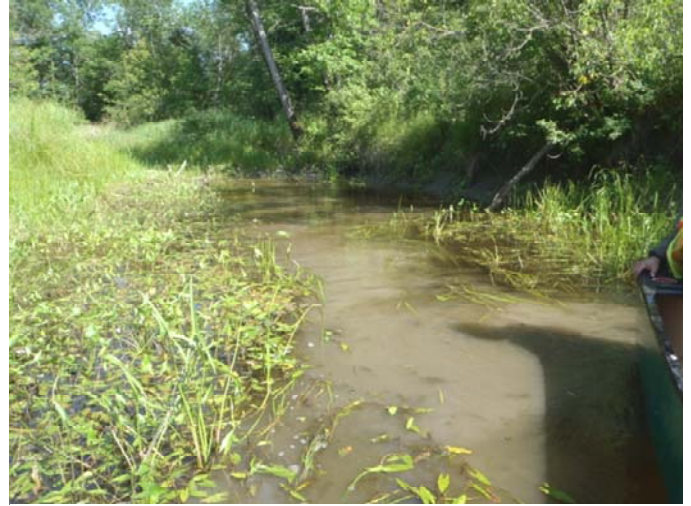
Photo 6: Pinewood River, facing upstream 200 m downstream PIN-9. Low water conditions, steep entrenchment and dense aquatic vegetation

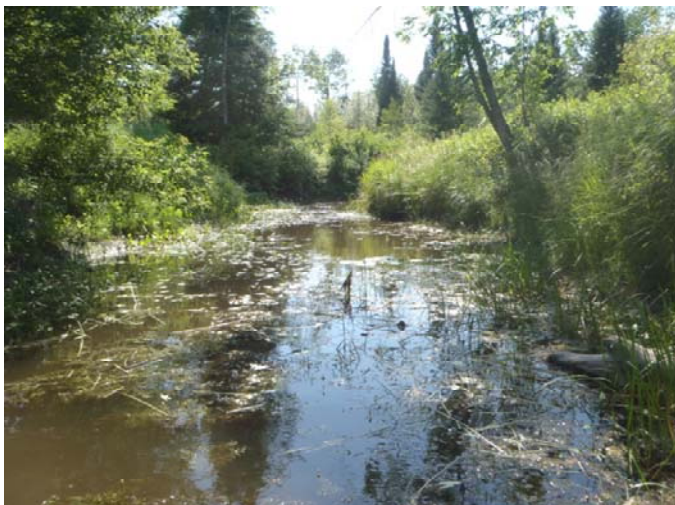
Photo 7: Flat water, with minimal bank undercutting ($\approx 5\%$), and instream ($\approx 10\%$) and overhanging ($\approx 15\%$) woody debris 200 m downstream PIN-9.

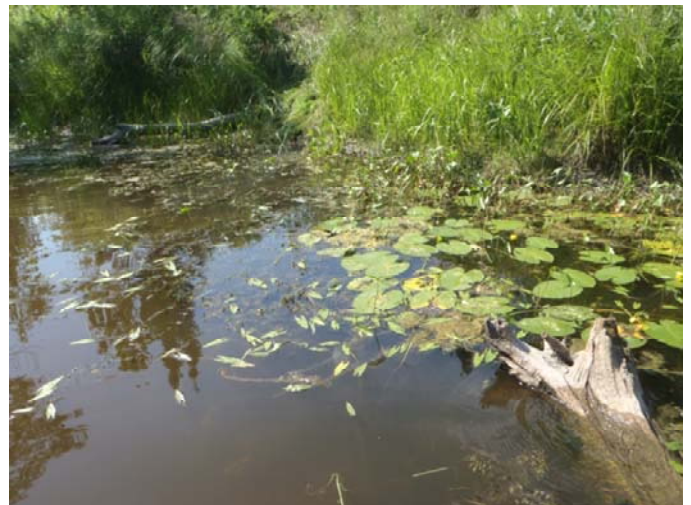
Photo 8: Standing pool with organic debris ($\approx 20\%$) and instream ($\approx 20\%$) and overhanging ($\approx 20\%$) vascular macrophytes.
