DATE October 12, 2010**PROJECT No.** 09-1416-0004/3100**TO** Derek Holmes
BURNCO Rock Products**CC** Mark Johannes, Fred Shrimmer, Rowland Atkins**FROM** Richard C. Butler, P.Eng.**EMAIL** rbutler@golder.com**GEOTECHNICAL STABILITY ASSESSMENT
COMPENSATION GROUNDWATER CHANNEL
MCNAB VALLEY PROJECT**

This memorandum presents the results of geotechnical stability analyses of the existing slopes of the compensation groundwater channel located within the southerly portion of the overall McNab valley and an engineering assessment of the impact of these stability conditions on the safety and performance of the compensation channel.

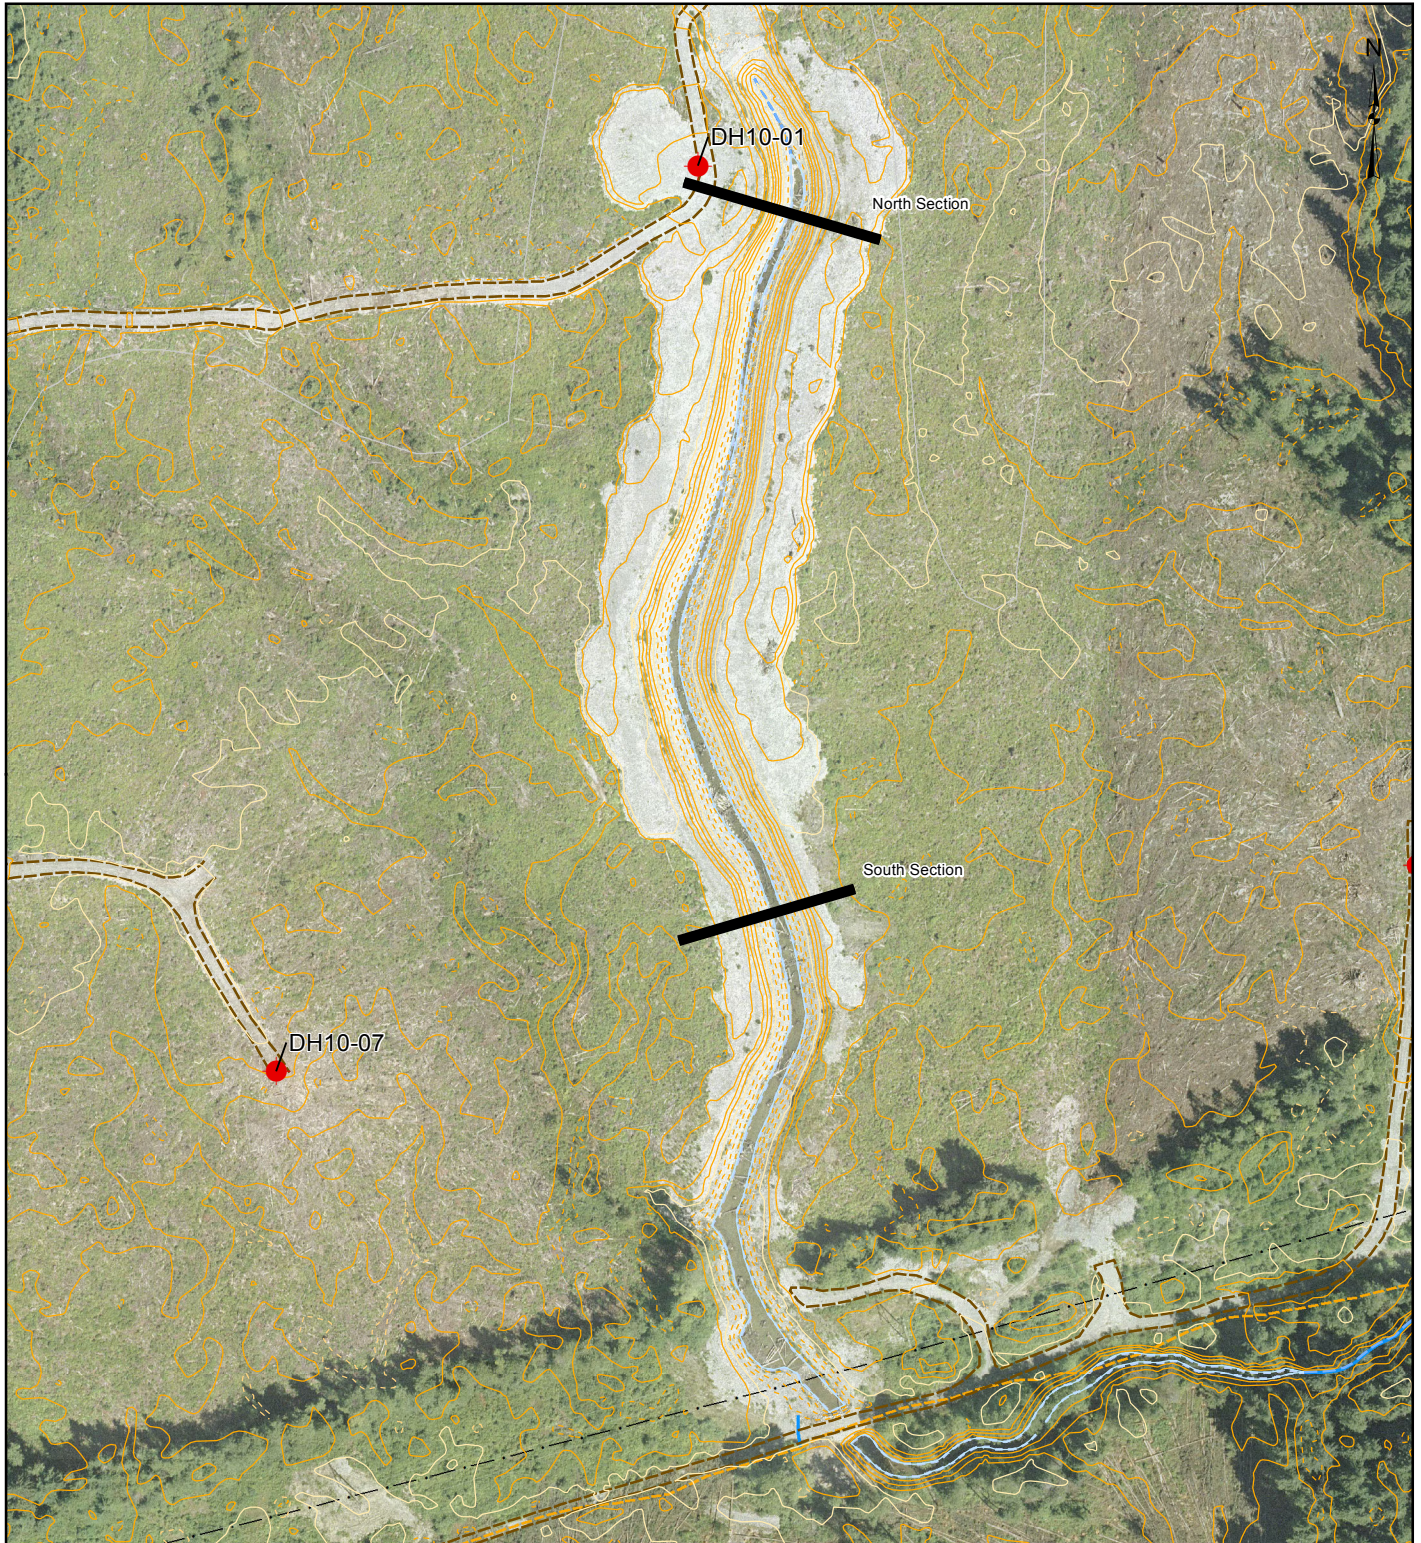
Based on the results of review of the available topographic mapping, test hole data and recently available groundwater level monitoring, the stability analyses results confirm that the existing compensation channel slopes do not achieve adequate Factors of Safety of 1.3 or more against deep seated slope failure. The steeper portions of the compensation channel, such as that represented by the North Section, are considered to represent a significant risk of large scale instability or slope movements.
